# Guest Road and Shallow Bay Road Intersection Improvement STA 100+75 to STA 112+31 Highway 16 Cluculz Lake, BC Geotechnical Assessment Report

April 2023

GK-18-750-MOT-13 (212111-05)

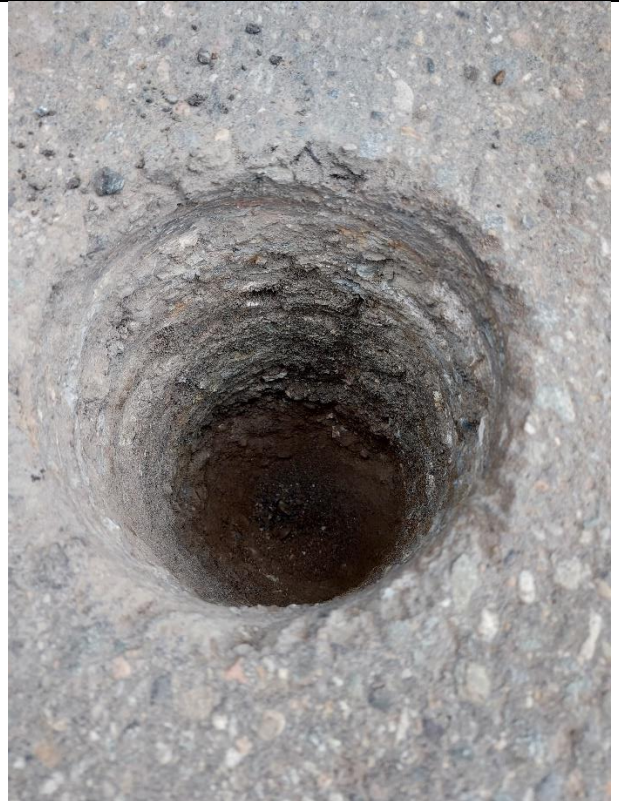
Photo 13 TH21-05 from 0 m – 1.5 m

Within holes TH21-05, TH21-06, TH21-08, TH21-09, TP21-02, and TP21-03 this material was encountered at depths ranging from 1 m to 1.5 m below existing grade and extending to the full depth of the respective (shallow) test hole or test pit. At TH21-01 and TH21-02 this material is found at shallow depths and interlayered with sandier layers and clay layers.

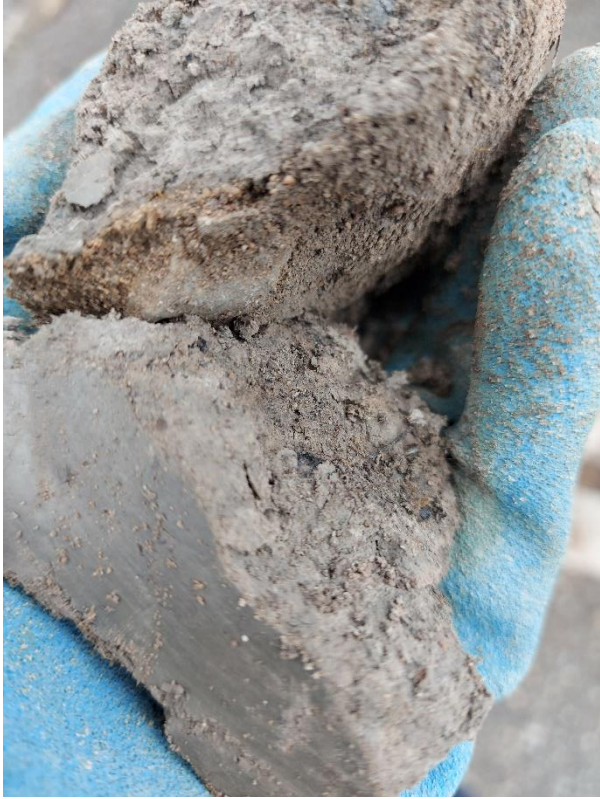
Photo 16 TH21-07 drilled material

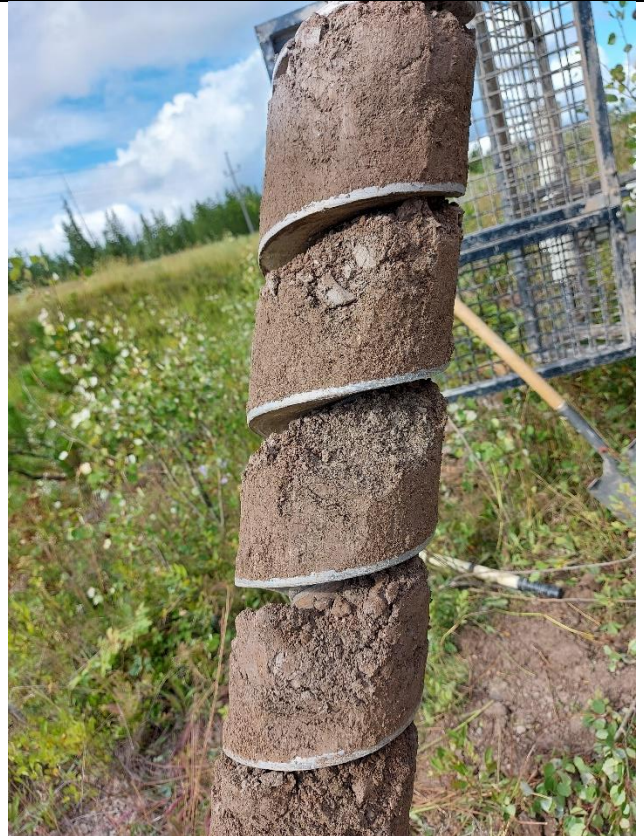
Photo 21 TH21-09 SPT09-1 split spoon

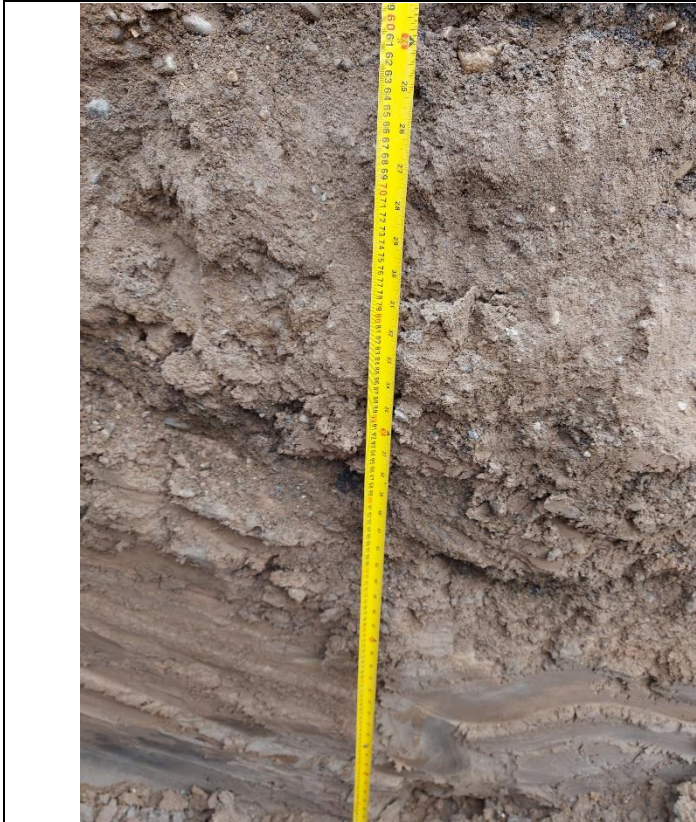
Photo 24 TH21-01 drilled material at 12 m

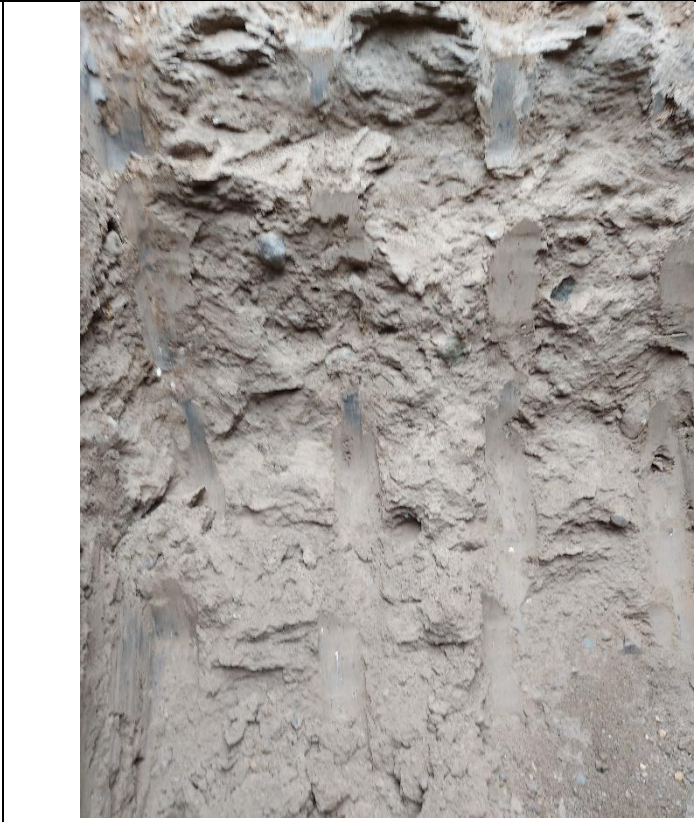
Photo 25 TP21-01 Excavation

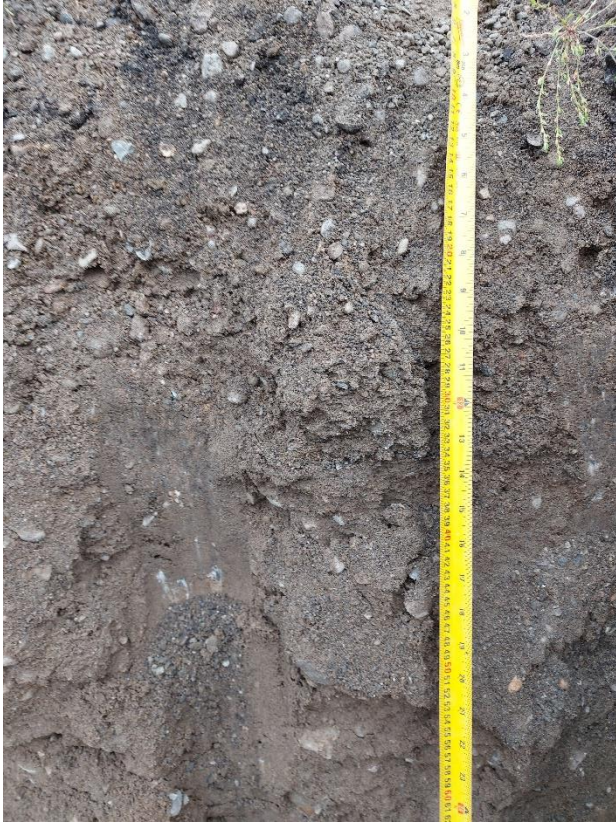
Photo 28 TP21-04 Excavation

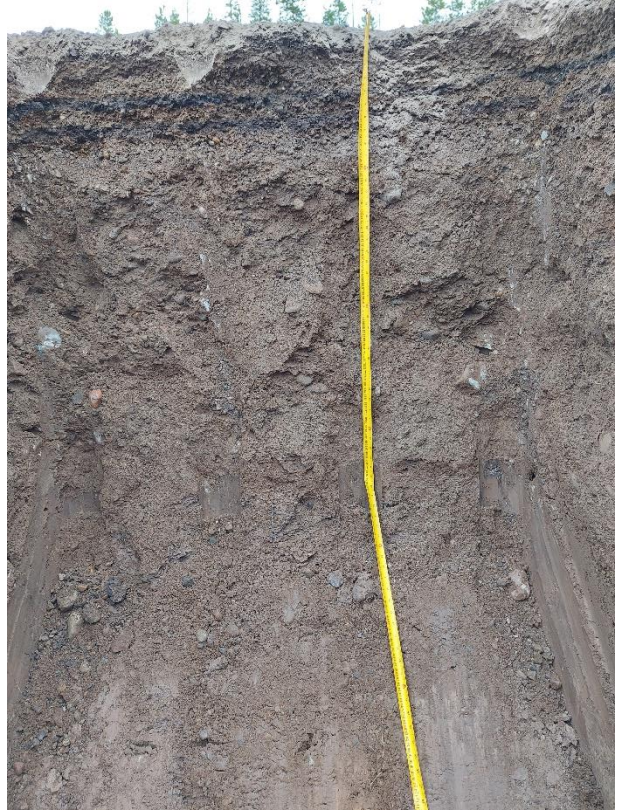
Photo 29 TP21-05 Excavation
