**Aquatic and Terrestrial
Assessment:
Shallow Bay Road and
Guest Road Intersection
Improvements**

September 2021 | Revision 0

Submitted to: Ministry of Transportation & Infrastructure
Prepared by McElhanney

Our file: 2341-02745-09

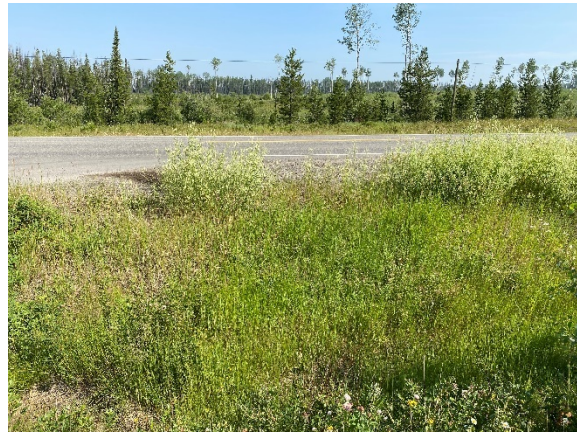
The topography is relatively flat with the ground elevation at the highway measuring approximately 780 m. The herb and shrub layer observed within the project footprint was typical for roadsides found within this region and included species such as fireweed, clover, prickly rose, dandelion, vetch, horsetail, yarrow, wild strawberry, willow, alder, paintbrush, spirea, and grasses. Tree species, observed mainly along the edges of the RoW, were typical of species found within the lower elevations of the SBSdw3 subzone. Invasive species of note included white sweet-clover (*Melilotus albus*), orange hawkweed, yellow hawkweed species, and oxeye daisy.

Photo 2: View north of roadside vegetation at the Shallow Bay Road intersection with Highway 16.

Several invasive plant species were identified within the immediate project area. A plan should be developed that addresses any soil movement in these areas to reduce the potential for spreading the plants. The construction contractor hired to conduct the construction should be made aware of this plant and ensure their equipment is free of plant parts prior to starting work and clean equipment prior to leaving the site to reduce the spread of invasive plants.

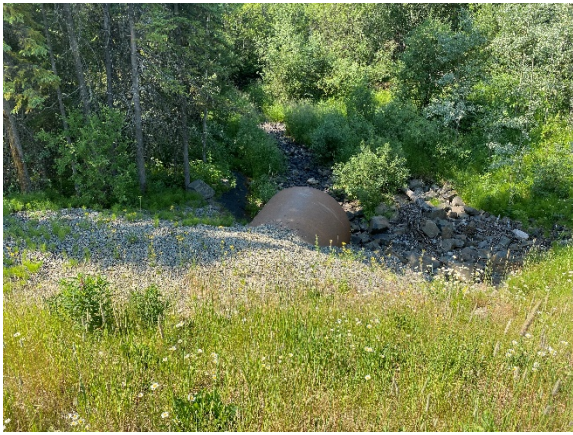
The unnamed stream crosses the highway towards Clucluz Lake through a 2400 mm steel culvert (70.2 m in length and dropping approximately 1 m in elevation). North of the highway, the channel is split, and both streams flow into a small pond (approximately 500 m²) directly upstream of the culvert. The culvert contains baffles, which in high flows would reduce the velocities to enable fish passage.

Photo 3: View downstream of the 2400 mm steel culvert.

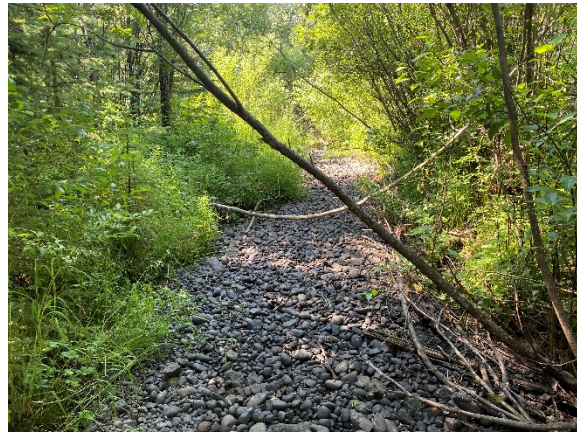
At time of assessment, water from the pond downstream was restricted by low flow conditions, potentially due to beaver activity upstream of the pond. Small pools of water were present behind each baffle within the culvert, but downstream of the culvert, the channel was dry. Fish sampling was not conducted; however, four Rainbow Trout (100 to 140 mm in length) were observed from the outlet in the pools of water within the culvert. The channel downstream from the culvert contained cobble and gravel substrate and had abundant overhanging vegetation.

Photo 4: View downstream of the dry channel south of the 2400 mm steel culvert.

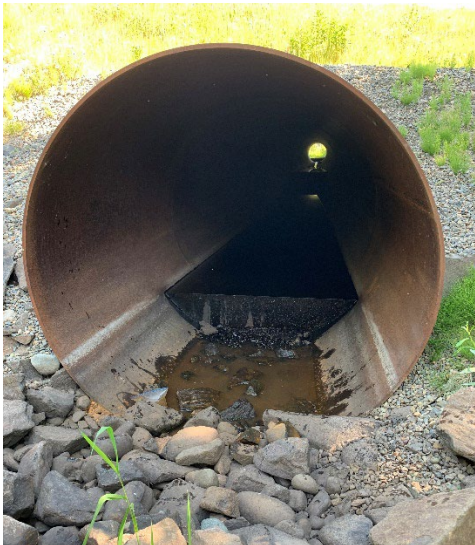
Photo 5: View upstream of the 2400 mm steel culvert and baffles where fish were observed.

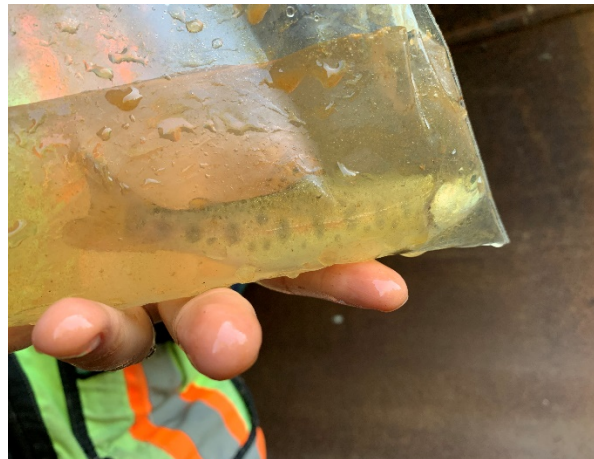
Photo 6: Rainbow trout observed within a pool of the lowest baffle (within the culvert).

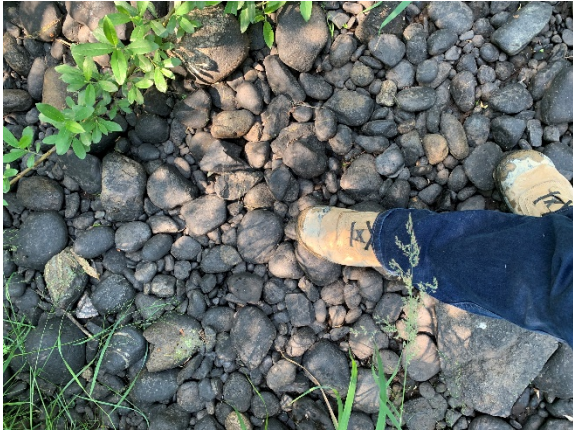
Photo 7: The channel substrate immediately downstream of the existing crossing.

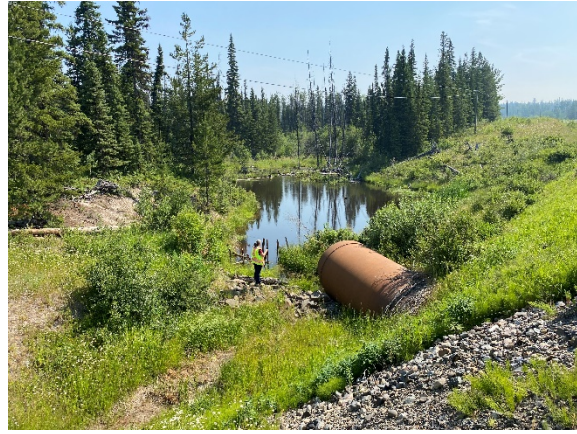
Photo 8: The pond immediately upstream, of the existing crossing, looking northeast.

There is potential for amphibians to be found throughout the project area, in particular the area surrounding the pond upstream of the unnamed tributary. It is recommended a general sweep of the area be conducted well in advance of any construction works. If any are found, a salvage permit from the province is required prior to moving any amphibians. Permits may take 60 to 90 days to obtain.

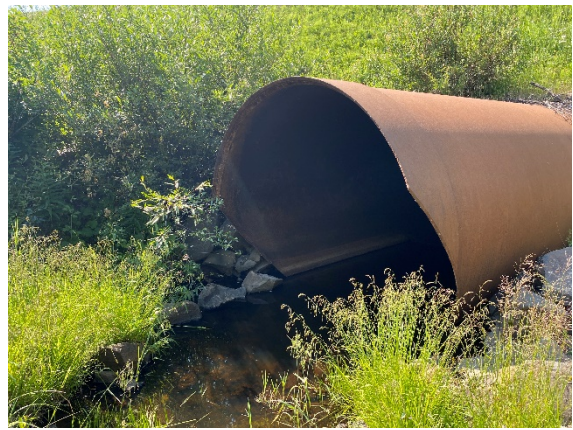
Photo 9: View of the 2400 mm steel culvert inlet from the pond.

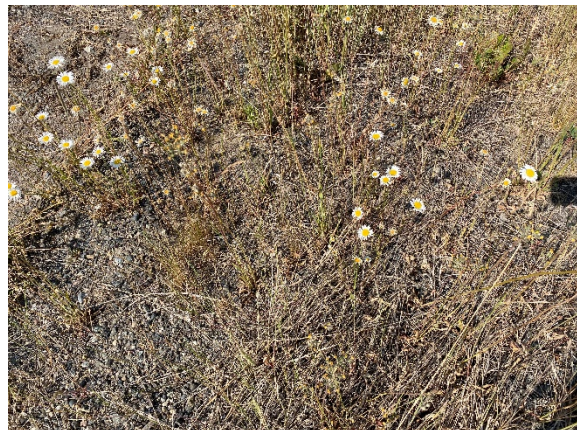
Photo 10: Roadside vegetation along Highway 16.
