# Friesen Farm Book - 2017

Prepared by: Ruth McDougall, M.Sc., PAg., Consulting Agrologist

v. 2 October 23, 2017

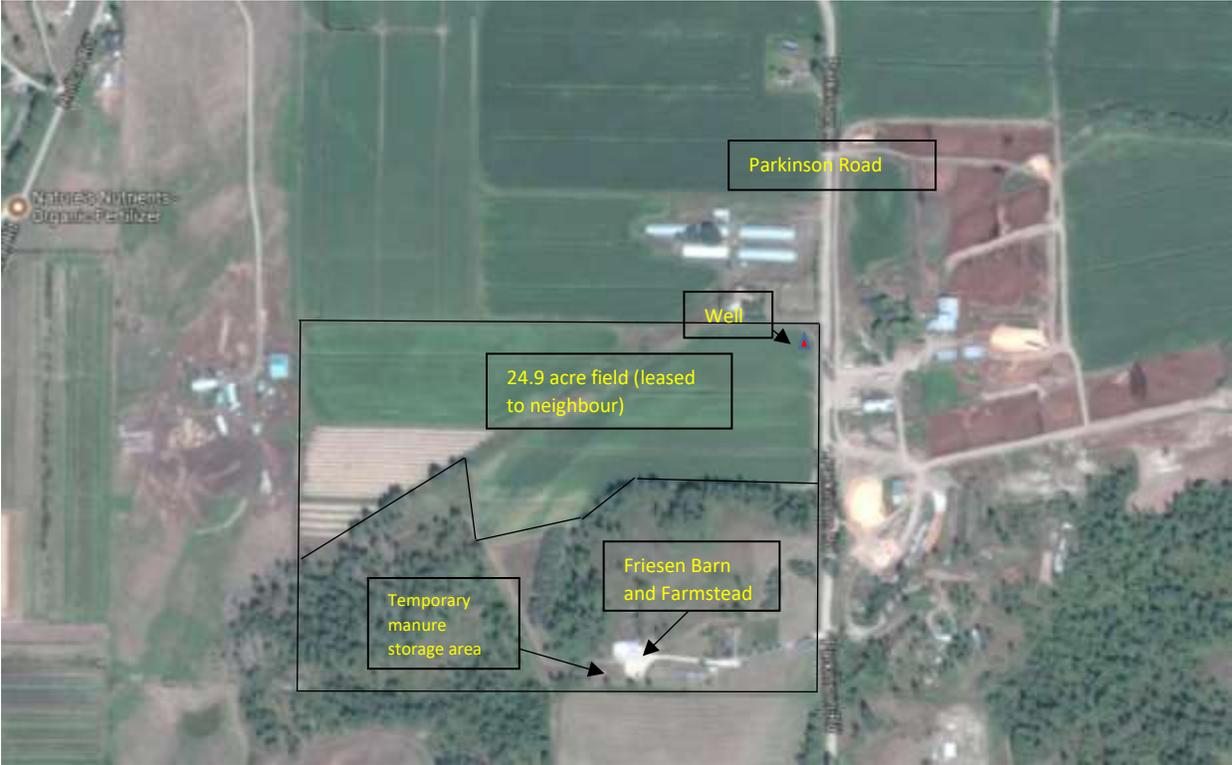
**Figure 1. Site map showing Friesen property boundaries, arable land, manure storage area and domestic well. Farm located on Parkinson Road, Spallumcheen BC**

**Surface and groundwater, and wells:** There are no surface water sources including seasonal streams on the Friesen property. The farm has one well which is located in the northeast corner of the leased field (marked on site map). All lessee’s are made aware of the well and respect the required 30 m manure application setback. Groundwater in all areas of the property is expected to be greater than 1 m from the soil surface throughout the year due to the coarse texture of soils and the distance to groundwater in the area.

The Friesen 60 acre property consists of a 24.9 acre field which in 2017 was leased to Curtis Farms who grew silage corn on the field. The field makes up the northern half of the property (see site map). It is located on the valley bottom over the Hullcar aquifer. Because Friesen does not farm the field or use any of his manure on the field, manure and fertilizer use on the field are not discussed in this Farm Book. The field is covered under the 2017 Curtis Nutrient Management Plan.
