# 2016 Farm Book – Canyon Road Farms Ltd.

Prepared by: Ruth McDougall, M.Sc., PAg, Consulting Agrologist

V3. July 19, 2016

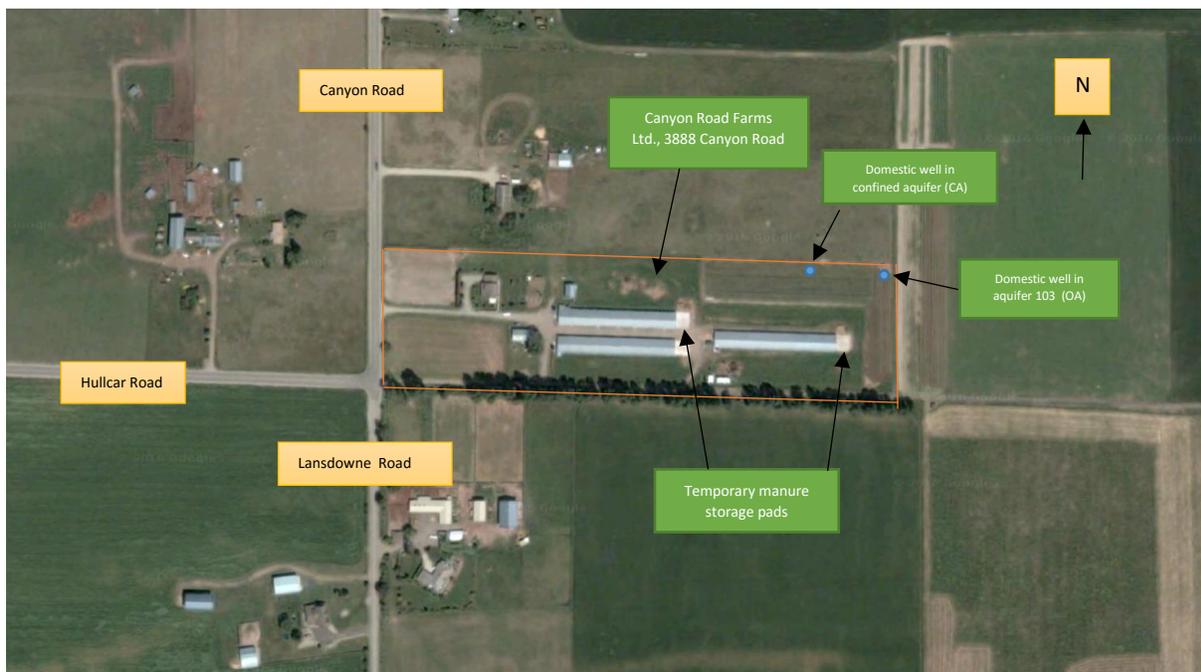
**Site Map: Canyon Road Farms Ltd., 3888 Canyon Road, Armstrong BC**

Canyon Road Farms consists of 10 acres of land (4 hectares) located at the junction of Canyon, Hullcar and Lansdowne Roads in Spallumcheen BC. The operation consists of 3 barns used for the production of broiler chickens as well as a dwelling and outbuildings (see location map and site map). Each barn is sized to produce 15,000 birds per cycle. The barns and farmstead occupy approximately half of the land base, leaving approximately 5 acres or 2 hectares of potentially farmable land. Broiler birds were produced on this site from 1985 to January 2016. The farm's quota was sold in February 2016 and production of birds has ceased due to owner retirement.

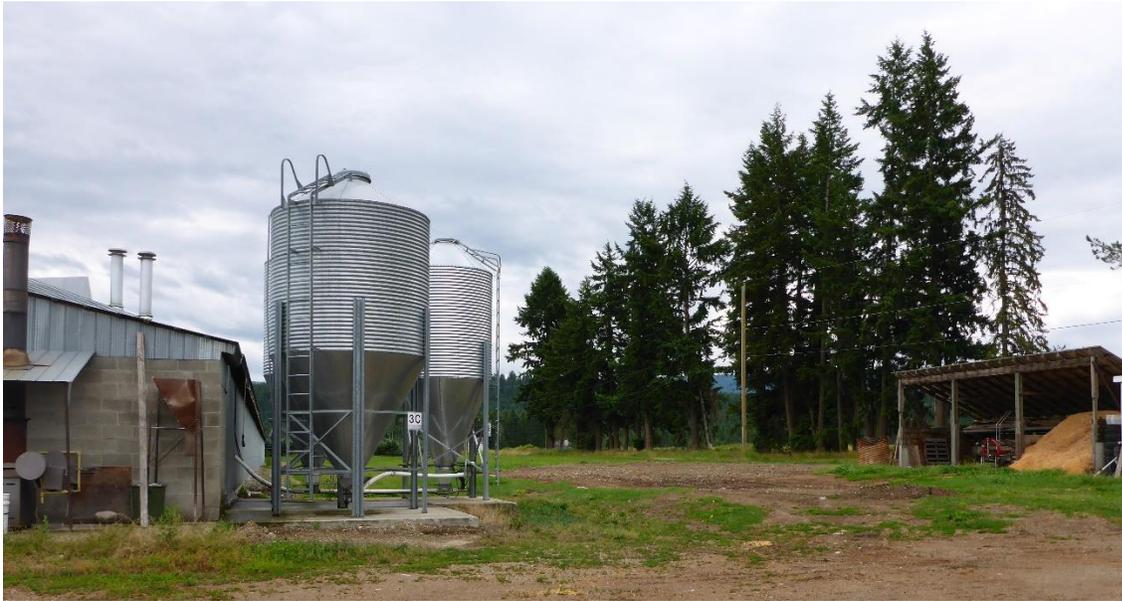
Photograph 1. Site of compost pile which was removed on June 1, 2016. Photo taken June 27, 2016.

Canyon Road Farms was in operation from 1985 until January 28, 2016 at which point the operation stopped producing chickens; the farm's quota was sold on February 10, 2016 (see Appendix 2. Proof of sale of quota). After that time, the barns were leased on a short-term basis to another operator who grew chickens in the barn for two cycles (approximately 3 months). Since May 29, 2016, the barns have been empty. No birds will be grown in the barns until the operation is sold. The owners are planning to sell the property. All manure has been removed from the property including a small pile of broiler manure compost that the owners were using to amend their vegetable garden (Photograph 1).

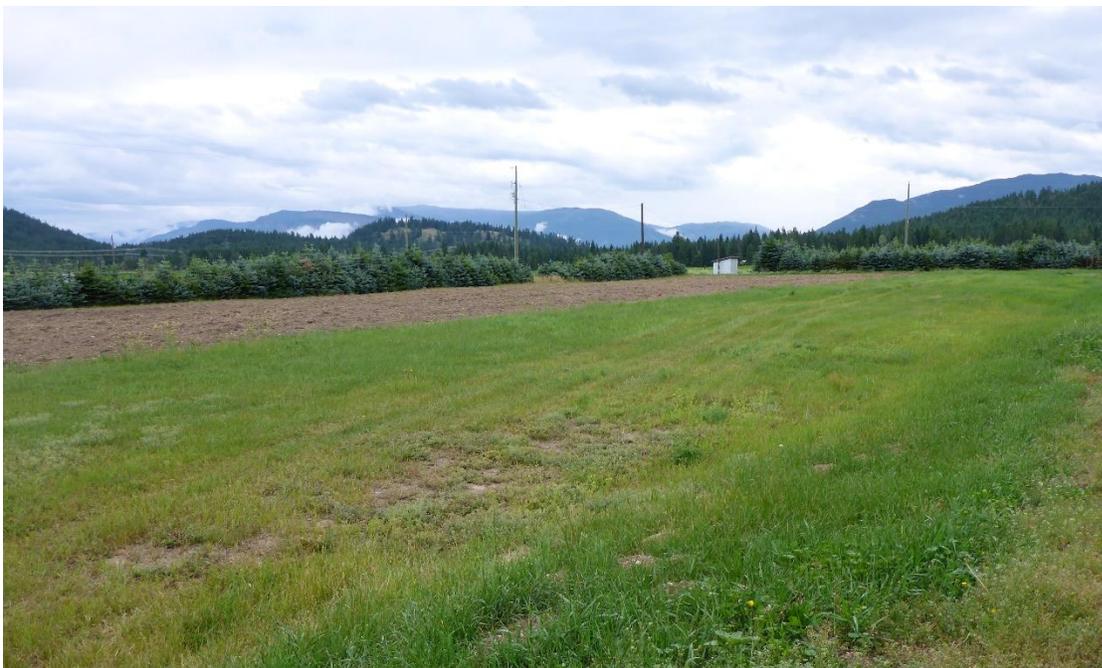
Photograph 2. Trees, fallow land and area of agronomic grasses to north of barns, June 27, 2016.

**Land use:** The owners have never applied any of their broiler manure or any other manure on their own land base (aside from a small amount used to amend their home vegetable garden). They have not produced crops on their land. They have not applied chemical fertilizer to the land. The land was leased for a short period of time between approximately 2005 and 2010 to a neighbour to grow trees, but that project was abandoned in approximately 2010 and since then the land has been neither fertilized nor irrigated. A small number of trees remain in the approximately 0.25 ha area that was planted to trees, and the remainder of the farm's arable land is fallow or planted to agronomic grasses which are not fertilized or harvested but are mowed periodically (Photograph 2).

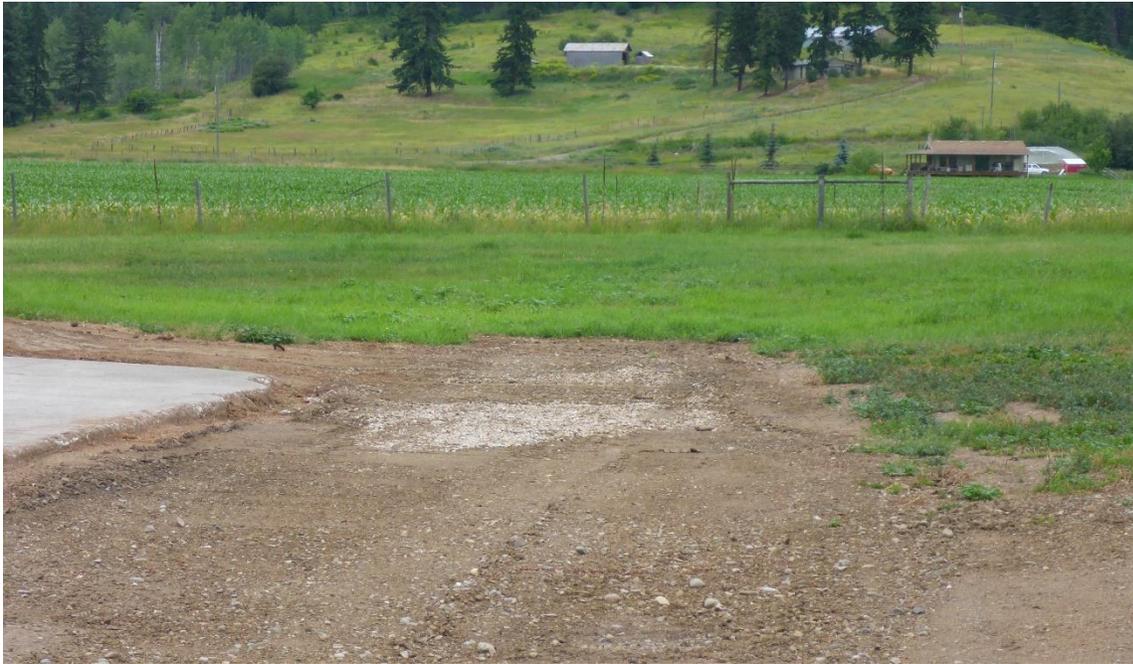
Photograph 3. Area where periodic runoff dissipates into ground (grassed area to north of barns) on June 27, 2016.

2. **Drainage management measures:** The farm requires no clean runoff management measures. There are no permanent or seasonal watercourses running through or within 30 m of the property. The farm's owner indicated that approximately once every 5 years during extreme spring melt events, a small volume of runoff water moves from the property to the south onto the subject property, flows in a south-north direction in the area between the two westerly barns and the easterly barn, and dissipates into the ground on the north edge of the property (Photograph 3). This occurs during February or March and when it occurs the flow lasts for 2 to 5 days depending on day and night temperatures, snow load and presence of frost in the ground. There is also occasionally pooling of snow melt water in areas of the property. The runoff/snowmelt water is not present in sufficient volume to contact manure should it occur when there is manure stored on the concrete pads, and therefore poses no risk of creating contaminated runoff or leachate.

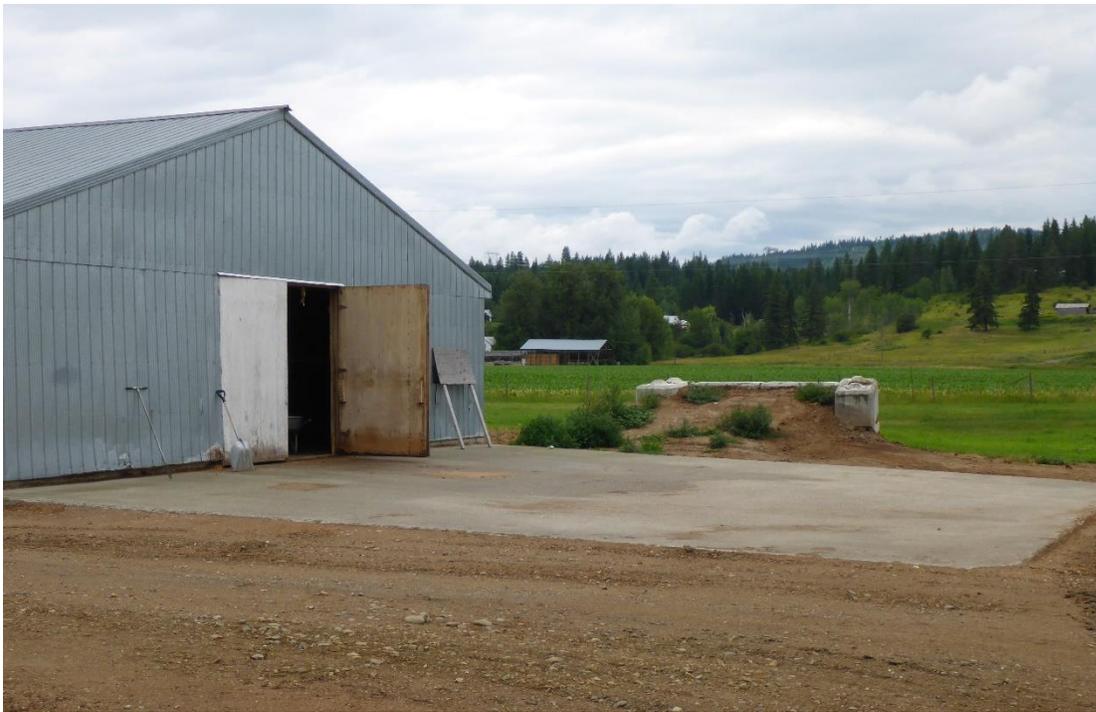
3. **Permanent and temporary manure storage facilities:** The farm currently has sufficient short term manure storage to hold manure from one cycle from each barn. The storage is in the form of 12 m by 12 m concrete pads extending off the back of each barn (Photograph 4). This provides approximately 120 m<sup>2</sup> of storage area assuming a 1 m setback from pad edges when manure is stored. Each barn holds 15,000 birds, and at 0.096 L of manure plus bedding per day per broiler (BCMAF 2010) over a 42 day cycle, approximately 60 m<sup>3</sup> of litter (manure+bedding) is produced each cycle in each barn. This would require an area approximately 8 m by 8 m, or 64 m<sup>2</sup> to store safely. Based on these calculated manure volumes, the existing concrete pads attached to each barn are of sufficient size provided that manure is hauled away after each cycle which has been the normal practice at the farm. These storages have been used for temporary

Photograph 4. Concrete pad for temporary manure storage as of June 27, 2016.

7. **Recommendations for future manure management on site:** If the operation is sold, and/or if production recommences in the existing barns, it is recommended that the operators implement the same manure management strategy as has been used historically on the site because the farm does not have sufficient land base to utilize the manure produced by the operation. It is recommended that manure is stored temporarily on the concrete pads outside each barn, and hauled away to be utilized elsewhere. Manure should be covered immediately after being removed from the barn.
