**From:** [spomo1701@outlook.com](mailto:spomo1701@outlook.com) [<mailto:spomo1701@outlook.com>]  
**Sent:** Thursday, November 30, 2017 5:22 PM  
**To:** Environmental Compliance ENV:EX; [marty@chholdings.ca](mailto:marty@chholdings.ca)  
**Subject:** SPO MO1701 20171130 Status Update

<b>FIELD REVIEW REPORT</b>		DATE: <b>Nov 30 2017</b>	ISLANDER PROJECT No.: <b>2087</b>
REPORT No: <b>9</b>	STAGE OF CONSTRUCTION: <b>Landfill Closure</b>	WEATHER: <b>Rainy 6 deg</b>	PAGE: <b>1 of 3</b>
PROJECT: <b>Cobble Hill Landfill 2017 Minor Construction Works</b>			
TO:	<b>Allterra Construction</b>	ATTENTION:	<b>Rahim Gaidhar</b>
CC:

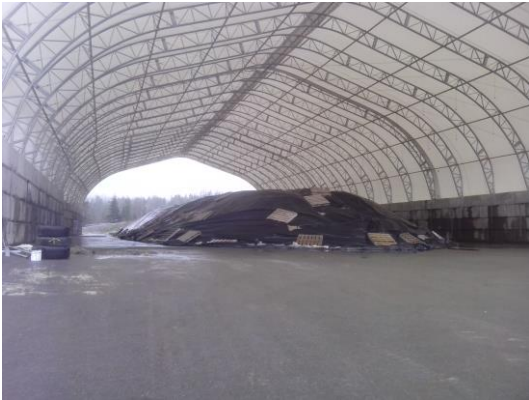
- **No leachate has migrated off-site**
- **Soil Management Area (SMA)**
  - Soil is covered with a PVC liner and weighted down with wooden crates and tires inside the SMA. All works are in good condition and no noticeable changes since the date of our last inspection

**SMA - liner – looking south**

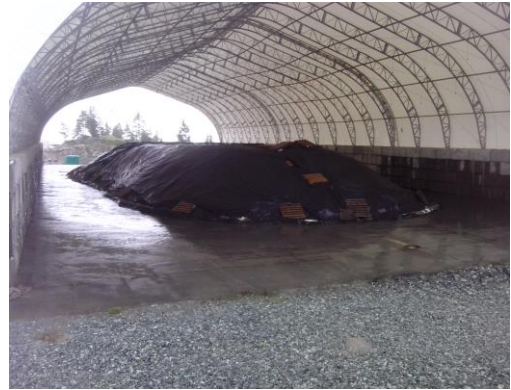
**SMA – looking north**

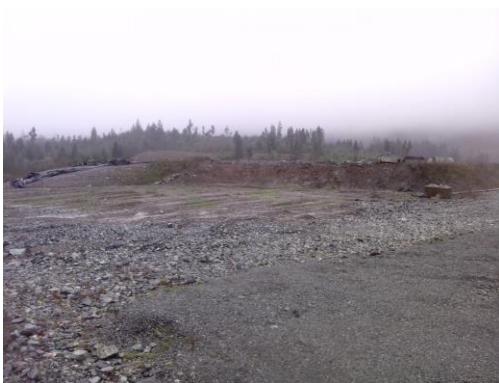
- **Contact Water Containment Pond**
  - All works are in good condition and no noticeable changes since the date of our last inspection
- **cut-off ditch upland of PEA**

**Contact water containment Pond**

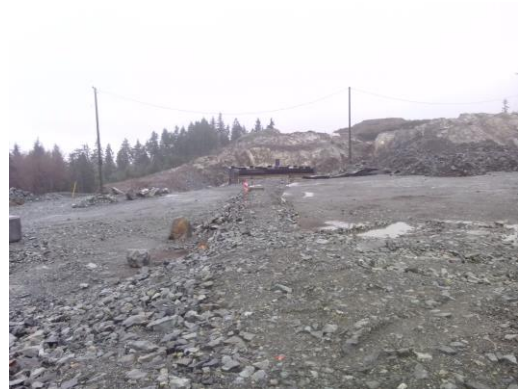
- **Leachate and Leak Detention facility**
  - Leachate collected = 11.79 m<sup>3</sup>; Total Leachate Stored = 43.49 m<sup>3</sup>; leachate transported 0 m<sup>3</sup>

**Pipe trenching and Leachate and Leak Detention facility**

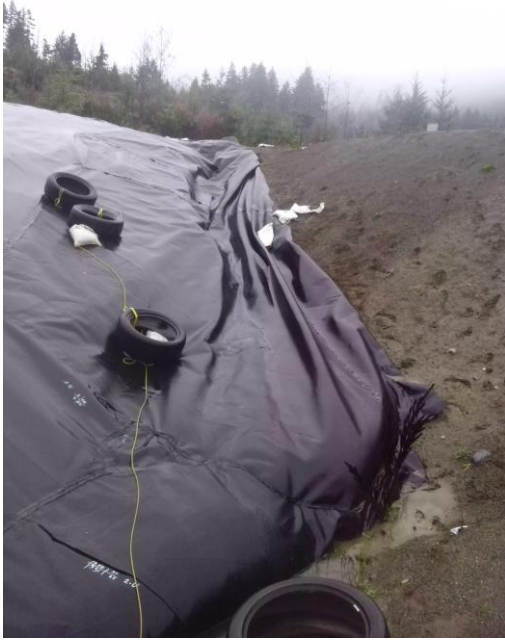
- **PEA**
  - *Liner appears to be in good condition and is shedding water effectively. Continued rains have not compromised the liner coverage and all repairs are continuing to hold up and are in good condition.*

**PEA – liner near NW corner**

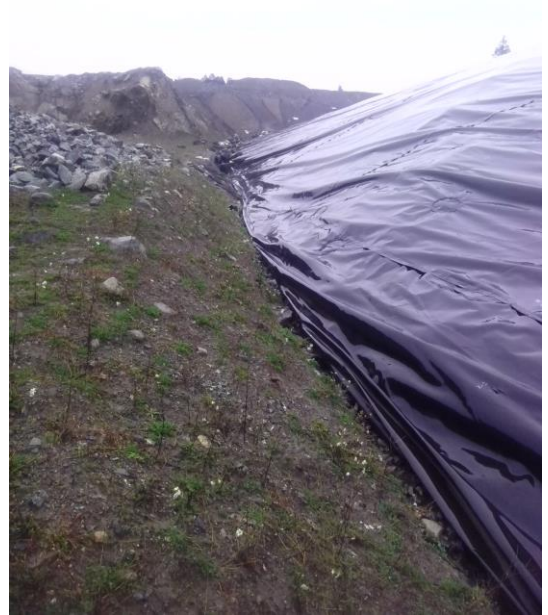
**PEA– NE corner**

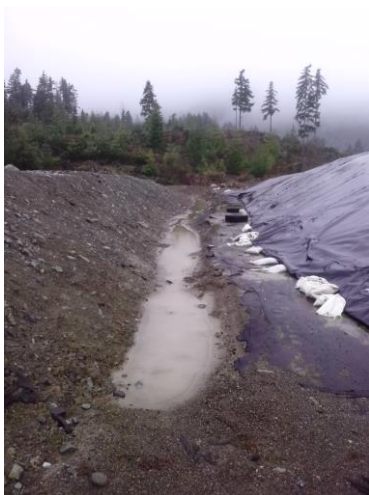
- This ditch continues to perform well. Raining during inspection confirming that ditch is functioning, and that all upland runoff is being contained and diverted around top (south) edge of PEA

**Cut-off ditch upland of PEA**

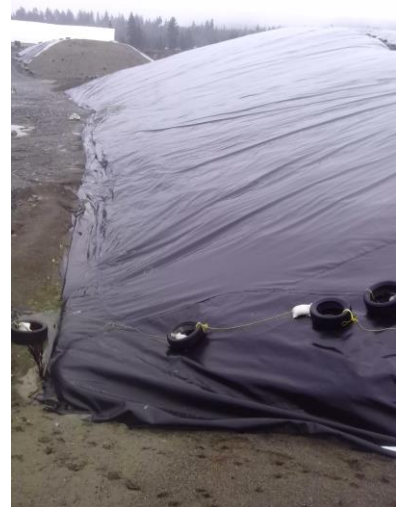
**PEA north face**
