Meadow Avenue Former Wood Treatment Facility, Burnaby, BC

Overview

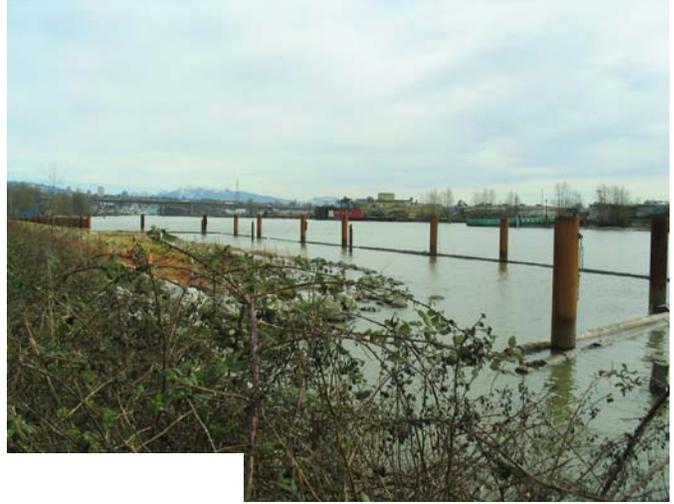
Marshland, riparian zone, and wharf area

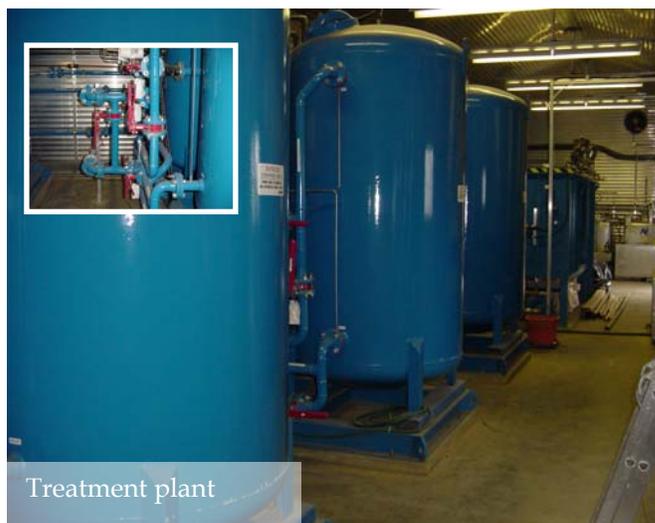
Treatment plant

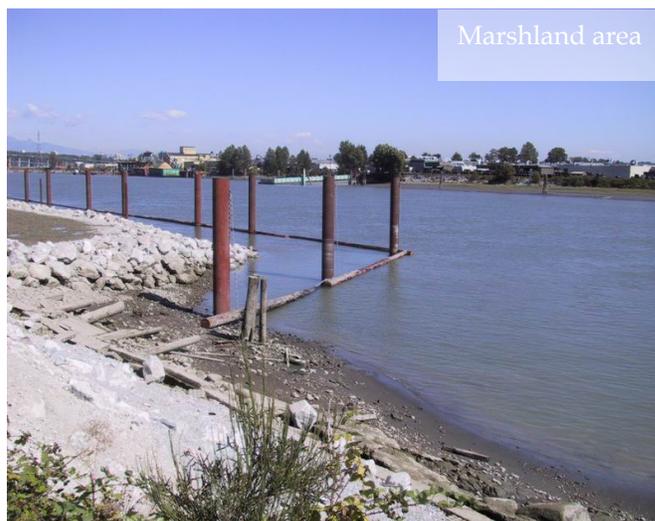
Marshland area
