Re: Warning Letter, Permit, 14590

On April 12, 2017, Ministry of Environment, Environmental Protection Division staff conducted an inspection under *Environmental Management Act (EMA)*, 14590. The inspection determined that Mount Polley Mining Corporation is out of compliance with its Permit 14590, and the section(s) listed below. This Warning Letter lists the compliance verification information contained below.

Ministry of Environment - Photo Record Sheet

PR14590	Mount Polley Mining Corporation
April 12, 2017	Mount Polley Mine

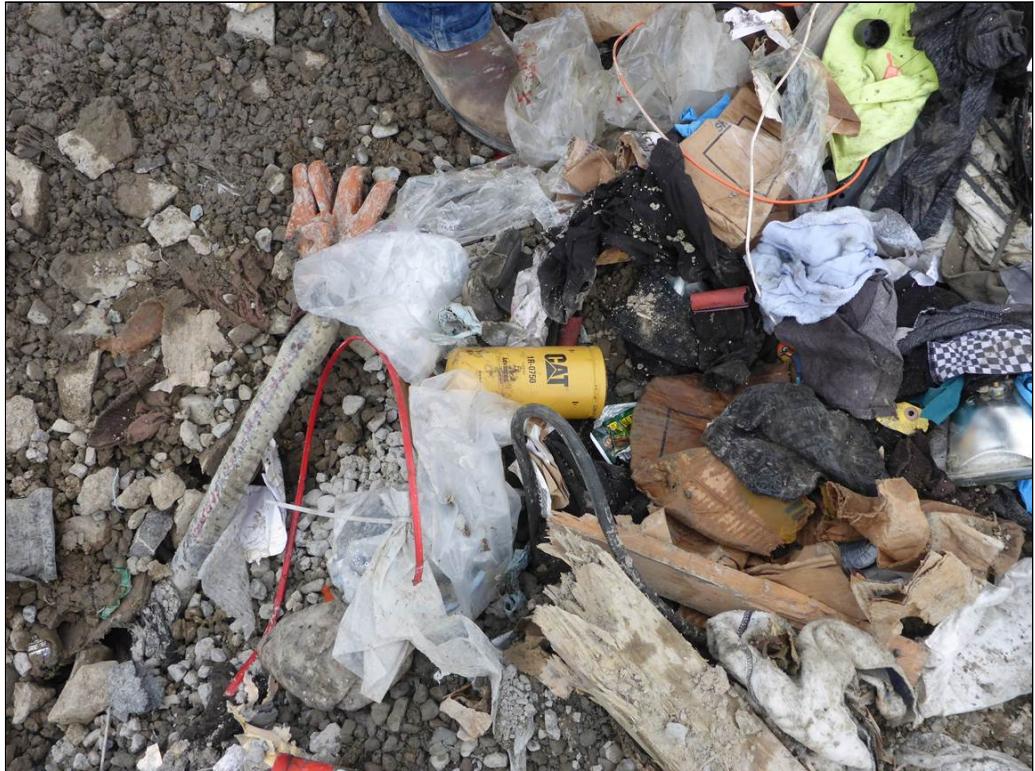
Requirement Description:	1. Authorized Discharges 1.1.2: The characteristics of the discharge shall be paper, cardboard, plastic, wood, rubber, and metal. This permit does not authorise the disposal of putrescible waste.
Details/Findings:	Although the majority of the waste on site was authorized, I did observe a used fuel filter (see Figure 1) and a few empty litre containers of oil. A large pool of water had collected in one area of the landfill, which had waste material floating in it. There was an oily sheen on the surface of the water at the downwind end of the pool (see Figure 2).
Compliance:	Out

Figure 1. Fuel filter disposed of in the landfill. This is considered hazardous waste and is not authorised for disposal at this site.

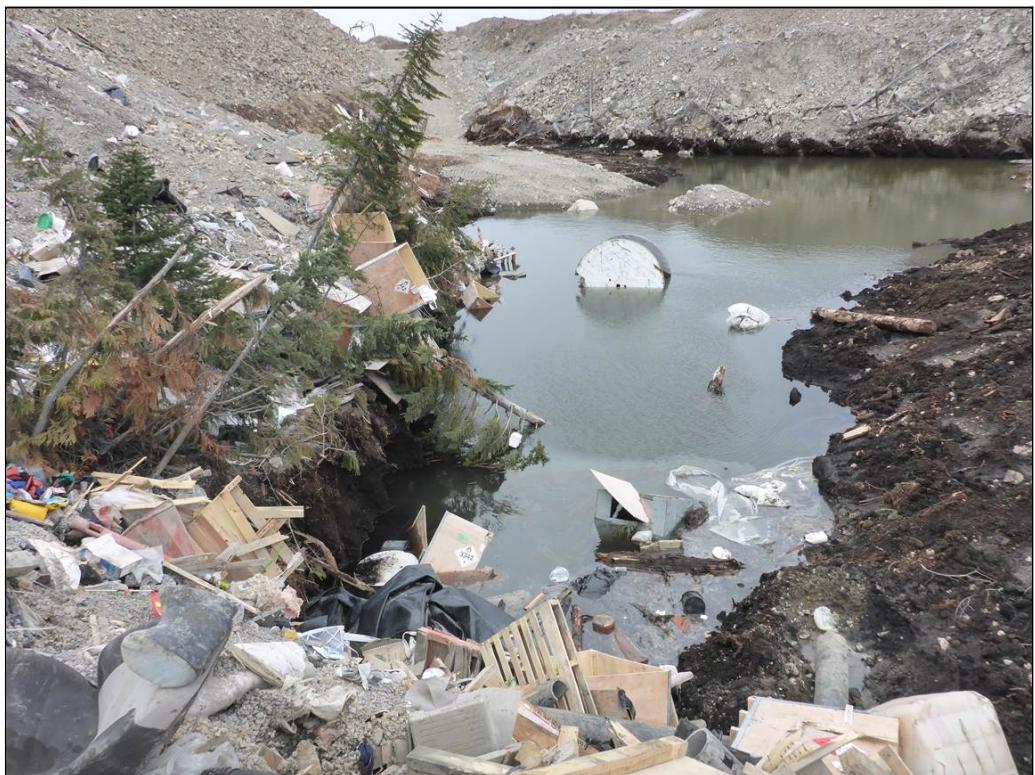
Actions to be taken:	
Requirement Description:	<p>2. General Requirements 2.3 Landfill Operation</p> <p>2.3: The Permittee shall maintain the landfill and apply cover material at least once per month. The Regional Waste Manager may vary the frequency of covering or issue specific operating instructions when circumstances affect normal operation. Refuse shall not be allowed to obstruct drainage works at the site.</p>
Details/Findings:	Since the inspection in June 2016, efforts have been made to reduce the size of the slope. Part of the landfill (including the slope) appears to have been filled and permanently covered. The remaining active area has been lowered, reducing the extent of the slope. A large hole has been excavated to the rear of the landfill, which following freshet, has filled with water. At the time of the inspection, waste was observed floating in the water and an oily sheen was evident at the downwind end of the pond (see Figure 2). Though the slope was smaller, the waste at the open face of the slope had not been covered (this issue was raised as part of the June 2016 inspection - IR28991) . At the time of the inspection, the landfill could not be considered to have been adequately maintained.

Compliance:	Out
Actions to be taken:	Provide an action plan, including timeline, detailing planned measures to address the issues of cover application and standing water at the site. Once the issues have been addressed, please provide photographic records of the improvements.
Requirement Description:	<p>2. General Requirements 2.5 Site Preparation and Restoration</p> <p>2.5: Provision of fencing, site access, vehicle safety barriers, surface water diversionary works, firebreaks and site restoration as required, shall be carried out to the satisfaction of the Regional Waste Manager.</p>
Details/Findings:	While some of the water in the newly excavated hole will have resulted from snowmelt in the immediate area, the surface water diversion works appeared insufficient to prevent surface run-off from entering the site. The excavated area is lower lying than much of the area surrounding it and without adequate surface water diversion works, has filled with water (see Figure 2).

Figure 2. Since the last inspection on 14 June 2016, an area has been excavated to the rear of the site. Following freshet, this hole has filled with water and waste material was observed floating in it. An oily sheen was evident at the downwind end of the pool.
