## Canadian National Railway Company

Burnaby Lake Coal Recovery  
Turtle Salvage/Restoration  
Yale Subdivision

June 2014

**Re: BURNABY LAKE COAL RECOVERY - TURTLE SALVAGE**

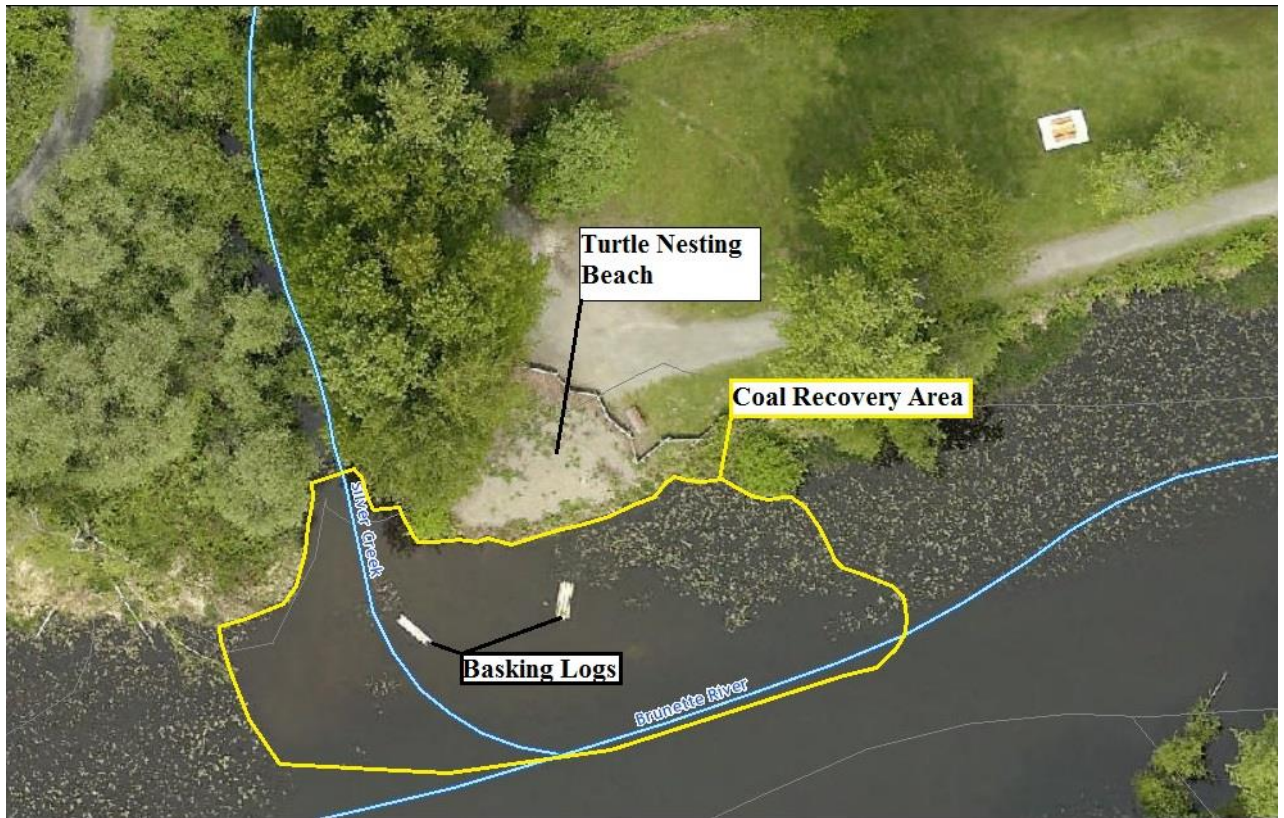
**Figure 1-2** Aerial photo of the site showing the turtle nesting beach and the approximate extent of the coal recovery area (Image Source: Burnaby Map - City of Burnaby).

The turtle nesting beach is located east of the confluence of Silver Creek and Burnaby Lake, next to a pedestrian trail that circles the lake (Figure 1-2). The area of this beach is approximately 118 m<sup>2</sup>. A sample of sand was collected from a representative area of the nesting beach where neonate turtles were found during nesting beach salvage efforts. Sieve analysis of this sample by Lafarge Canada indicated that almost 90% of the material was larger than fine sand (>0.15 mm grain size). Ten percent of the sample was coarse to medium sand (1 - 0.25 mm grain size) and the remainder was fine sand. Less than 3% of the material tested was in the silt/clay grain size range. When wetted, the material could be formed into a ball (i.e. it was not 100% sand), but could not be formed into a ribbon. The gritty texture of this substrate, its consistency (i.e. able to be formed into a ball), and its lack of cohesion (i.e. as is necessary to form a ribbon) indicated that the nesting beach material was best described as loamy sand.

The turtle nesting beach habitat begins near the shoreline and extends to approximately 2 to 3 m south of the fence that demarcates the beach area (Figure 1-2). This 2 to 3 m section of land was comprised mainly of compact clay soils. This is typically not suitable nesting material because turtles are unable to dig effectively in compact substrate, and because this type of substrate has relatively high moisture content, which increases risk of neonates freezing during sub-zero temperatures. In addition, during the salvage efforts, similar compacted material was also encountered beneath the sand layer in some areas of the beach. This restricted the search depth in some areas (mainly the north portion of the beach) to less than 20 cm.

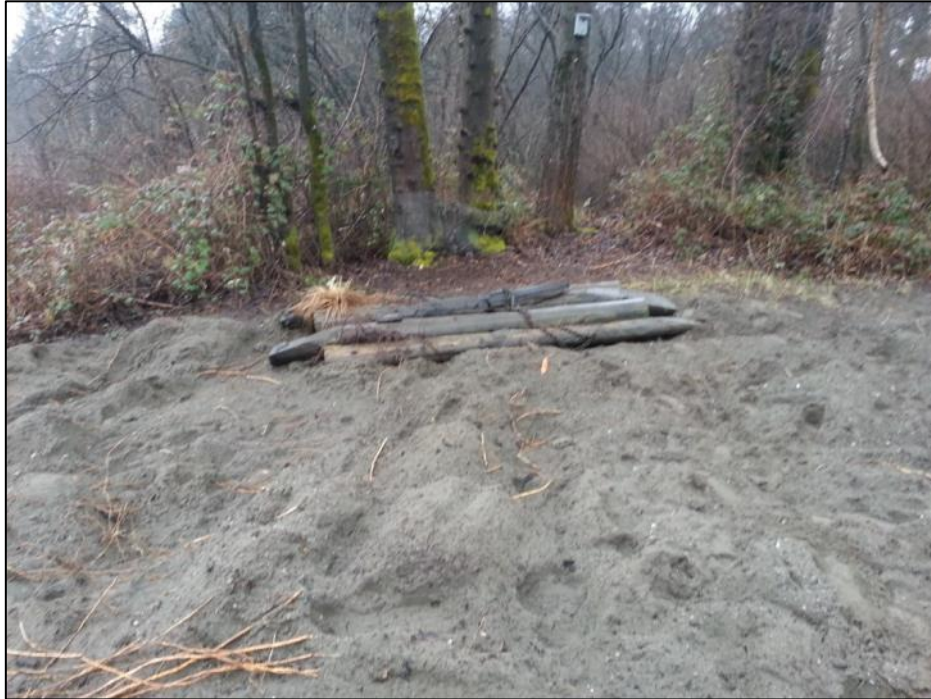
Photograph 15: The basking logs were removed from the shallow area adjacent to the nesting beach and stored until they could be cleaned

the area with dip nets to detect turtles or turtle movement. Two basking logs in the coal recovery area were removed during this time using an excavator. They were later pressure washed and replaced during site restoration. The second and third areas were then isolated using silt fence (the second area was located to the west of the outlet of Silver Creek and Burnaby Lake and the third was to the east of the outlet of Silver Creek bordered along the second area). Hand searches were conducted for turtles of all age classes by raking sediment up to the shoreline or into piles. The deeper areas were searched using a seine net to dredge the top layer of the isolated area. Finally, the areas were swathed by three people in a line using dip nets to search for turtles or turtle movement. The same isolation areas were salvaged for amphibians and fish.

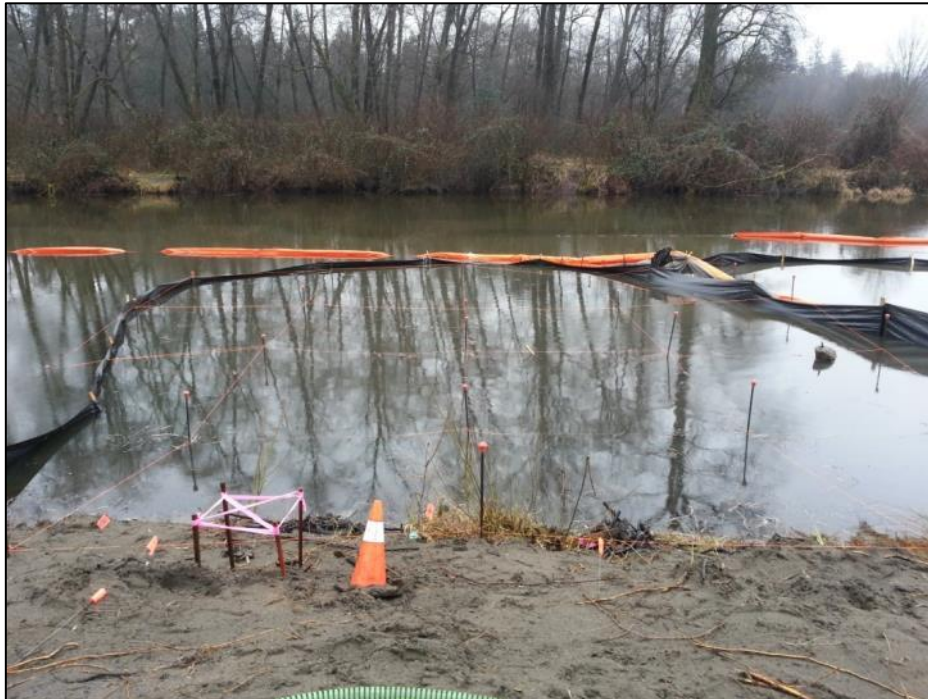
Photograph 17: South facing view of the recovery area and established grid for coal recovery adjacent to the turtle nesting beach

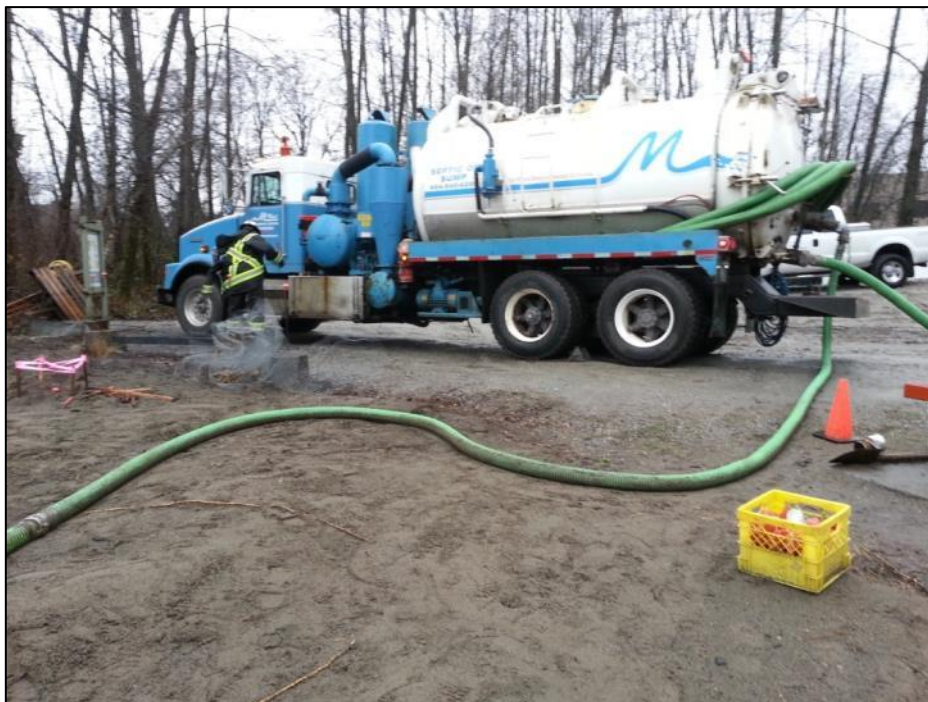
Photograph 18: Vacuum truck used in the recovery of coal

Once the isolated areas were cleared of aquatic life, Quantum used a hand controlled vacuum truck system to suck coal into drying bins on site. The material was then disposed of offsite. Initially, the vacuum was outfitted with a metal screen to protect any undetected turtles from the vacuum system; however, initial attempts with this method prevented successful recovery of the coal and the screen had to be removed at various times, until a modified screen was later attached. To help mitigate impacts, Quantum staff maneuvered the vacuum end by hand slowly through the piles of substrate that had been previously sifted through for turtles.

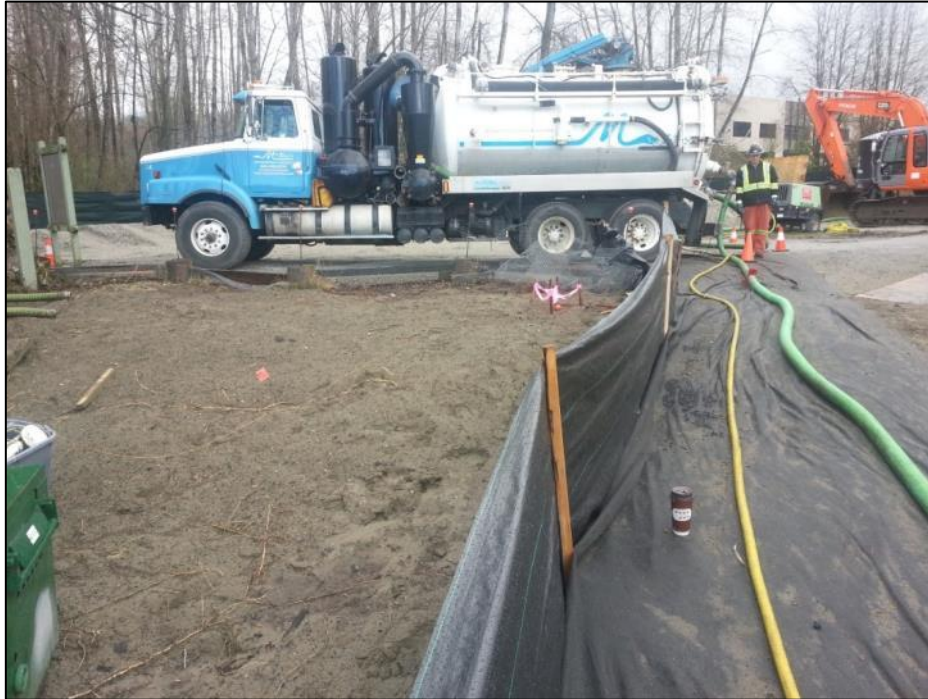
Photograph 19: East facing view of the filter fabric and sediment fence used to protect the turtle nesting beach during coal recovery

- On March 17, filter fabric and sediment fencing was installed on the turtle nesting beach to reduce the chance of contaminating the beach sand with unwanted materials, and foot traffic on the nesting beach area

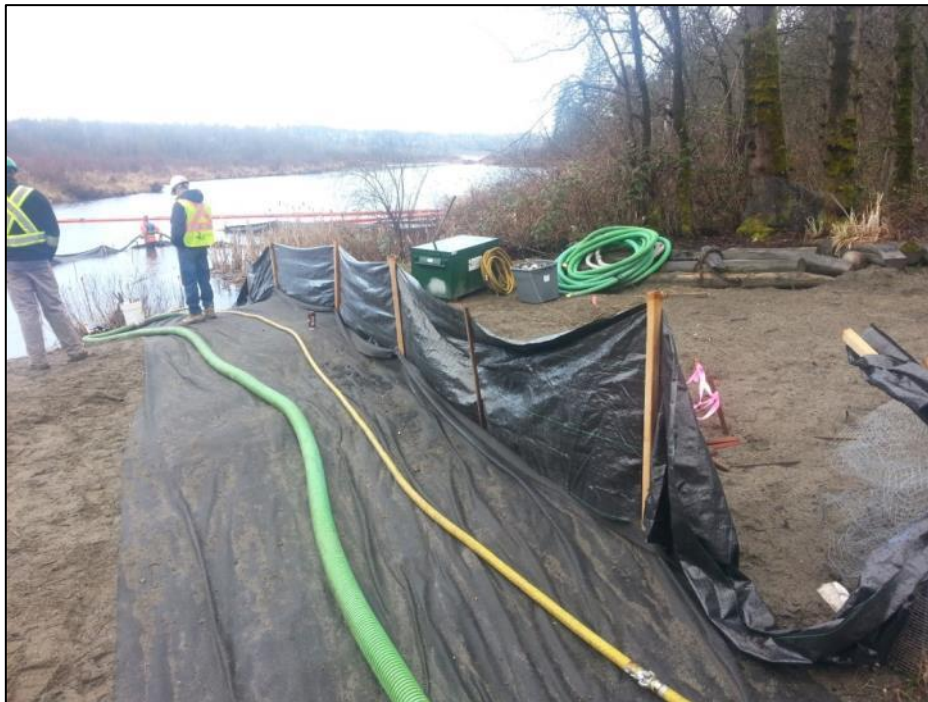
Photograph 20: South west facing view of the filter fabric and sediment fence used to protect the turtle nesting beach during coal recovery

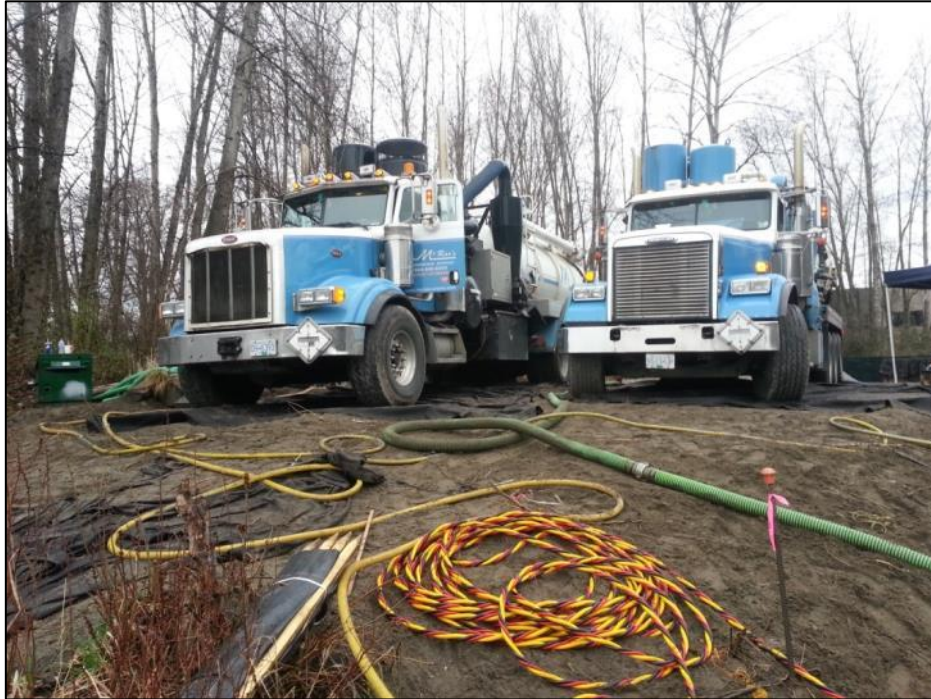
Photograph 21: South facing view of the two vac trucks on the work pads constructed on the turtle beach while recovery was underway

- On March 24, work pads were constructed on the turtle nesting beach to act as a protective barrier and allow equipment closer access to the coal recovery area. The main purpose of these pads was to reduce compaction and create a protective barrier beneath the two vacuum trucks that had to be parked on the turtle nesting beach. The work pads were constructed with a layer of ¾-inch plywood, a layer of poly, and a layer of filter fabric. The pad was checked daily for any forms of contamination, which could then be removed and/or cleaned as needed. No contaminants were found on the work pads

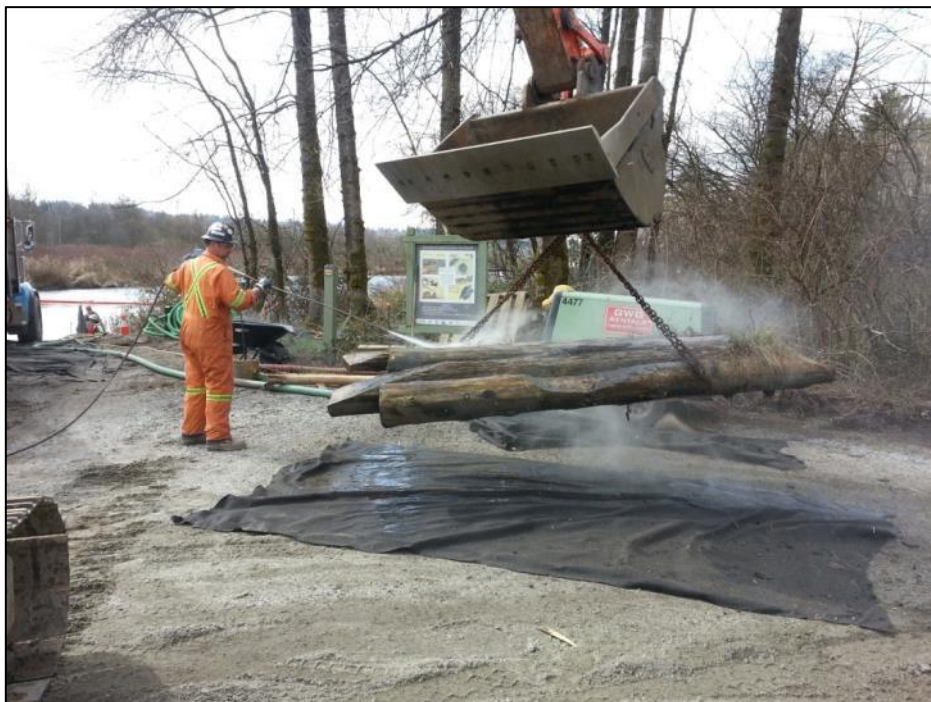
Photograph 22. Basking logs were washed off the nesting beach over the pedestrian path with clean high pressure water

- The section of original exclusion fencing at the turtle nesting beach that had been disassembled to allow equipment access was restored. Care was taken to follow the original fence design and ensure that fence materials were replaced in their original positions
- New hardware cloth was re-installed on the exclusion fence to minimize predator and dog access to the nesting beach
- Information signs were replaced on the exclusion fence
- After these initial steps a representative from MFLNRO visited the site and directed Quantum to re-position the fence such that it enlarged the nesting beach area by approximately 4 m<sup>2</sup>
- Basking logs were washed using a high-power pressure washer before they were re-installed

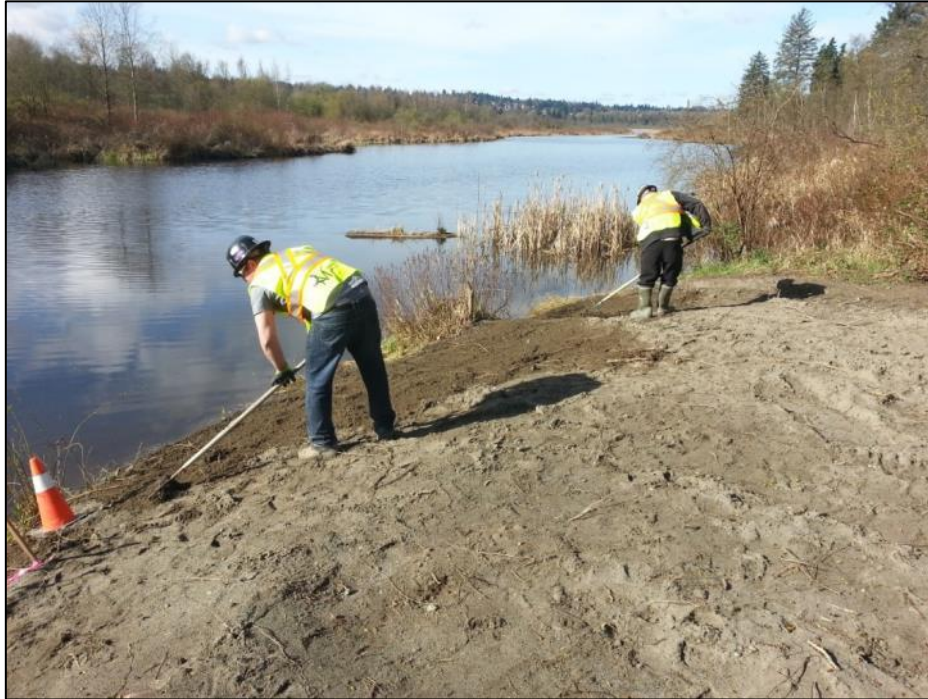
Photograph 23: Crew raking up the turtle nesting beach to reverse any compaction which might have occurred. The beach sand was raked to a depth of 100 mm to 200 mm, depending on the depth of the base material.

- Work pads and other mitigation materials (e.g. geotextile on the turtle nesting beach, sediment fencing, and materials for area grid) were removed
- Organic materials and debris in or on the nesting each (e.g. leaf matter, root systems, tree stumps) were removed by hand, rake, and excavator
- To reverse any potential compaction from the machinery, rakes were used to turn the nesting beach sand over. This was done under the supervision of the environmental monitor and in consultation with Nicole Basaraba. The beach sand was raked to a depth of 10 cm to 20 cm, depending on the depth of the base compact clay material

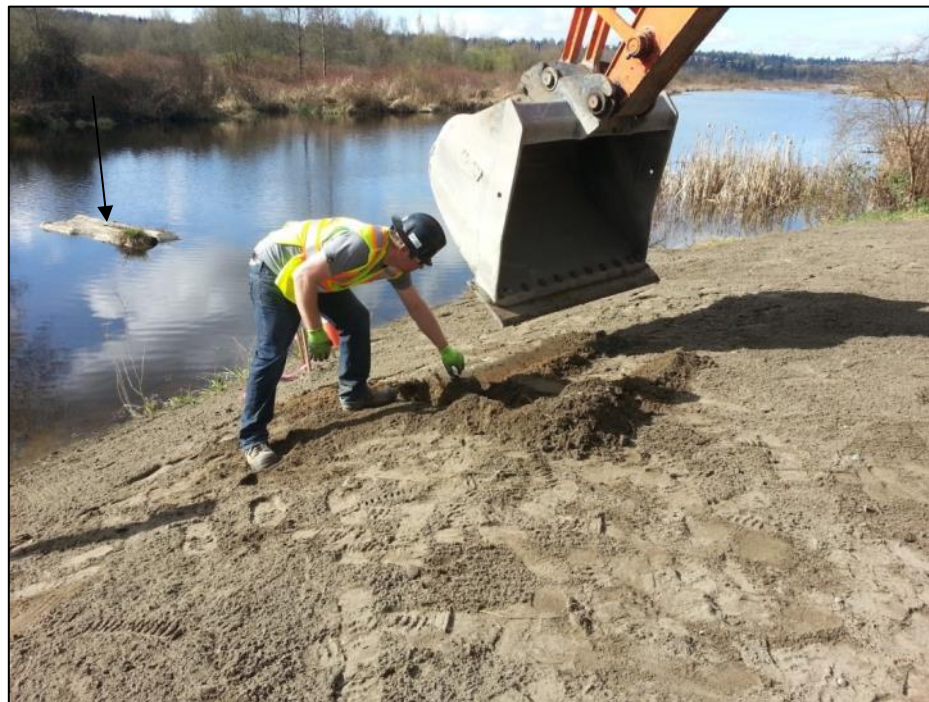
Photograph 24: Crew removing stump found in the turtle nesting beach

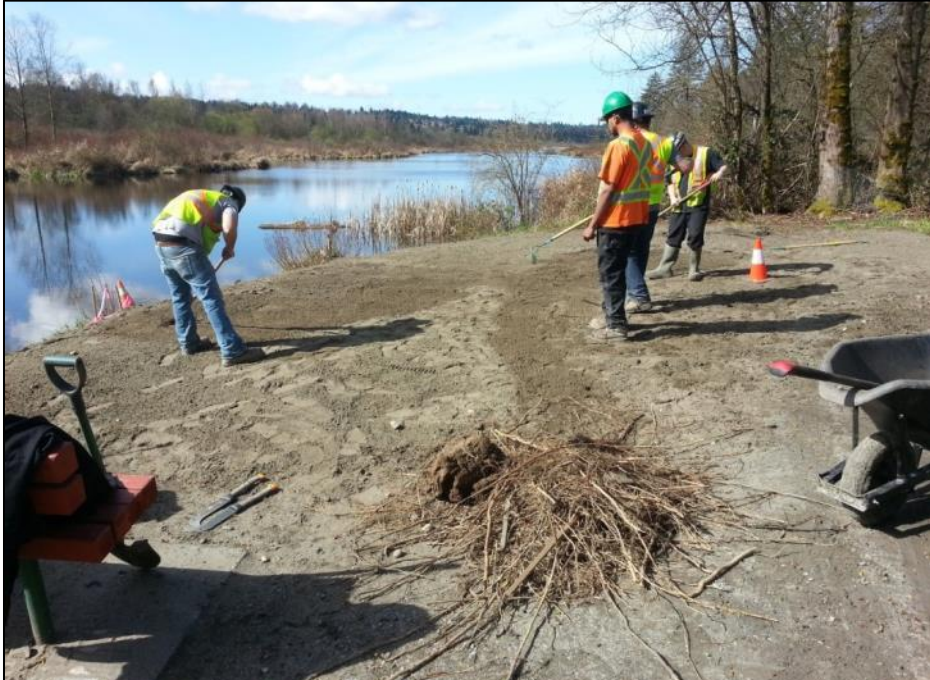
Photograph 25: Crews raking up the turtle nesting beach to reverse any compaction which might have occurred and removing roots and other debris

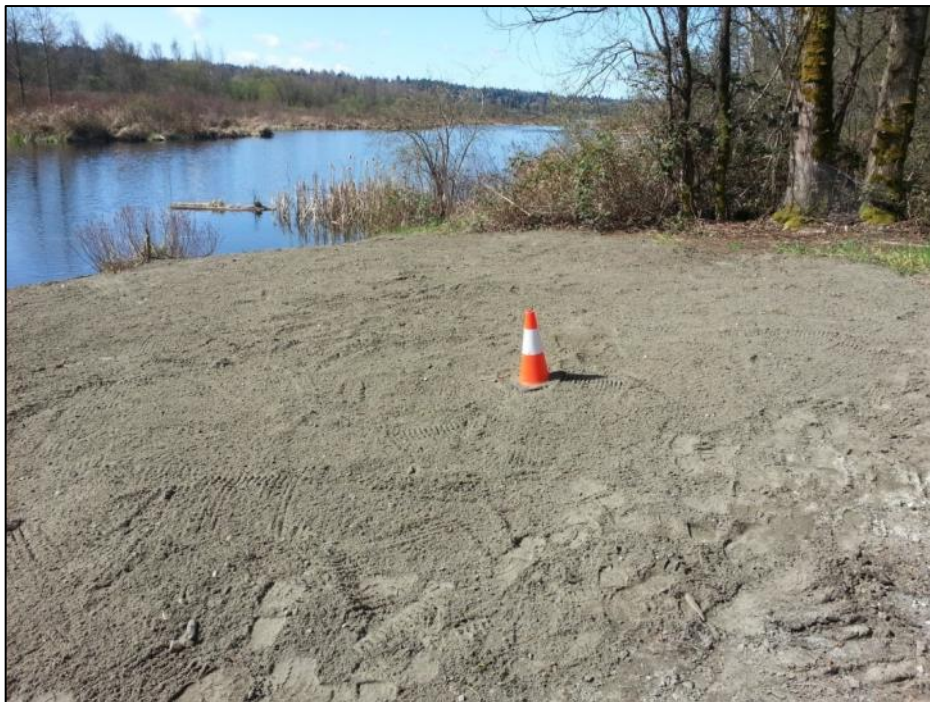
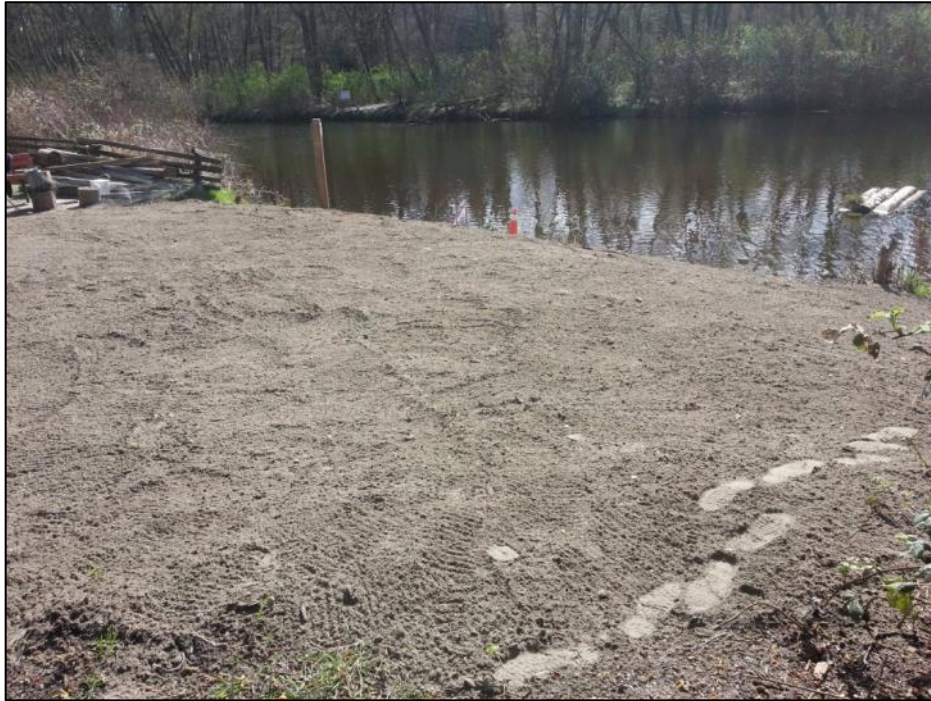
Photograph 26: Turtle nesting beach after restoration was complete

Photograph 27: Turtle nesting beach after restoration was complete

Post-coal recovery, there was no visible coal and/or recoverable coal in the wetted habitat adjacent to the turtle nesting beach. As noted, organic materials (roots, stumps, leaves, and other debris) were removed from the beach area, and this will help to restore/increase the quality of the nesting habitat. Further, the turning of the beach sand will have helped reverse any compaction of substrate that occurred during the recovery works. Covering the beach with the containment pad and filter fabric, and installing the sediment fence to restrict foot traffic and isolate recovery areas were successful in protecting the nesting beach and areas outside of the coal recovery operations from contamination.

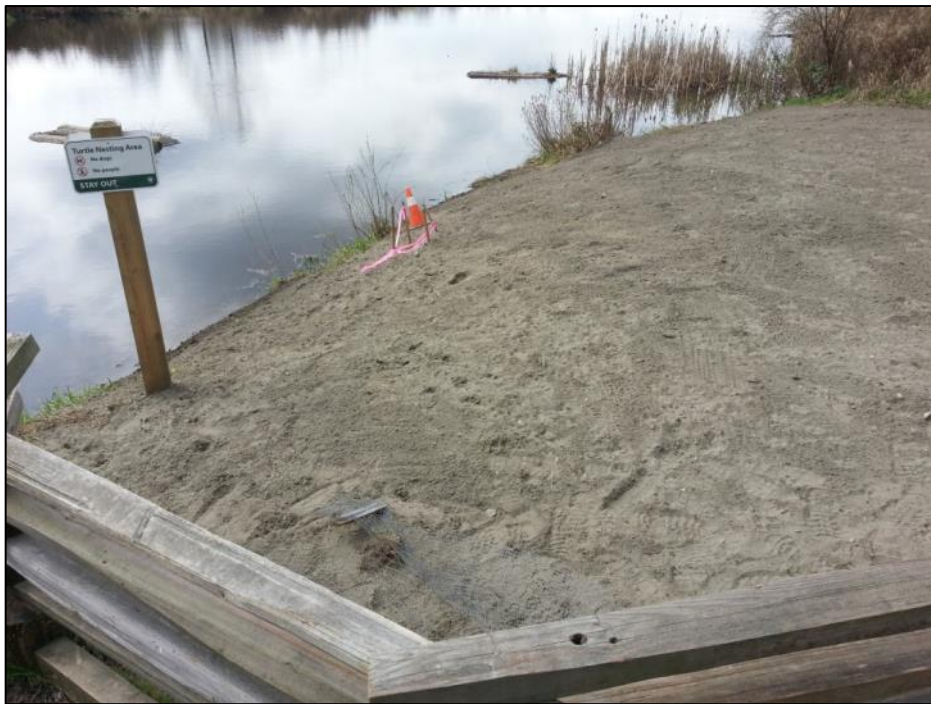
Photograph 28: Southwest facing view of the turtle nesting beach after restoration was complete – fence replaced

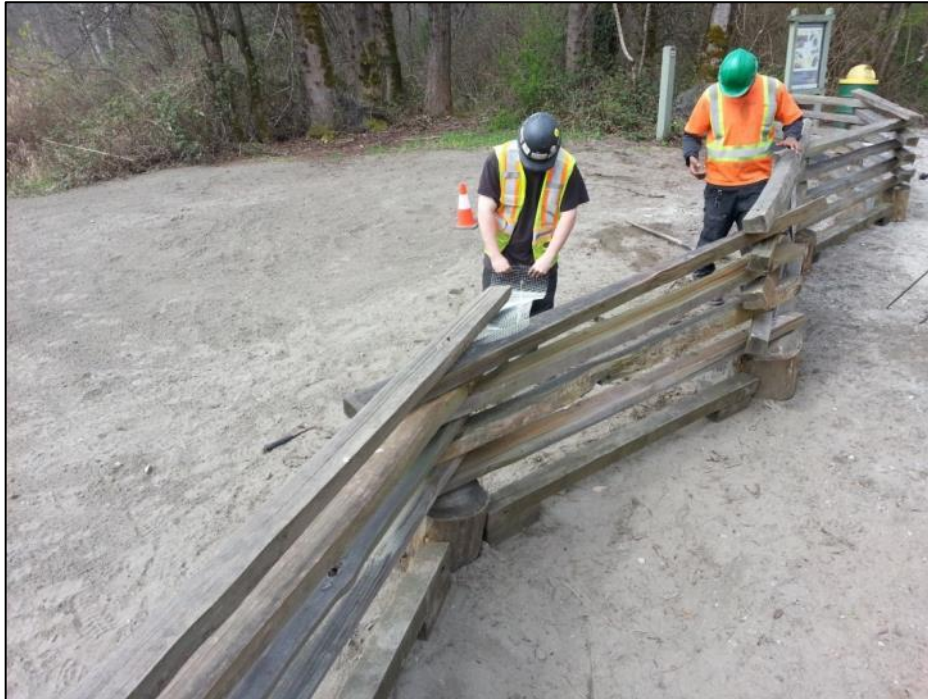
Photograph 29: Northwest facing view of the turtle nesting beach, crew installing the exclusion fence

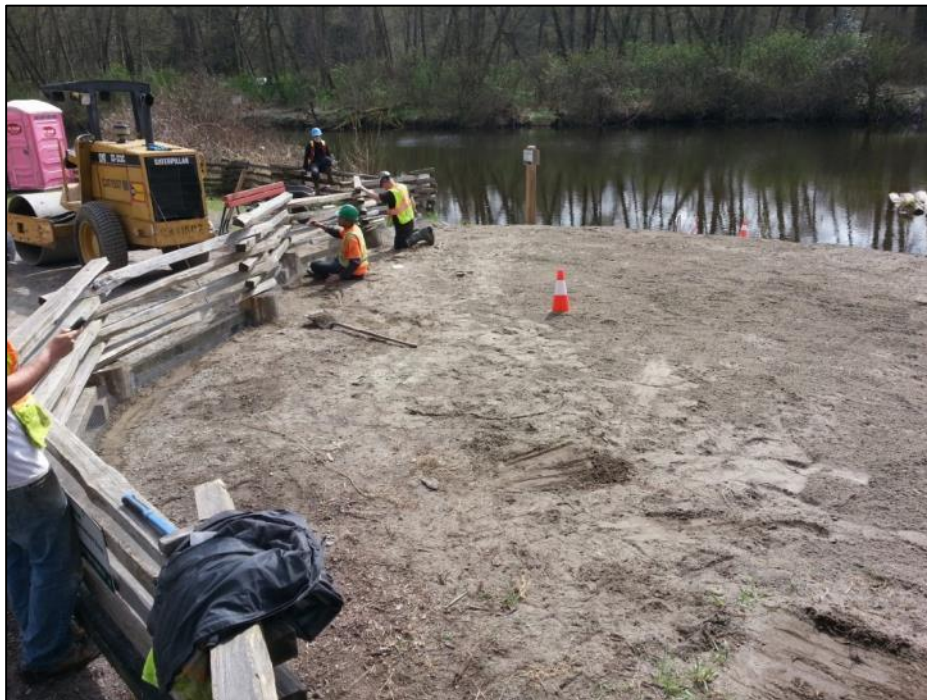
Photograph 30. Southeast facing view of the turtle nesting beach while crews installed the exclusion fence.
