Drinking Water Source Quality Monitoring 2002-03

Parasite Sampling in Northwest Coastal Communities: Prince Rupert, Terrace and Kitimat

A.J. Downie
Environmental Protection Division
Skeena Region

December 2005

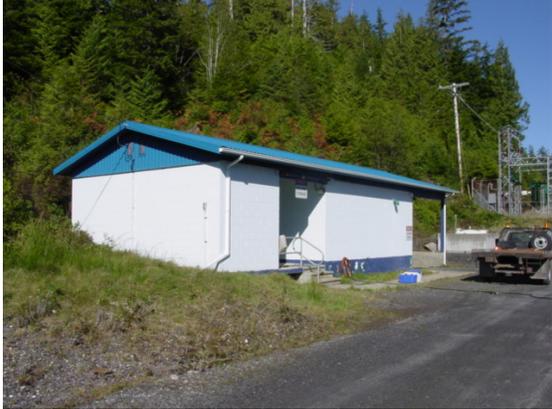
<p>Photo 1: Shawatlan Lake treatment facility</p>	<p>Photo 2: Filtration apparatus set up outside Shawatlan Lake treatment facility</p>

In October 2003, Woodworth Lake raw (untreated) source water was sampled from a tap at the Shawatlan Lake treatment facility (Figure 2 and Photos 1 and 2).

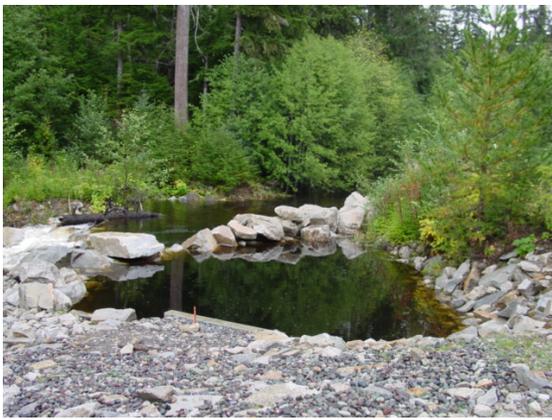
<p>Photo 3: Deep Creek with intake impoundment pool in foreground</p>	<p>Photo 4: Deep Creek intake screen in impoundment pool, with submersible sampling pump and hose at bottom of photo</p>

In October 2003, Deep Creek source water was sampled from the impoundment where the City of Terrace intake is located (Figure 3 and Photos 3 and 4). The Water Survey of Canada (WSC) has a gauging station on Deep Creek directly above the intake site; discharge levels over the September-October 2003 sampling season are shown in Figure 4. Sampling dates are indicated by arrows on the graph. Appendix 1 contains a graph of historical daily discharge values for Deep Creek.

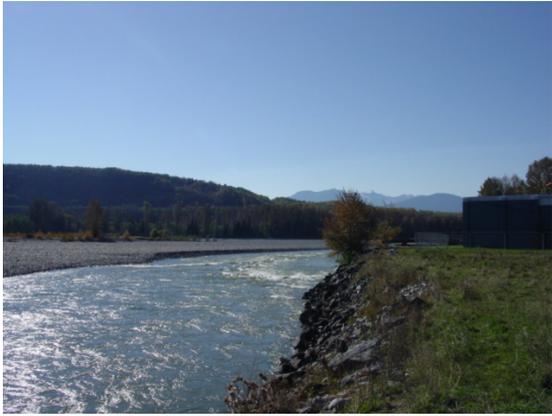
<p>Photo 5: Skeena River; infiltration gallery is under gravel near left river bank, pump house is on right side of river</p>	<p>Photo 6: Skeena River with submersible sampling pump under water near river bank</p>

The City of Terrace's Skeena River intake is an infiltration gallery that was constructed on Little Island (downstream from Ferry Island) in 1967-68. A pump house is located on the adjacent mainland at the south end of Kalum Street. Treatment consists of chlorination and fluoridation (same as Deep Creek), and it occurs immediately after the water enters the system through the infiltration gallery. The water is then pumped directly into the distribution system without storage, so chlorine contact time is limited to about 20 minutes at the rated capacity. This contact time is likely adequate for bacteria and viruses, but provides almost no protection against *Giardia* or *Cryptosporidium* (Watson, 2000).

In October 2003, Skeena River source water was sampled directly from the river (at a depth of approximately 15 cm) near the City of Terrace intake (Figure 3 and Photos 5 and 6). The WSC has a gauging station on the Skeena River at Usk, approximately 25 km upstream from the Terrace intake site.⁶ Discharge levels over the September-October 2003 sampling season are shown in Figure 5. Sampling dates are indicated by arrows on the graph. Appendix 1 contains a graph of historical daily discharge values for the Skeena River.

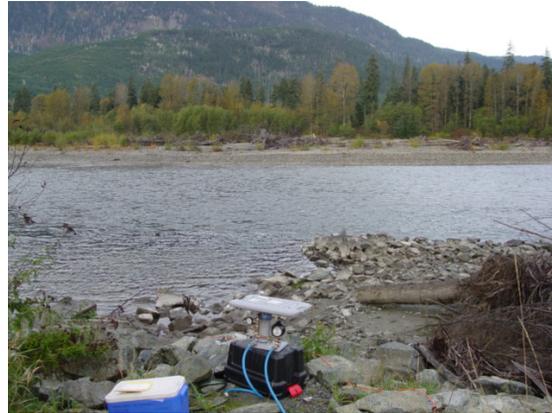
Photo 9: Sampling tap inside pump house #7

In October 2003, Kitimat River source water was sampled directly from the river (at a depth of approximately 15 cm) near the District of Kitimat intake (Figure 6 and Photos 7 and 8) and at Pump house #7 after the infiltration gallery (Figure 6 and Photo 9). This enabled a comparison of source water quality before and after the infiltration gallery, to examine its effectiveness in reducing levels of turbidity, bacteria and parasites.

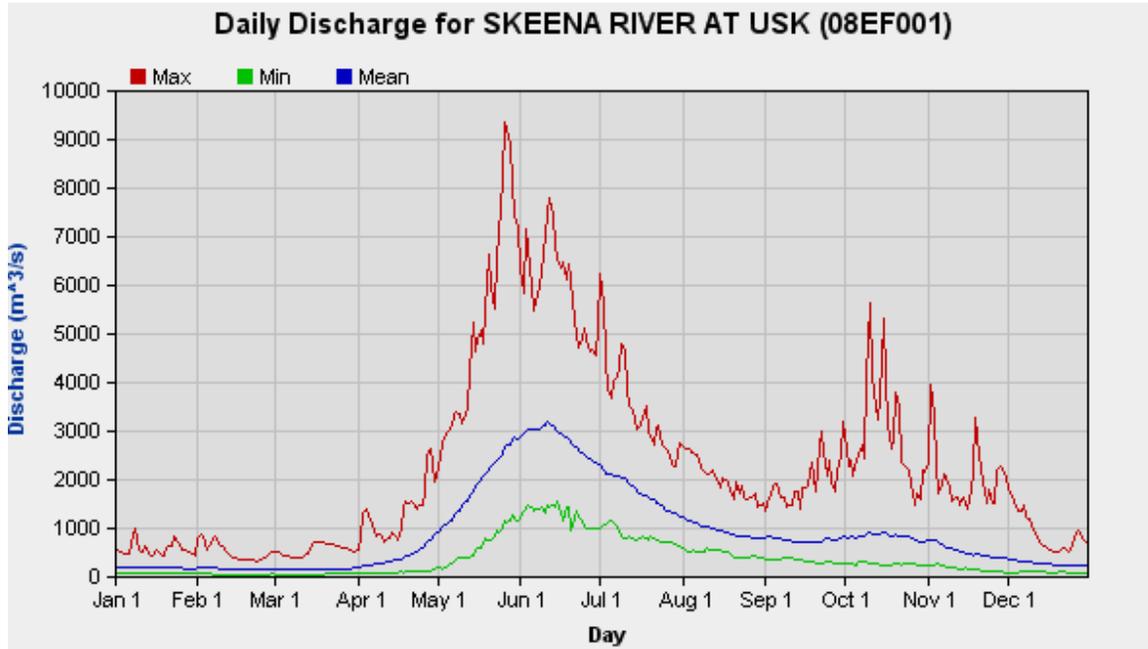
Skeena River Annual Flows

Discharge Curves for River and Creek Sampling Sites (WSC, 2004c)
