**McMillan Creek Monitoring Project
2006 EPD Data Summary**

**James Jacklin, B.Sc.
Ministry of Environment
Environmental Protection Division
Environmental Quality Section
Omineca-Peace Region
March, 2007**

Executive Summary

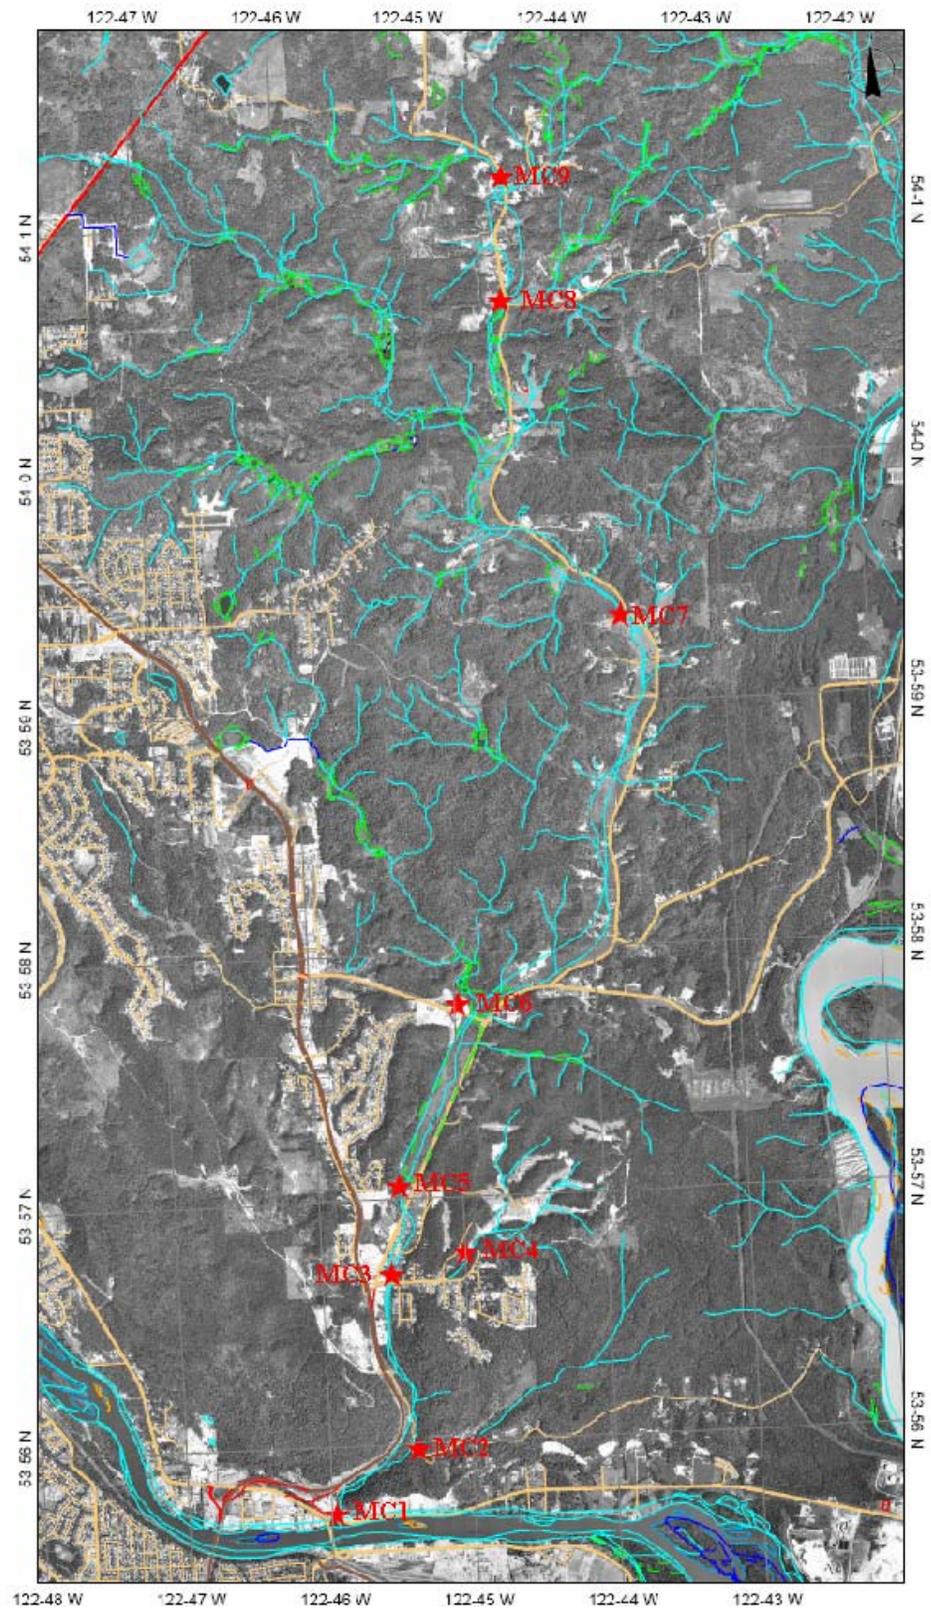
Figure 1. McMillan Creek watershed sample sites. Note, two samples sites were removed due to poor field conditions, sites MC4 and MC9. The map scale is 1:50,000.

A total of nine sites were initially selected (Figure 1) during the office exercise; however, this was reduced to seven sites after field inspections. Site MC4 was eliminated from the program based on non-existent flow conditions and site MC9 was eliminated due to poor access combined with the inability to find a representative site with positive stream flow. Descriptions and pictures of the sample sites are provided in Appendix A. All seven sites were scheduled to be sampled four times based on available budget, once in each of summer low flow, summer rain event, fall rain event and during winter low flow. However, winter low flow samples were not collected due to the stream being completely frozen during the site visit in January 2007. The sampling program ran from July, 2006 to January, 2007.

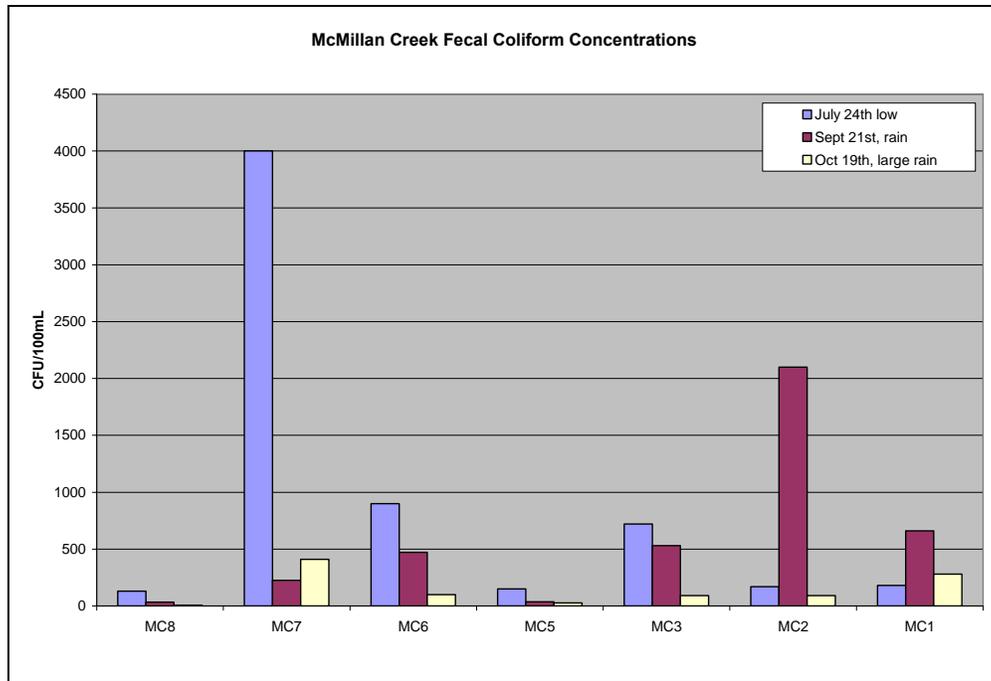
As seen in the September 21st data, fecal coliform concentrations gradually increase from MC8 to MC6, suggesting fecal input between these sectors. There is a large decline in concentration between MC6 and MC5, followed by a substantial increase at MC2.

Figure 2. McMillan Creek Fecal Coliform concentrations.

As displayed in the bacterial results section, some of the highest bacterial concentrations were found at sites MC1 and MC2 after the rain event sampling. The results were usually higher at MC2, suggesting some dilution at the MC1 location. The area dividing sites MC2 and MC3 is not a large area, with most of the coliforms likely originating from the City storm system above Hoferkamp Road; however, a more detailed sampling program is required to confirm this, or, signs should be posted indicating that stream conditions tend to have elevated coliform levels during rainfall events. These results also agree with data collected by the Ministry in 2001 which identified site MC2 as having the highest bacterial concentrations in the watershed (Carmichael and Warren, 2001).

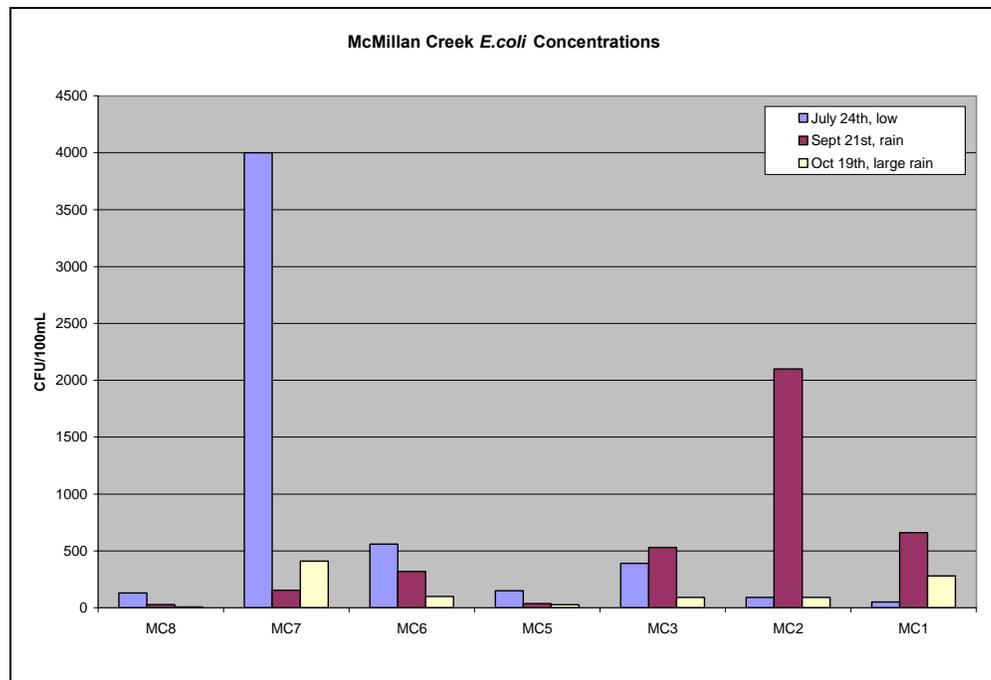
E. coli concentrations, presented in Figure 3, show a very close relationship to the fecal coliform results. Although the concentrations differed, the trends were almost identical suggesting that *E. coli* represent a large proportion of the fecal coliforms.

Figure 3. McMillan Creek E. coli concentration.

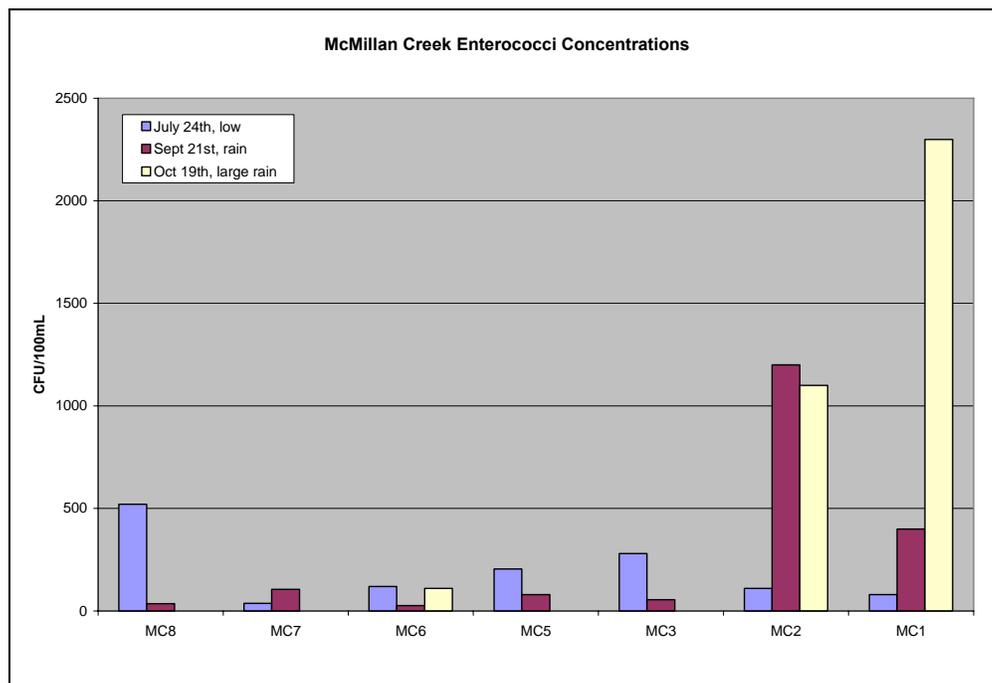
Enterococci results (Figure 4) illustrate a different trend, suggesting the largest inputs originating between sites MC1 and MC3. Large spikes are seen at sites MC2 and MC1 after the September and October rain events, with the October MC1 result of 2300 CFU/100mL being the largest detected. The July low flow samples suggest Enterococci inputs upstream from site MC8, followed by a decline (likely from stream dilution) and a gradual increase from sites MC7 to MC3. The concentrations then decrease from MC3 to MC1.

Figure 4. McMillan Creek Enterococci concentrations. It is of note that results from MC3, MC5, MC7 and MC8 for the October sample were removed from analysis due to DQO exceedances.

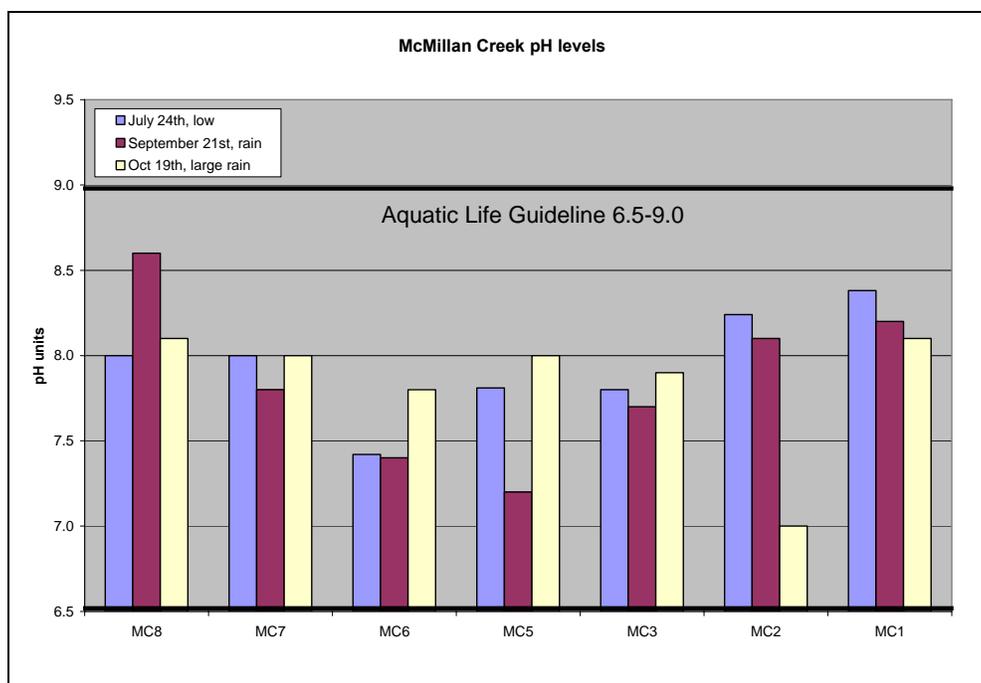
Chemical parameters were tested by both the field probes listed in Table 1 and by the analysing laboratory. Field probe measurements are listed in Table 4. As displayed in Figure 5, McMillan Creek is slightly alkaline with pH levels ranging from 7.0-8.6. The pH values at site MC2 are unique to the other sites, specifically on October 19th after a precipitation event. On the first two sample dates, pH values were 8.1 and 8.2, decreasing to 7.0 on October 19th. In general, the pH levels appear to decline from MC8 to MC5, after which they increase until MC1.

Figure 5. McMillan Creek pH levels.

The pH of McMillan Creek appears to drop at site MC6, which is characterized by slow moving, slightly coloured water originating from a wetland complex dammed intermittently by beaver activity. This drop in pH may be due to organic acid formation within the wetland complex. Levels subsequently rise at MC3 which is almost 2km downstream from the wetland complex and are likely influenced more by ground water chemistry than wetland chemistry.

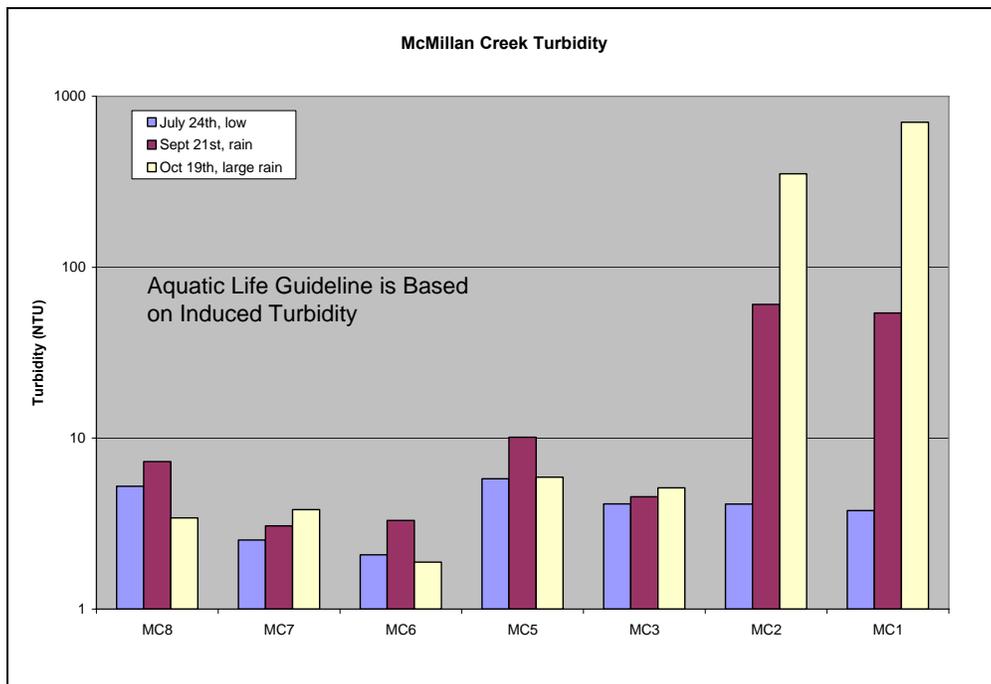
Turbidity levels (Figure 6) were generally low with concentrations less than 10 NTU at most sites during most dates; however, there were large spikes at sites MC2 and MC1 during both the September and October rain events. During the September event, levels peaked at site MC2 at 60.6 NTU (although very similar concentrations were at MC1) while concentrations peaked at MC1 during the October event at 705 NTU.

Figure 6. McMillan Creek Turbidity data. The y-axis is log transformed.

McMillan Creek turbidity and total suspended solid (TSS) levels were found at low concentrations during all dates at all sites, except sites MC2 and MC1 after precipitation events. The increased turbidity and TSS at site MC2 can be attributed to the City storm drain located approximately 500 m upstream from the site. As found during an October 5th field inspection (Plates 1-3), the City storm system substantially increased the TSS and turbidity concentrations of the stream. This induced TSS exceeds the recommended British Columbia aquatic life guideline level (25 mg/L in 24 hours when background concentrations are less than 25 mg/L). This elevated TSS will reduce light penetration in the water and can affect fish and fish habitat (RISC, 1998). The data also suggest the turbidity and TSS levels continue to increase to MC1, which is likely due to overland flow and ditch water.

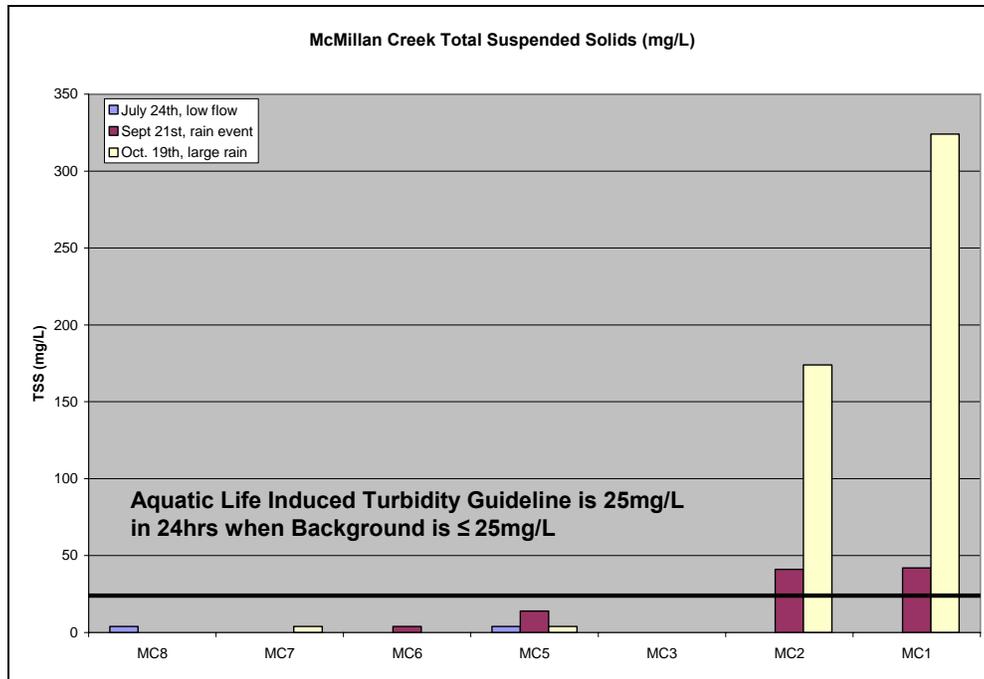
Total suspended solid (TSS) results suggest most sites have very low levels. The exceptions are sites MC1 and MC2, specifically during rain events. As seen in Figure 7, concentrations increased to 174 mg/L at MC2 and 324 mg/L at MC1 during the October sample. This suggests a large input of suspended solids between sites MC2 and MC3.

Figure 7. McMillan Creek Total Suspended Solids data.

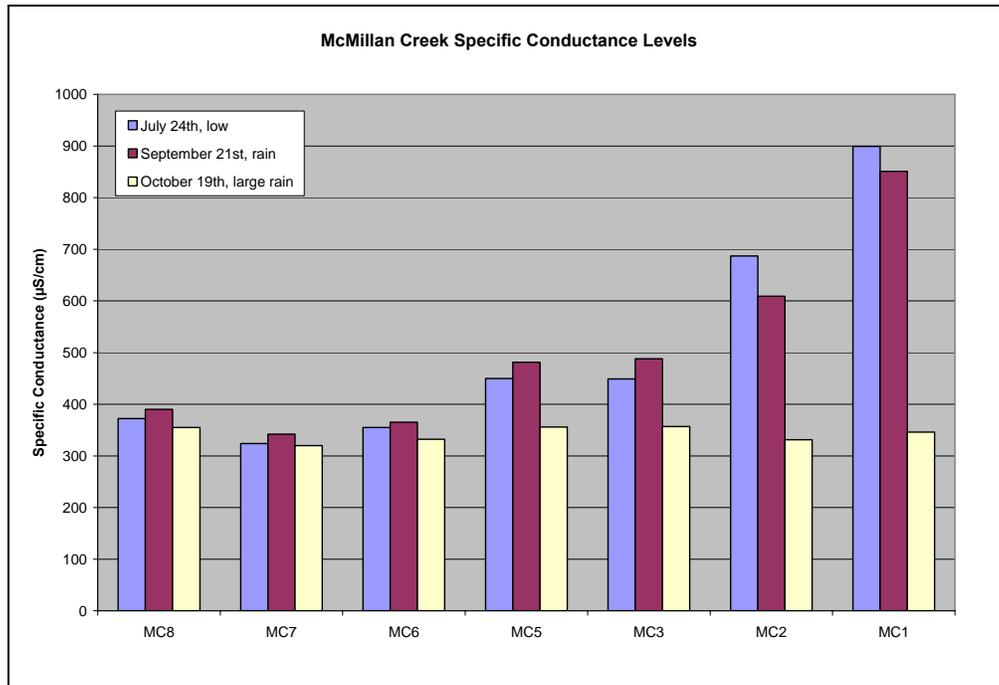
Specific Conductance levels (Figure 8) typically had very low variability at sites MC3-MC8, while much larger differences were observed at sites MC1 and MC2. During the heavy rain event in October, concentrations appeared to be similar between all sites, while in contrast, during the July low flow concentrations appeared to increase from upstream to downstream.

Figure 8. McMillan Creek Specific Conductance Data.

Specific conductance, total sodium and dissolved chloride all showed similar trends increasing in concentration from the top of the watershed to the bottom. Values were particularly high during lower flow conditions, suggesting a large contribution from ground water. This also agrees with Ministry data collected in 2004, which suggests a similar trend (Jacklin, 2004). There is a substantial increase at sites MC2 and MC1, suggesting input from some external sources other than ground water. Natural sources of sodium include the weathering of salt deposits and contact of water with igneous rock. Anthropogenic sources include road salts, sewage and industrial effluents and the use of sodium products in corrosion control and water softening products (Health Canada, 1992).

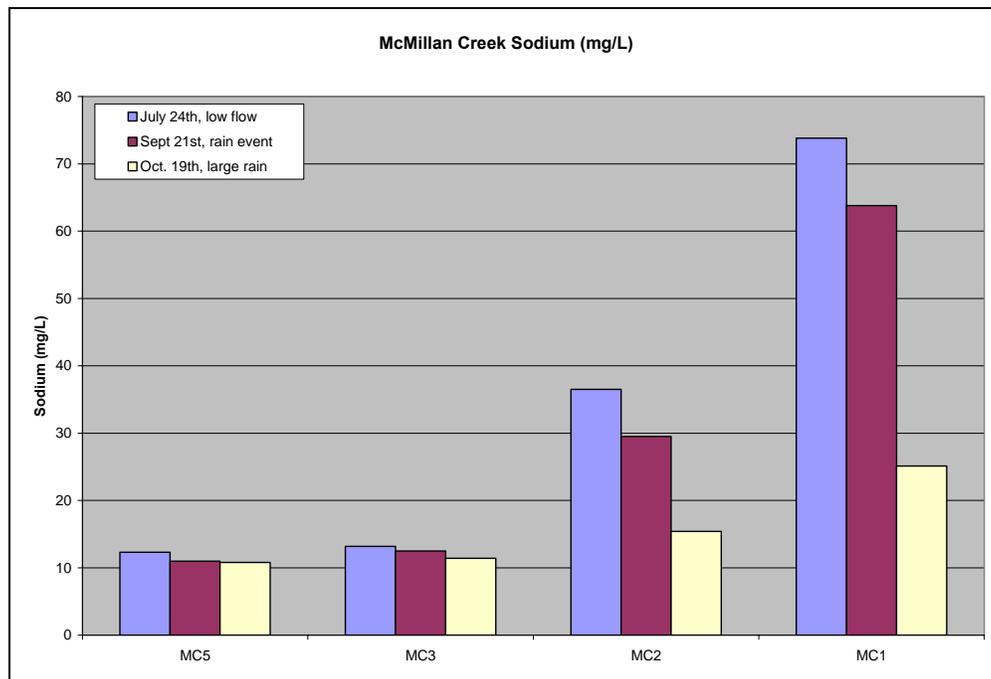
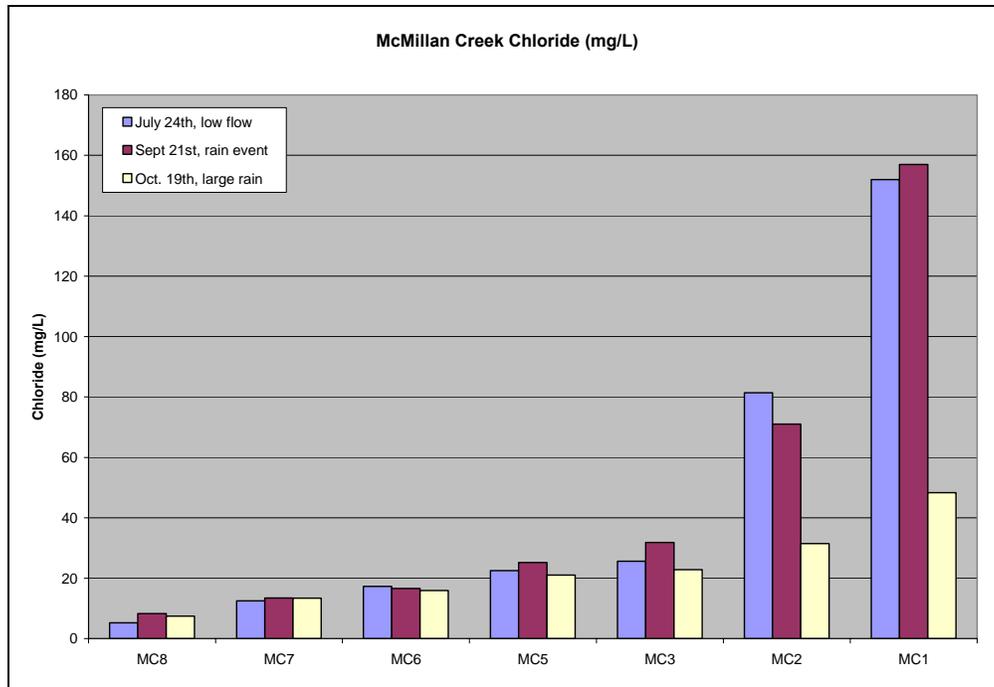
Sodium and chloride levels, displayed in Figures 9 and 10, show an increasing trend from the top of the watershed to the mouth. The highest concentrations were detected at sites MC1 and MC2 during July and September, with concentrations decreasing during the October rain event. The highest chloride concentration was detected in September at site MC1, with a concentration of 157 mg/L. In contrast, concentrations near the top of the watershed, site MC8, averaged 6.9 mg/L.

Figure 9. McMillan Creek Total Sodium data.

Figure 10. McMillan Creek Dissolved Chloride data.

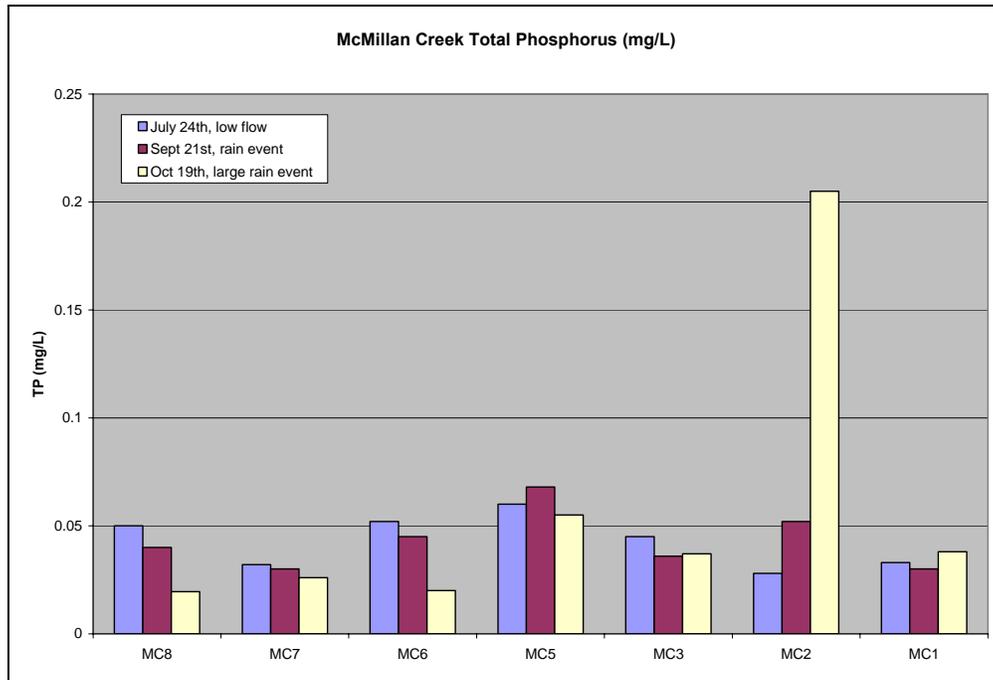
Nutrient levels were measured in McMillan Creek during the program, with total phosphorus levels being displayed in Figure 11. Although there is no specific water quality guideline for total phosphorus, it is apparent there is a sharp increase in background concentration at site MC2 during the October precipitation event. This suggests a large input upstream from this location; however, it appears to be diluted as levels decrease to somewhat normal conditions at site MC1. The impact from high phosphorus concentrations will be reduced if there are high coincident turbidity levels since light penetration into the water column will become the limiting factor for algal production at such times.

Figure 11. McMillan Creek Total Phosphorus data.

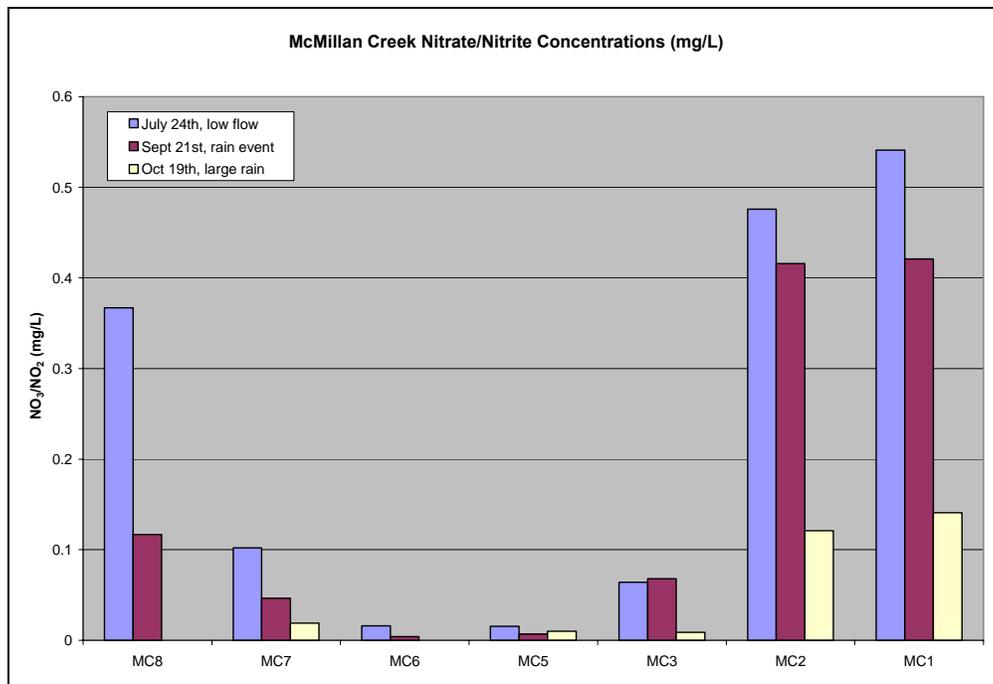
As seen in Figure 12, the nitrate/nitrite concentrations were highly variable between the sites, with elevated levels in the upstream sampling locations that are surrounded by hobby farm and agricultural sectors, followed by a large decrease until a substantial spike at site MC2 and MC1 (downstream from the commercial sector). The highest concentrations were detected during low flows (indicating a persistent/constant, low-level source); however, elevated levels were still found during the high flows in October at sites MC1 and MC2.

Figure 12. McMillan Creek Nitrate/Nitrite data.

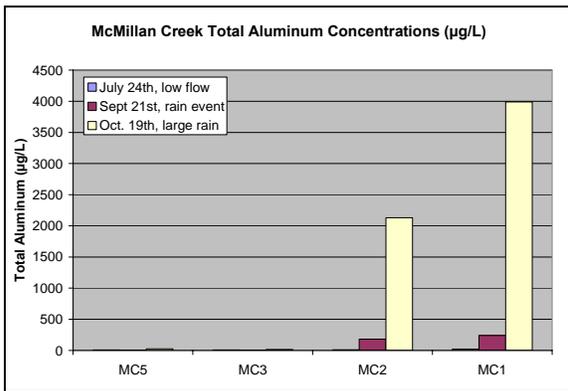
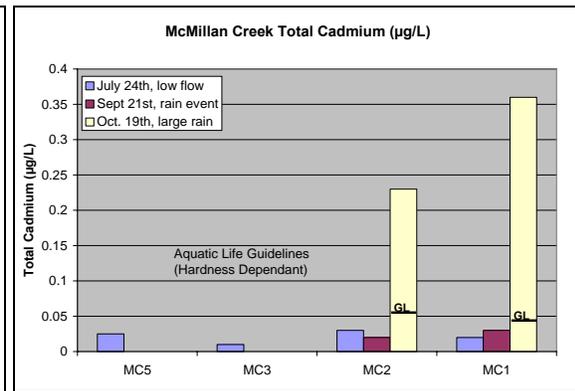
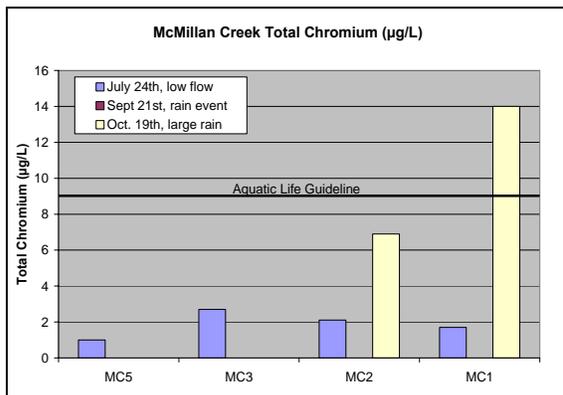
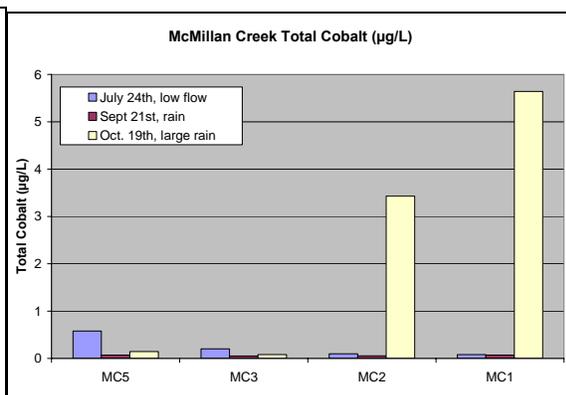
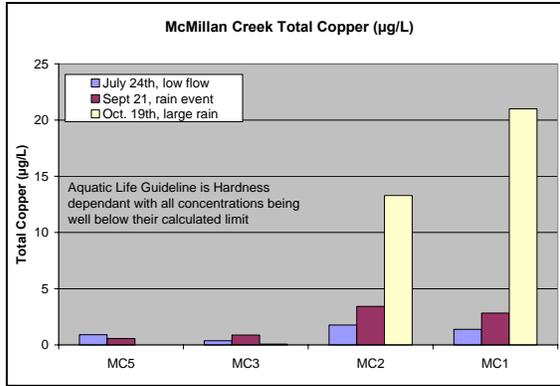
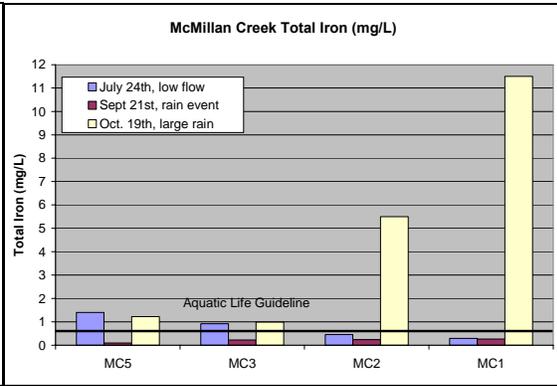
Metals data were collected at the lower sites in the watershed: sites MC1, MC2, MC3 and MC5. Numerous metals had similar trends including total aluminum (Figure 13), total cadmium (Figure 14), total chromium (Figure 15), total cobalt (Figure 16), total copper (Figure 17), total iron (Figure 18), total lead (Figure 19), total manganese (Figure 20), total vanadium (Figure 21) and total zinc (Figure 22). All 10 of these metals had large spikes in concentration during the October rain event at sites MC1 and MC2. These spikes were not detected in the dissolved form (which stayed relatively stable), suggesting the metals were bound to particulates and would likely not be biologically available. This correlates with the large TSS spike during the same time period, originating between sites MC2 and MC3.

Figure 13. McMillan Creek Total Aluminum.

Figure 14. McMillan Creek Total Cadmium. GL=Guideline Level.

Figure 15. McMillan Creek Total Chromium.

Figure 16. McMillan Creek Total Cobalt.

Figure 17. McMillan Creek Total Copper.

Figure 18. McMillan Creek Total Iron.

The metal results showed elevated levels of Al, Cd, Cr, Co, Cu, Fe, Pb, V, Zn and Mn. The large spikes were initially detected at site MC2, with a further increase at MC1. As previously mentioned, these elevated metals were dominantly in the total form, suggesting they were bound to particulates, also detected in the elevated TSS. This TSS was initially found to be from the City storm drain; however, there also appears to be an increase between sites MC2 and MC1. The source of this second increase is unknown, but it may be due to a combination of overland flow, increased ditch water entering the stream, the re-suspension of settled particles during increased flows, erosion within the creek or other contaminant sources. More detailed monitoring is required to sufficiently identify the contamination sources. Recommended aquatic life guidelines were exceeded by numerous metals, including cadmium, chromium, iron, vanadium and zinc. Although some of these metals may occur naturally in the soils, a description of them and their associated anthropogenic sources are listed below.

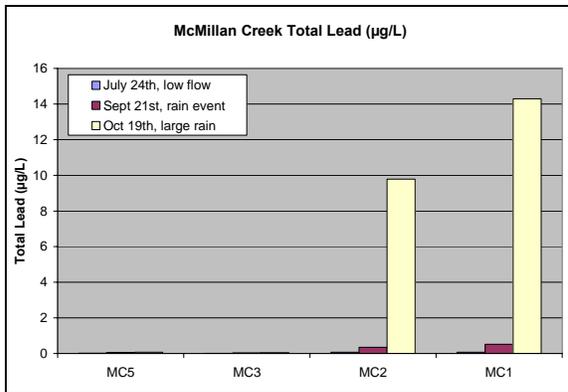
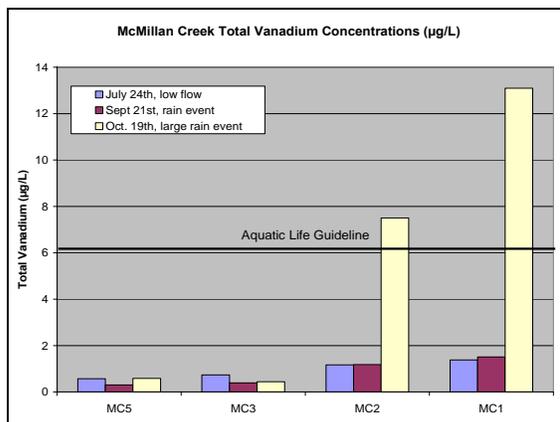
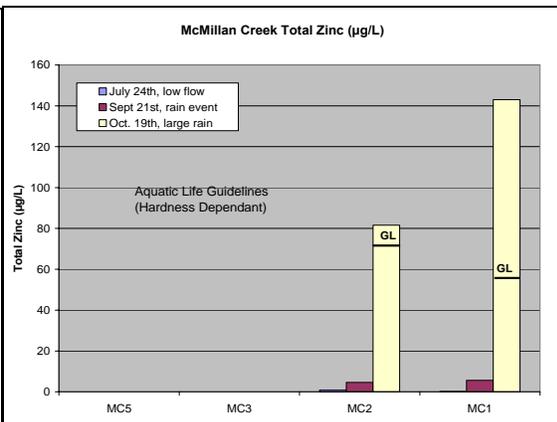
Figure 19. McMillan Creek Total Lead.

Figure 21. McMillan Creek Total Vanadium.

Figure 22. McMillan Creek Total Zinc.
GL=Guideline Level.

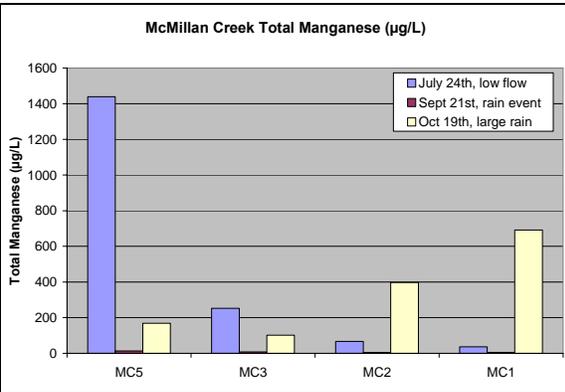
Total Manganese had a very high concentration at site MC5 during the July low flow, which differs from any of the other sites or metal tested.

Figure 20. McMillan Creek Total Manganese.

Manganese also showed similar trends to the other metals, except for the large spike detected at MC5 during low flow conditions. This site is upstream from most of the commercial businesses, but downstream from residential development and a large wetland/beaver complex. Low oxygen concentrations are typical for eutrophic wetlands and can cause manganese to be released from the sediment into the water column (Wetzel 2001). During this very warm, low water period, the oxygen concentrations likely dropped resulting in a chemical shift and the subsequent release of manganese to the water column. Although this peak concentration of 1440 µg/L exceeds the recommended drinking water guideline of 50 µg/L, it is below the aquatic life guideline. The aquatic

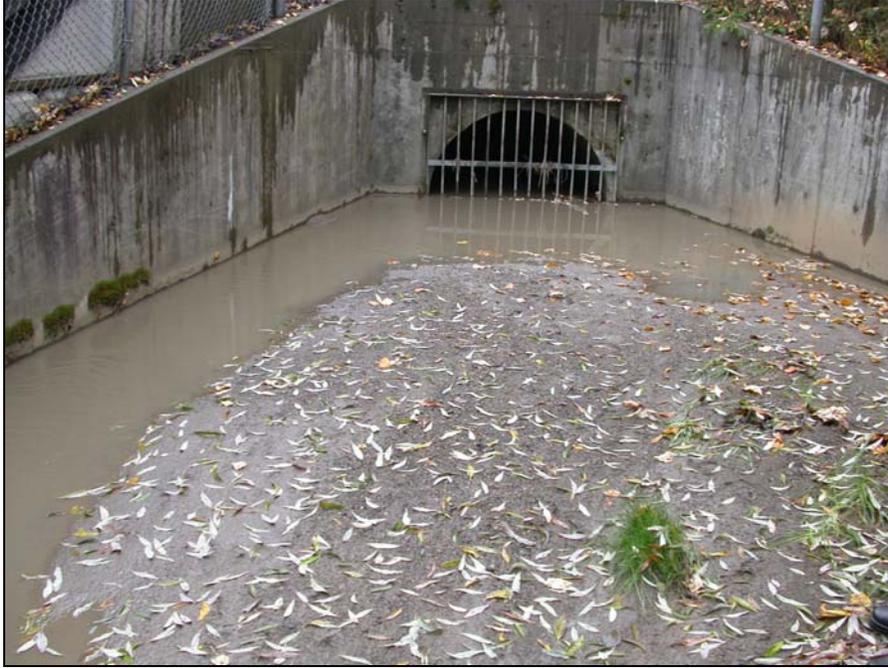
Plate 1. A view of the City storm drain flowing into McMillan Creek above Hoferkamp Road. Note the highly turbid water.

various potentially toxic metals (in the total form). Although there may be other contributing sources, such as observed ditch drainage and overland flow, the field inspection in October clearly showed an impact from the drain's induced TSS and turbidity (Plates 1-3). If TSS and turbidity levels cannot be reduced at their source, sediment traps or other particulate reducing methods should be used or constructed near the confluence with McMillan Creek to help reduce the direct impact.

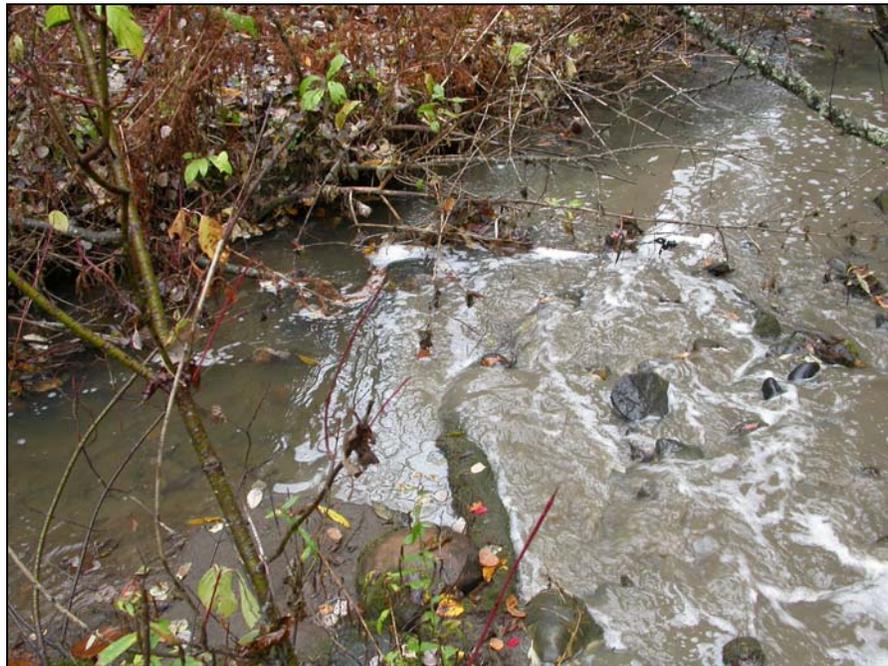
Plate 2. A downstream view from the confluence between the City storm drain (right) and McMillan Creek (left). Note the clear water in McMillan Creek and the highly turbid water from the City storm drain.

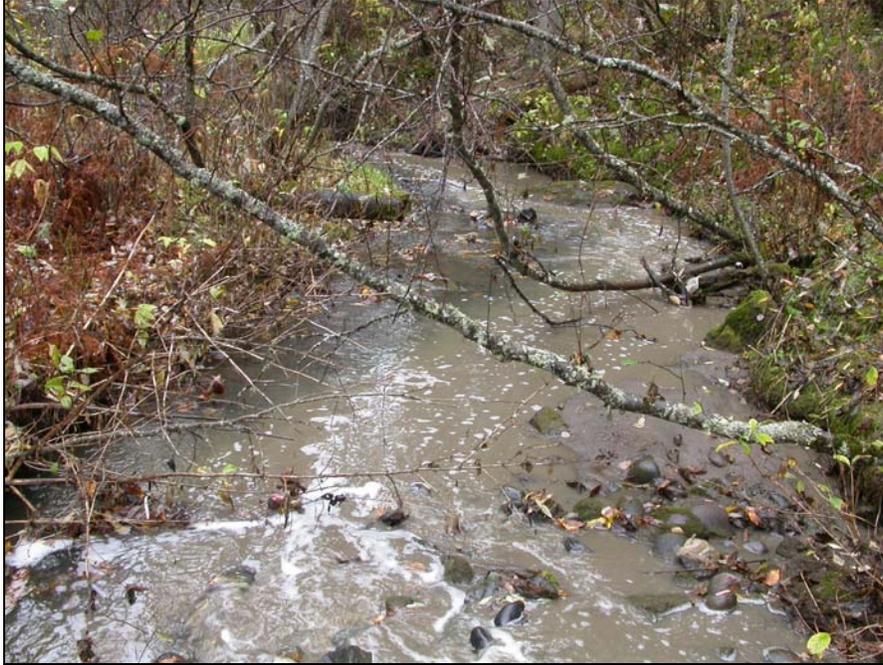
Plate 3. A view of the mixing zone immediately downstream from McMillan Creek and the City storm drain confluence. Note the highly induced turbid water from the City Storm drain (right side of channel) and the clear water from McMillan Creek (left side of channel).

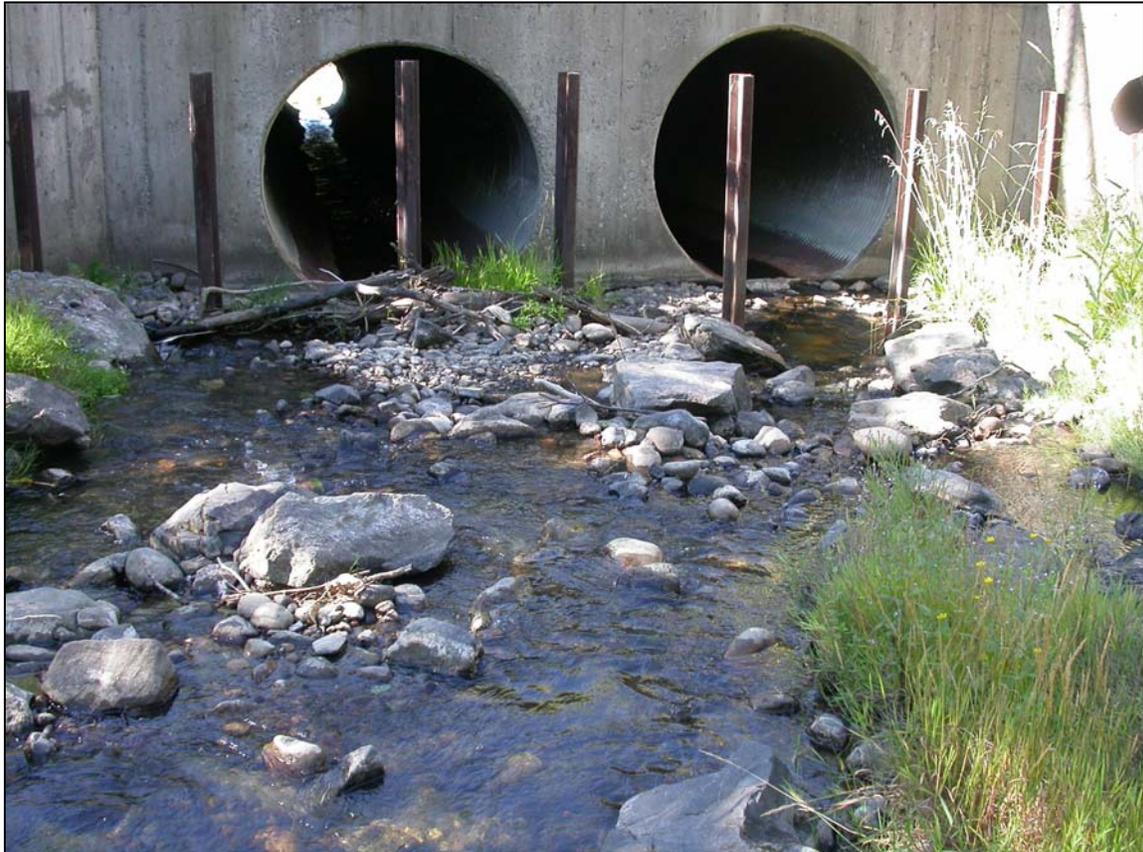
07/24/06: Low flow sampling, stream very low and clear, garbage observed instream, sample collected in riffle section.

09/21/06: Stream up in volume due to recent rain, turbid appearance

10/19/06: Stream conditions high and turbid, approximately 3.5mm rain in previous 5 hours, muddy appearance.

Plate A1. Site MC1. McMillan Creek, downstream view towards the culverts under the Pulpmill Road crossing, September 24th, 2006.

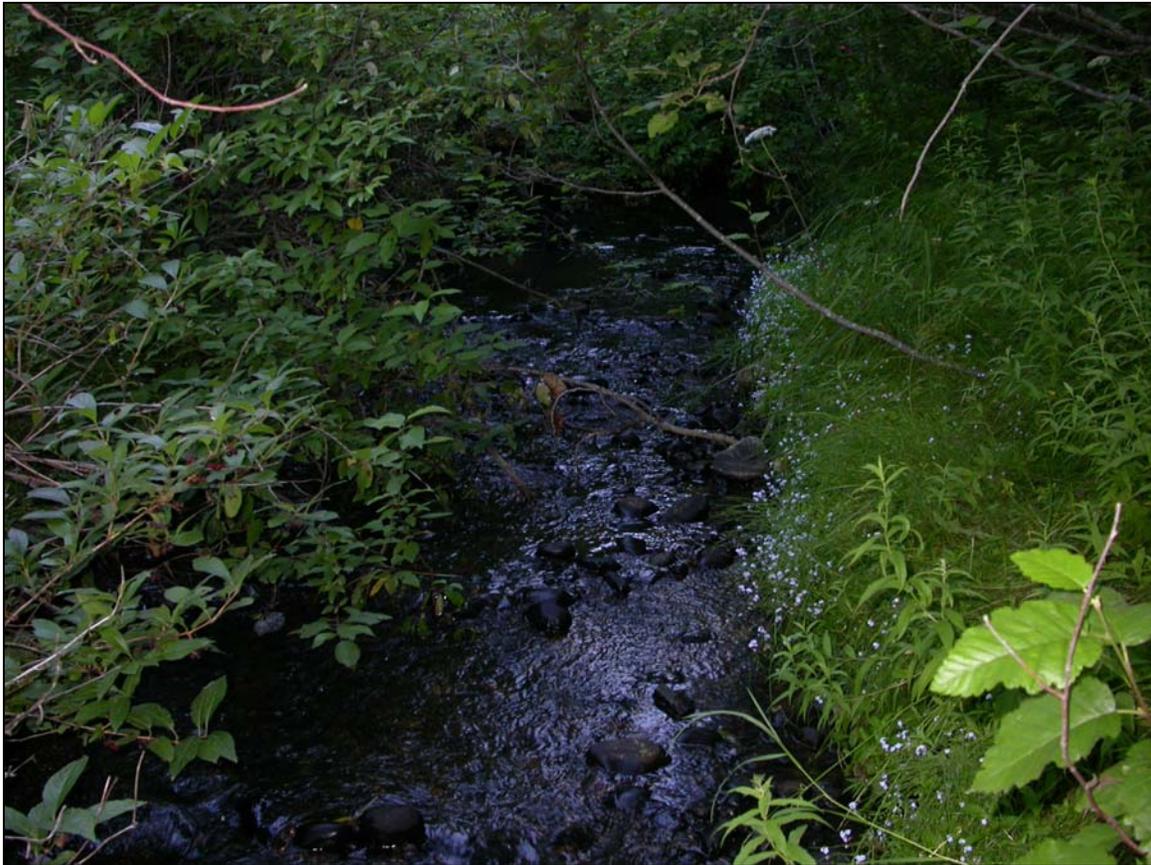
Site MC2

07/24/06: Low flow sampling, sampled upstream from road crossing, above culvert. Water has good flow, average depth 0.05m, 1.5m wetted width, cobble/gravel substrate, rocks appear very black but no sheens observed.

09/21/06: Slightly turbid, 2.3m wetted width, ditch water draining into creek via culverts downstream from site.

10/19/06: Stream high and turbid, water running into stream downstream from site from road ditch water.

Plate A2. Site MC2. McMillan Creek, upstream from the road crossing, upstream view, September 24th, 2006. Substrate appeared very black however no sheens observed when agitated.

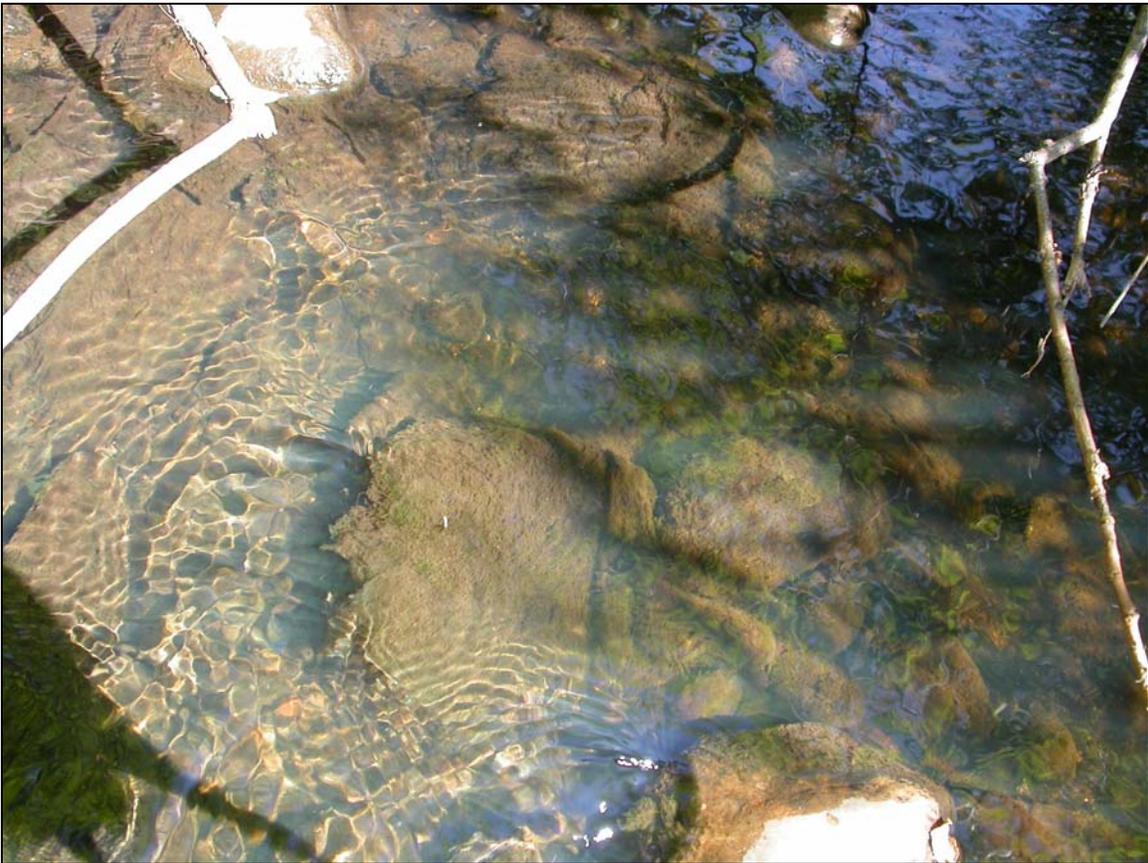
Site MC3

07/24/06: Low flow sampling, sampled upstream from road, high amount of periphyton and algae unlike MC2, lower velocity, small rainbow trout observed.

09/21/06: Water appears clear at site, positive flow.

10/19/06: Stream high but still clear, does not appear turbid.

Plate A3. Site MC3. McMillan Creek, upstream from the road crossing, upstream view, September 24th, 2006. Note the green periphyton growth on the rocks.

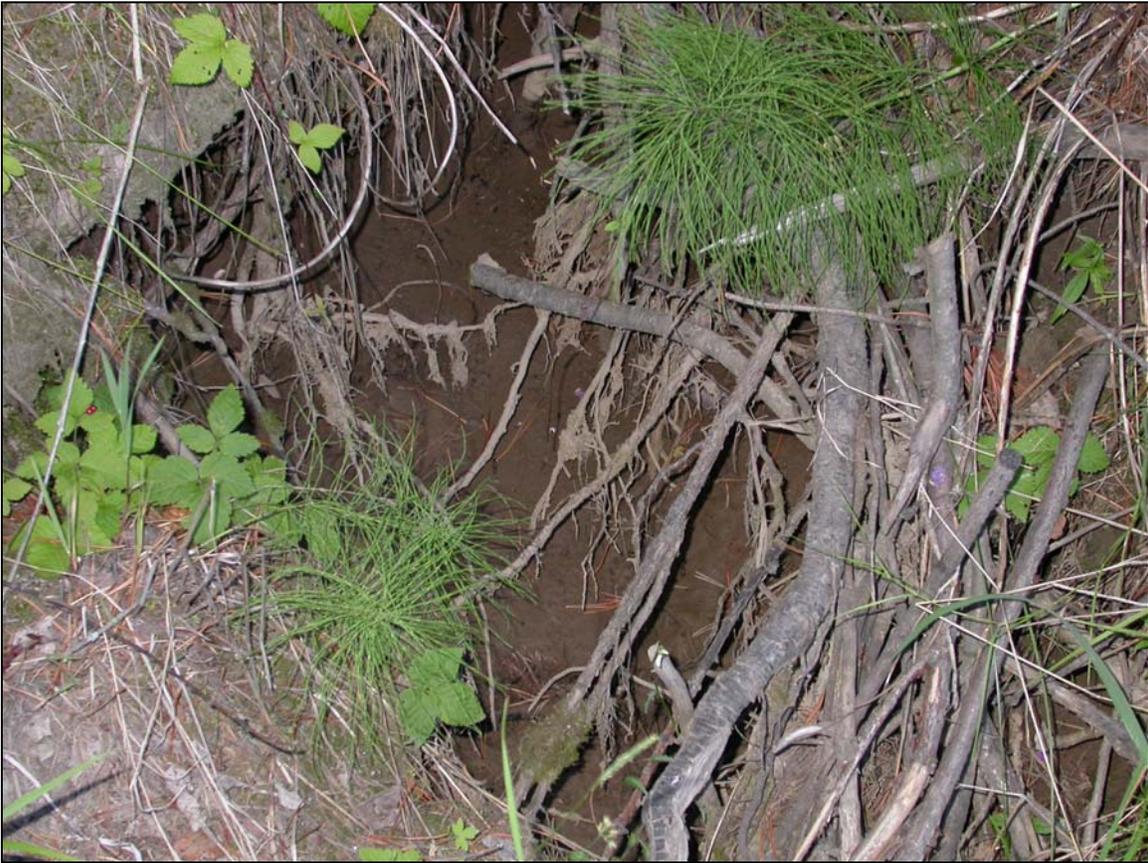
Site MC4

07/24/06: Channel dry with no flowing water. Water scour marks and sand deposits suggesting flow during freshet and rain events. No water sample collected.

Plate A4. Site MC4. McMillan Creek tributary, upstream view, September 24th, 2006. Note the channel has no flowing water; however, there were some fluvial deposits suggesting flow during spring freshet or other wet periods.

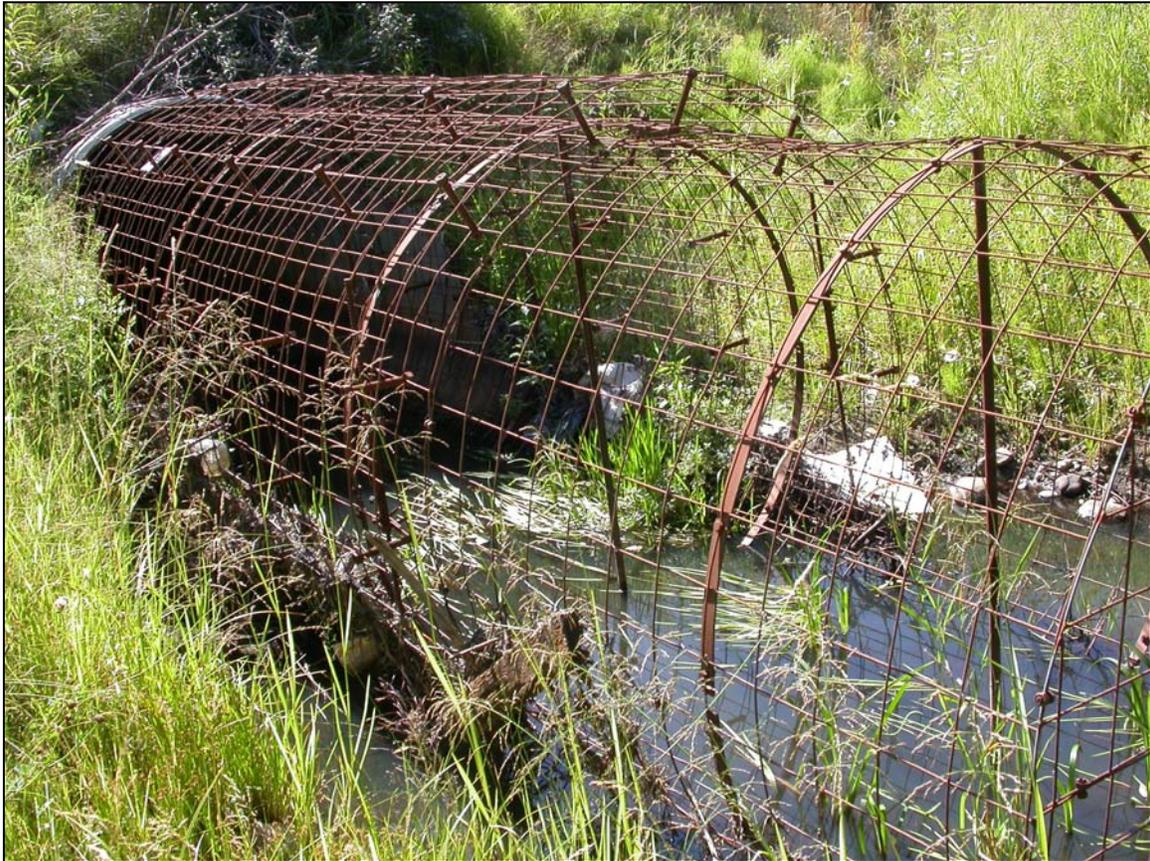
Site MC5

07/24/06: Low flow sampling, cobble substrate with some periphyton (less than MC3), large guard on culvert blocking debris and beaver access, very low velocity however still positive flow, slightly coloured, small rainbow trout observed.

09/21/06: Abundant garbage in stream, slow positive flow, slightly turbid water (more turbid than MC3).

10/19/06: Site high and slightly turbid in appearance, garbage in stream.

Plate A5. Site MC5. McMillan Creek, upstream from road crossing, downstream view, September 24th, 2006. View of the large metal structure blocking large debris from entering the culvert. Note the abundance of vegetation growing instream.
