**McMillan Creek Monitoring Project
2006 EPD Data Summary**

**James Jacklin, B.Sc.
Ministry of Environment
Environmental Protection Division
Environmental Quality Section
Omineca-Peace Region
March, 2007**

Executive Summary

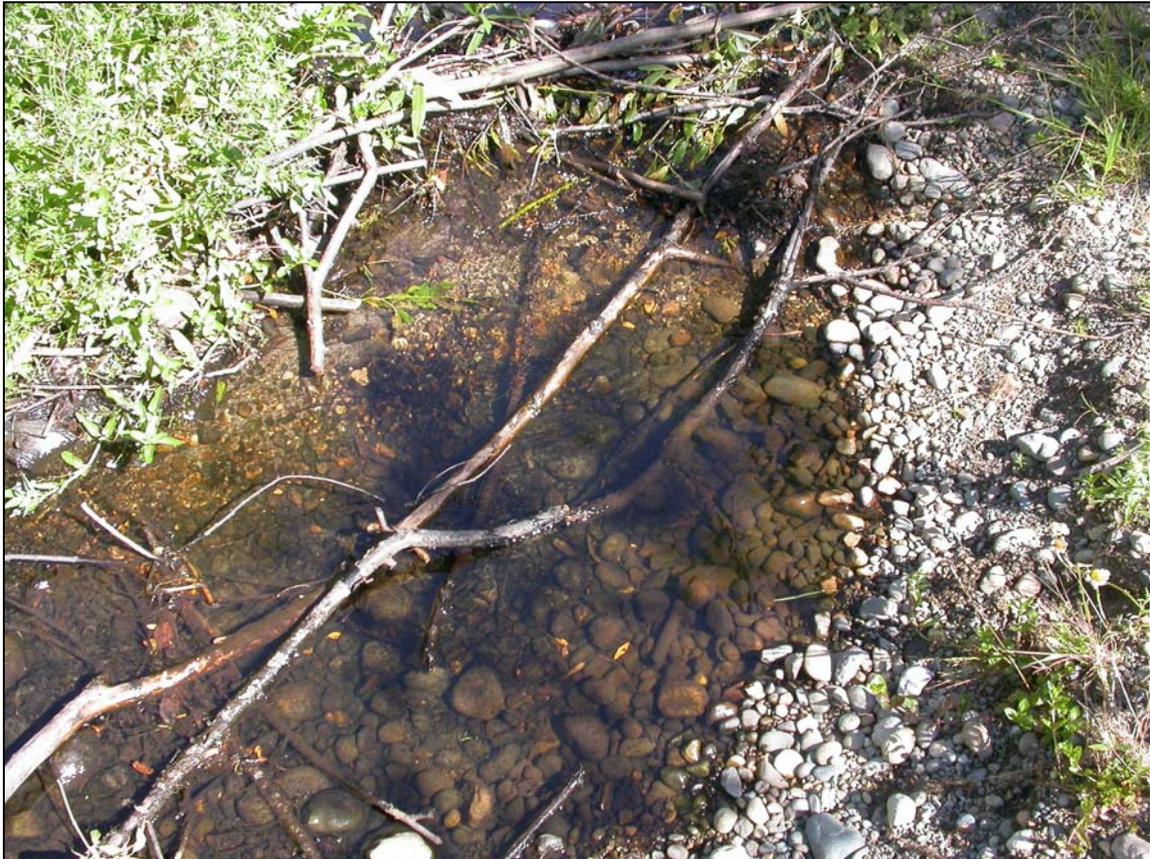
Site MC6

09/21/06: Water relatively clear, likely from the settling of sediments in the pond upstream from beaver dams.

10/19/06: Rain starting to fall, good flow with clear water.

Plate A6. Site MC6. McMillan Creek, upstream of road crossing, upstream view, September 24th, 2006. View of the small stream draining the large wetland complex.

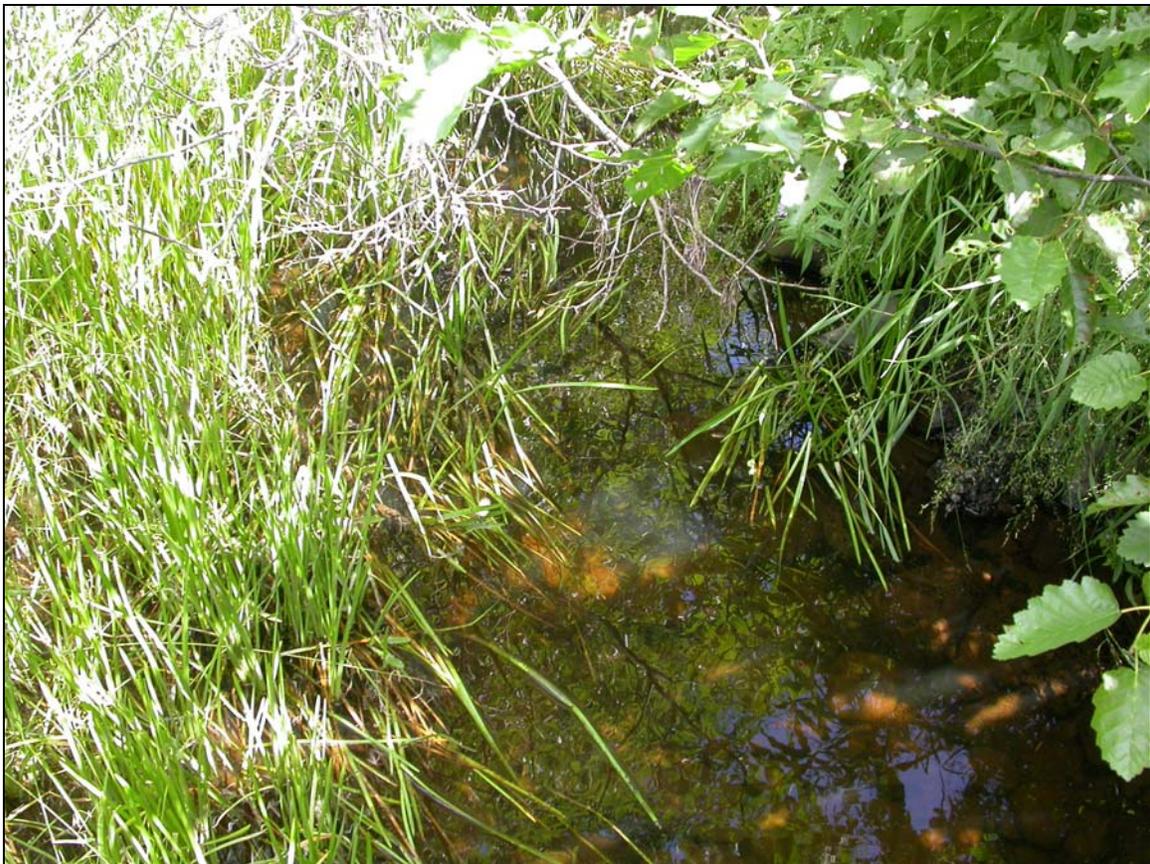
Site MC7

09/21/06: Water appears clear, good flow

10/19/06: Site has good flow and clear water

Plate A7. Site MC7. McMillan Creek, upstream from road crossing, upstream view, September 24th, 2006. View of the small stream with abundant riparian vegetation. The site has a cobble substrate.

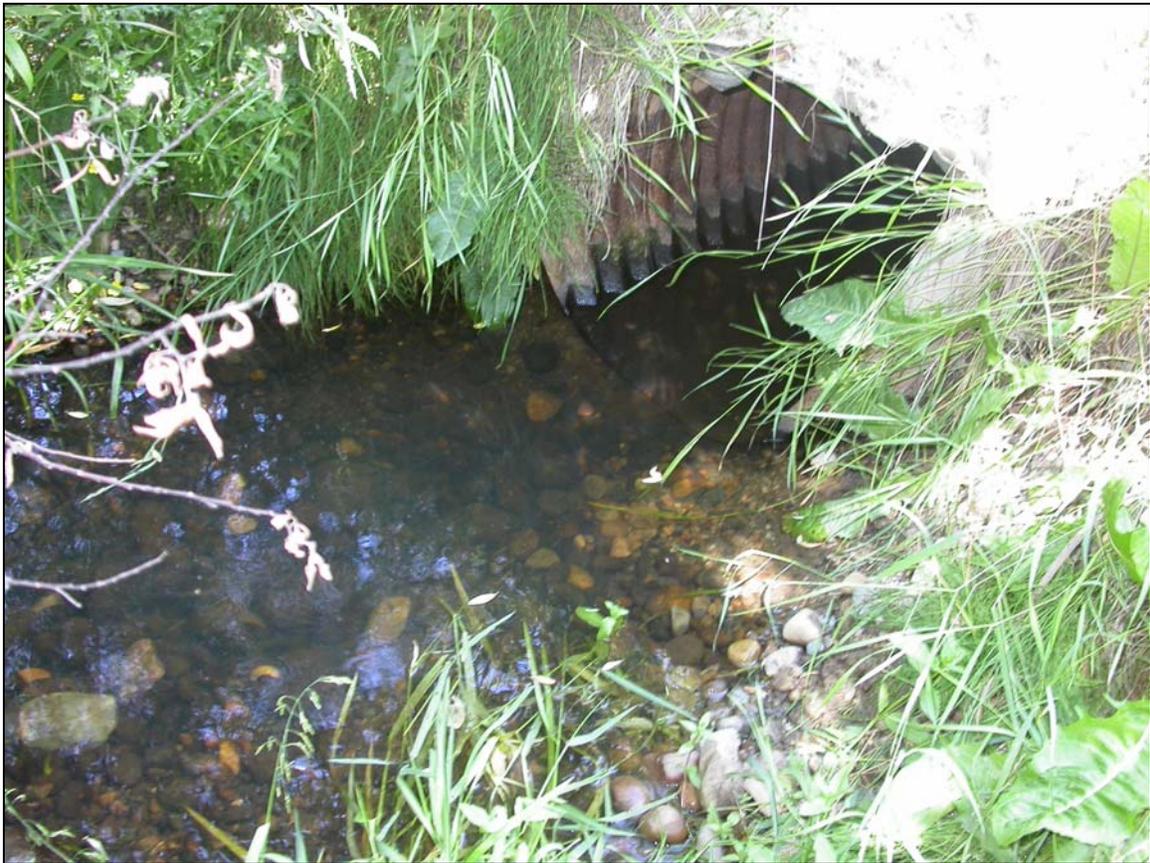
Site MC8

09/21/06: Stream low, clear with good flow. Abundant foliage in creek.

10/19/06: Site has good flow with clear water.

Plate A8. Site MC8. McMillan Creek, downstream from road crossing, upstream view, September 24th, 2006. Note the cobble substrate and abundant riparian vegetation.
