WATER QUALITY MONITORING AGREEMENT

WATER QUALITY ASSESSMENT OF Elk River AT HIGHWAY 93 NEAR ELKO (1968 – 2005)

Prepared by:
L. G. Swain, P. Eng.
B.C. Ministry of Environment

March 2007

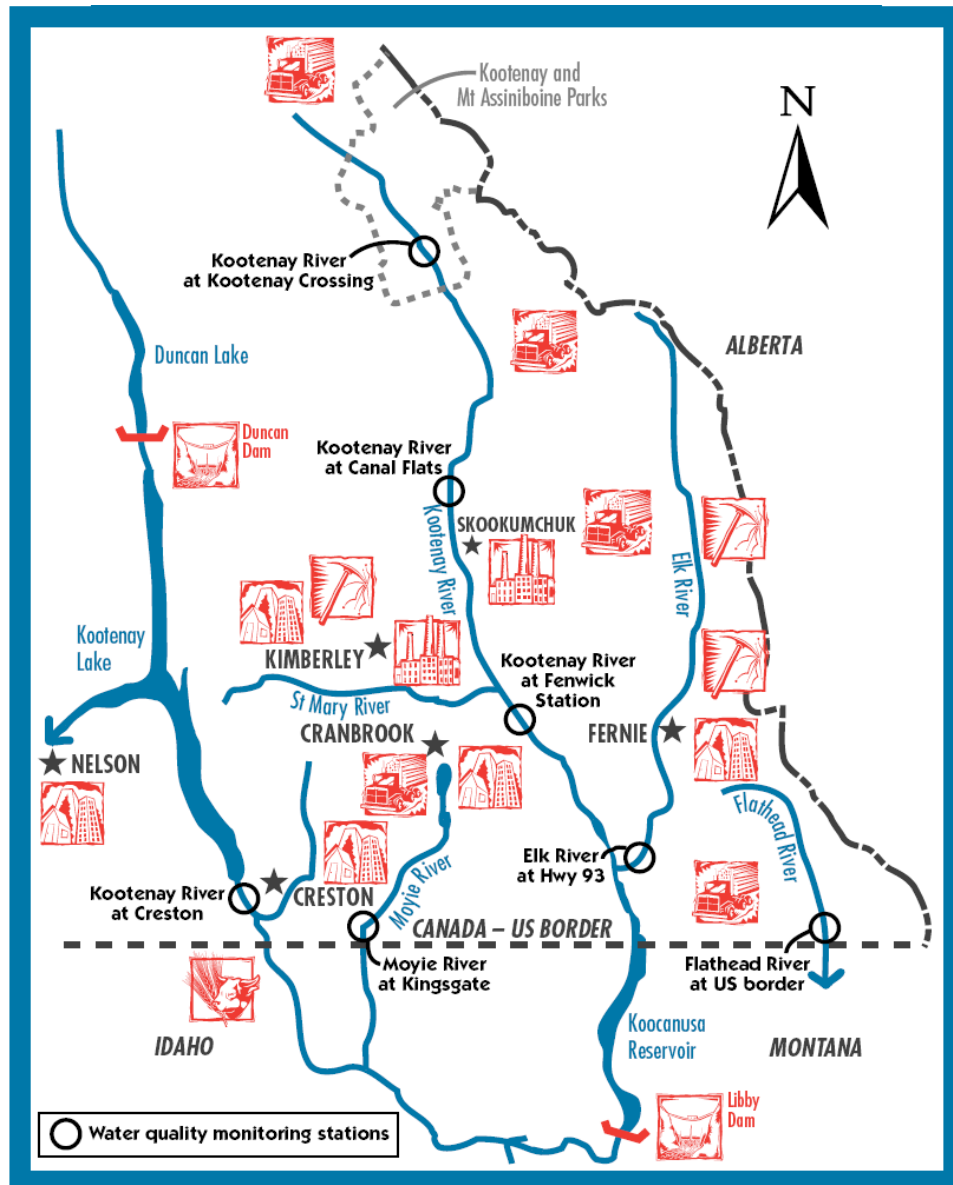
FIGURE 1: ELK RIVER NEAR ELKO

The water quality sampling station on the Elk River is located just upstream from the confluence with the Kootenay River/Lake Koocanusa at Highway 93.

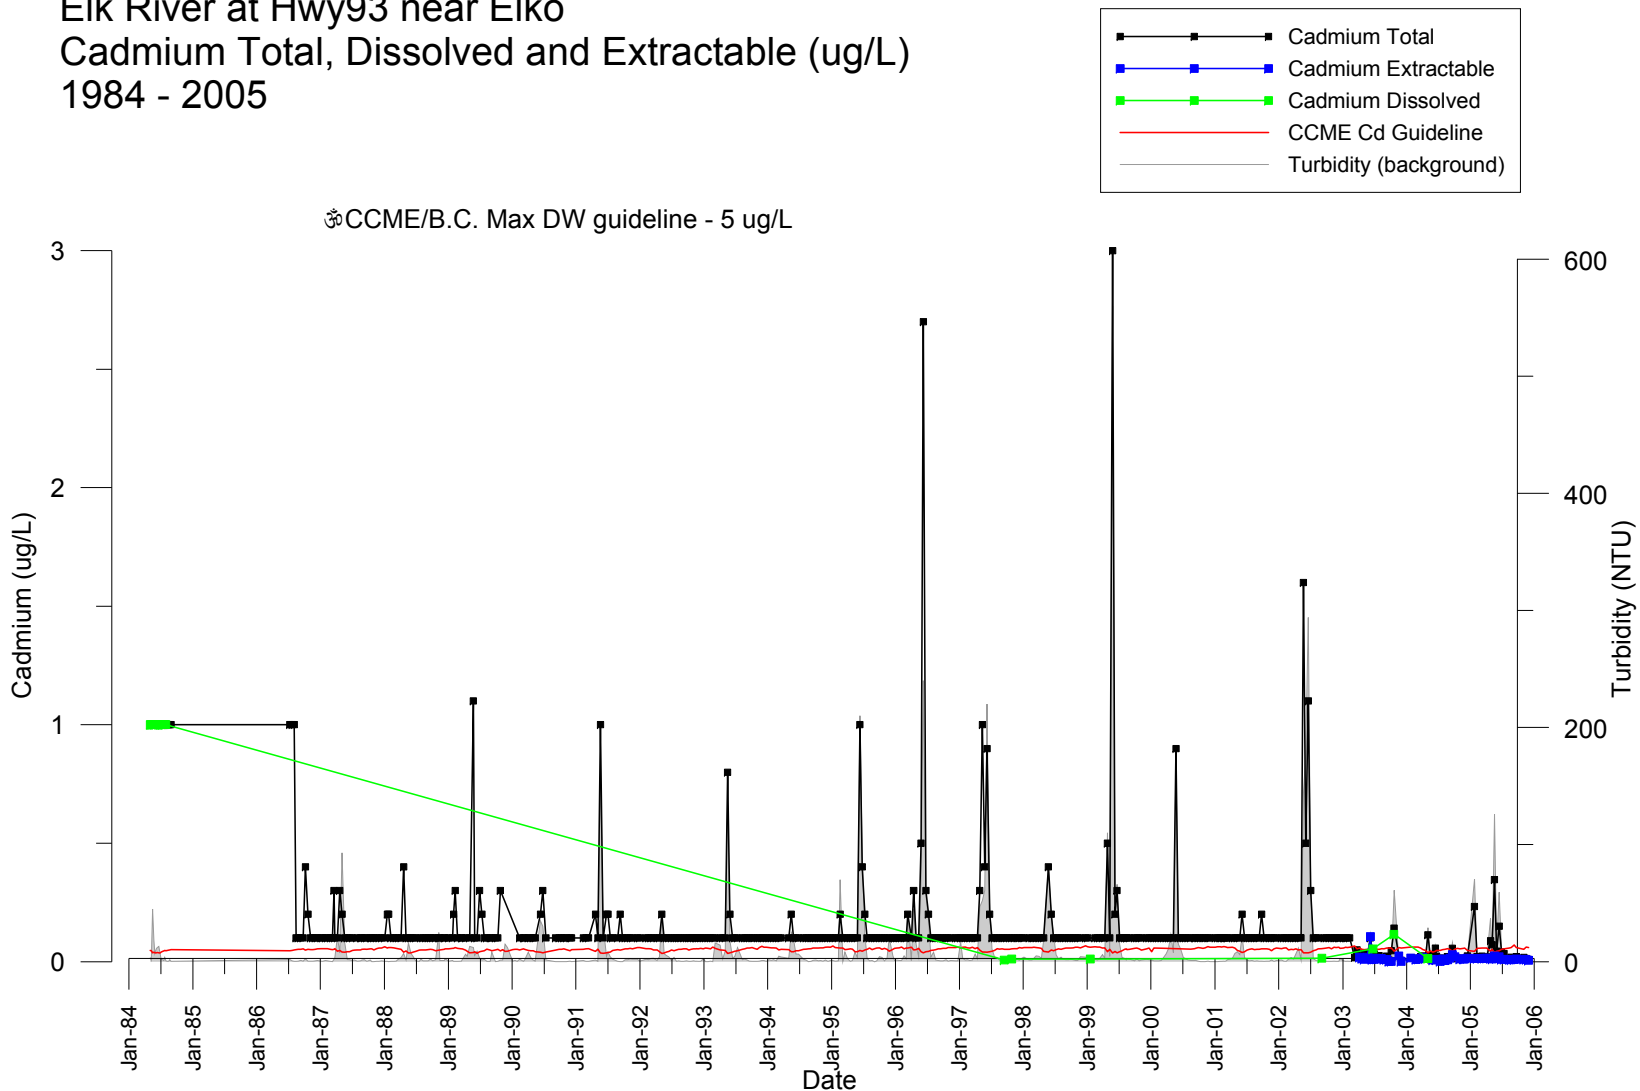
Figure 17
 Elk River at Hwy93 near Elko
 Cadmium Total, Dissolved and Extractable (ug/L)
 1984 - 2005

Cadmium (Figures 17 and 18) values occasionally exceeded the guideline to protect aquatic life that is based on water hardness. Most values that exceeded the guideline were total cadmium values, which were correlated with turbidity, where the cadmium would be in particulate form and not biologically available.

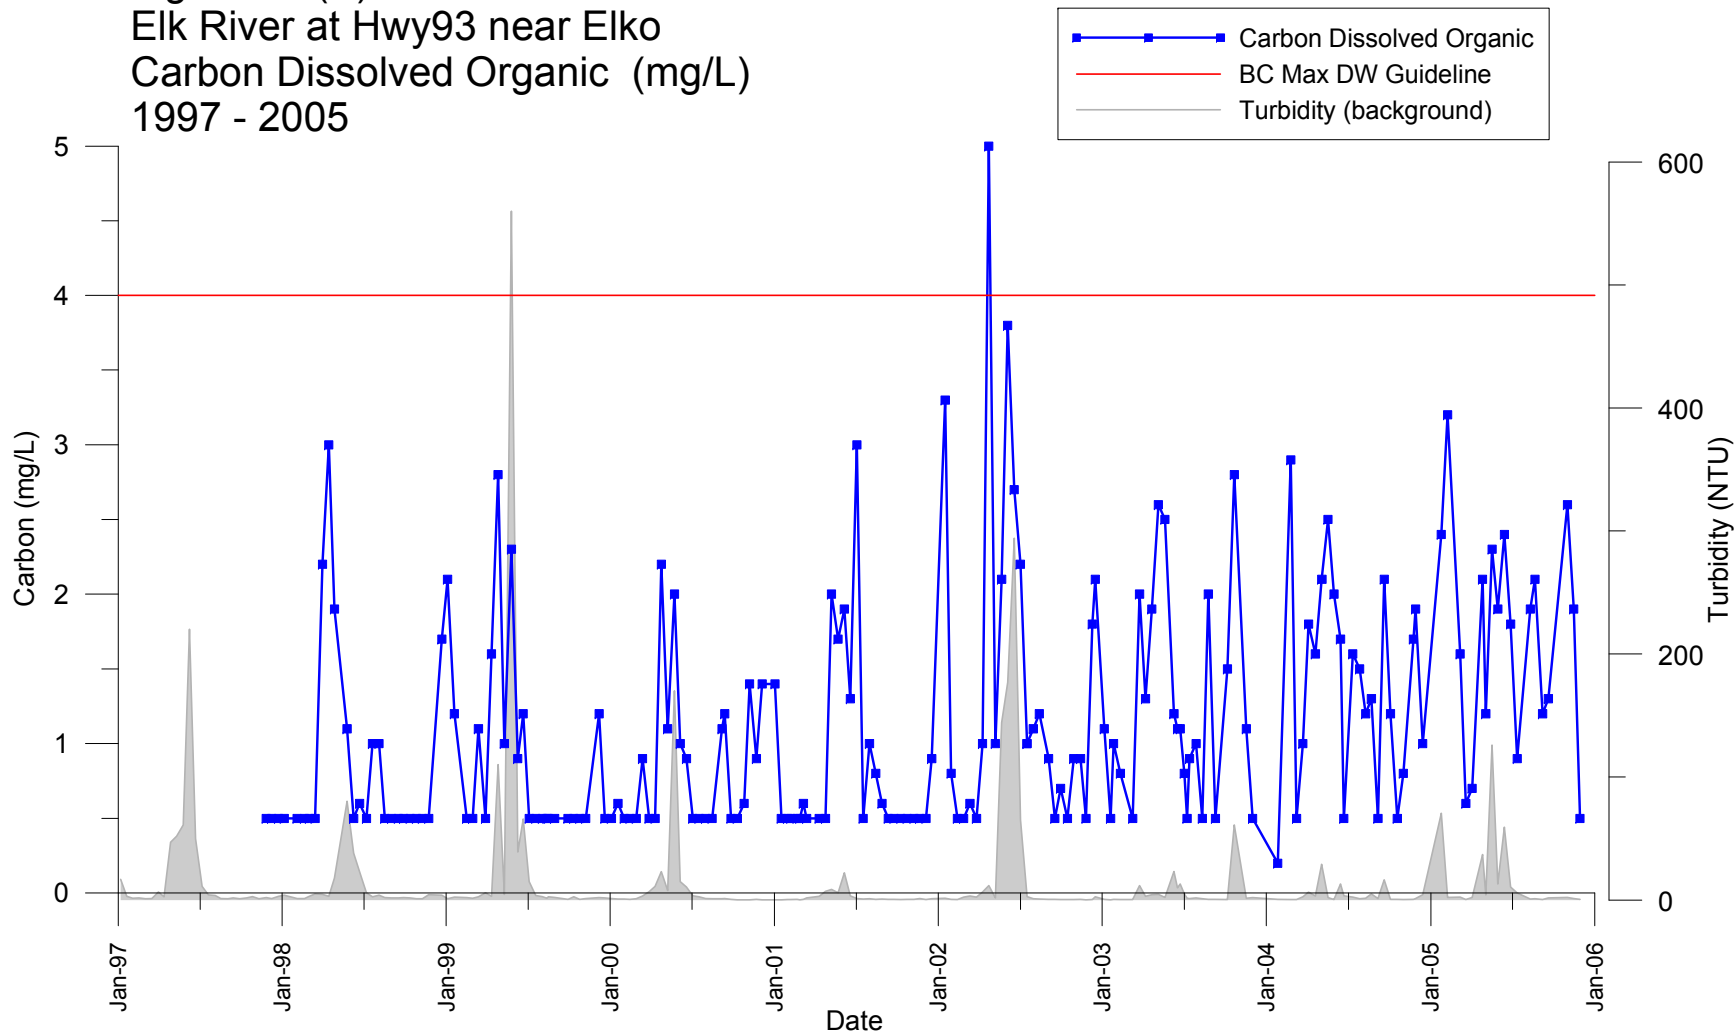
Figure 21 (A)
 Elk River at Hwy93 near Elko
 Carbon Dissolved Organic (mg/L)
 1997 - 2005

Dissolved Organic Carbon (Figures 20 and 21) values usually met the guideline for total organic carbon of 4 mg/L to protect source waters used for drinking water supplies. The guideline was exceeded by only one DOC value in 2002.

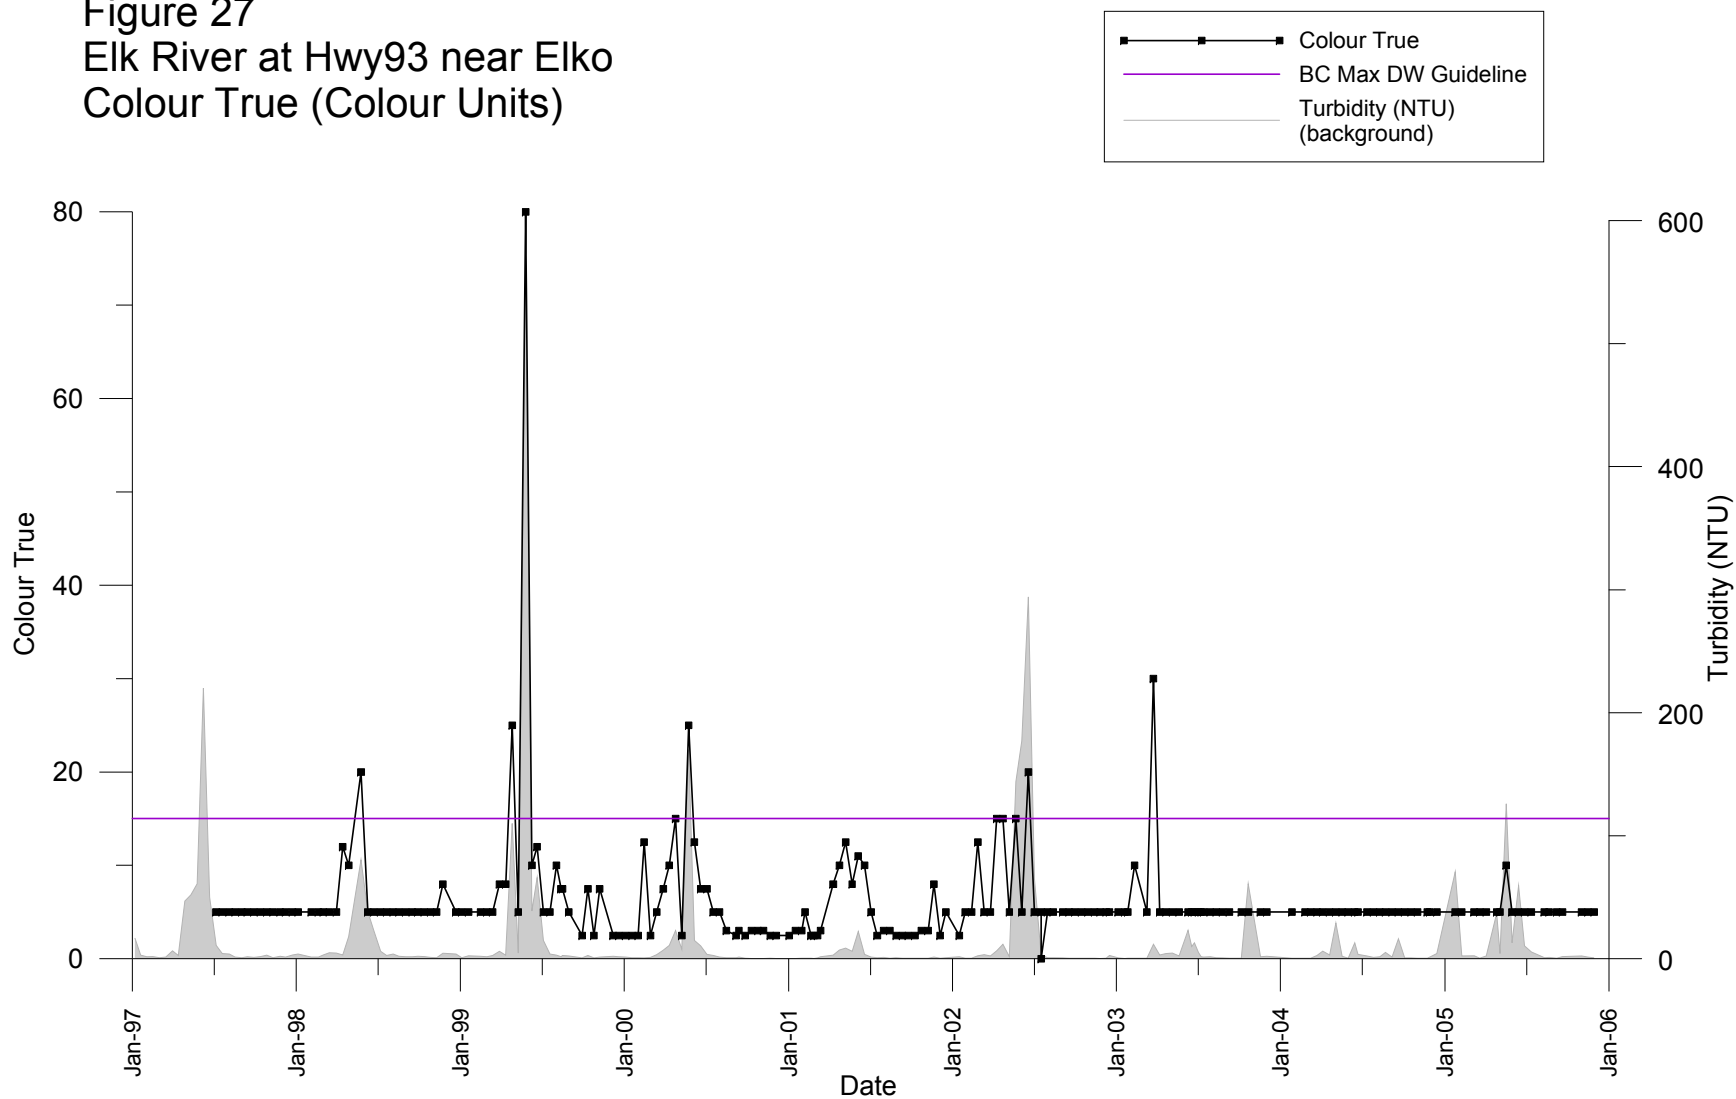
Figure 27
Elk River at Hwy93 near Elko
Colour True (Colour Units)

True colour (Figure 27) values generally met the guideline for source waters used for drinking although there were some occasions when the guideline was exceeded. The guideline is based on aesthetics of the water supply, not health considerations.

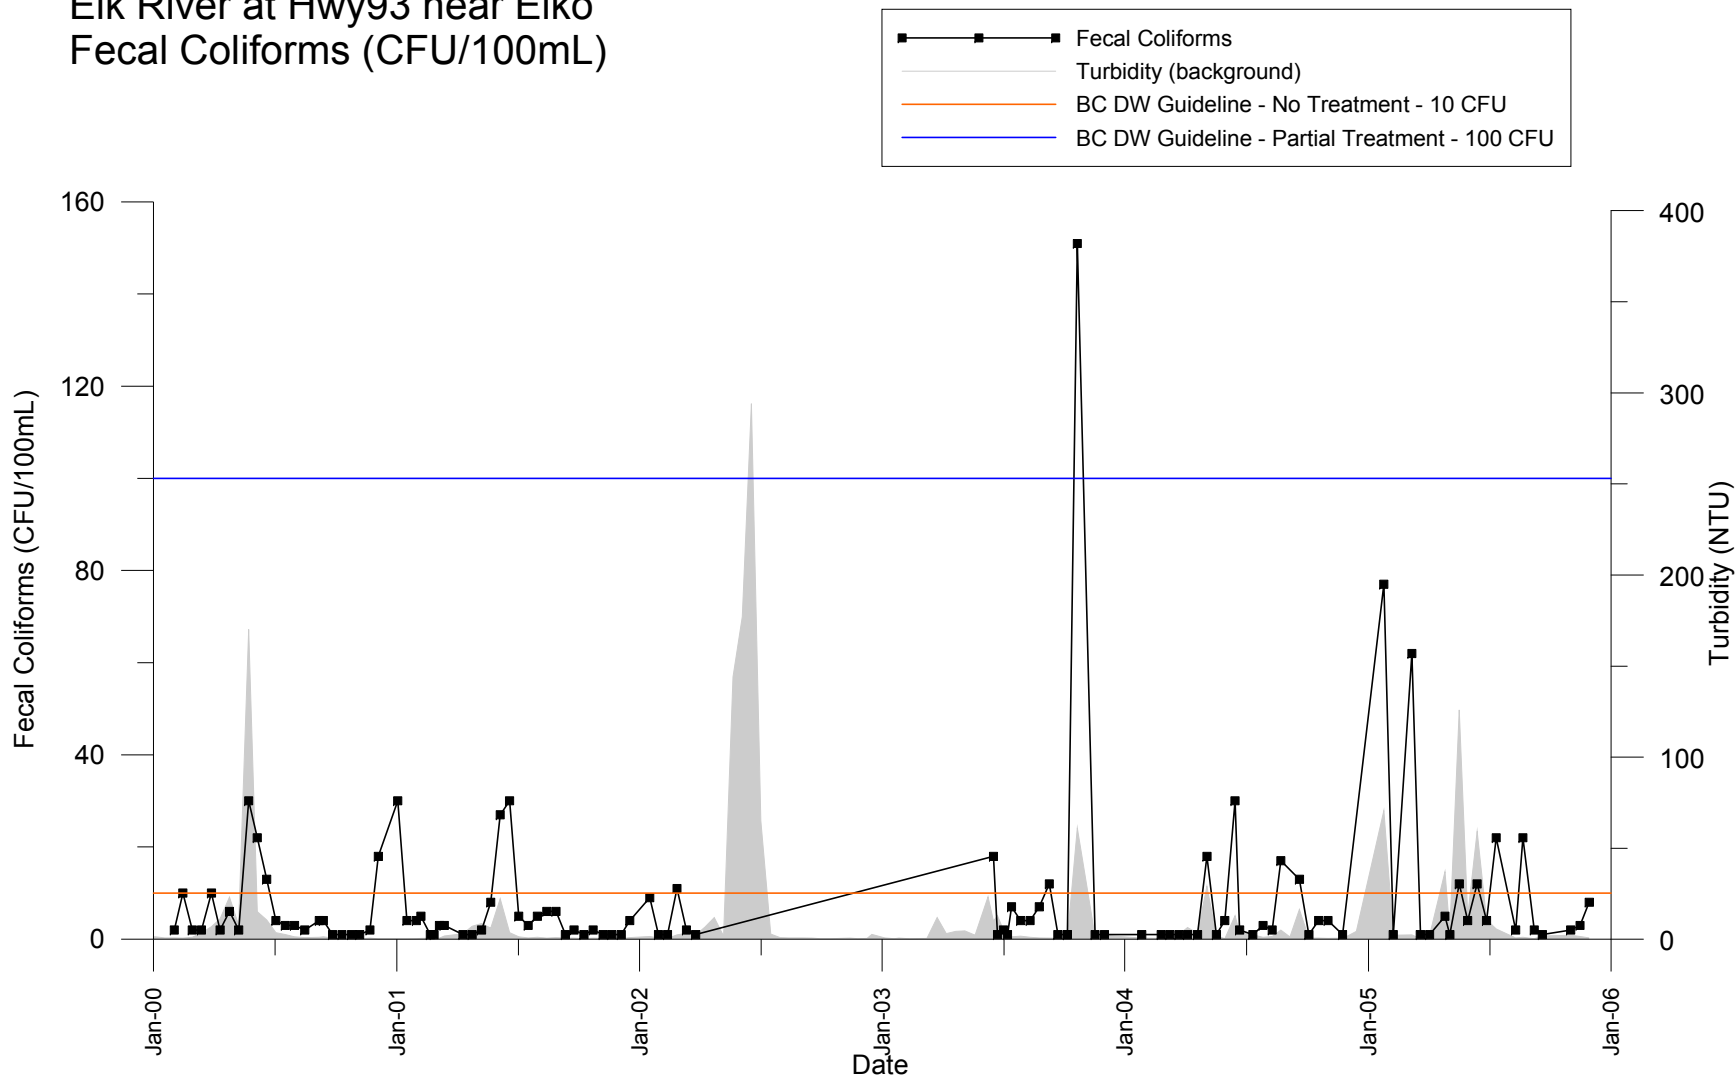
Figure 31
 Elk River at Hwy93 near Elko
 Fecal Coliforms (CFU/100mL)

Fecal Coliforms (Figure 31) were often above the guideline for source waters used for drinking that apply disinfection only. This means that some form of partial treatment of the water supplies should also be applied for effective disinfection to occur.

- Fecal coliform concentrations exceeded source water protection guidelines for use of the water with disinfection only. This means that the water should have partial treatment to remove both turbidity and improve the removal of bacteria.

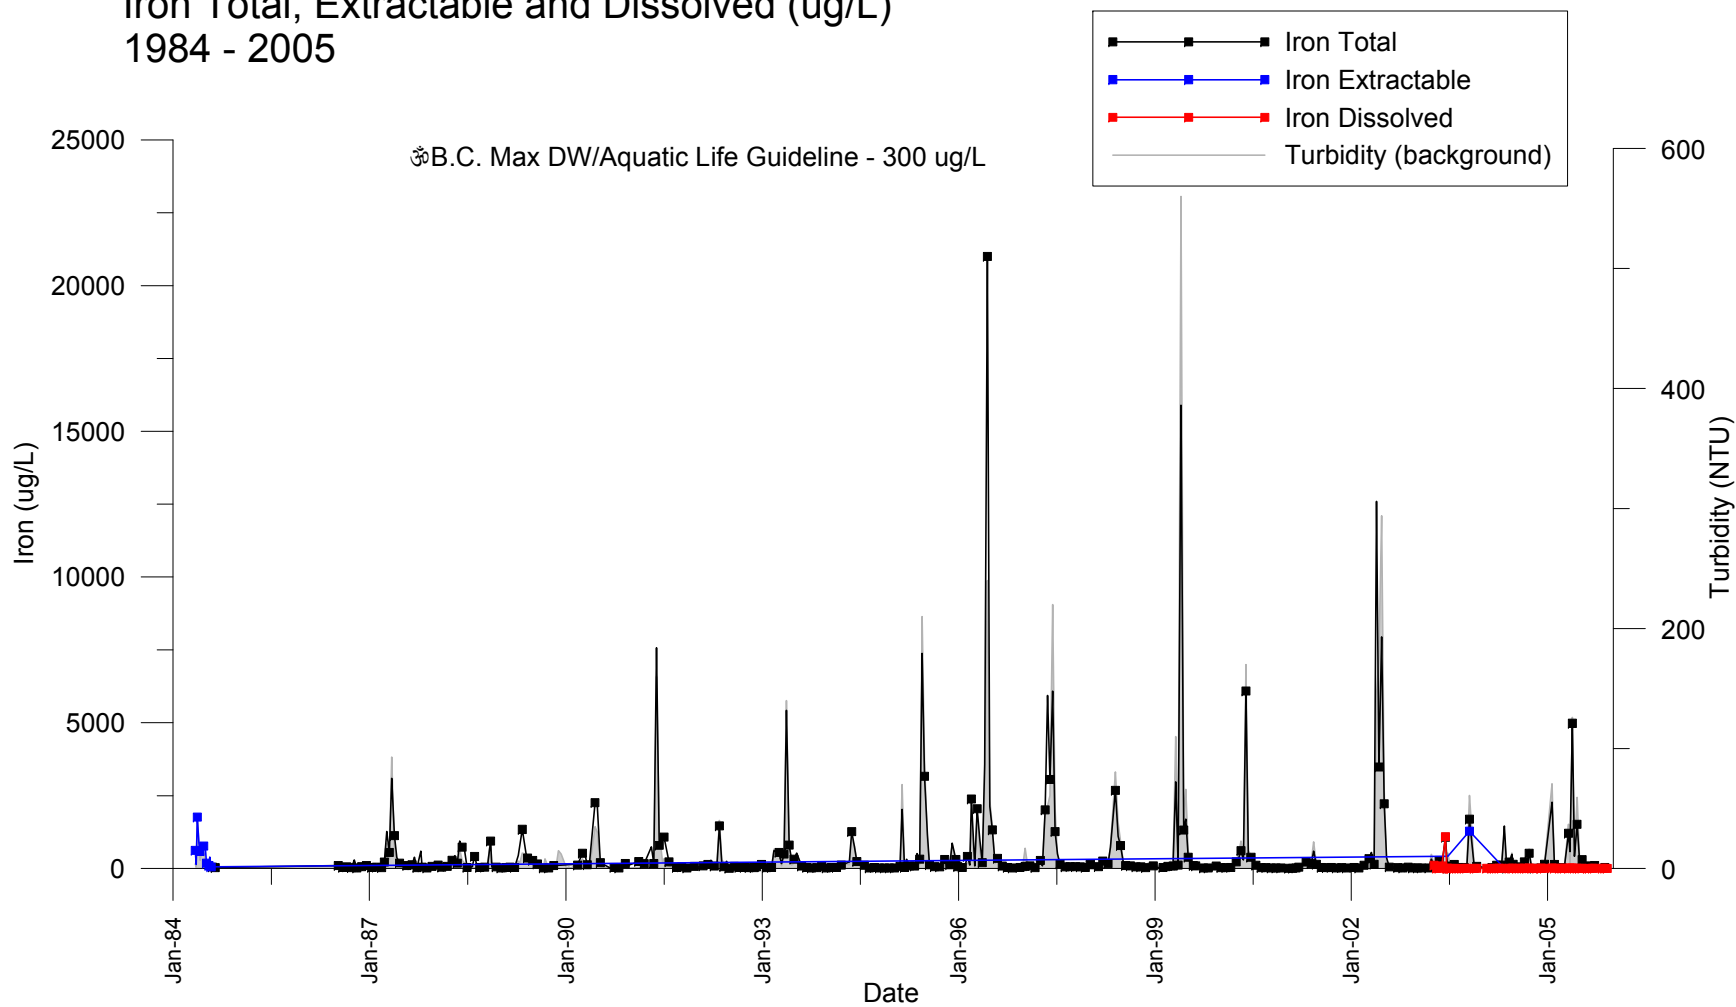
Figure 36
Elk River at Hwy93 near Elko
Iron Total, Extractable and Dissolved (ug/L)
1984 - 2005

Iron (Figures 36 and 37) values often exceeded the guidelines for protection of aquatic life and source waters used for drinking. Iron is an aesthetic concern related to drinking water supplies, while total iron concentrations were correlated with turbidity and would not likely be biologically available.

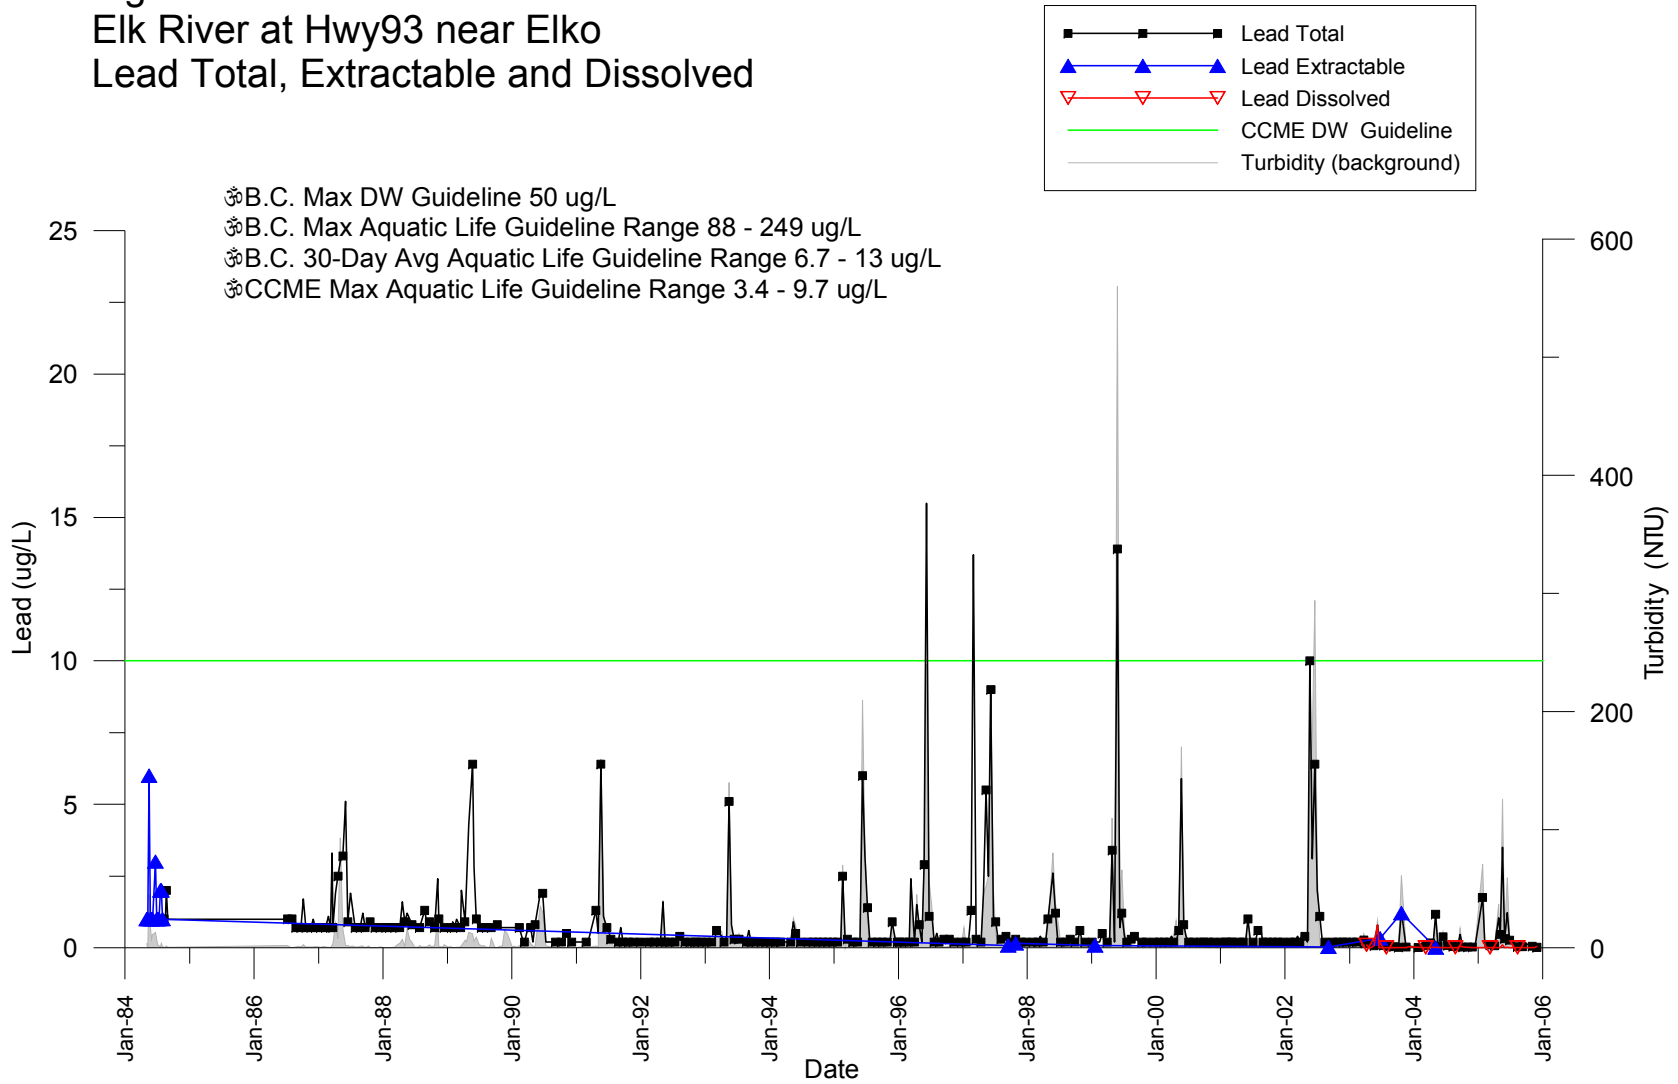
Figure 40
 Elk River at Hwy93 near Elko
 Lead Total, Extractable and Dissolved

Lead (Figures 40 and 41) values generally appear to have met the guidelines since 2003 when lower detection limits were instituted. Prior to that time, some total concentrations

exceeded the guidelines; however, these values were correlated with high turbidity and would not likely be biologically available.

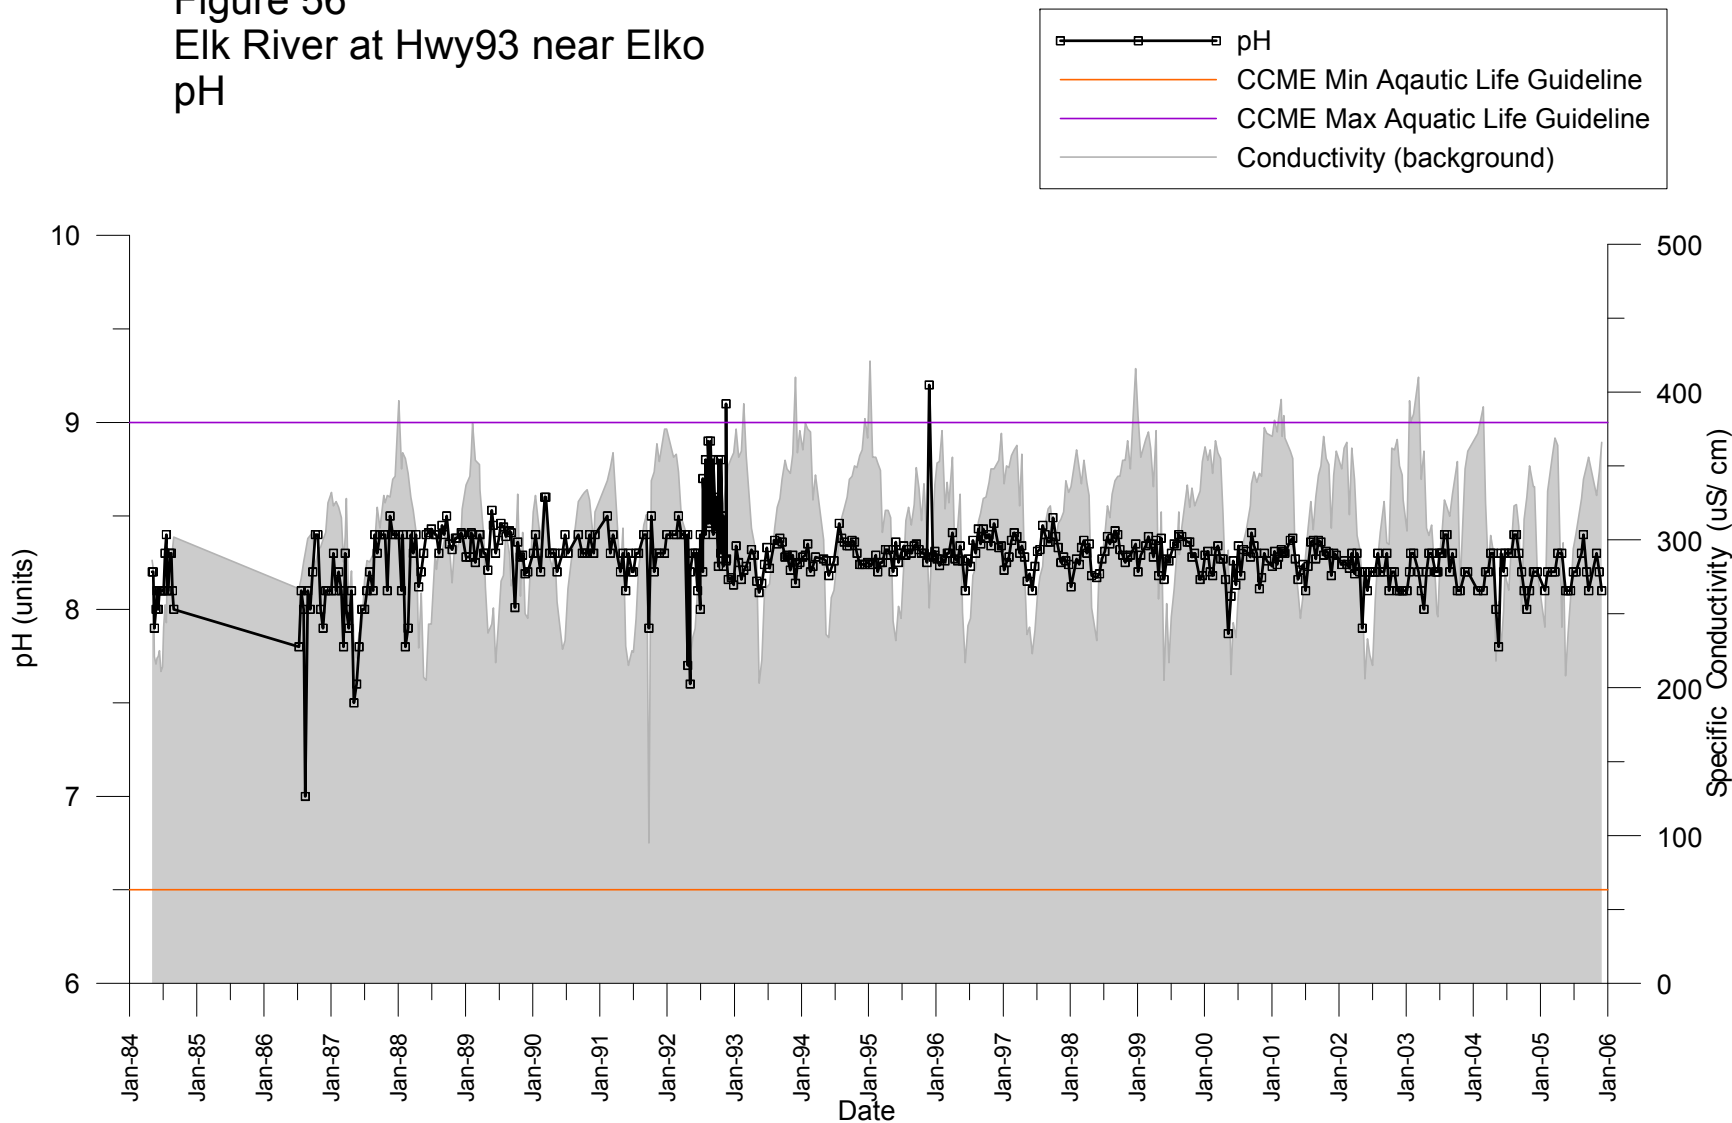
Figure 56
Elk River at Hwy93 near Elko
pH

pH (Figure 56) values in the mid-1990's occasionally exceeded the upper limit of 9.0 to protect aquatic life; however, these values which were at least one pH unit greater than the normal range and if these were real, would represent a ten-fold increase in the amount of basic material in the river, a highly unlikely event. Thus, the pH excursions seem like random events and may have actually been a contaminated sample or a poorly calibrated probe.

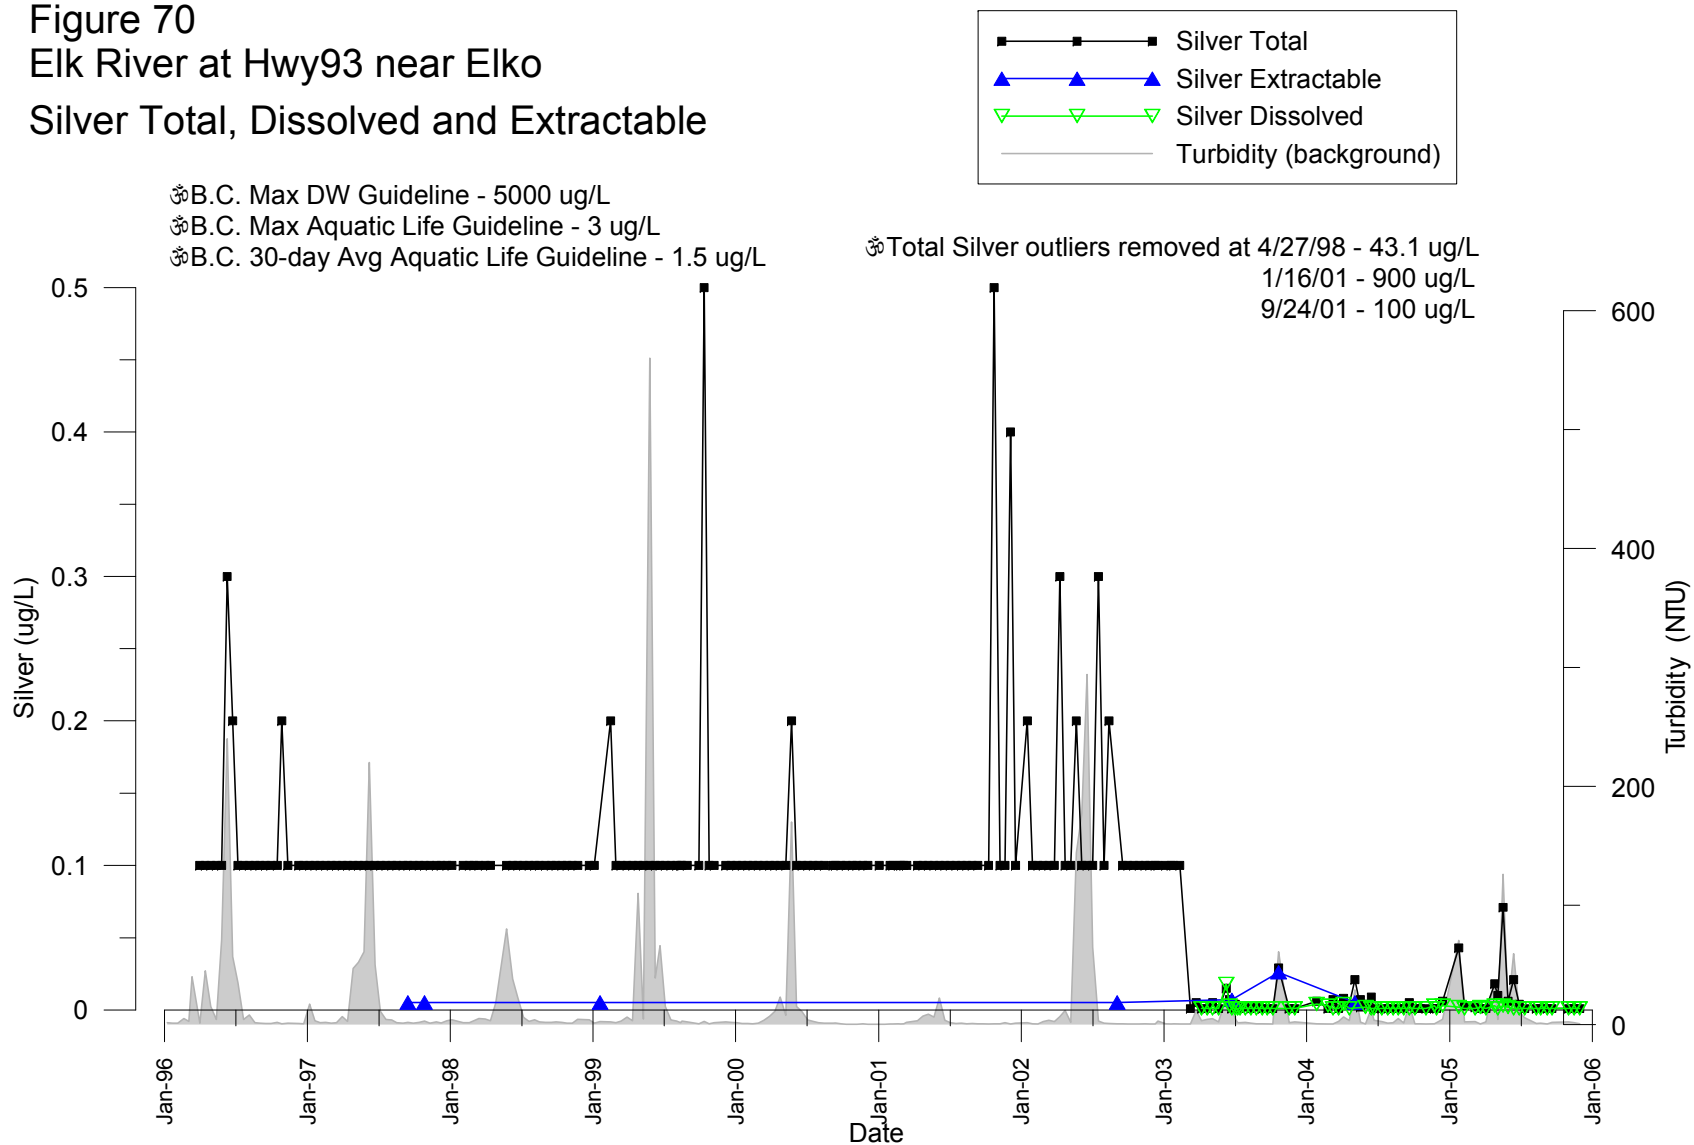
Figure 70
 Elk River at Hwy93 near Elko
 Silver Total, Dissolved and Extractable

Silver (Figures 70 and 71) exceeded the 30-day average guideline until 2003 when lower analytical detection limits became available. After that time, the guideline has not been exceeded. The values in excess of the guideline which was also the detection limit were “noise” associated and typical of what is encountered near the detection limit. Silver is not expected to be a concern.

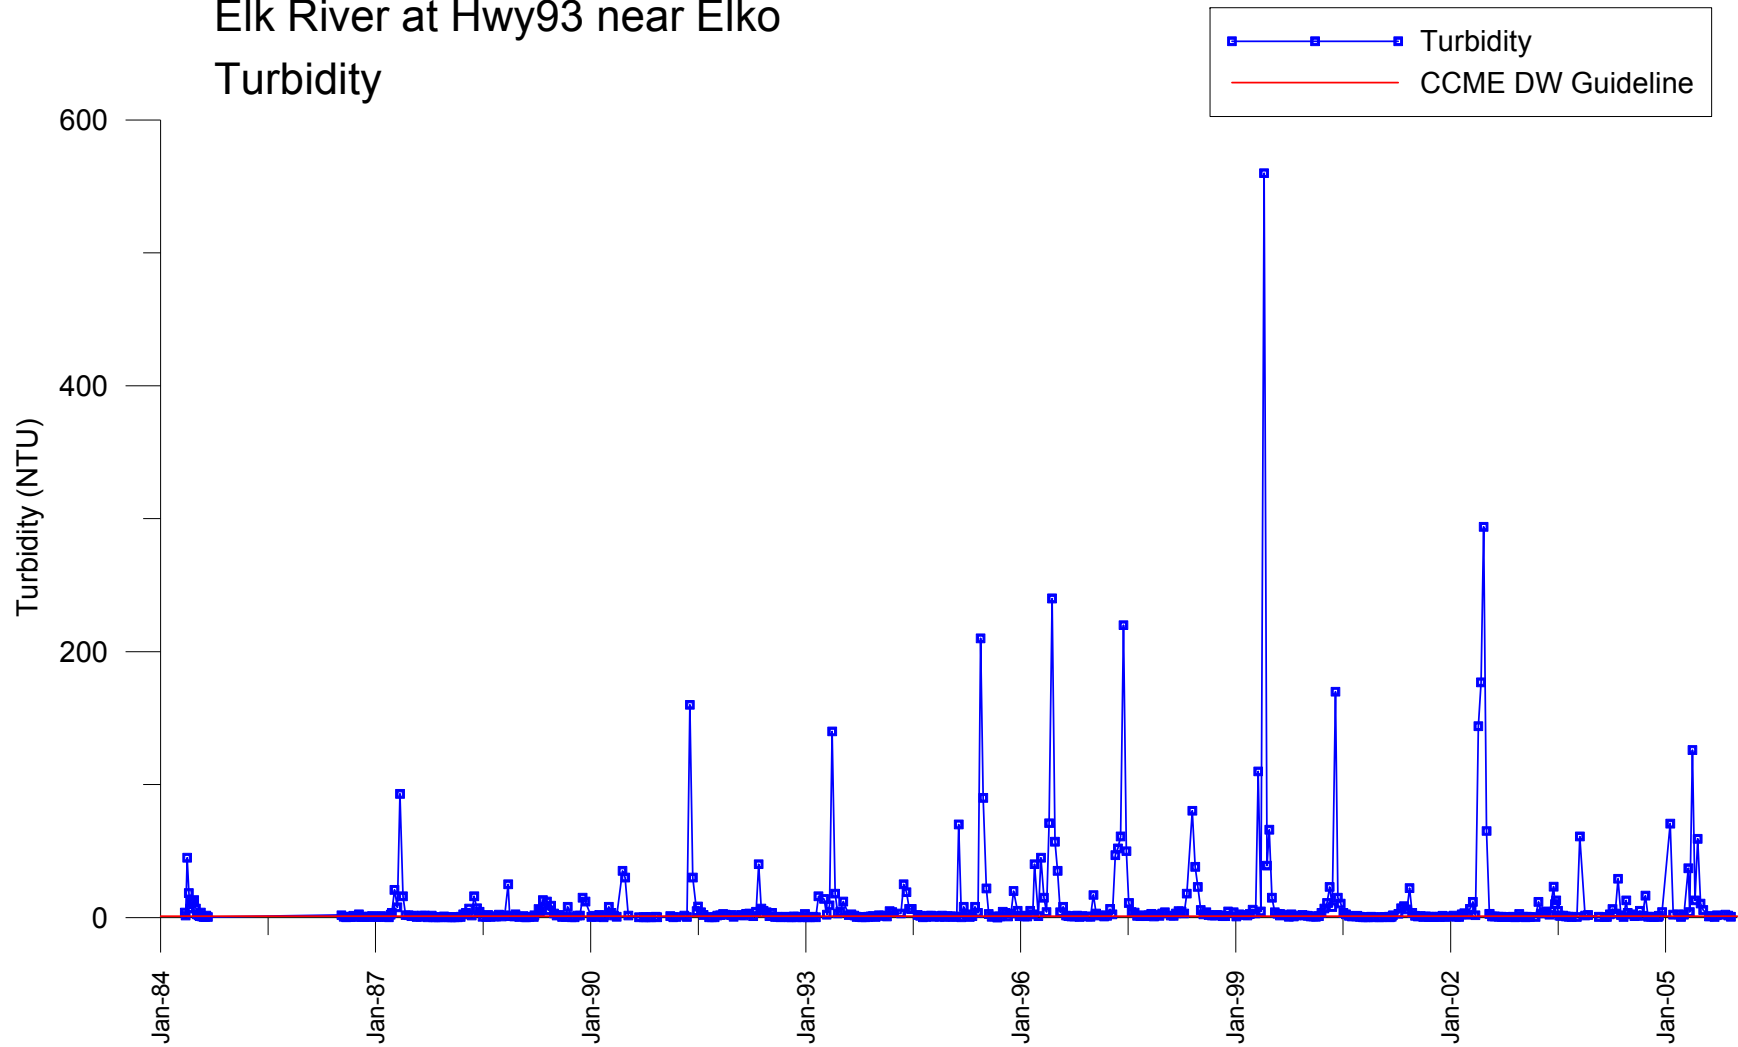
Figure 80
Elk River at Hwy93 near Elko
Turbidity

Turbidity (Figure 80) values often exceeded the guideline for source waters used for drinking. This means that a minimum of partial treatment is required before this water can be used as a reliable source water for drinking.

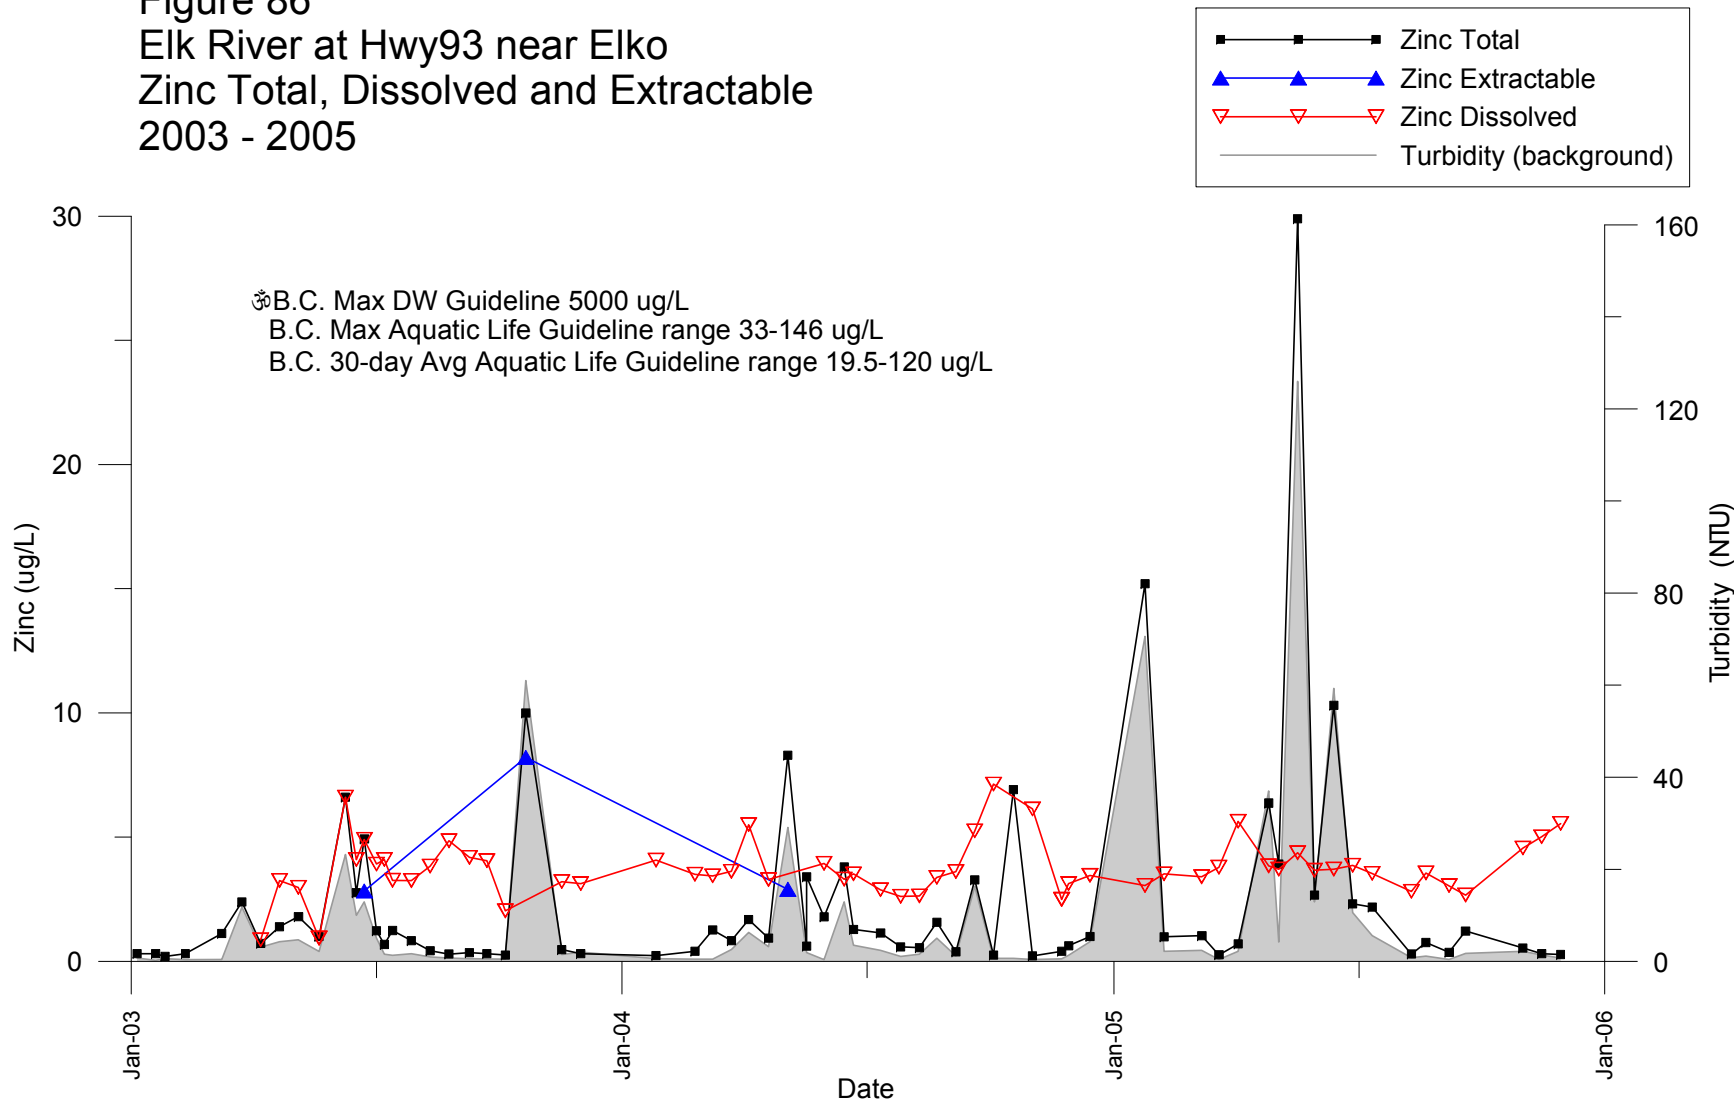
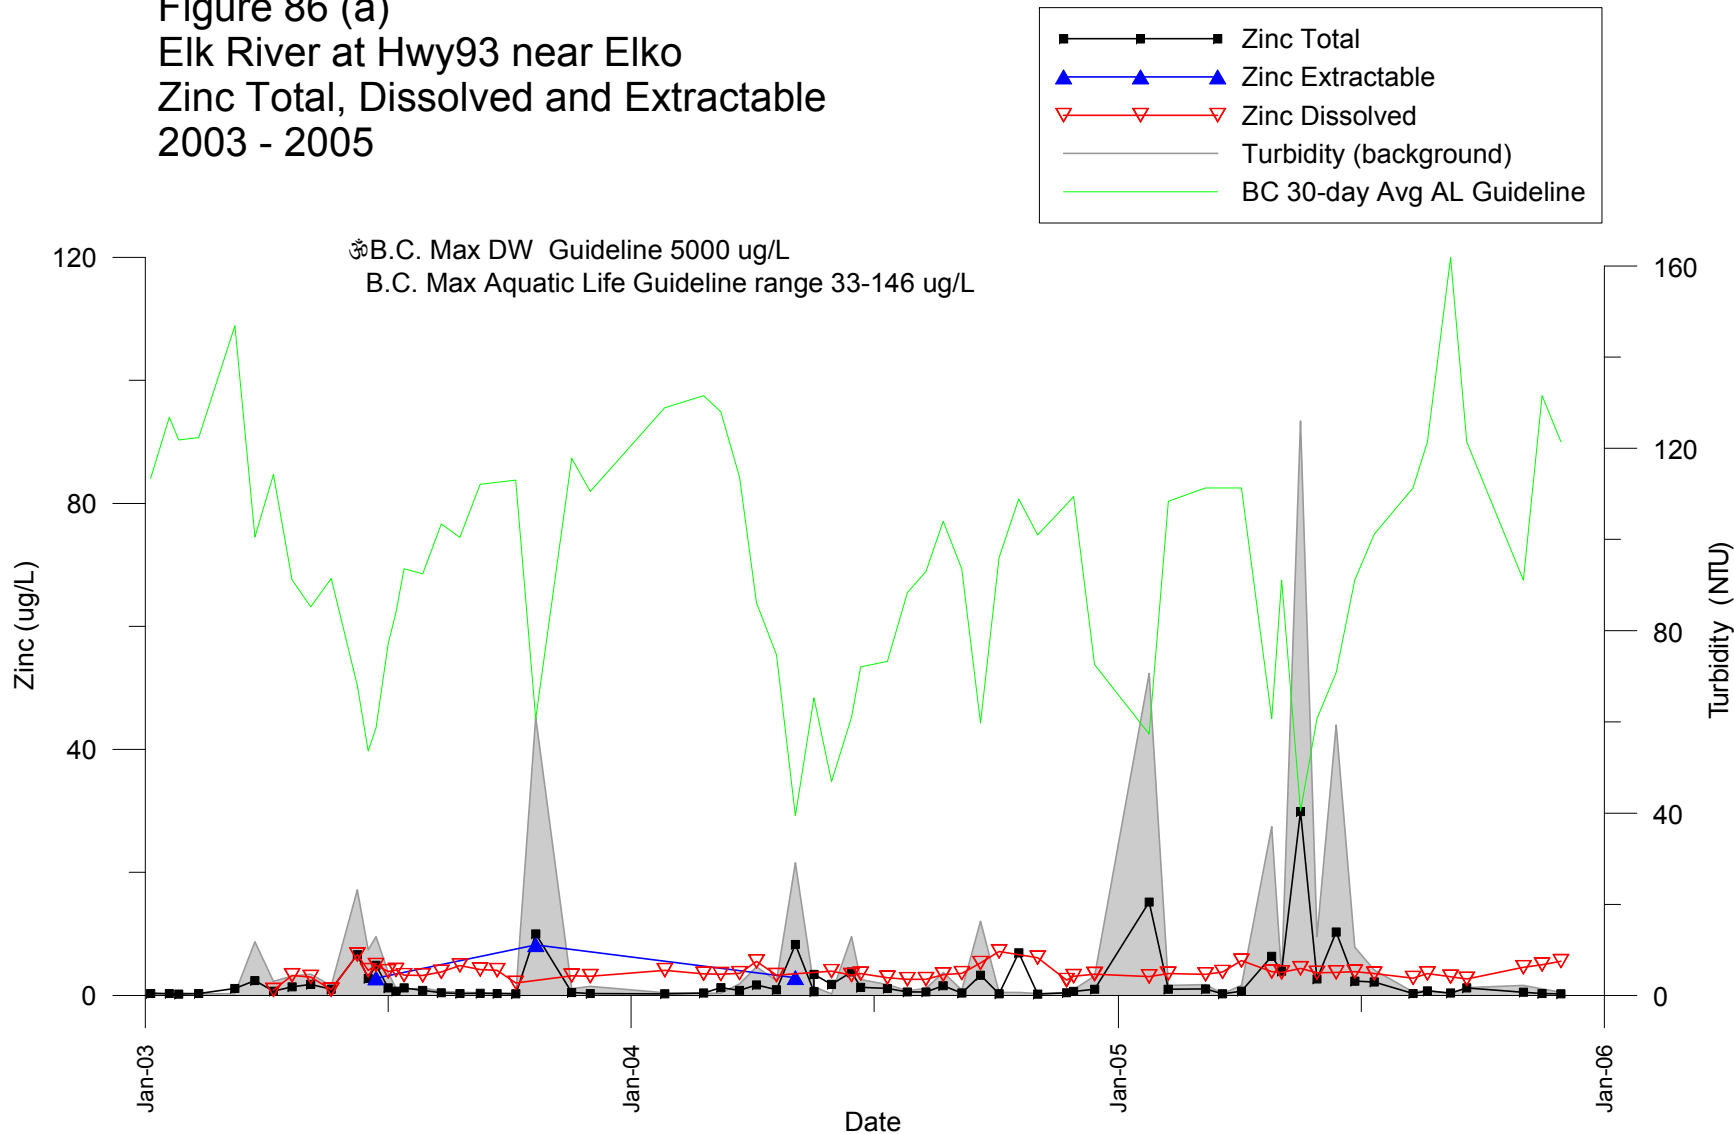
Figure 86
 Elk River at Hwy93 near Elko
 Zinc Total, Dissolved and Extractable
 2003 - 2005

Zinc (Figure 86-86a) values sometimes exceeded guidelines when detection limits were higher but in recent years when detection limits were lowered, this problem seems to have been eliminated. This is likely related to difficulty in obtaining quantitation within five times the detection limit. Zinc values were correlated to turbidity, so that high zinc concentrations are likely associated with particulate matter and would not be biologically available.
