WATER QUALITY MONITORING AGREEMENT

WATER QUALITY ASSESSMENT OF Elk River AT SPARWOOD (2002 – 2005)

Prepared by:
L. G. Swain, P. Eng.
B.C. Ministry of Environment

March 2007

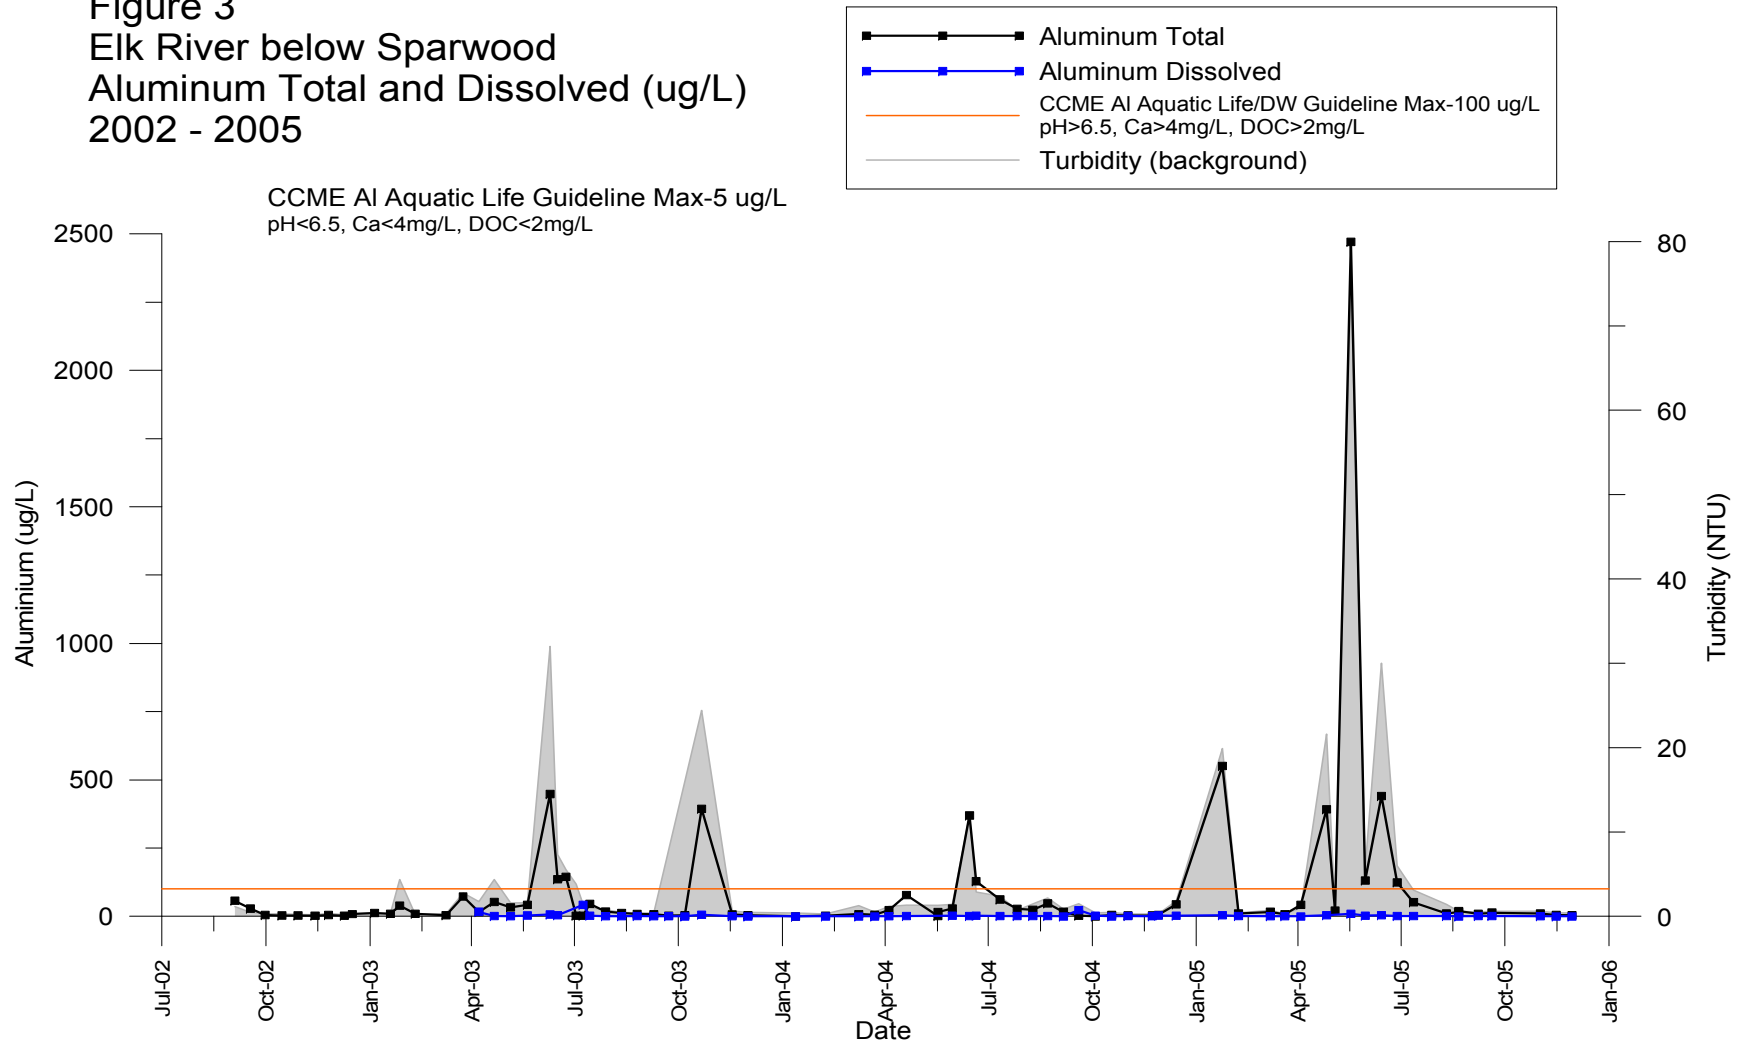
Figure 3
Elk River below Sparwood
Aluminum Total and Dissolved (ug/L)
2002 - 2005

Aluminum (Figure 3) values (dissolved) never exceeded the guideline; however, total concentrations on occasion did exceed the dissolved aluminum guideline. These high total values corresponded to high turbidity values and so were not likely biologically available. As expected, there was no apparent correlation between dissolved aluminum and turbidity levels.

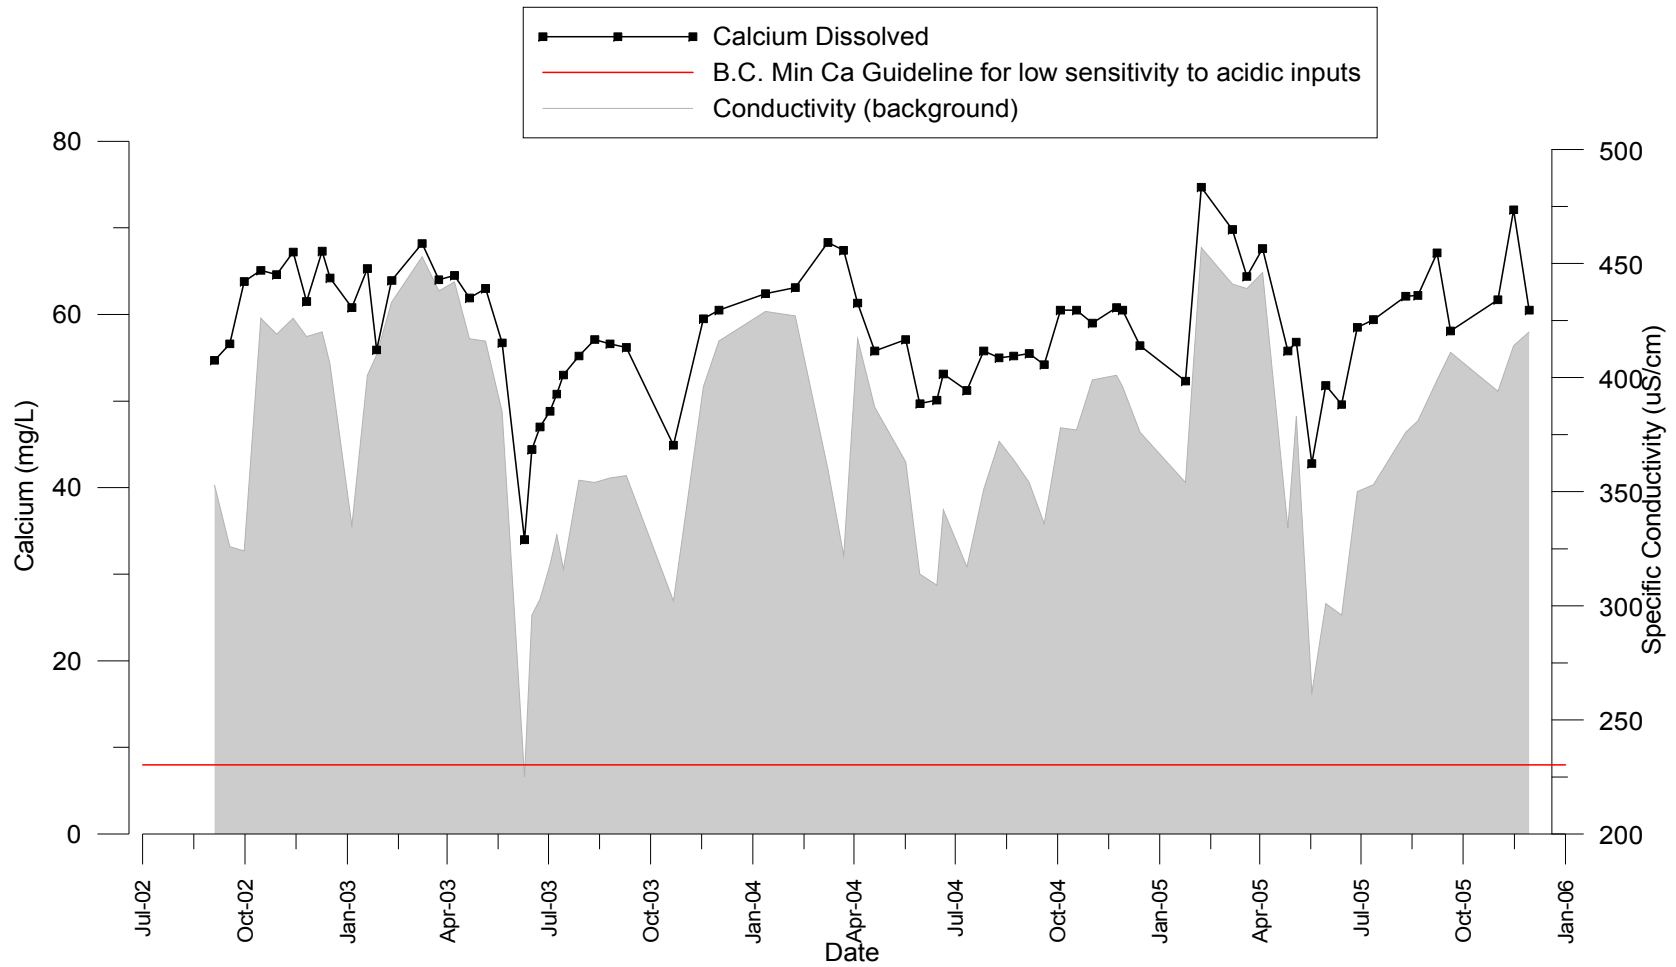
Figure 13
Elk River below Sparwood
Calcium Dissolved (mg/L)

Calcium (Figure 13) values fluctuated with specific conductivity, as expected. Values were well in excess of 8 mg/L guideline that indicates that the water is well buffered to acidic inputs.

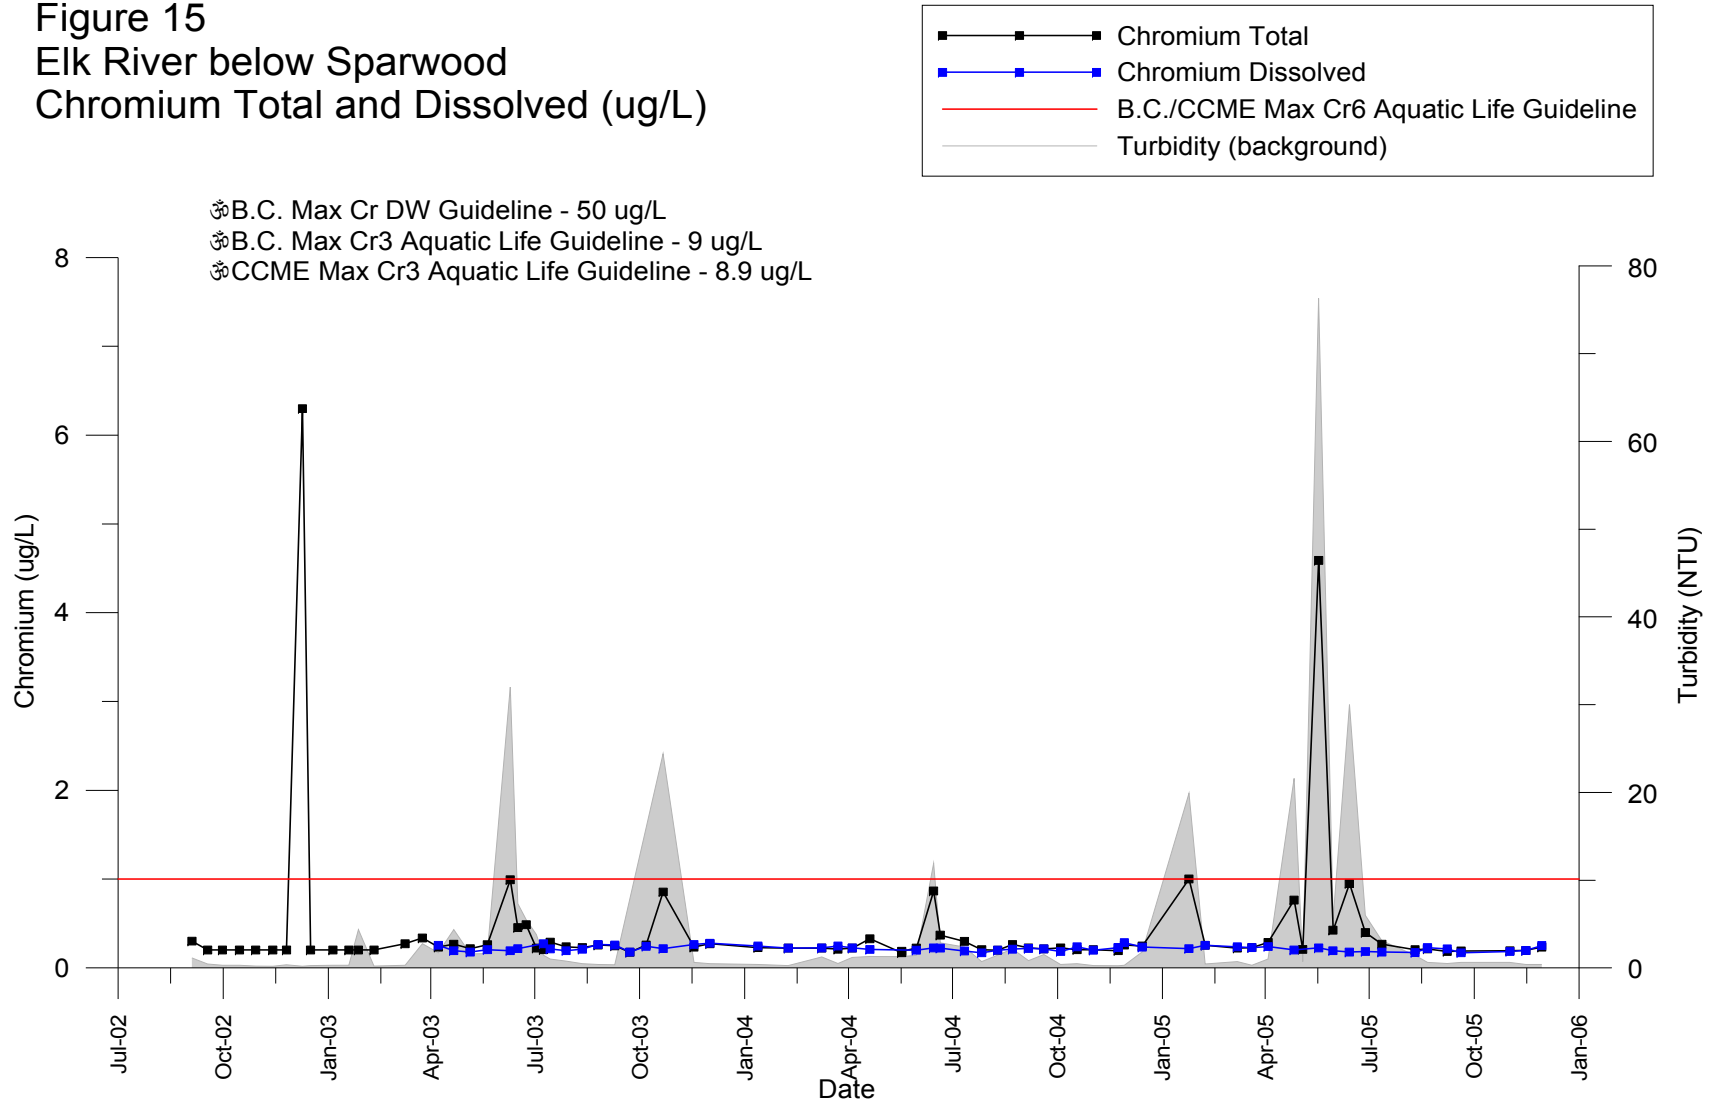
Figure 15
Elk River below Sparwood
Chromium Total and Dissolved (ug/L)

Chromium (Figure 15) concentrations (total) fluctuated with turbidity and occasionally exceeded the most restrictive guideline for hexavalent chromium. The chromium was likely associated with particulate matter on such occasions and would not be biologically available. All dissolved concentrations were below the hexavalent chromium guideline.

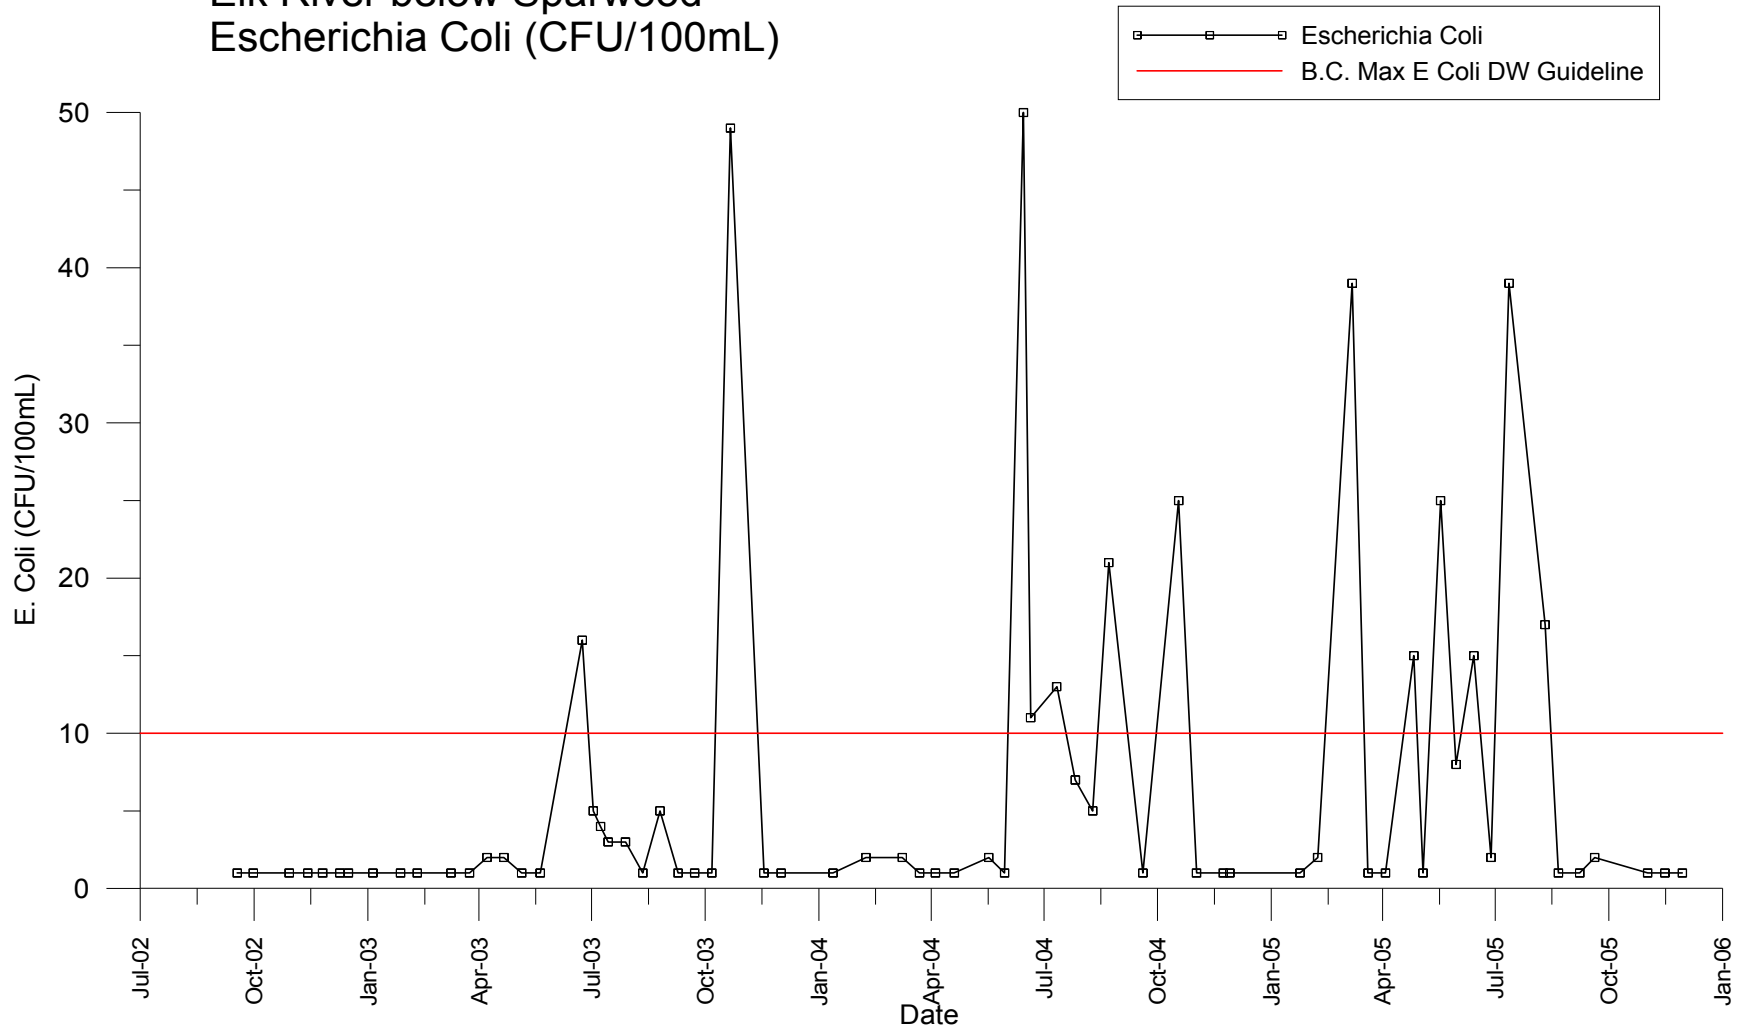
Figure 20
Elk River below Sparwood
Escherichia Coli (CFU/100mL)

Escherichia Coli (Figure 20) values often exceeded the B.C. guideline of 10 CFU/1000 mL to protect water supplies with only disinfection.

- Turbidity, fecal coliform and e. coli concentrations exceeded source water protection guidelines for use of the water with disinfection only. This means that the water should have partial treatment to remove both turbidity and improve the removal of bacteria.

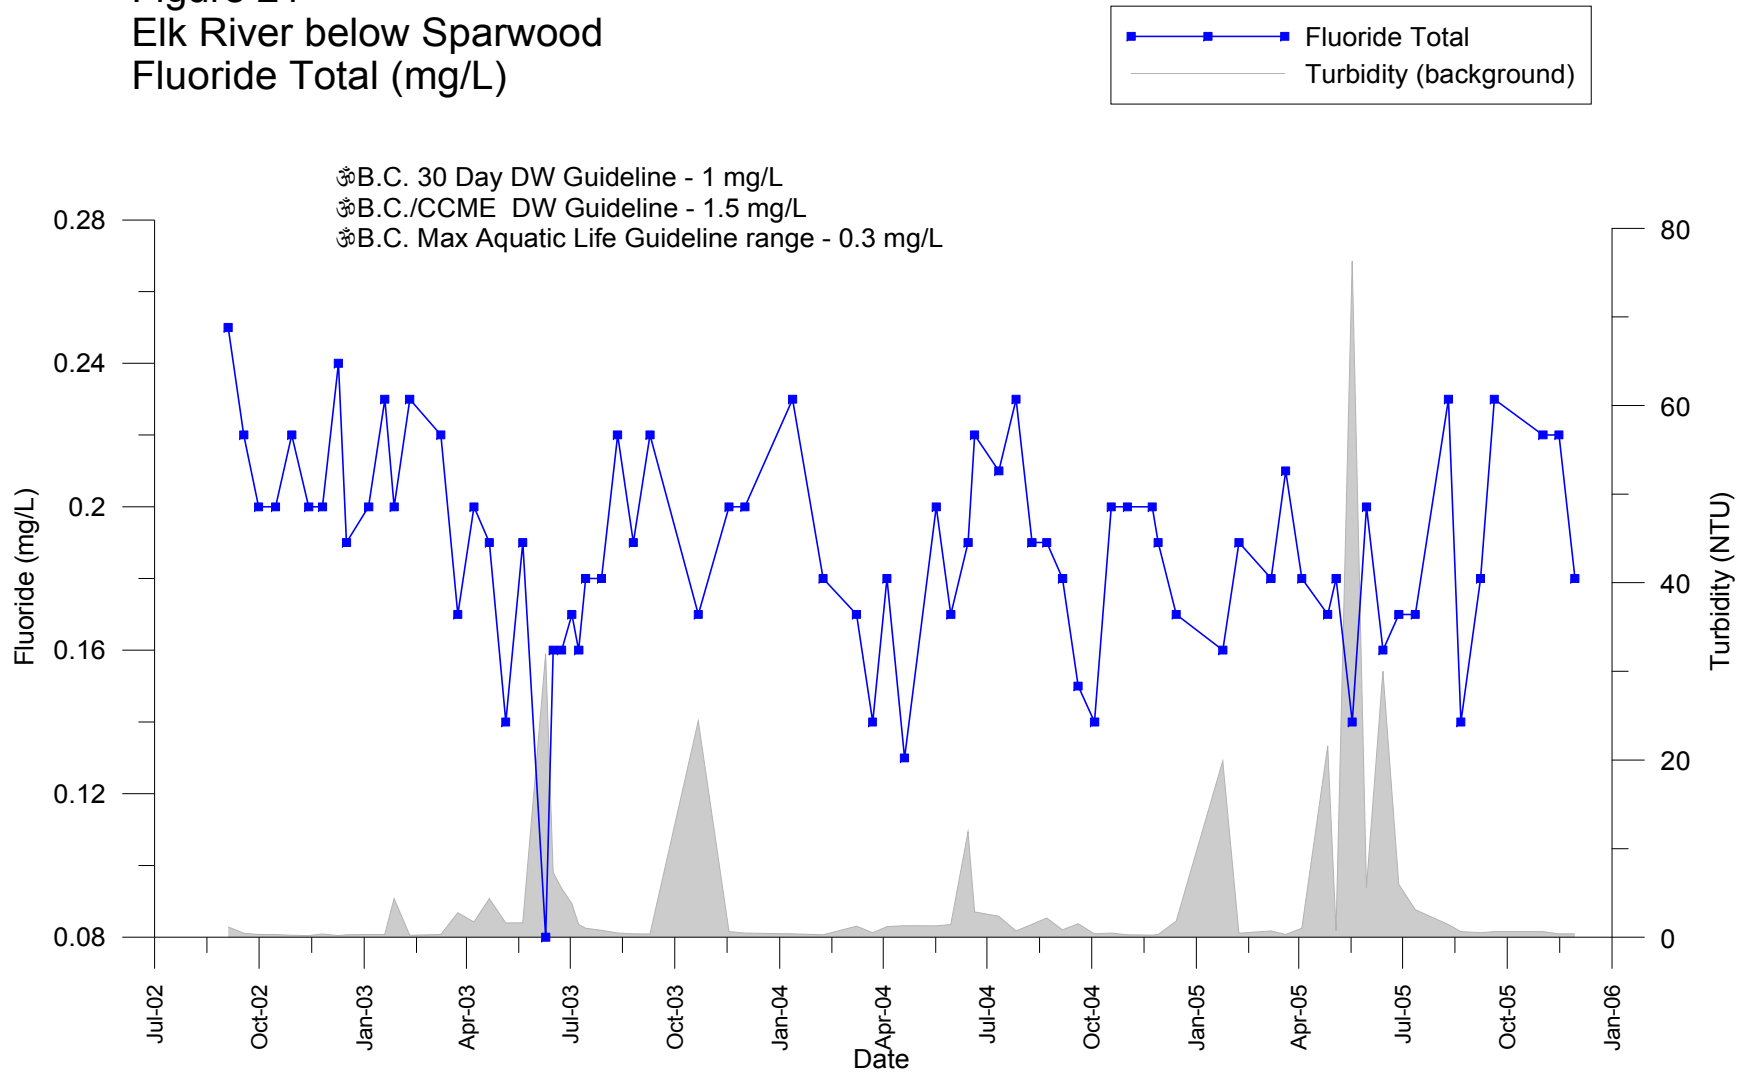
Figure 21
Elk River below Sparwood
Fluoride Total (mg/L)

Fluoride (Figure 21) may be showing a slight trend to decreasing concentrations; however, the period of record (four years) is too short to confirm this.

- Fluoride concentrations may be showing a slight trend to decreasing concentrations; however, a longer period of record is needed to confirm this possible trend.

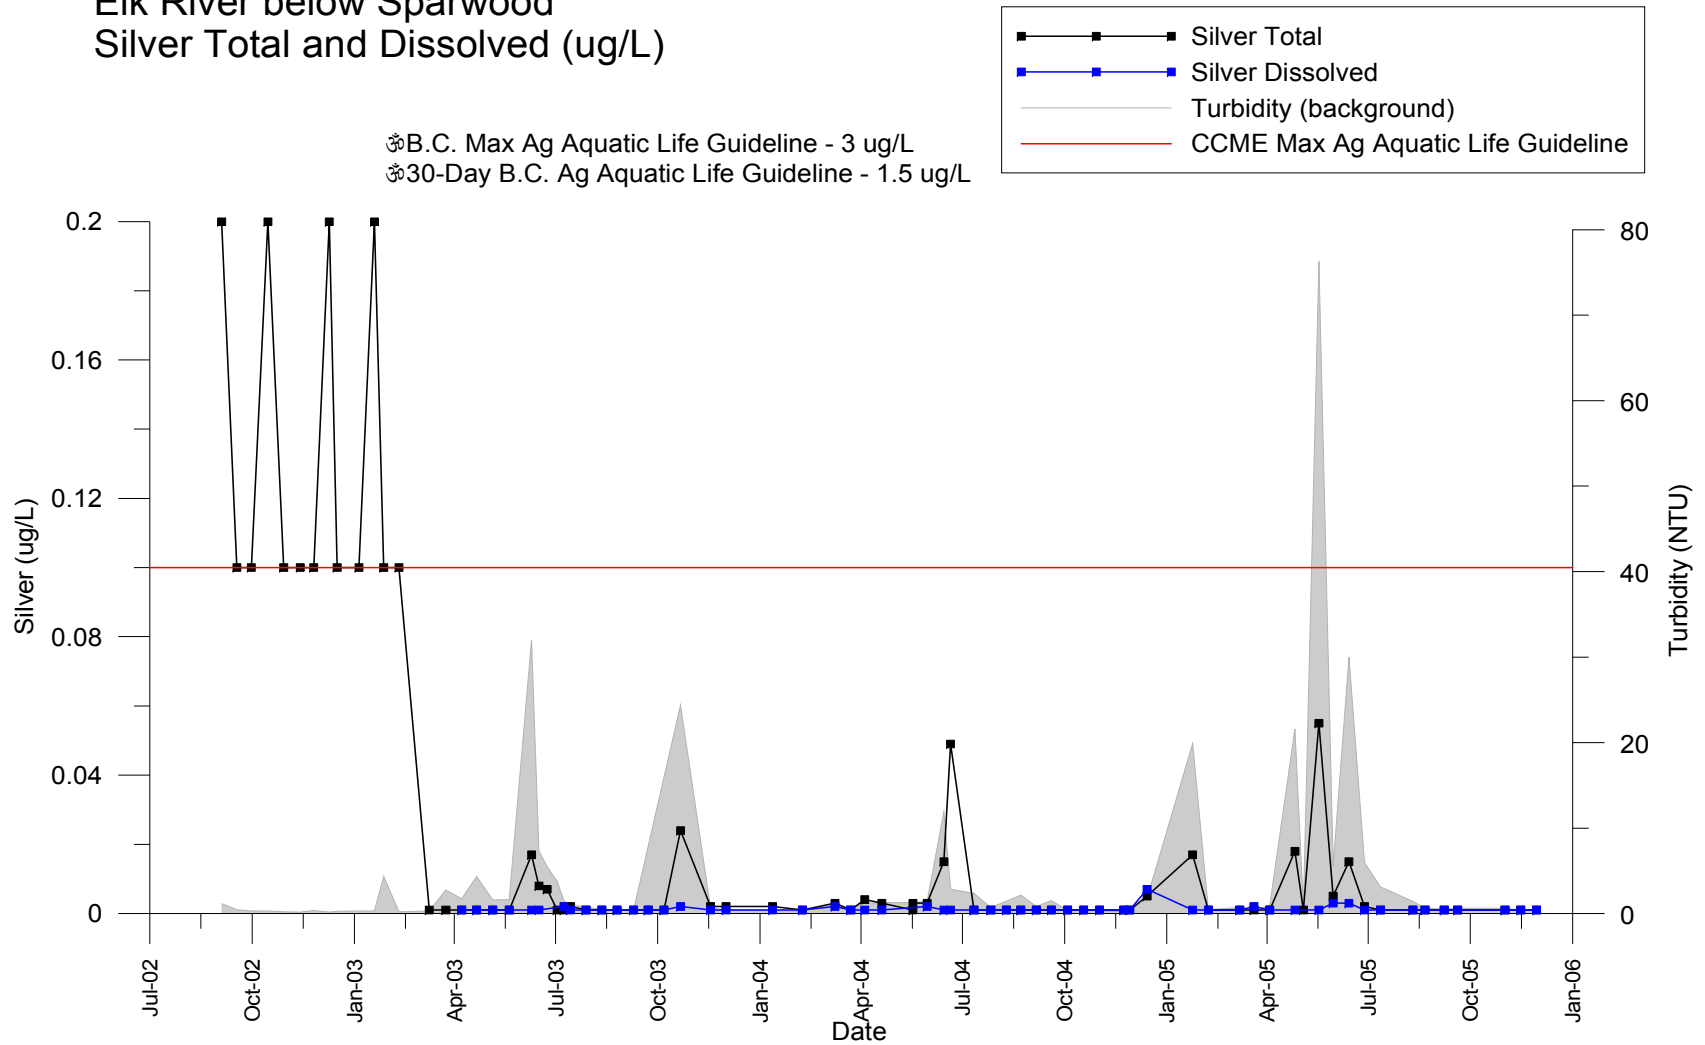
Figure 44
Elk River below Sparwood
Silver Total and Dissolved (ug/L)

Silver (Figure 44) values in 2002 exceeded the guideline but this appears to be purely a function of the detection limit because when it was reduced in 2003, all values met the guideline to protect aquatic life. Any total silver values that are above the detection limit since that time are correlated to higher turbidity values, meaning that the silver is in particulate form and not likely biologically available.
