### WATER QUALITY ASSESSMENT OF KOOTENAY RIVER AT CRESTON (1979 – 2005)

Prepared by:  
L. G. Swain, P. Eng.  
B.C. Ministry of Environment

May 2007

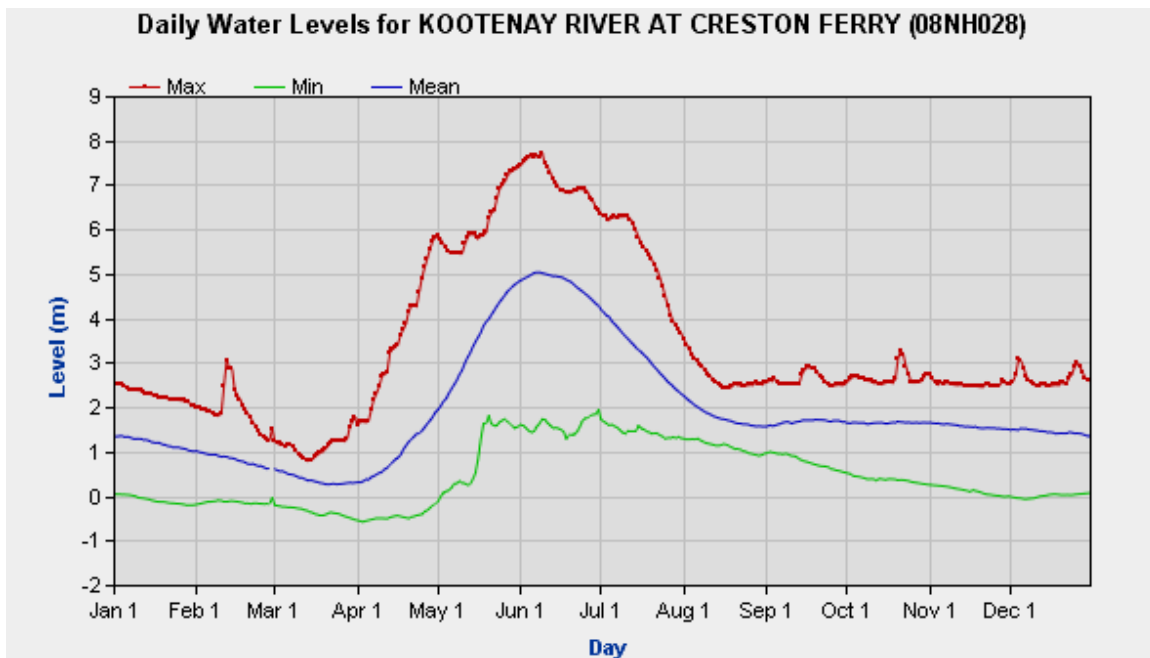
FIGURE 2: WATER SURVEY OF CANADA FLOW DATA FOR KOOTENAY RIVER AT CRESTON

**Flow** (Figure 2) values showed fairly typical patterns characteristic of an interior river, with freshet taking place between mid-April through July. Average flows through the year are in the order of  $1 \text{ m}^3/\text{s}$ , although low flows in late March just prior to freshet can be as low as  $0.3 \text{ m}^3/\text{s}$ . Average peak flows are about  $5 \text{ m}^3/\text{s}$ .

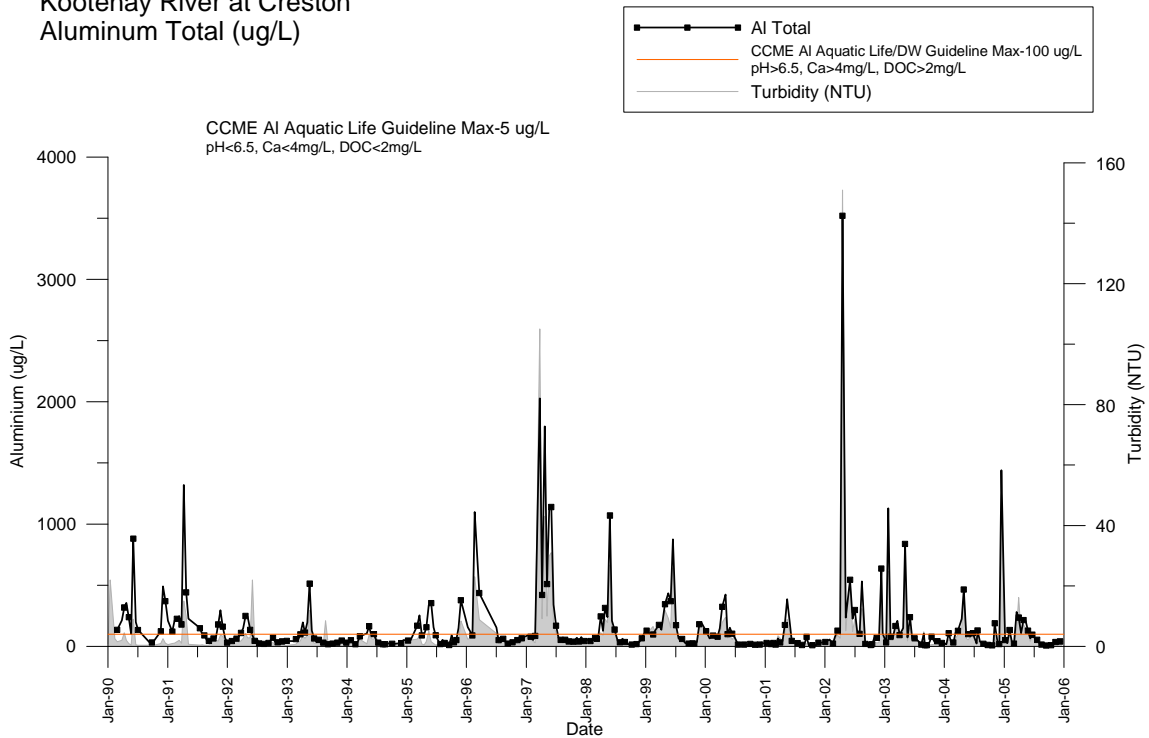
Figure 4  
Kootenay River at Creston  
Aluminum Total (ug/L)

**Aluminum** (Figure 4) values (total) were correlated to turbidity levels in the river, with total aluminum concentrations exceeding the B.C. guideline for dissolved aluminum concentrations for protection of aquatic life of 100 µg/L. This in itself is not a concern because the forms of aluminum measured and the guidelines are different. However, since values that exceeded the guidelines were associated with high sediment concentrations, the aluminum was likely in particulate form and not biologically available.

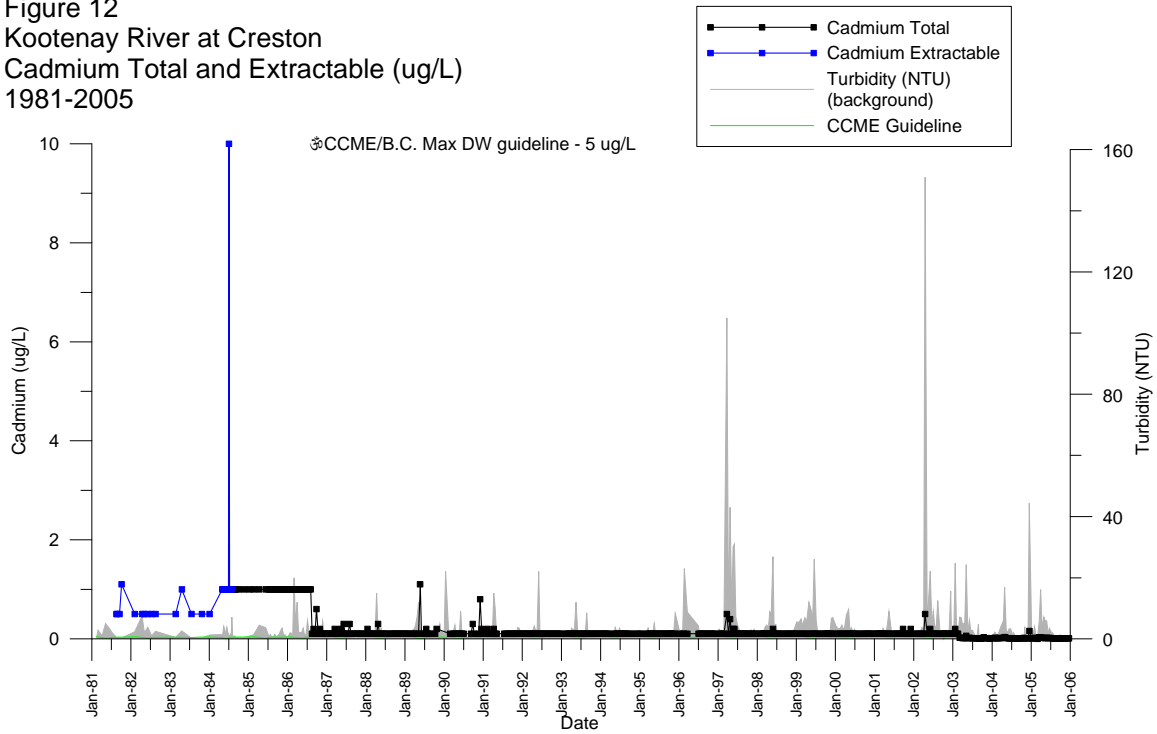
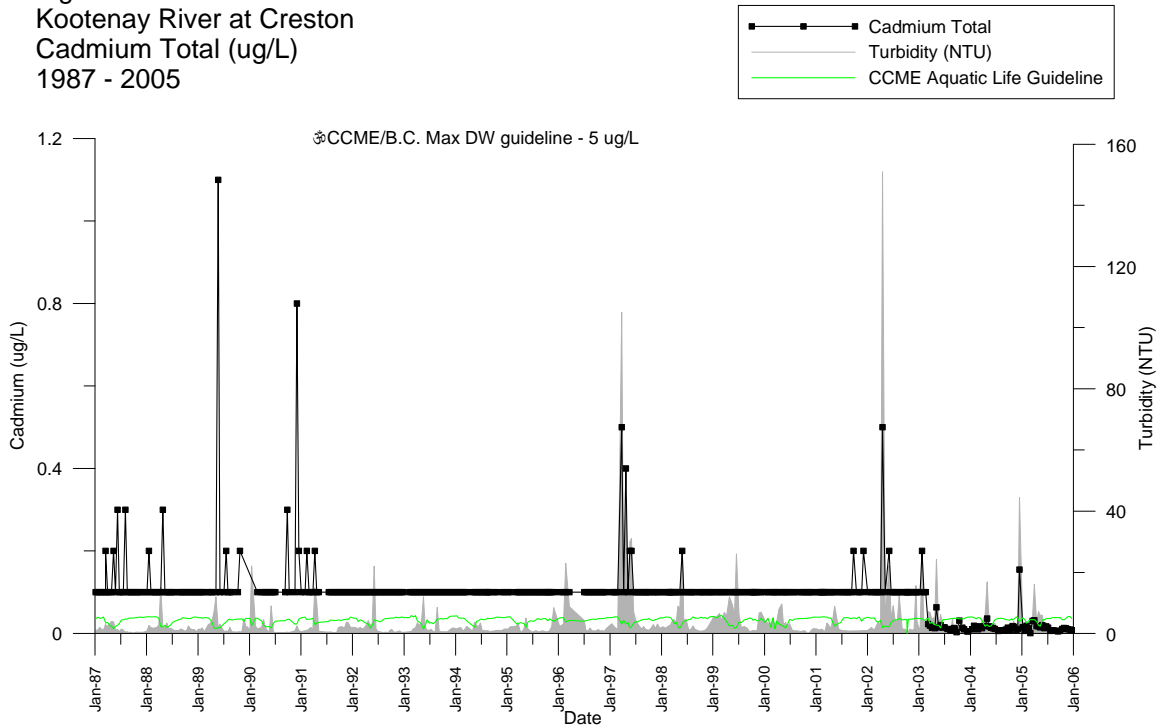
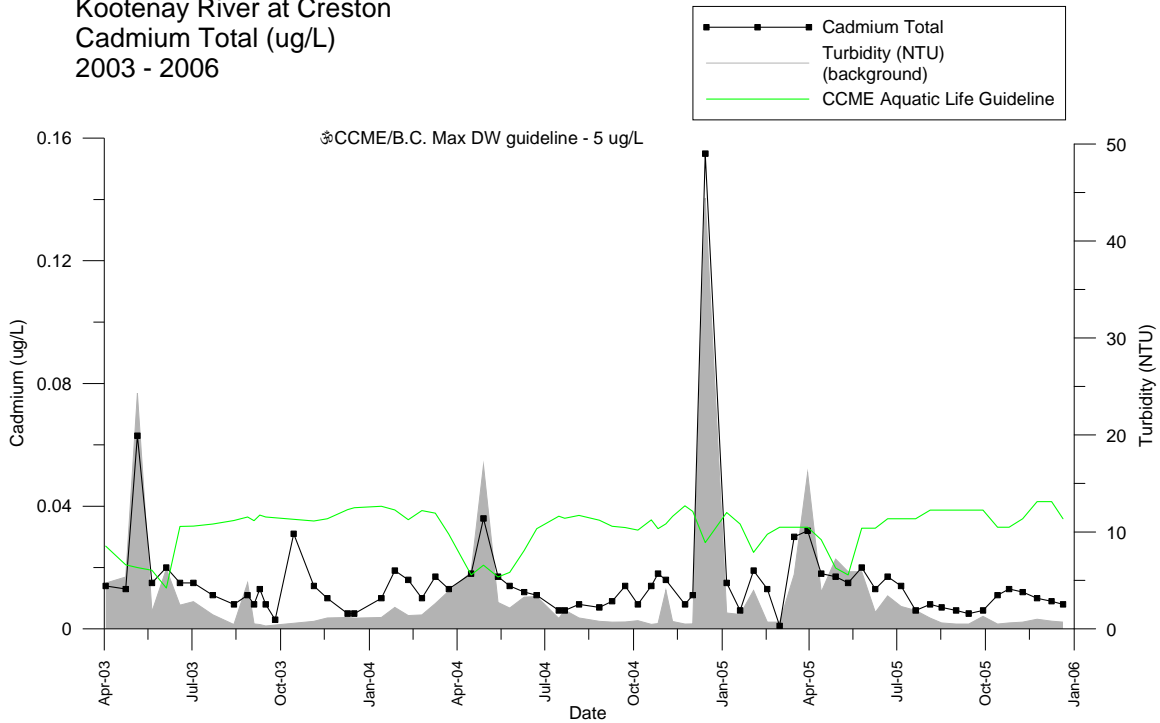
**Cadmium** (Figures 12-14) values have only been measured since 2003 with detection limits low enough to allow for a meaningful comparison to guidelines. Data from 2003-2005 show that the guidelines are usually met and were only exceeded twice during that period when turbidity levels were elevated. Thus the cadmium would likely be in particulate form and not biologically available.

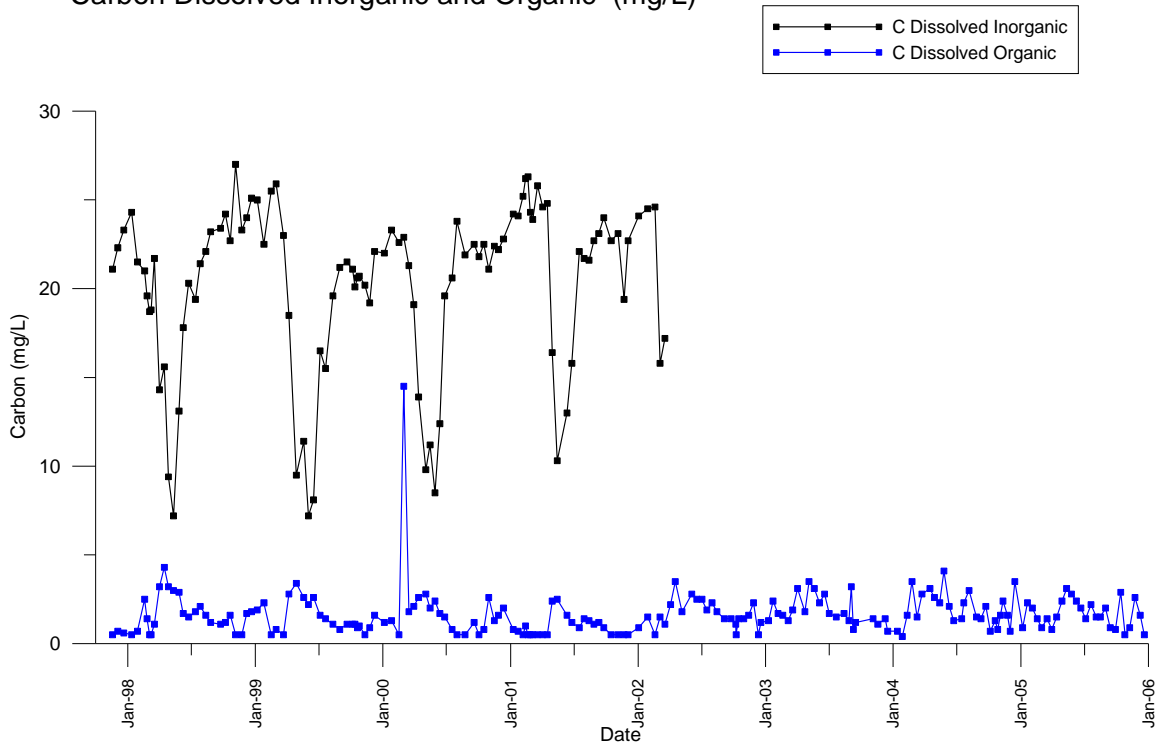
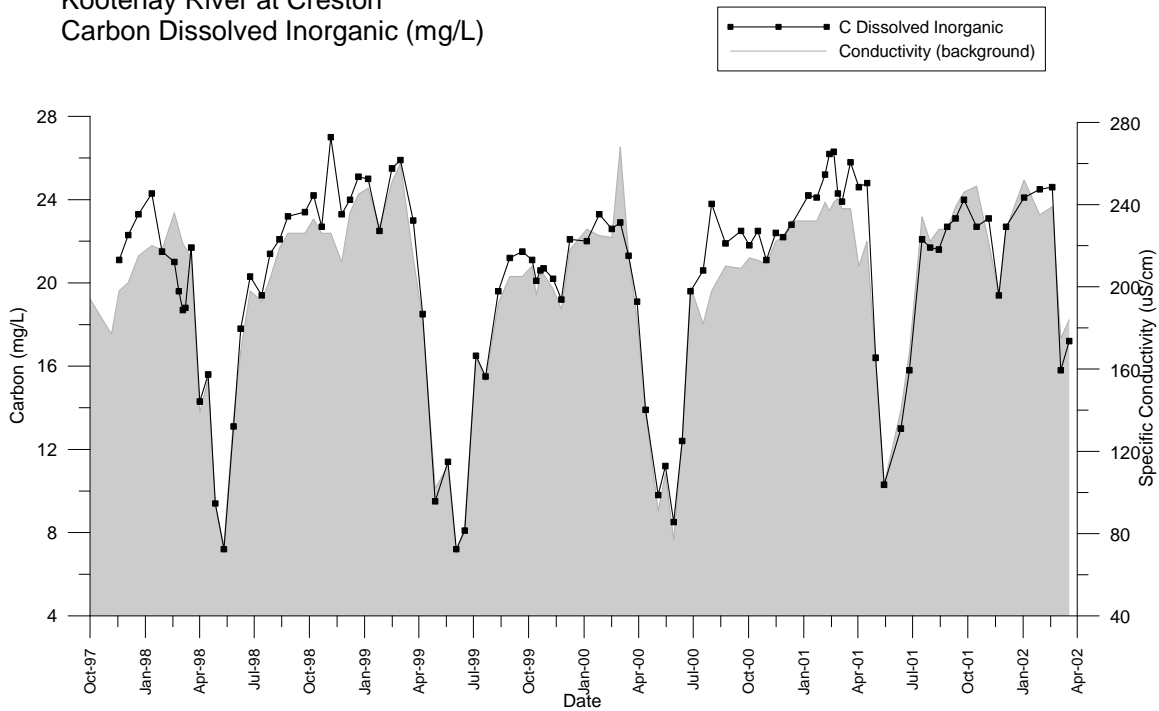
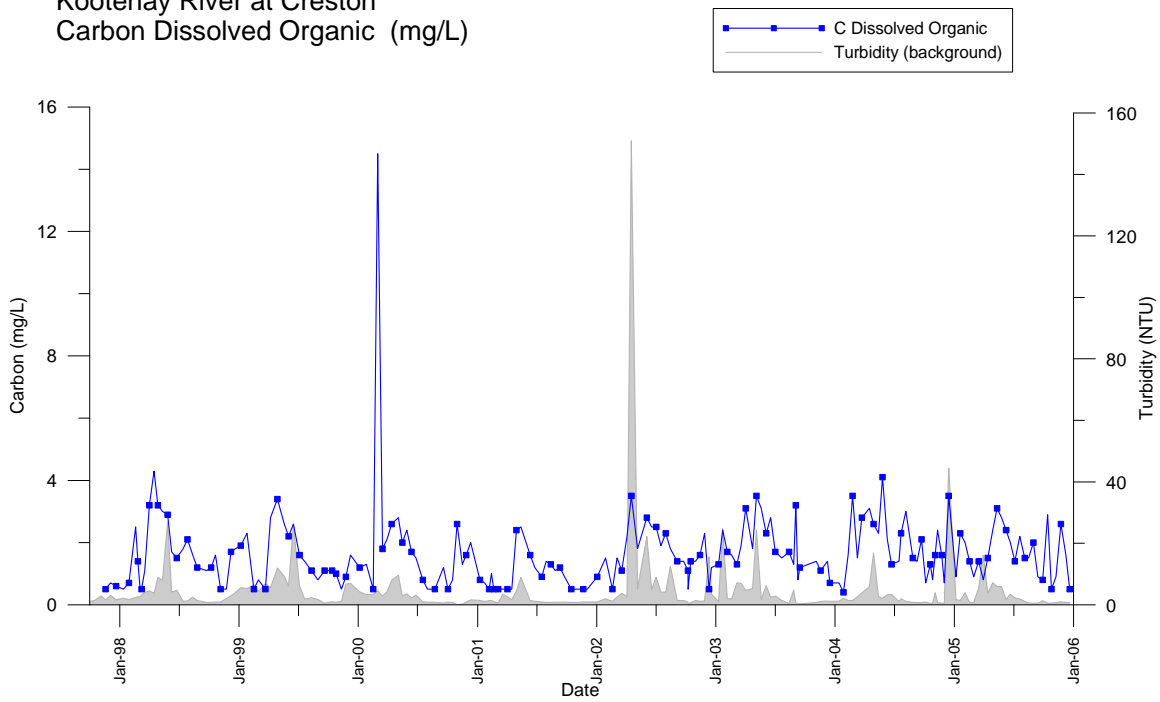
**Carbon** (Figures 16 – 18) was measured as dissolved organic and inorganic. The guideline to protect drinking water supplies is a maximum of 4 mg/L as total organic carbon. This level has generally been achieved by measurements of dissolved organic carbon. There appears to be a correlation between turbidity and dissolved organic carbon concentrations.

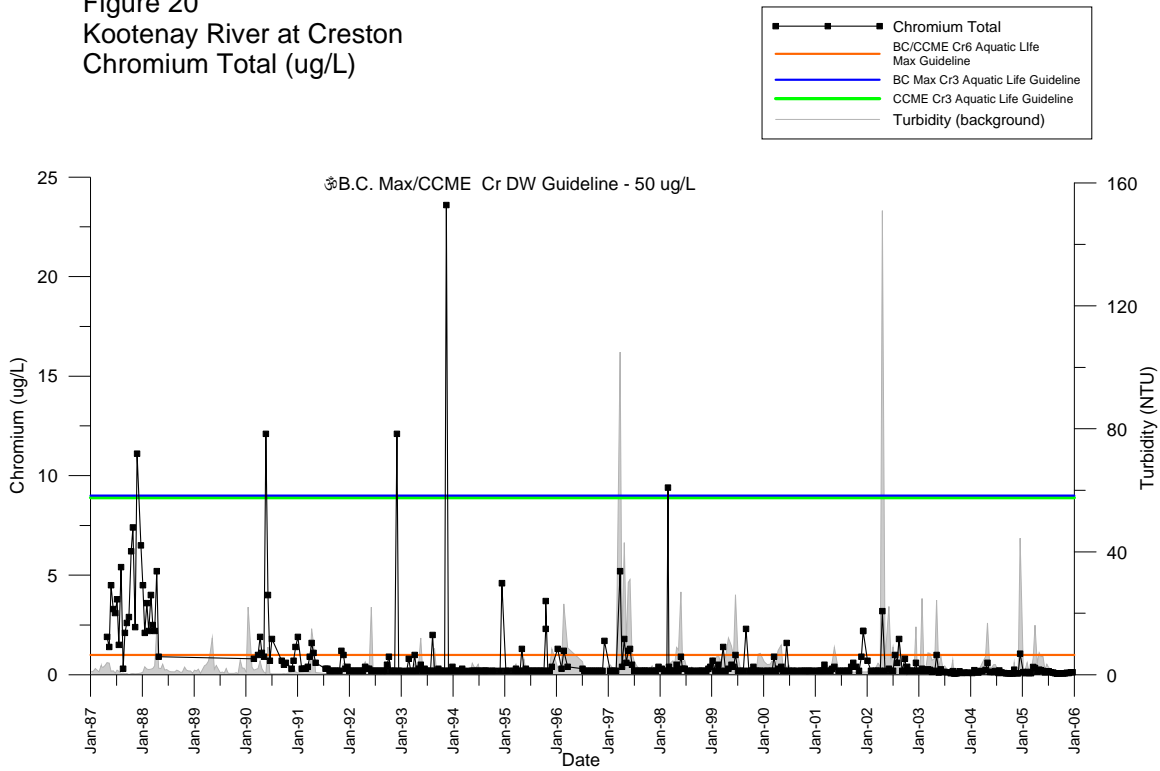
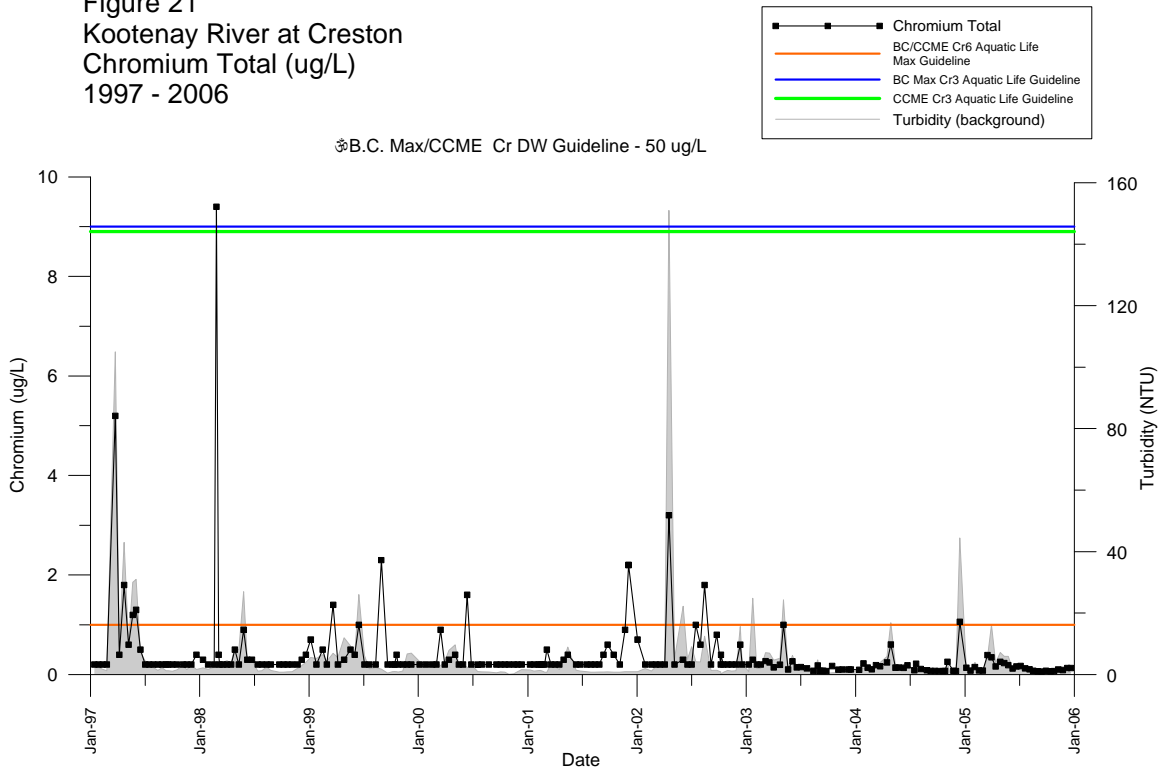
**Chromium** (Figures 20 and 21) concentrations when measured as total concentrations occasionally exceeded the guideline for trivalent chromium and regularly exceeded the guideline for hexavalent chromium. These values seem to be correlated to turbidity concentrations.

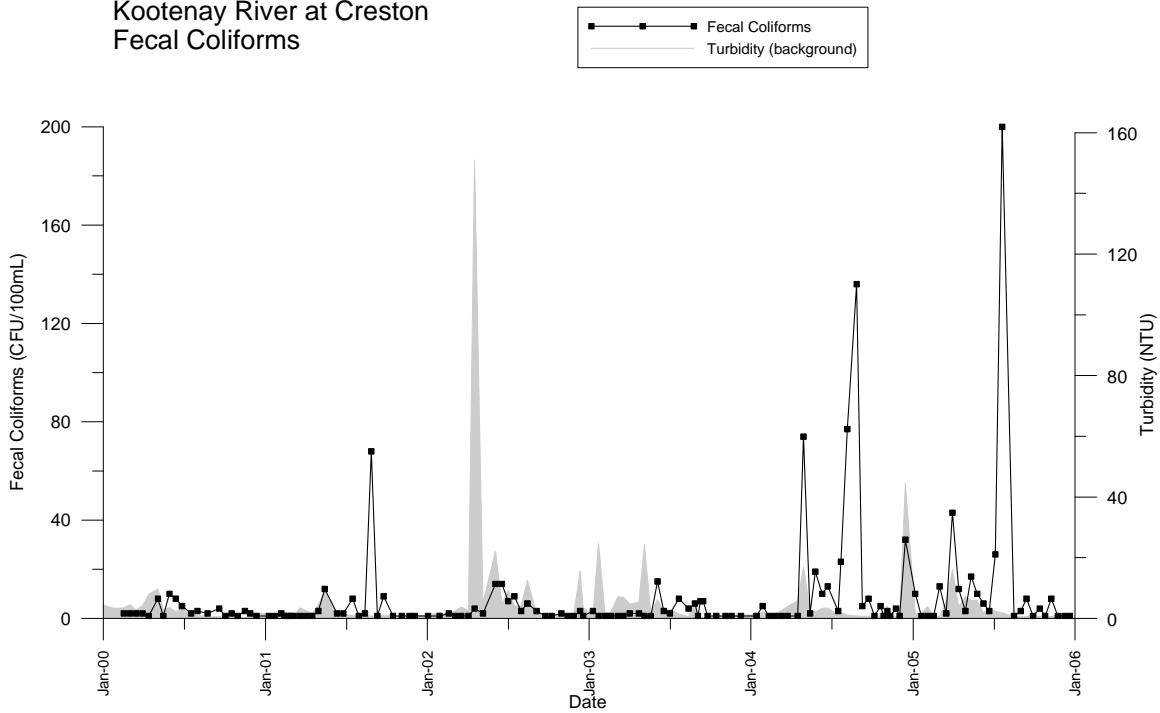
Figure 23  
Kootenay River at Creston  
Fecal Coliforms

**Fecal Coliforms** (Figure 23) have only been measured since 2000, but values often exceed the guideline for source water used for drinking with no treatment other than disinfection, and have twice exceeded the guideline where partial treatment of source

water is employed. Concentrations do seem to be correlated with turbidity, meaning that it would be difficult to remove bacteria when disinfecting these higher turbidity waters.

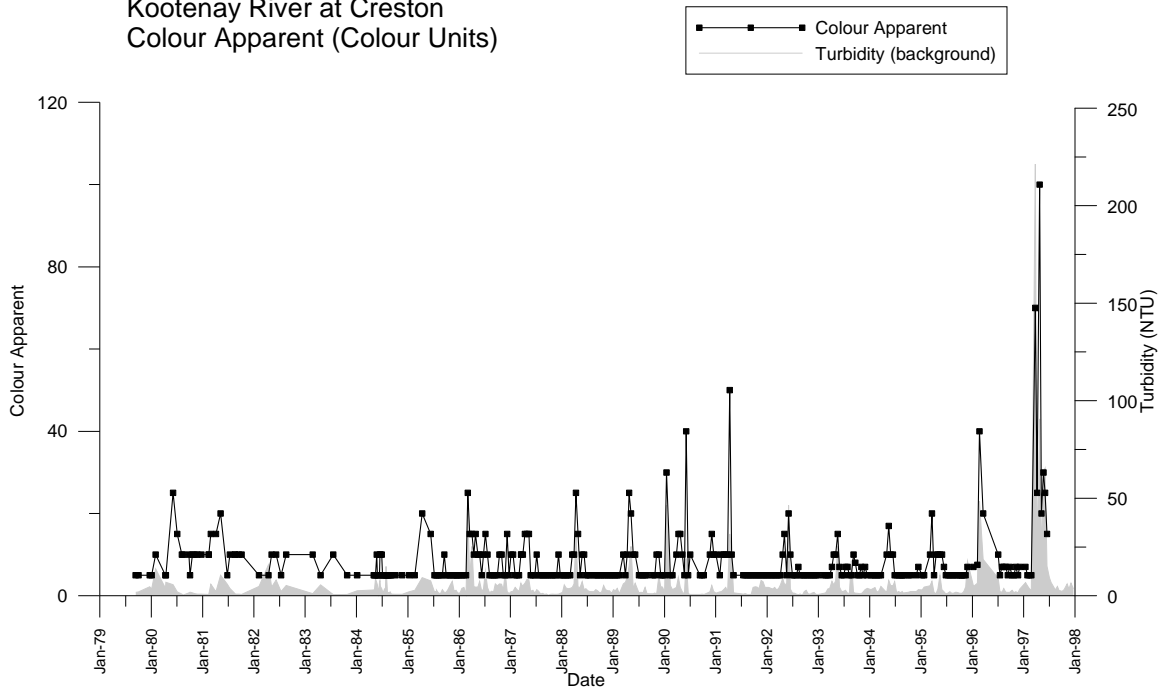
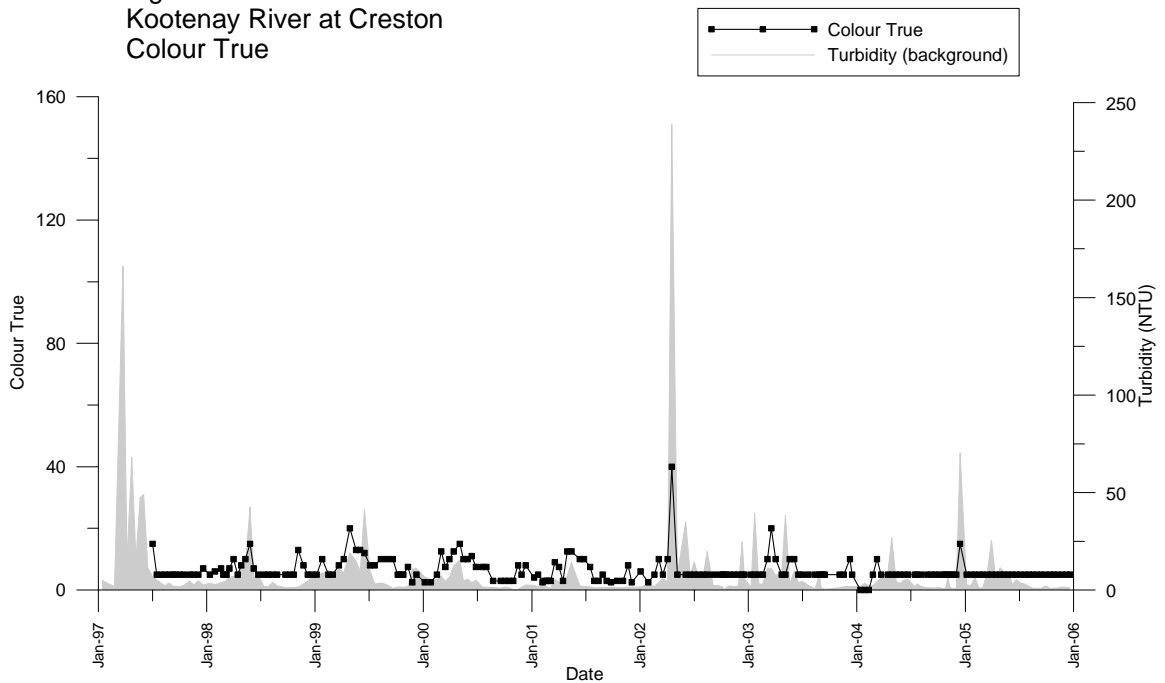
**Colour** (Figures 24 and 25) has a guideline of 15 units for true colour for protection of aesthetics of source water used for drinking. This guideline has been exceeded only three times since 1997, and is not a significant problem in the river.

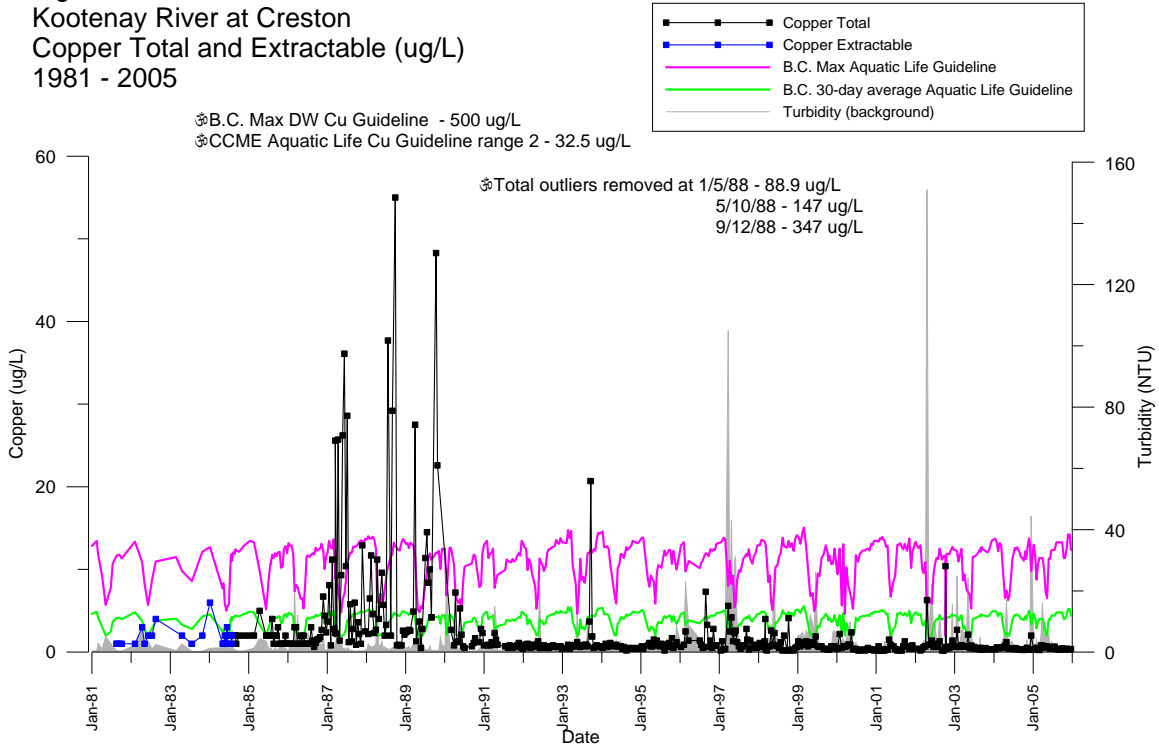
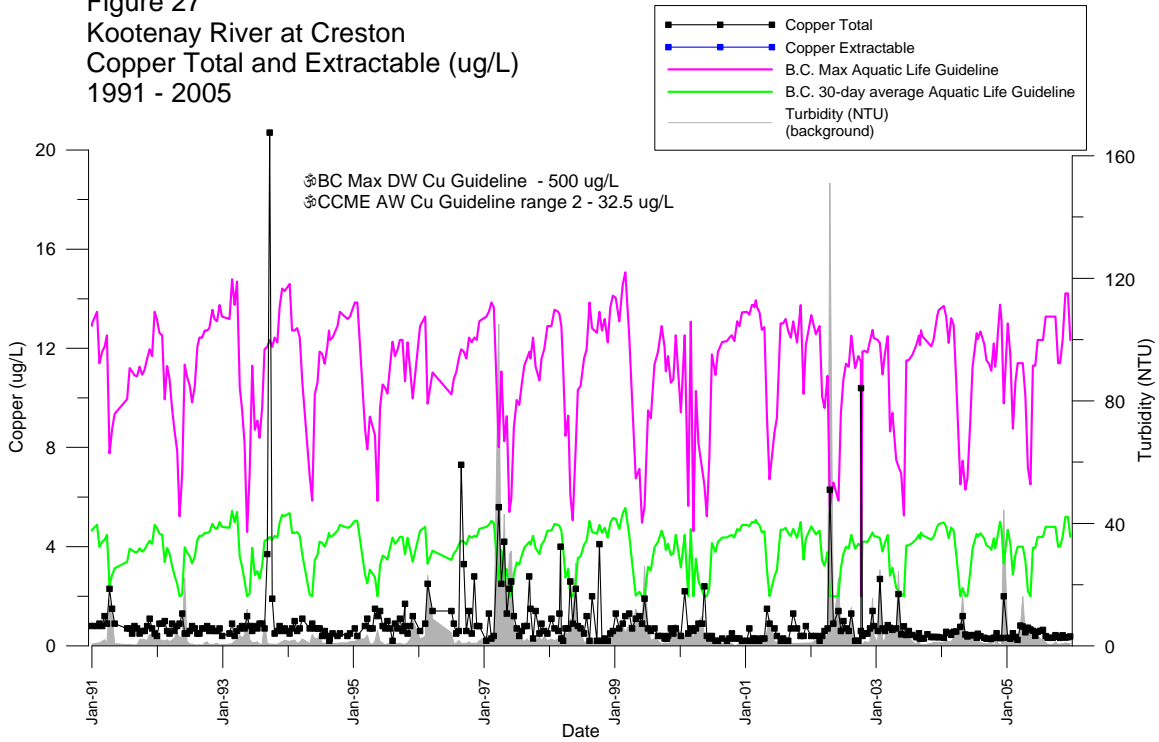
**Copper** (Figures 26 and 27) values generally meet the B.C. guideline for the maximum allowable concentrations, and only occasionally do these individual values exceed the 30-day mean concentration. Copper seems to be correlated with turbidity concentrations and so the higher copper concentrations are likely in particulate form. This means that the copper is not likely biologically available and thus not a concern in the river.

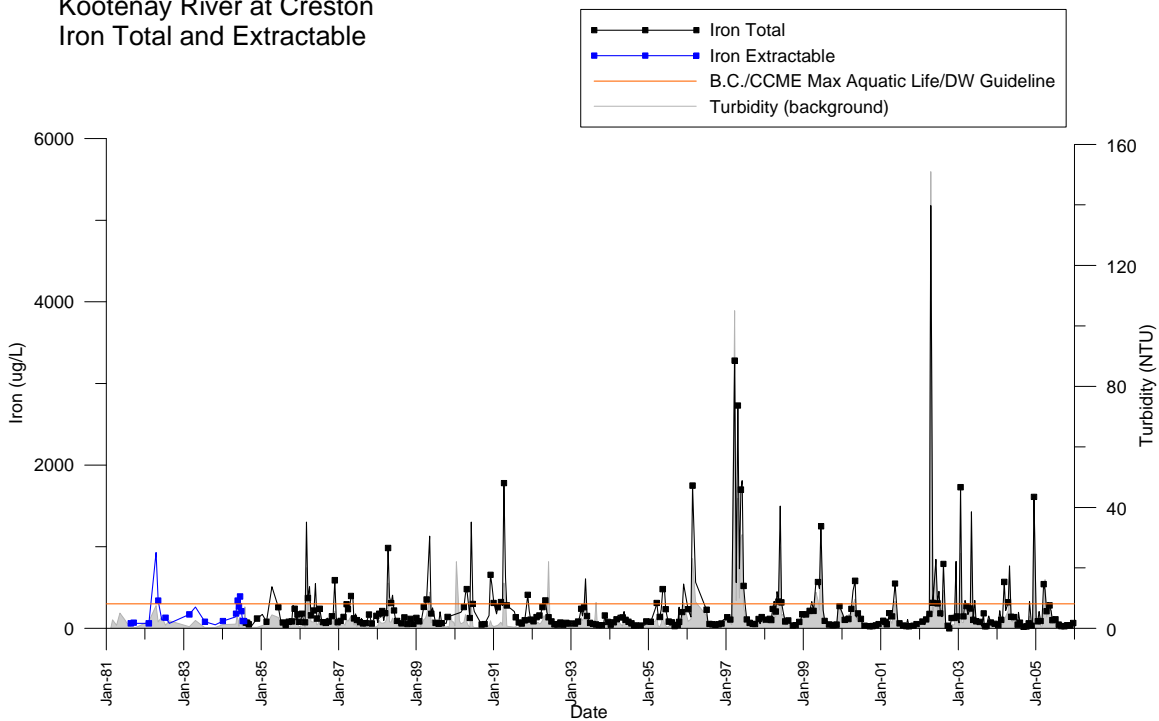
Figure 31  
Kootenay River at Creston  
Iron Total and Extractable

**Iron** (Figure 31) concentrations frequently exceeded the guidelines; however, these instances were associated with high turbidity values. Thus, the iron was not biologically available and not a concern for aquatic life.

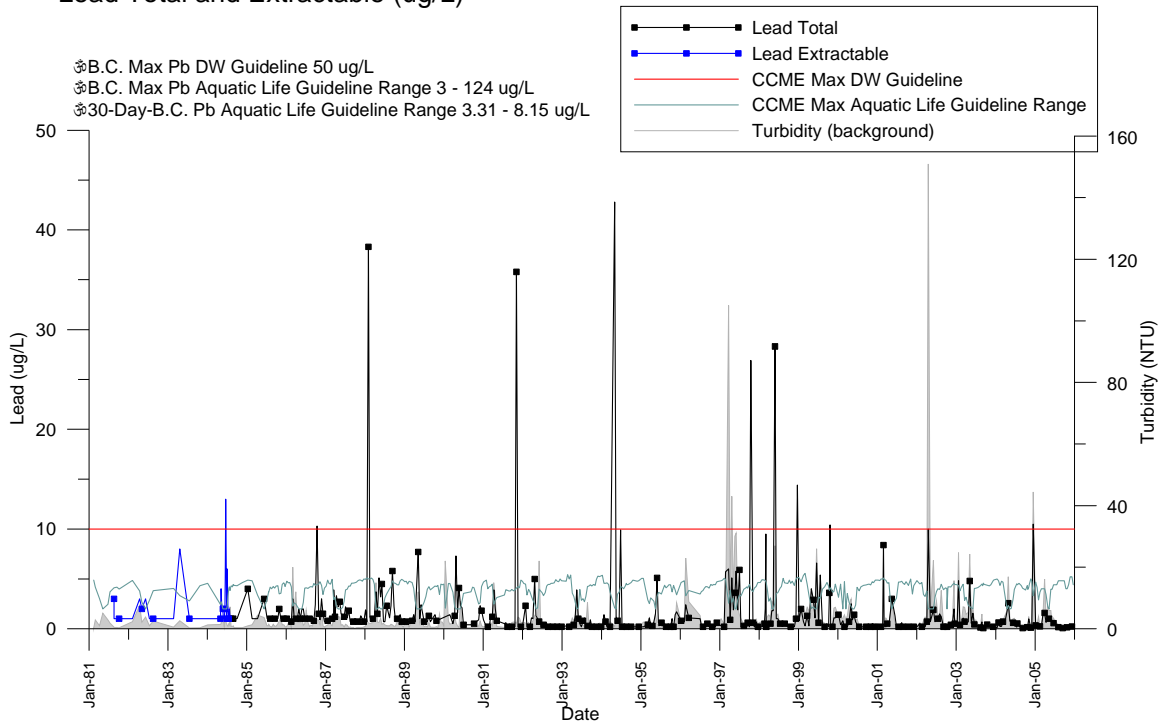
Figure 32  
Kootenay River at Creston  
Lead Total and Extractable (ug/L)

**Lead** (Figure 32) concentrations seemed to be correlated with turbidity and occasionally exceeded the guideline for the protection of aquatic life. Since higher values were associated with particulate form, there is not likely a concern for aquatic life.

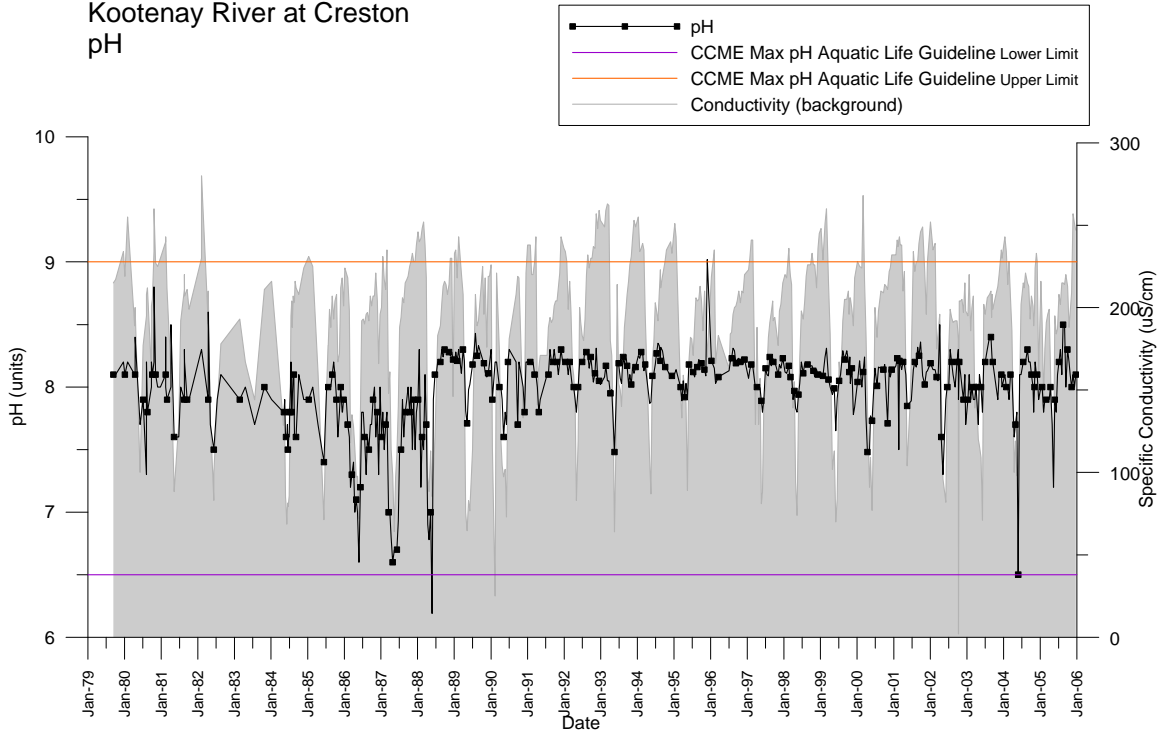
Figure 44  
Kootenay River at Creston  
pH

**pH** (Figure 44) on infrequent occasions was at, or below the lower acceptable range of the guideline for the protection of aquatic life and source water used for drinking. This is not considered to be a concern for the Kootenay River.

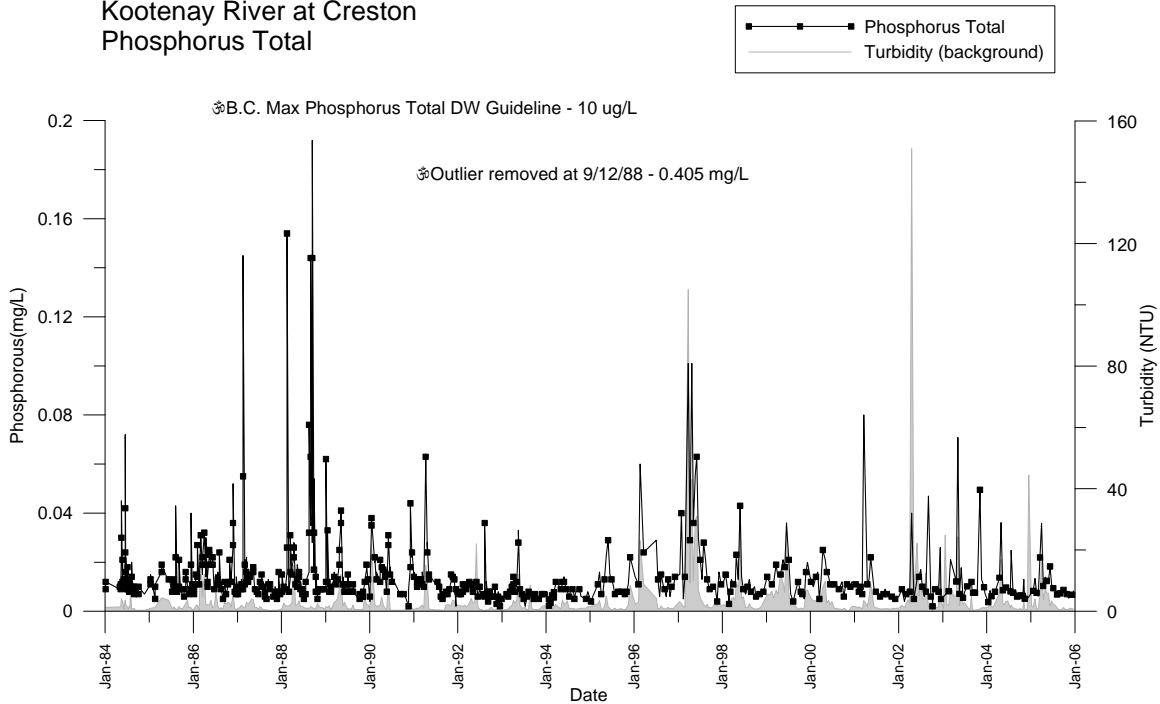
Figure 47  
Kootenay River at Creston  
Phosphorus Total

**Total Phosphorus** (Figure 47) values sometimes exceeded the guideline of 10 µg/L that is used for the protection of source water used for drinking. In the *Water Quality Trends 2000* report, it was determined that phosphorus levels in the Kootenay River at Creston for the period up to 1997 had been declining (deemed to be a subtle change with levels in

1995 and 1996 increasing); however, this assessment indicates that phosphorus concentrations appear to be stable over time.

- In an earlier assessment of the data (to 1997), it was determined that there was a subtle trend of decreasing total phosphorus concentrations. This was not deemed a positive thing since fisheries production was declining downstream in Kootenay Lake. From our analysis of data up to the end of 2005, it would appear that this apparent trend no longer exists and the total phosphorus concentrations are stable.

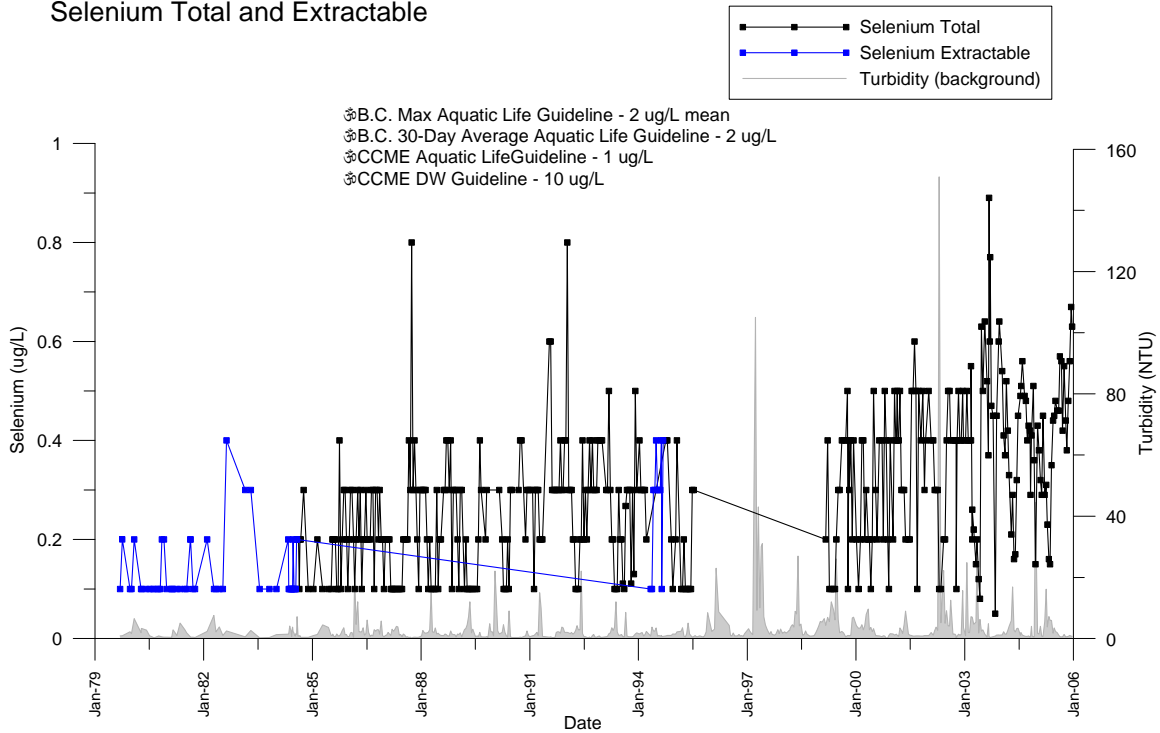
Figure 54  
Kootenay River at Creston  
Selenium Total and Extractable

**Selenium** (Figure 54) appears to be increasing over time, although all values are below but approaching the guidelines at present. A linear regression analysis of total selenium data since 1985 indicated an increasing trend with a  $R^2$  value of 0.25; however, for data collected since 1999, the  $R^2$  value is 0.12. This possible increasing trend should be verified by a statistician. If selenium concentrations in the Kootenay River are increasing, it could be due to the increasing concentrations noted in the Elk River, since the Fenwick station located upstream from the confluence of the Elk River, on the Kootenay River has not shown increasing selenium concentrations.

- On the other hand, selenium concentrations in the river at Creston appear to be increasing significantly. No such trend can be observed upstream at Fenwick Station, and it has been documented that the human coal mining operations on the Elk River have increased significantly. Although values in the Kootenay River at Creston are not as high as in the Elk River, concentrations are certainly getting closer to guideline values that indicate possible concern for aquatic life.

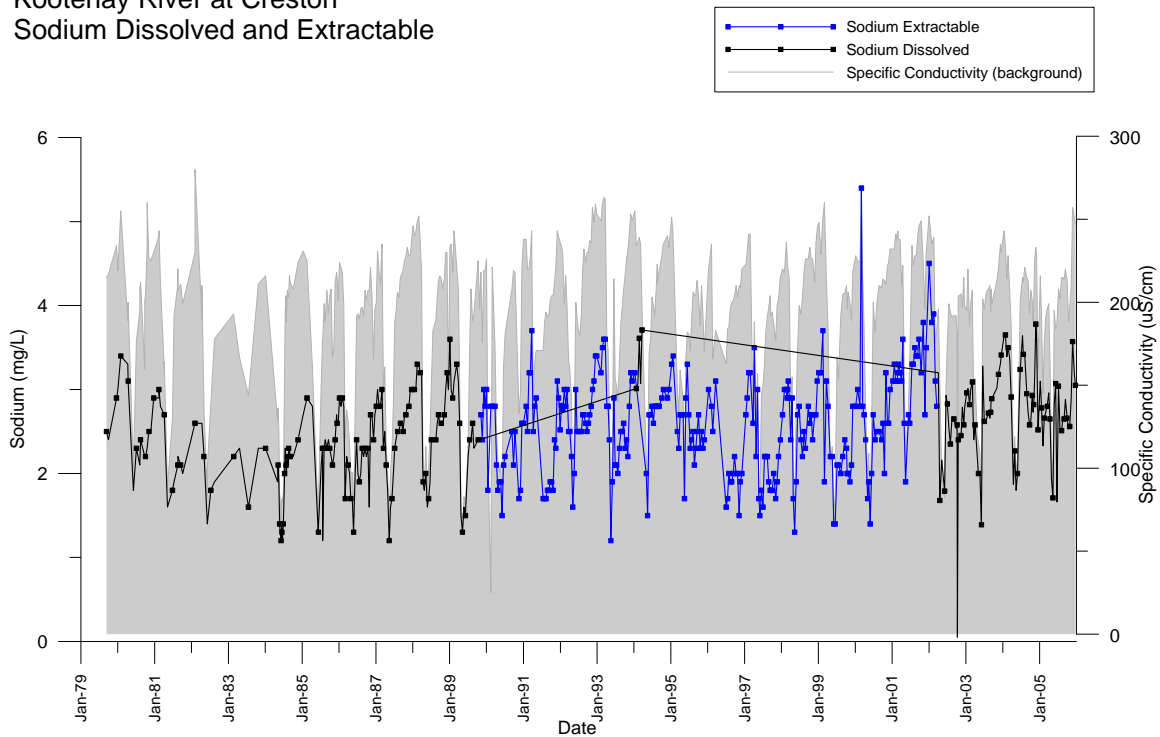
**Figure 59**  
Kootenay River at Creston  
Sodium Dissolved and Extractable

**Sodium** (Figure 59) values when measured as dissolved concentrations may be increasing over time. A linear regression analysis of dissolved sodium data since 1979 indicated an increasing trend with a  $R^2$  value of 0.14. Values also seem to possibly be increasing at the upstream Fenwick station but the  $R^2$  value is only about one-half recorded here. Unfortunately, for a period of time from 1989 until 2001, sodium was measured in the extractable form so that a complete record is not available on which to perform trend analyses. This possible increasing trend should be verified by a statistician.

- Dissolved sodium concentrations may also be showing an increase through time. A similar trend that is not as strong is also apparent at the Fenwick station.

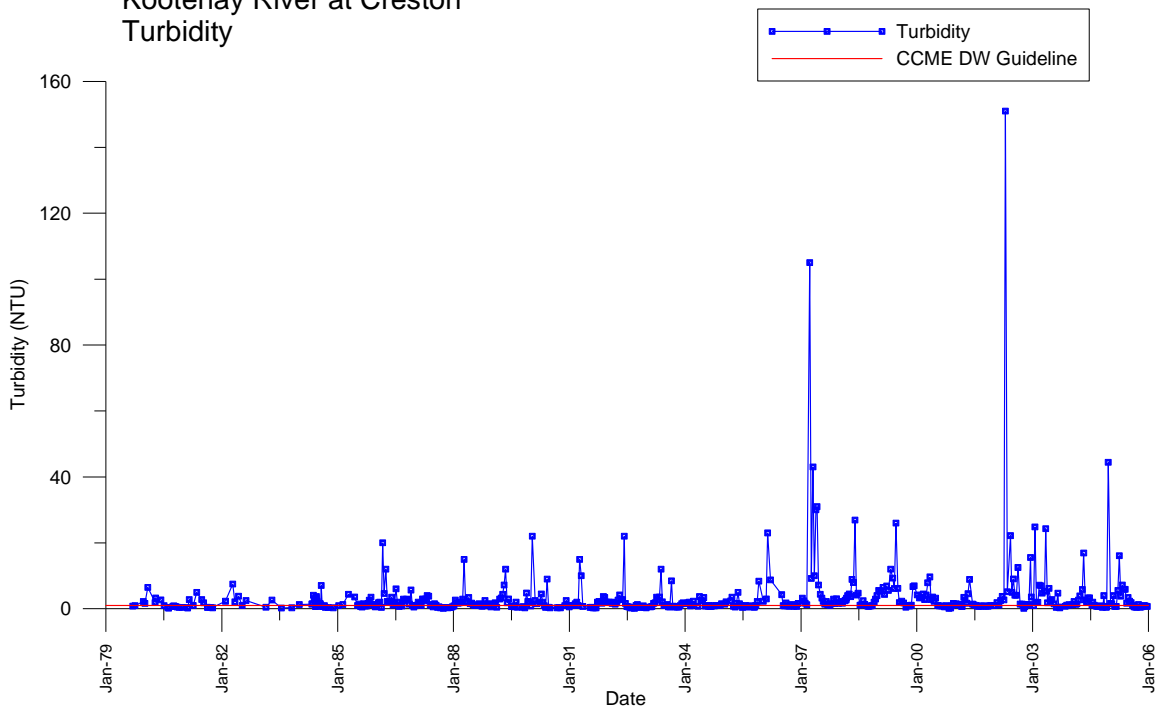
Figure 66  
Kootenay River at Creston  
Turbidity

**Turbidity** (Figure 66) values were regularly higher than the guideline for the protection of source water used for drinking. For effective disinfection of this source water, removal of solids will be required as treatment.

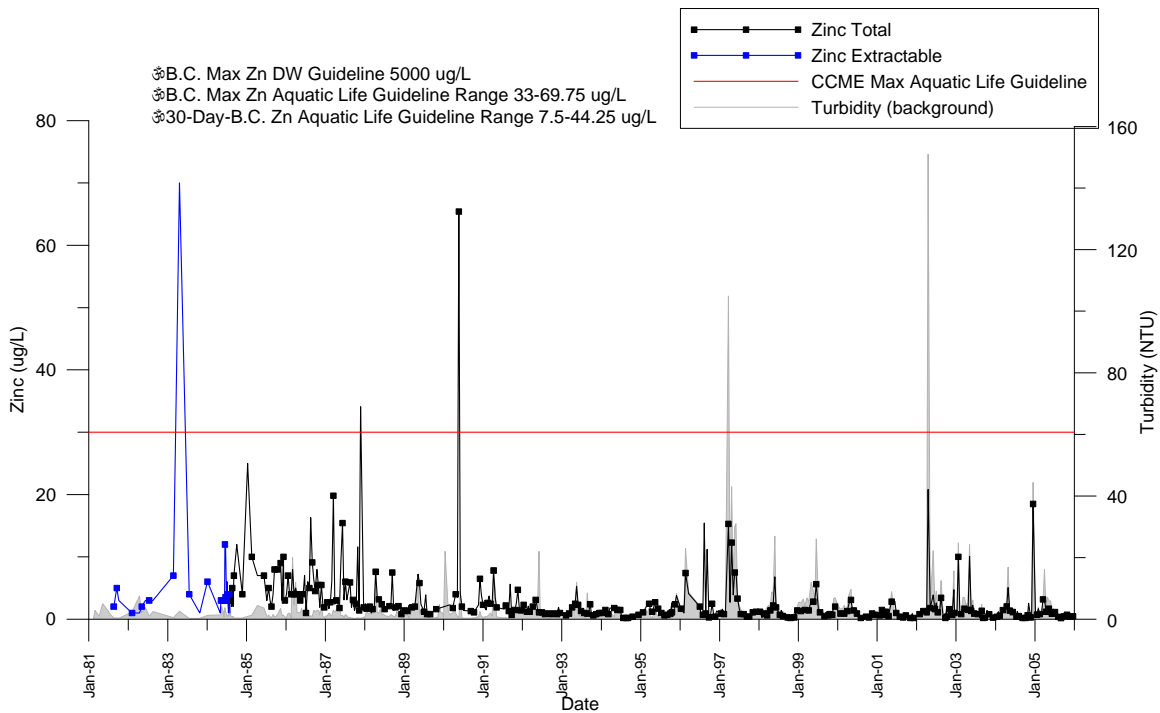
Figure 69  
Kootenay River at Creston  
Zinc Total and Extractable

**Zinc** (Figure 69) concentrations (individual) occasionally exceeded the guideline for a monthly mean for the protection of aquatic life. These values were correlated to high

turbidity measurements, indicating that the zinc would be in particulate form and not biologically available.
