### Ambient Water Quality Monitoring in Kilgaard Creek in 2001

# **Ambient Water Quality Monitoring in Kilgaard Creek in 2001**

Diane Sutherland  
Ministry of Environment  
Environmental Quality Section  
2nd Floor, 10470 152 Street  
Surrey, B.C.  
V3R 0Y3

August 2005

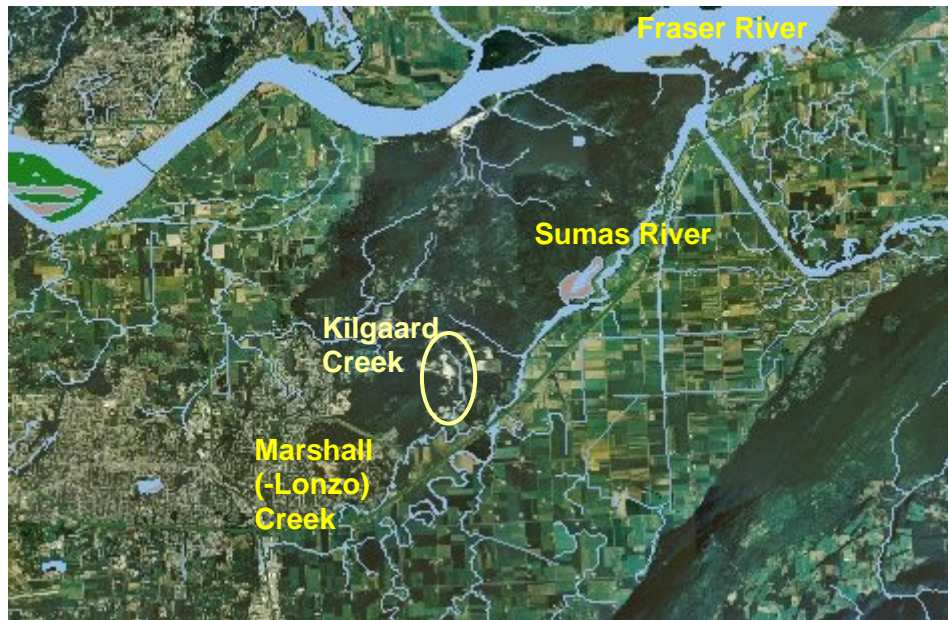
**Figure 1: Location of Kilgaard Creek, Marshall (-Lonzo) Creek, Sumas River and Fraser River.**

Kilgaard Creek is located in Abbotsford, British Columbia and is part of the larger Sumas River watershed (Figure 1). This area consists of the extensive floodplains of the Lower Fraser Valley and the surrounding mountainous area. Kilgaard Creek is 2.5 kilometres in length with its headwaters originating on the southern slope of Sumas Mountain. The creek flows through the Sumas First Nations Reserve and discharges to Marshall Creek (also known as Lonzo or Marshall-Lonzo Creek) at the base of Sumas Mountain. Marshall Creek discharges into the Sumas River which then flows into the Fraser River.

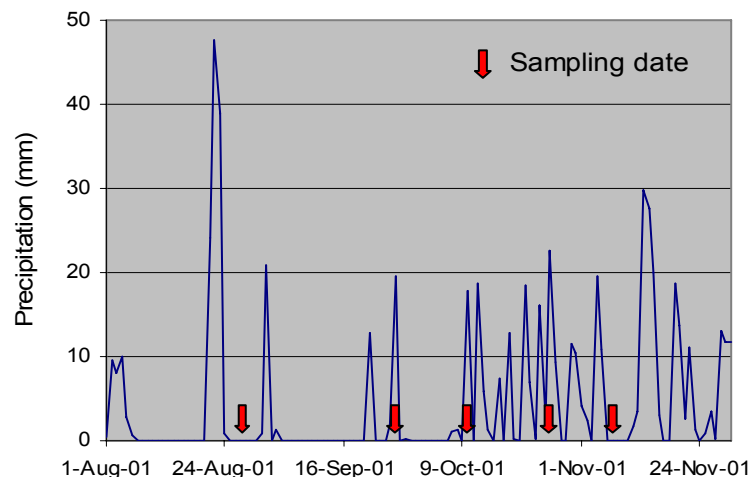
Figure 2: Rainfall in Abbotsford during the sampling period and the time of each sample collection.

Discrete water samples were collected on five dates between August 28 and November 7, 2001. All discrete water quality sampling was conducted according to standards outlined in the *Ambient Fresh Water and Effluent Sampling Manual* (Resources Inventory Committee 1994). Samples for pH, turbidity and nutrients were collected in clean, one litre polyethylene bottles. Non-filterable residue samples were submitted in separate one litre polyethylene bottles. Each bottle was labeled with a unique identifier and the date. Time and conditions at the time of sampling were recorded in field notes. Visual fish, wildlife and water condition observations were also recorded in field notes. Precipitation measurements at the time of sampling are illustrated in Figure 2.

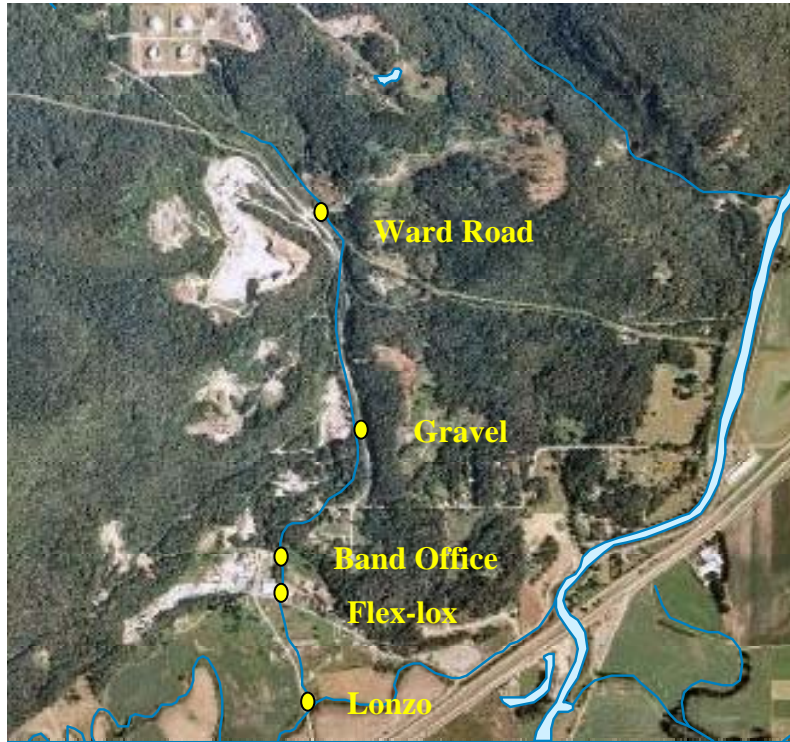
Figure 3: Sampling sites in Kilgaard Creek.

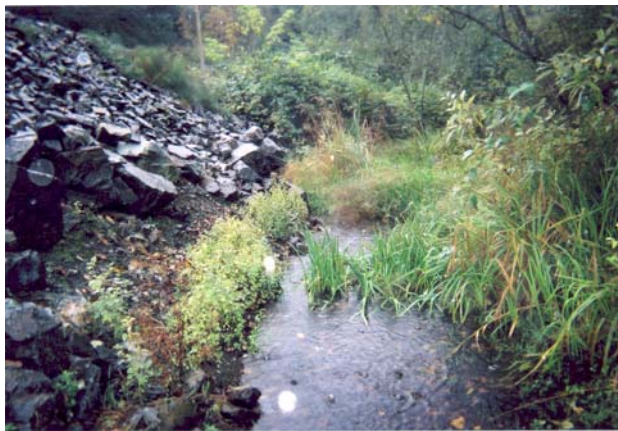
Figure 4: Ward Road sampling site.

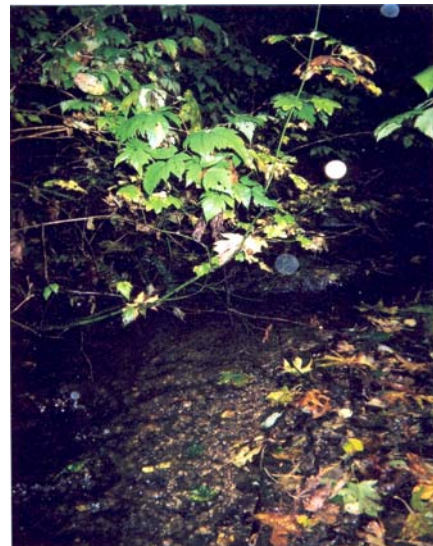
Figure 5: Gravel extraction sampling site.

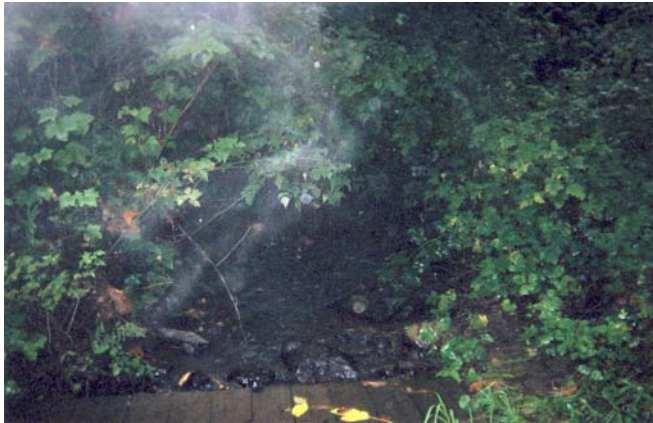
**Figure 6: Band office sampling site.**

Samples were also collected behind the Sumas First Nations band office. This area has riparian vegetation on both sides of the creek and is forested upstream (Figure 6). The substrate is composed of gravel and bedrock. A culvert discharges to the creek upstream of the sampling location on the west side of the creek. This culvert appears to direct the flow of a small tributary under Sumas Mountain Road and into Kilgaard Creek. A brick manufacturing operation (Sumas Clay Products) is located west of this area, across Sumas Mountain Road.

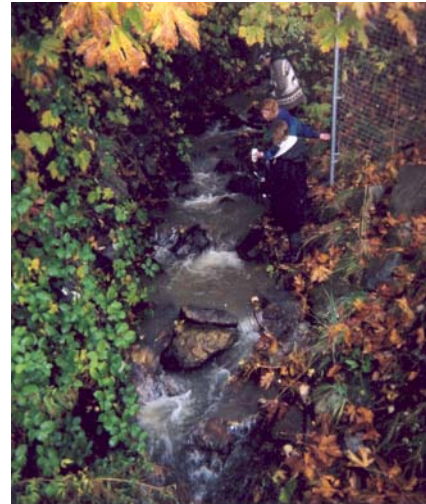
**Figure 7: Flex-lox sampling site.**

The next site was located upstream of Kilgaard Road (Flex-lox site). There is riparian vegetation on both sides of Kilgaard Creek in this area and upstream is forested (Figure 7). Samples were collected upstream of the culvert, which the creek flows through to pass under Kilgaard Road. The substrate here is rocky with many large boulders and the bedrock is visible. Bordering both sides of the creek in this area is Flex-lox Industries, which manufactures PVC piping.

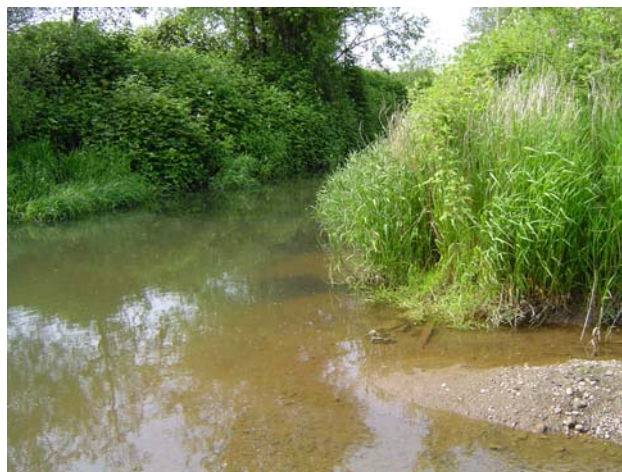
**Figure 8: Sampling site at Marshall Creek confluence.**

The most downstream site sampled in Kilgaard Creek was just upstream of its confluence with Marshall Creek. Between Flex-lox Industries and this site, the landscape changes as the creek enters the floodplain and is primarily bordered by agricultural activities. Upstream of this sampling site, a few houses, band buildings, a soccer field and a major road (Sumas Mountain Road) border the creek. The riparian area has been removed in these lowlands and has subsequently been colonized by blackberry bushes. At the confluence with Marshall Creek, there is very little shade cover as only grass borders the creek (Figure 8). The bottom substrate is gravel in this area although fine sediments appear to be filling in some of the stream bottom. During the sampling period, adult coho salmon were observed migrating upstream. Waste from the cleaning of harvested fish was visible in Marshall Creek near this sampling site. People were seen cleaning fish and then disposing of the waste into the creek from the Sumas Mountain Road bridge, which passes over Marshall Creek.

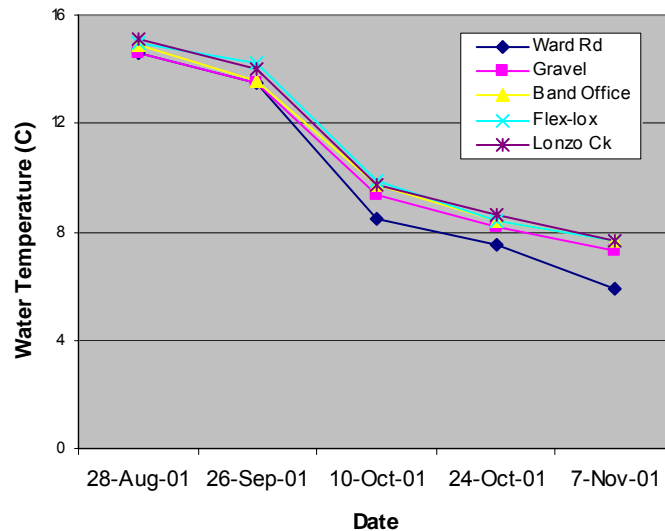
Figure 9: Water temperature at each site on each sampling date.

The water temperature decreased at all of the sampling sites in Kilgaard Creek during the sampling period (Figure 9). This was anticipated as the sampling began in the summer and carried on through the fall. Water temperatures were consistently elevated above the recommended guidelines on some dates. The guideline suggests that the water temperature should be no more than 1° above or below the optimal temperature ranges for salmonid species present in the watercourse. Coho are known to use Kilgaard Creek as they were seen returning to spawn during the course of the sampling. Water temperatures were above the spawning guideline (13.8°C) on the first date (August 28, 2001) at all sites, as well as on the second date (September 26<sup>th</sup>) at the two most downstream sites (Flex-lox and Marshall).

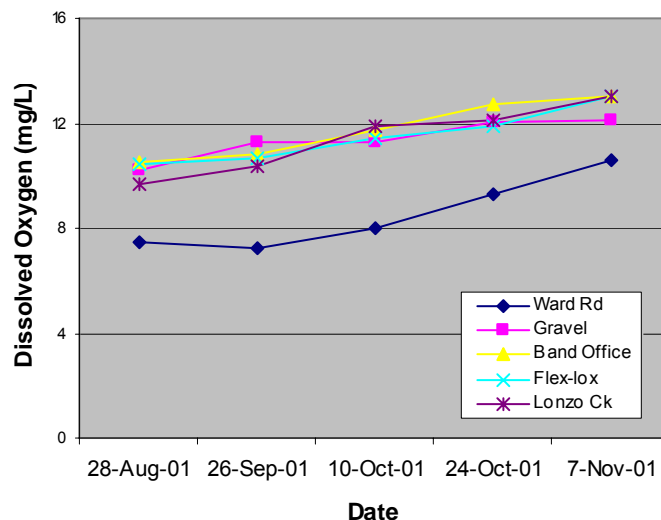
**Figure 10: Dissolved oxygen at each sampling site on each sampling date.**

The dissolved oxygen (DO) concentrations in Kilgaard Creek showed a general increase during the sampling period as the sampling progressed from summer to fall months (Figure 10). This is due to the solubility of oxygen in freshwater increasing with decreasing temperature. The Ward Road site showed the same pattern however the DO was lower than at the other sites. The lower DO at this site may reflect the decomposition of the large amount of organic matter in the creek in this area. As well, this site is closest to the headwaters with less turbulent water flow upstream of it, and thus less atmospheric oxygen is likely to get dissolved in the water. Downstream of the Ward Road site, the creek progresses down Sumas Mountain and flows over steep, rocky reaches which generate more turbulent water action.

The DO concentrations were never below the instantaneous minimum DO criteria for salmonids (excluding buried embryo and alevins) (5 mg/L) at any of the sites (Truelson 1997). From the time of spawning until fry emerge, the criteria for buried embryos and alevins applies. The instantaneous minimum criteria for buried embryo/alevin (9 mg/L) was not reached at the Ward Road site on the first three dates. Low DO can be common in freshwater systems in late summer or in fall during algal decomposition. It is unlikely however that spawning salmon reach these upper sections of Kilgaard Creek. On the first two sampling dates, most sites had DO concentrations below 11 mg/L, which is the 30-day mean criteria for buried embryos and alevins. There are not adequate samples, however, to determine whether these conditions persisted over time and thus whether this chronic criteria was exceeded.

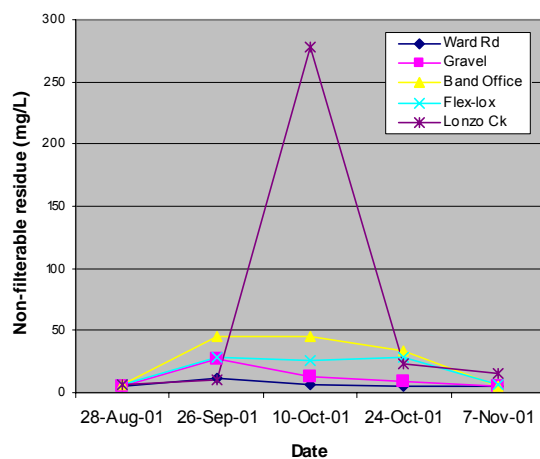
Figure 11: Total suspended solids (NFR) at each site.

Two common patterns seen in water quality data from altered watersheds is that siltation tends to increase with precipitation as well as with movement downstream in a watershed. Both the TSS and turbidity data reflect these patterns (Figures 11 and 12). All suspended sediment concentrations (measured as non-filterable residue) and turbidity values were lowest and quite similar, at all sites on the first and last sampling dates which corresponded with dry conditions prior to sampling. The most upstream site, Ward Road, had relatively consistent TSS and turbidity values on all dates, regardless of precipitation. When sampling occurred during wet weather (the three middle sampling dates), suspended sediment and turbidity increased at the other sites, although to different levels. TSS and turbidity values at the three more downstream sites on these dates increased by up to approximately 40 times that of the Ward Road site.

Higher turbidity and suspended sediments are common downstream of developed areas and road surfaces as was seen in Kilgaard Creek. The most upstream sites consistently had the lowest suspended sediment measurements. These values were relatively consistent on all of the sampling dates at these sites. Downstream, however, the values of these parameters increased with the Band Office site often having the highest TSS and turbidity values on the wet weather dates. Consequently, the higher values downstream of the more residential and industrial locations near the band office, Flex-lox Industries and Marshall Creek sites are likely due to the surface runoff they receive from roadways, residential, agricultural and industrial areas. The peak TSS value occurred at Marshall Creek on October 10<sup>th</sup> which was elevated nearly six times above the next highest value. There was no corresponding peak in turbidity nor in TSS at the other sites on this date. As this only occurred at this most downstream site located near Kilgaard Creek's confluence with Marshall Creek, it is possible that Marshall Creek was the actual source of this elevated sediment measurement at this site.

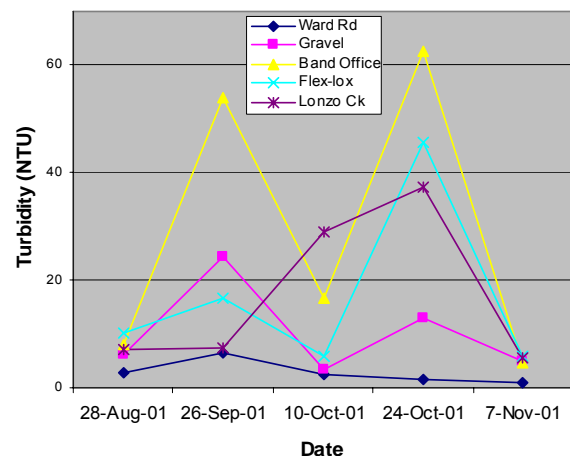
Figure 12: Turbidity at each site.

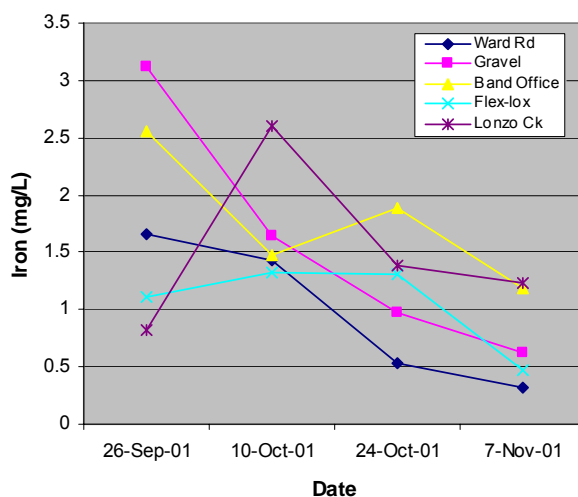
Figure 14: Iron concentrations at each site.

The concentrations of most metals were low at the Ward Road site. A few metals exceeded (or may have exceeded) their criteria at all sites. Iron was consistently elevated in Kilgaard Creek with concentrations exceeding the maximum working guideline (0.3 mg/L) on all dates at all sites (Figure 14). The site with the highest iron concentration varied with date. This data suggests that there is likely no one large point source of iron and the iron elevations may not be indicative of anthropogenic impacts. These high iron concentrations are similar to those in other coastal B.C. streams which are naturally iron-rich.

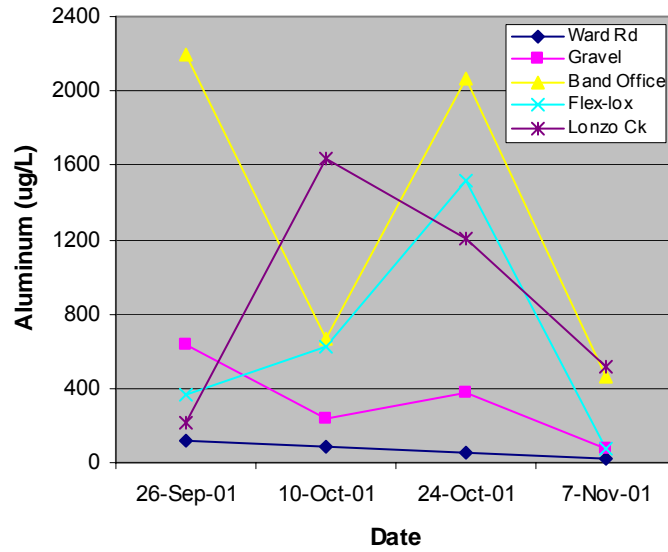
Figure 15: Aluminum concentrations at each site.

Total aluminum concentrations in Kilgaard Creek were greater than the maximum (0.1 mg/L dissolved Al) and average 30-day criteria (0.05 mg/L dissolved Al) for dissolved aluminum at most sites on many of the dates (Figure 15). Ward Road had the lowest aluminum concentrations, only exceeding the acute criteria on the first sampling date and the chronic criteria on two sampling dates. At the other sites, either the acute or chronic criteria was exceeded on each date. This data is not conclusive regarding whether the criteria were exceeded, however, since aluminum was measured as total aluminum, yet the criteria are based on dissolved aluminum concentrations. The value for total aluminum will be higher than the dissolved fraction and thus when measurements of total aluminum exceed that of the dissolved aluminum criteria, it does not necessarily mean that there is an exceedance of the dissolved criteria value. In order to determine how much of the total is dissolved, further analyses would need to be conducted.

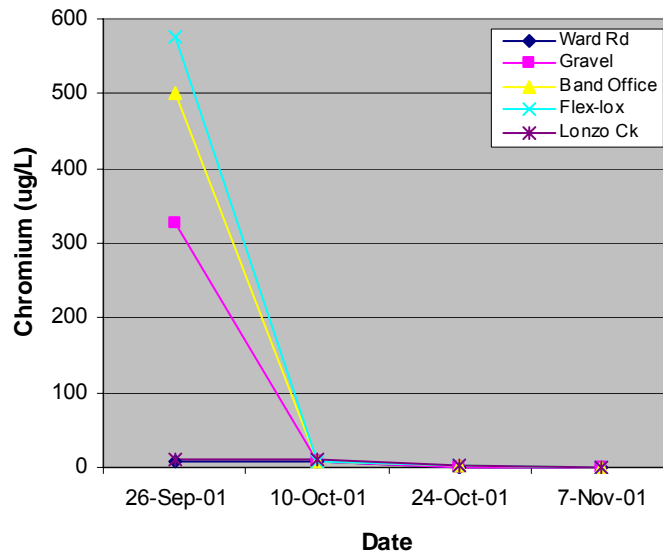
Figure 16: Chromium concentrations at each site.

Chromium concentrations were also elevated at some sites on some dates. Chromium concentrations were very high at the middle three sampling sites (gravel, band office and flex-lox sites) on the first date (Figure 16). The concentrations were 36 to 64 times higher at these sites than at the Ward Road site on the same sampling date. Chromium concentrations may have exceeded the maximum working guideline (1 ug/L Cr<sup>+6</sup>; 9 ug/L Cr<sup>+3</sup>) at all sites on the first three sampling dates (first two dates at Ward Road) depending upon the species of chromium present. As the criteria is based upon the specific species of chromium present, it is not possible to be certain whether the guideline was exceeded or not. Hexavalent chromium (+6) is the most common chromium species found in surface waters. This is also the more toxic form.

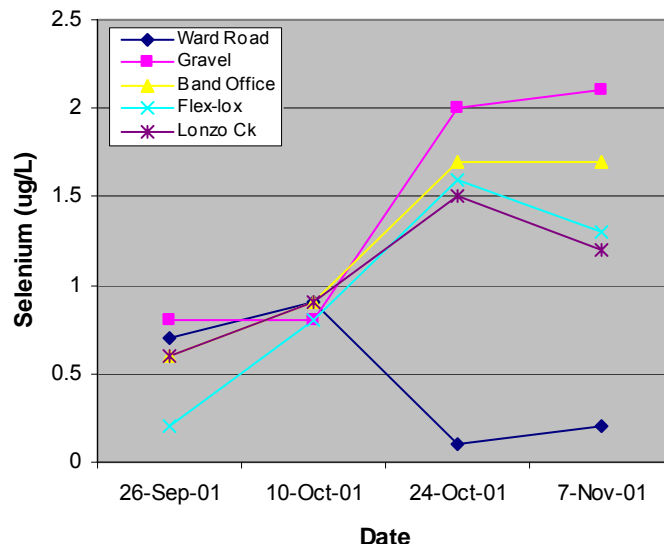
Figure 17: Selenium concentrations at each site.

In general, selenium concentrations increased over the sampling period. There was a peak in concentration at all sites downstream of Ward Road on October 24<sup>th</sup> and November 7<sup>th</sup> (Figure 17). The concentration at the gravel site was equal to or greater than the criteria (2.0 µg/L) on these dates. As this is a chronic criteria, and it is not known how long the selenium concentration was elevated, it is not known whether these conditions persisted long enough to have chronic impacts on aquatic life. This was the only potential selenium exceedance in Kilgaard Creek during sampling, although the concentrations did approach the criteria on some dates at the other downstream sites. Selenium was the only metal of concern which did not exhibit a positive trend in concentration with storm events.

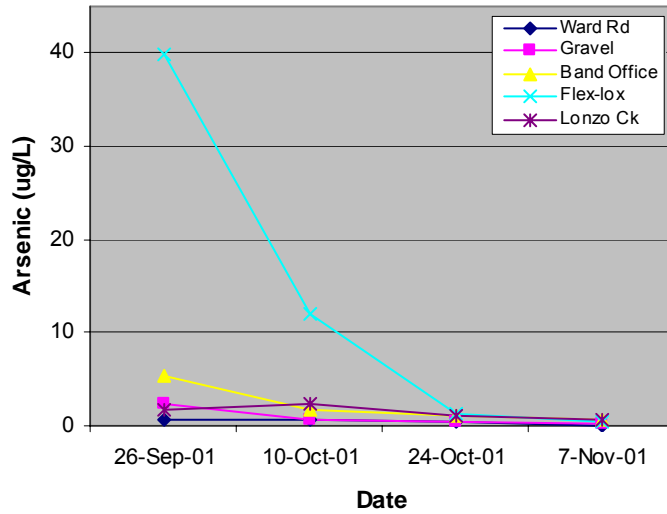
Figure 18: Arsenic concentrations at each site.

The concentration of arsenic was low at most sites on most dates. The maximum working guideline (5.0 µg/L) was exceeded at the band office site on September 26<sup>th</sup> and at the Flex-lox site on this date and October 10<sup>th</sup> (Figure 18). The other sites however had much lower arsenic concentrations than the Flex-lox site on these two dates suggesting that this is not a natural elevation.

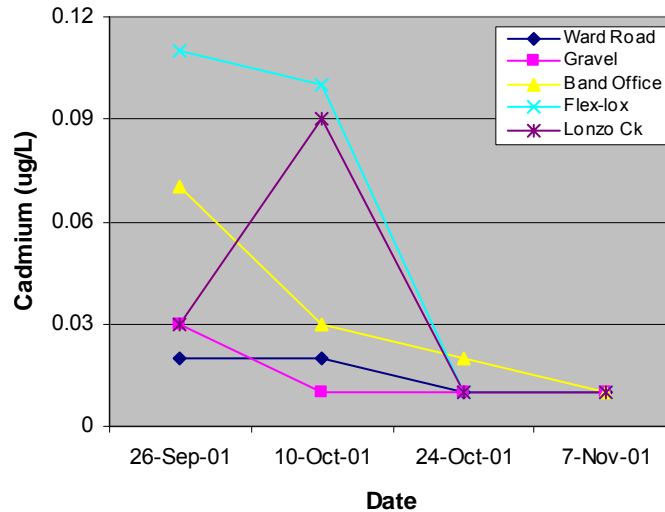
Figure 19: Cadmium concentrations at each site.

Besides iron, aluminum and chromium, cadmium was also elevated at the three most downstream sites on some dates (Figure 19). Total cadmium concentrations exceeded the maximum working guidelines (0.01 - 0.06 ug/L depending upon water hardness) on one or both of the first two sampling dates at these sites. The highest cadmium concentrations were measured at the Flex-lox site on both of these dates. Cadmium concentrations were below detection limits at most sites on the last two sampling dates, and near or below detection on all dates at the two upstream sites. This data again suggests that there may be a source upstream of this site.

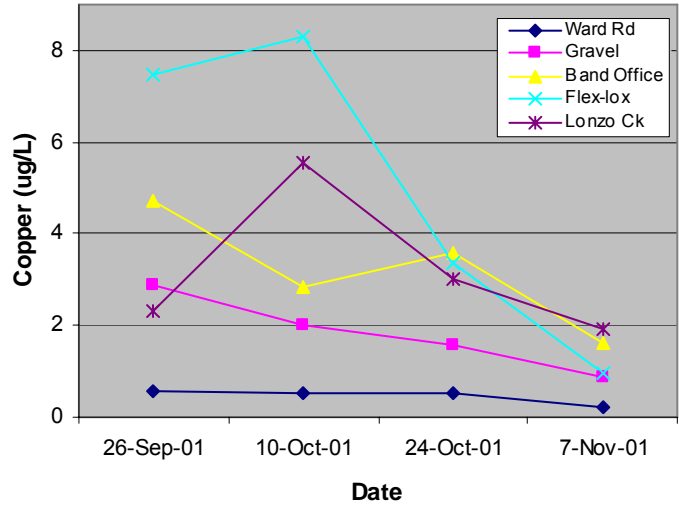
Figure 20: Copper concentrations at each site.

Copper is usually found in trace amounts in B.C. waters. In Kilgaard Creek, copper concentrations exceeded the chronic criteria at Flex-lox on the first two dates (Figure 20) as other metals (Figures 18, 19 and 21). By the last sampling date, the concentration was closer to the value at Ward Road, and was lower than at the Band Office. Elevated copper concentrations in the local surface waters could come from mining operations and/or urban development.

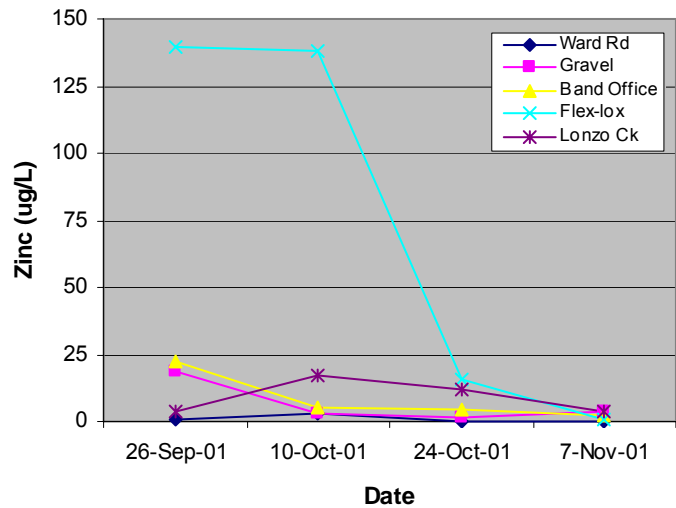
Figure 21: Zinc concentrations at each site.

Zinc concentrations were low at most sites on most dates. At the Flex-lox site on the first two dates, however, the maximum criteria (40-115 ug/L) was exceeded (Figure 21). At the gravel site, the chronic criteria (33-115 ug/L) was exceeded on the first date. It is not known, however, how long these conditions lasted and whether the chronic criteria at the gravel site was actually exceeded. The values at the Flex-lox site, however, were 6 - 8 times higher than the next highest concentrations on these dates and exceeded the maximum criteria. As these values were so much higher only at this site on the two dates, it appears that there is a source of this metal entering Kilgaard Creek upstream of Flex-lox.
