## State of Water Quality of Liard River at Fort Liard 1984-1995

### Canada - British Columbia Water Quality Monitoring Agreement

Water Quality Section  
Water Management Branch  
Ministry of Environment, Lands and Parks

November, 1996

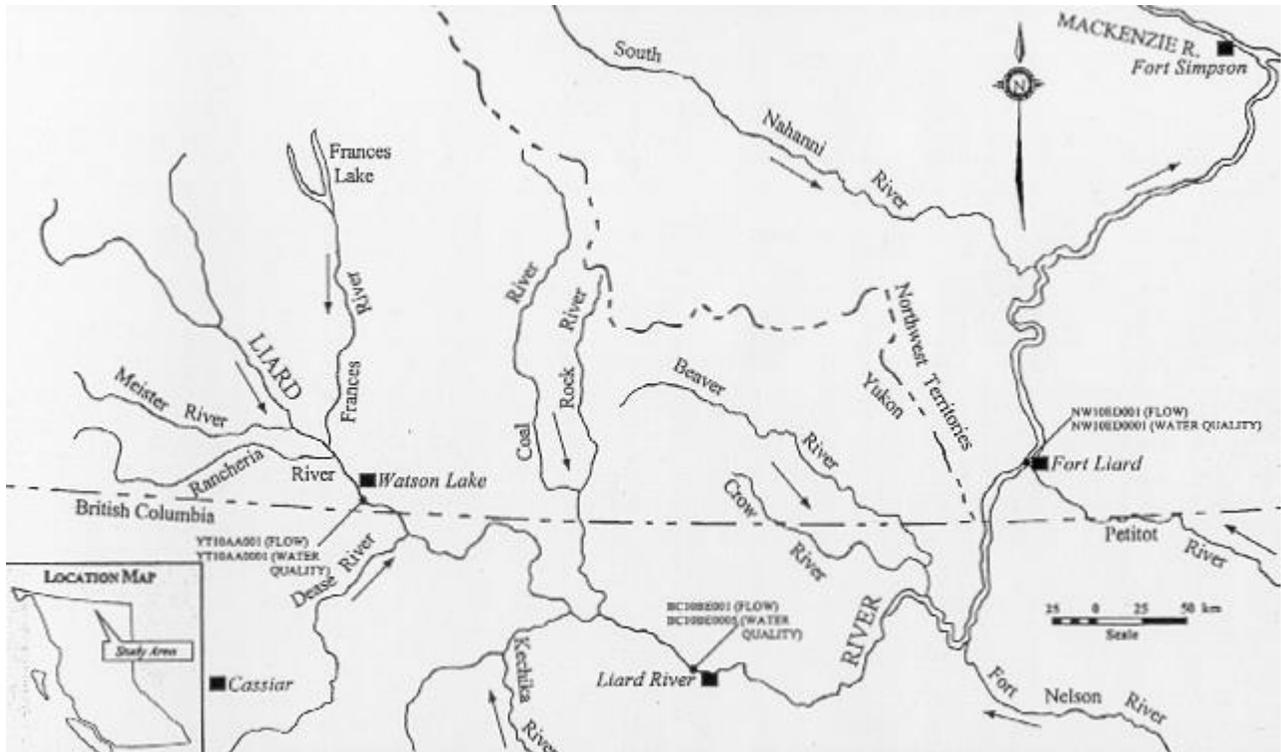
**Figure 1 Map of Liard River (Scale 1:3,300,000)**

The Liard River is a major tributary of the Mackenzie River, flowing southeast from the Yukon into British Columbia, looping through northern B.C., and then flowing northeast into the Northwest Territories to the Mackenzie (Figure 1). Water quality is affected by various activities including oil and gas development, mining, forestry and agriculture.

There are three water quality stations on the Liard River: Upper Crossing near the Yukon-B.C. border, Lower Crossing at Liard River, B.C., and at Fort Liard in the Northwest Territories (Figure 1). This report assesses water quality data collected at the Fort Liard monitoring station, located at the Hudson's Bay

There are three water quality monitoring stations on the Liard River (Upper Crossing in the Yukon, Lower Crossing in British Columbia, and Fort Liard in the Northwest Territories). The Fort Liard monitoring station is located at the Hudson's Bay Company Post, 1.2 km downstream from the confluence with the Petitot River. The water quality of the other two stations is discussed in two separate reports (Jang & Pommen, 1996a & 1996b).

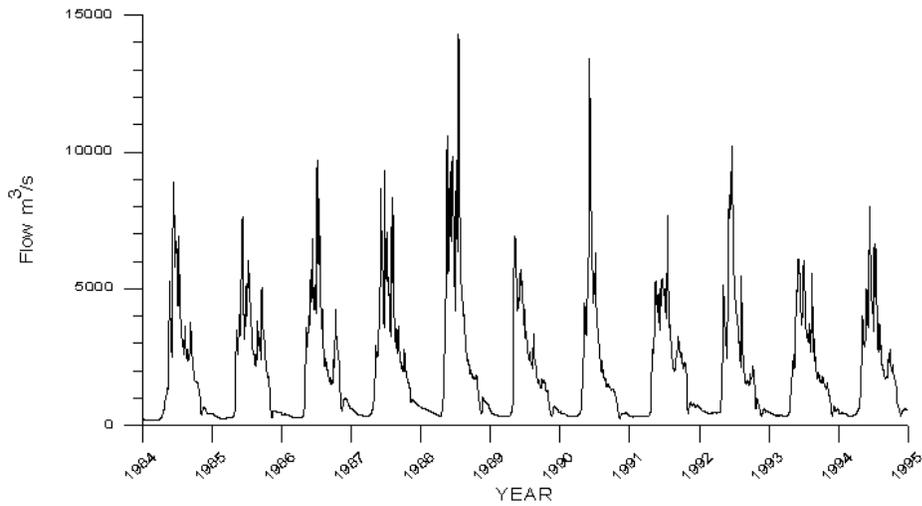
NW10ED001

**Flow** (Figure 2) values were highest during spring freshet (May-July). Peak flow values were similar in most years except for higher values in 1988 and 1990. The lowest peak values occurred in 1989 and 1993.

Data for this report are from sampling by Environment Canada, between 1984 and 1995, and are stored under ENVIRODAT station number NW10ED0001. The water quality indicators are plotted in Figures 3-45. Water Survey of Canada operates a flow gauge at the water quality monitoring station (site number NW10ED001). The drainage area at the flow station is 222 000 km<sup>2</sup>. Flow data are graphed in Figure 2.
