The Shawnigan Lake Watershed Contaminated Soil Landfill: A Case Study Illustrating Regulatory Capture & Complete Failure Of The Professional Reliance Model

Bernhard H.J. Juurlink, PhD

█'s Non-Functional Leak Detection System

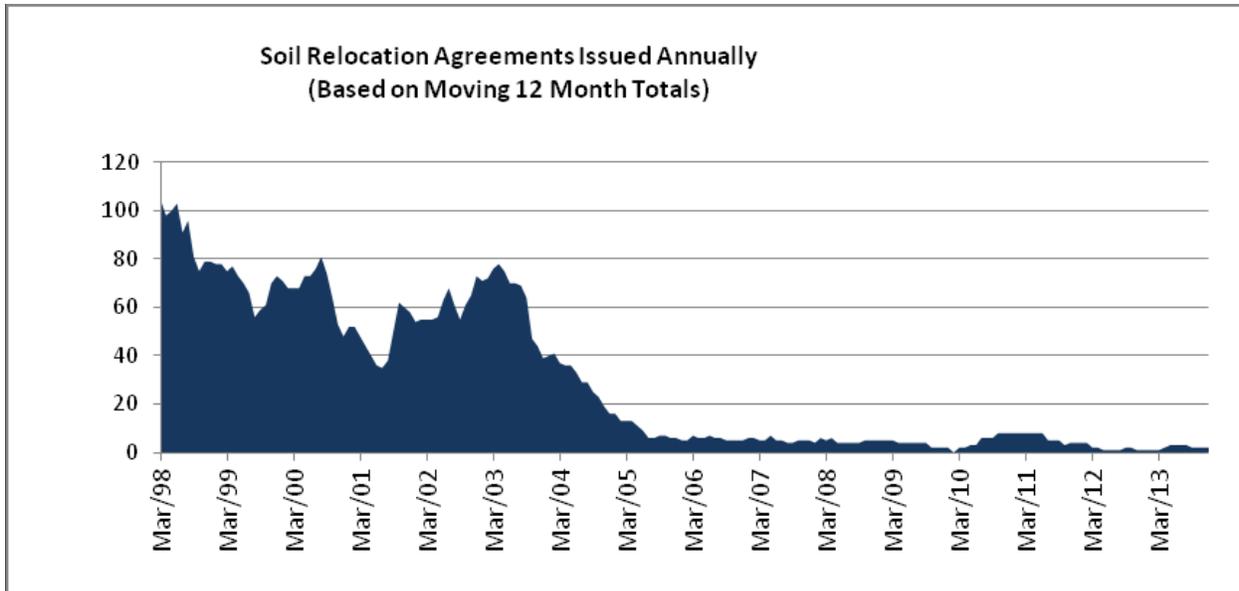
Ministry's Response To Decrease Of Soil Relocation Permit Applications & Issuances: The Ministry of Environment noted that in recent years there was a huge decrease in Soil Relocation Permits issued in BC – see graph below.

Graph: Decrease in Soil Relocation Permits as documented by the Ministry of the Environment

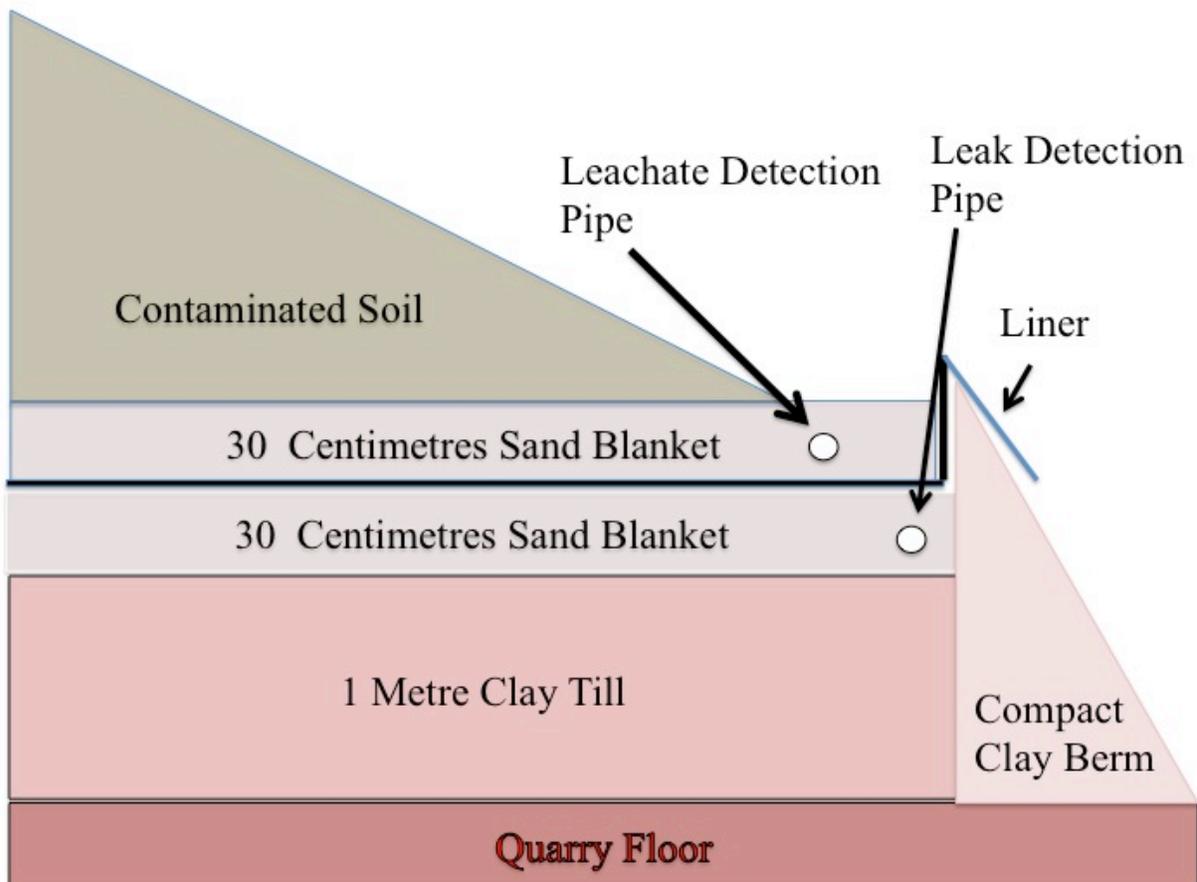
Figure 1. Diagram illustrating how the leak detection system should be located in a landfill.

A leak detection system in a landfill should be designed to detect movement of water and contaminants through the polyethylene liner. In the case of 460 Stebbings Road, Shawnigan Lake, the liner is a 40 mil linear low density polyethylene (LLDPE) liner. The proper design for a leak detection system is illustrated in Figure 1. Here we see that the perforated pipe of the **leak detection system** is well below the LLDPE liner. Above the liner we have the **leachate detection system**.

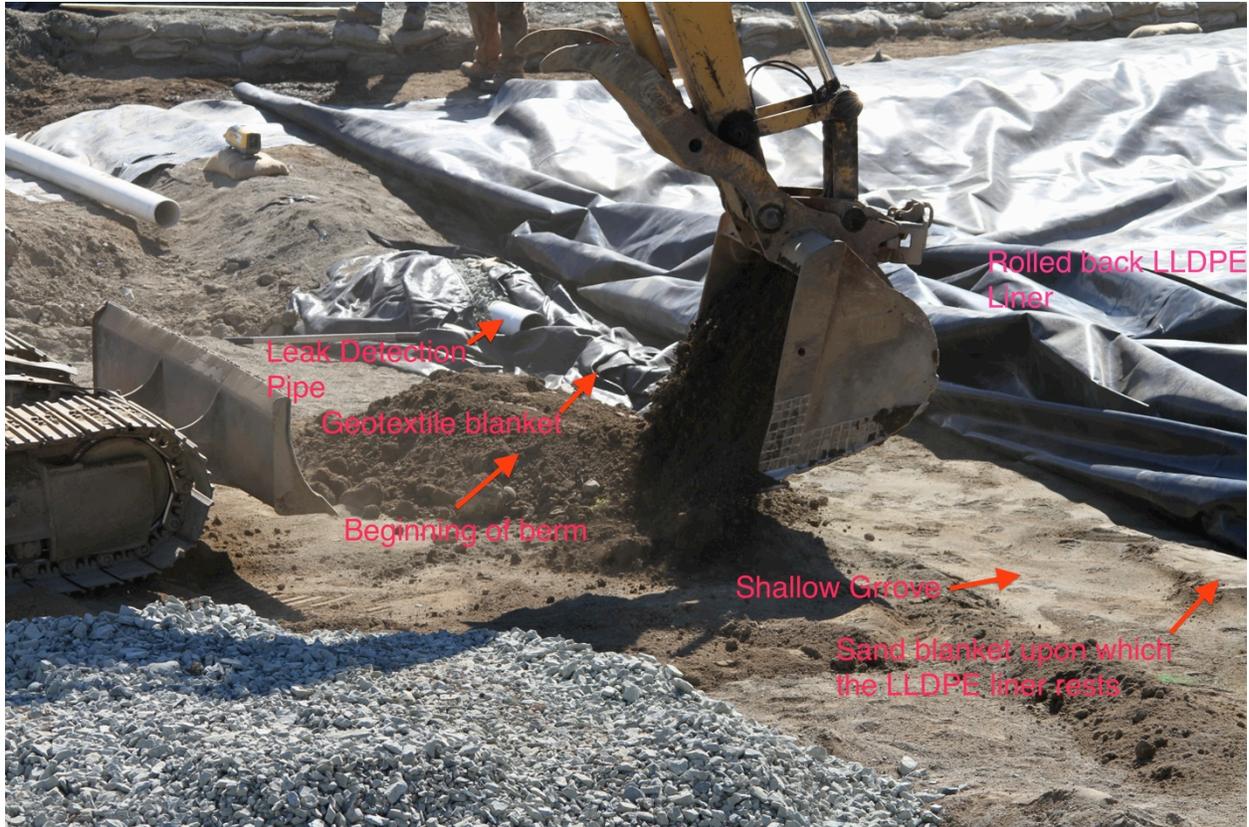
Figure 2 illustrates an early stage of the construction of █'s Leak Detection System. It starts by folding back the LLDPE liner from its sand blanket at the edge of the Soil Containment Area

#2. A very shallow groove is then produced in this sand blanket. The groove appears to be 3-5 cm deep. A loose clay till berm is then placed alongside this groove. A geotextile blanket is then placed over the berm and the sand-blanket groove.

Figure 2. Early stage of [redacted]'s leak detection system construction.

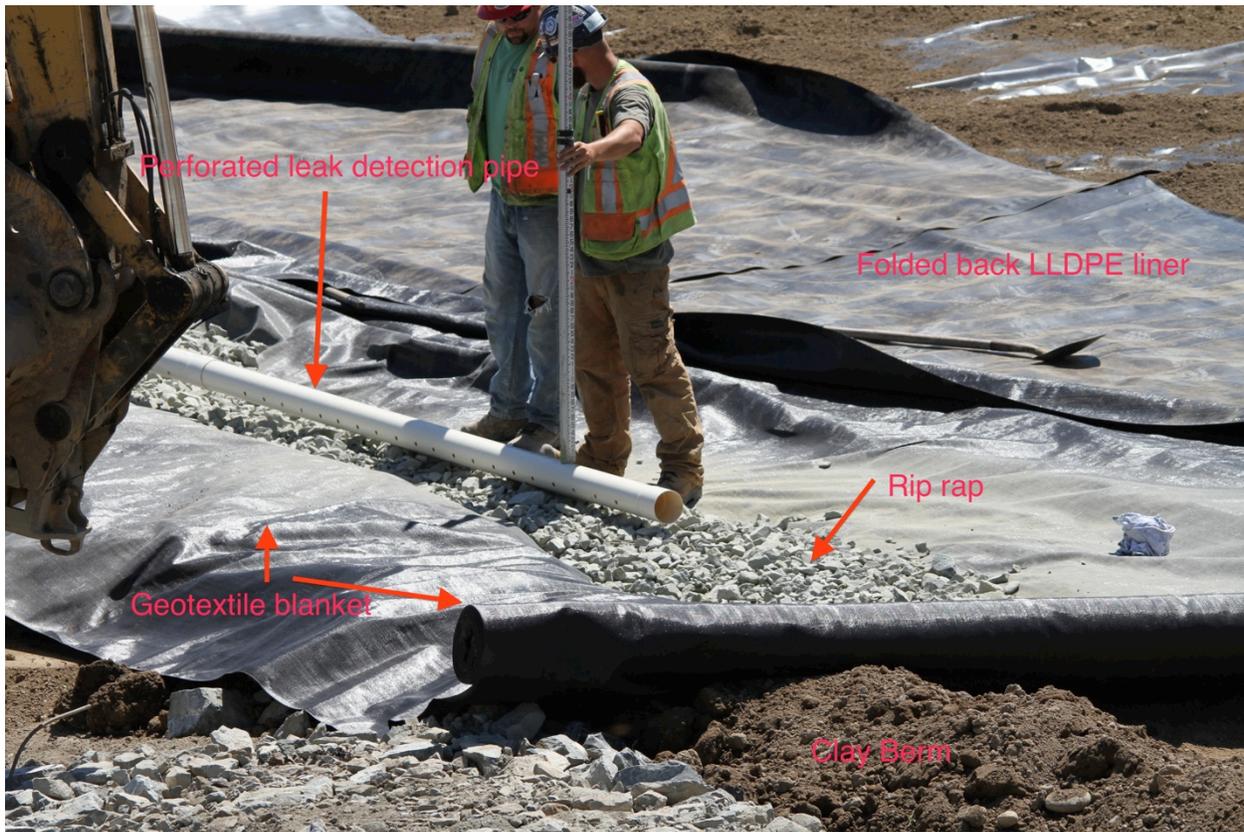
Figure 3 illustrates a new segment of the leak detection pipe glued to the previous segment. Note the perforations are on the sides of the pipe. The pipe extends over the geotextile blanket laid over the shallow groove in the sand blanket and over the clay berm. Rip rap or coarse crushed

rock is then added supporting the pipe from below, the sides and finally on top. Note that the pipe lies on crushed rock that has an apparent greater depth than the groove in the sand blanket and that the perforations are half way up the sides of the 4 inch pipe. The geotextile blanket is then folded over as seen in Figure 4. Note that the pipe appears to be above the level of the sand blanket upon which the LLDPE liner rests. One of the workers was asked if the pipe was below the liner level. He answered “it was supposed to be”. He did not say that it *was* below the liner level. It looks like the perforations are possibly 4-6 inches above the level of the LLDPE liner.

Figure 3 illustrating how rip rap is placed around the leak detection pipe.

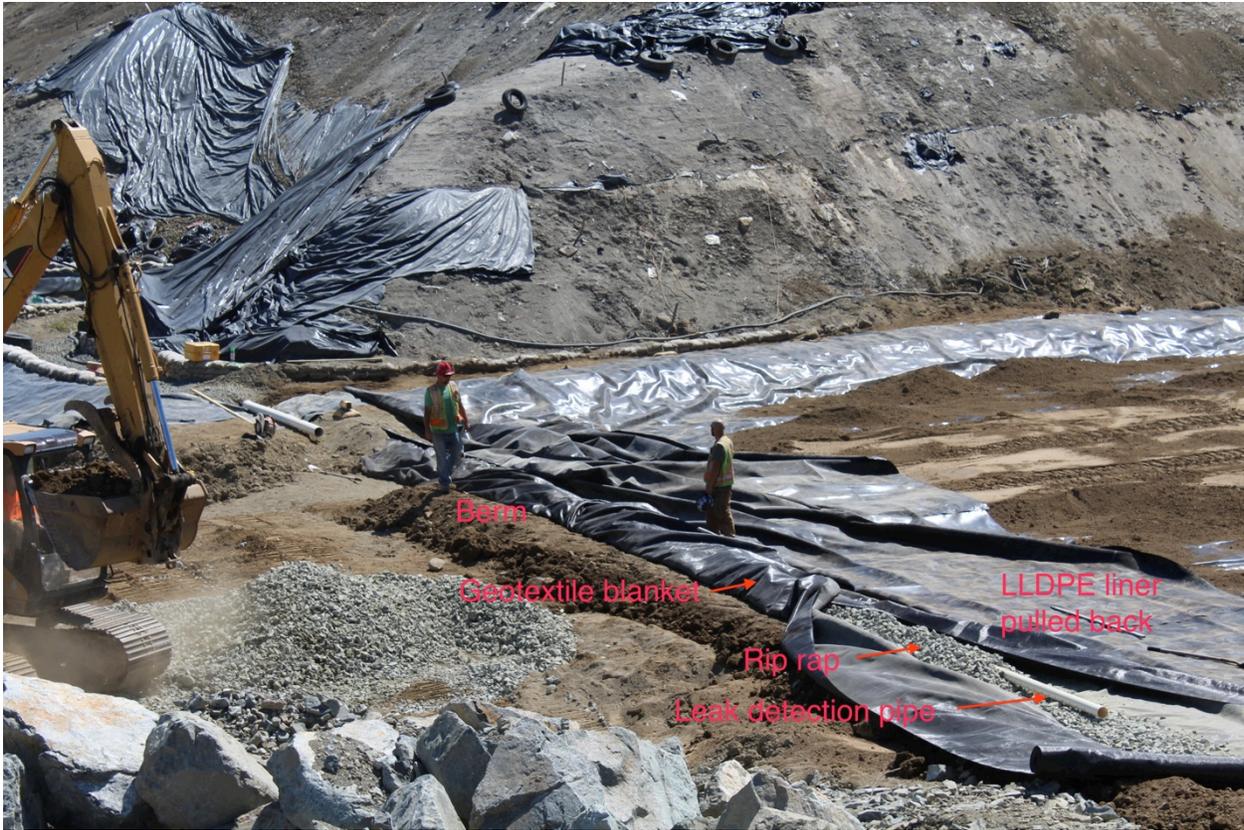
Figure 4 more clearly illustrates how rip rap is placed around the leak detection pipe followed by wrapping with the geotextile blanket.

Figure 4. Demonstrates the 'leak detection' system extending further in the westerly direction.

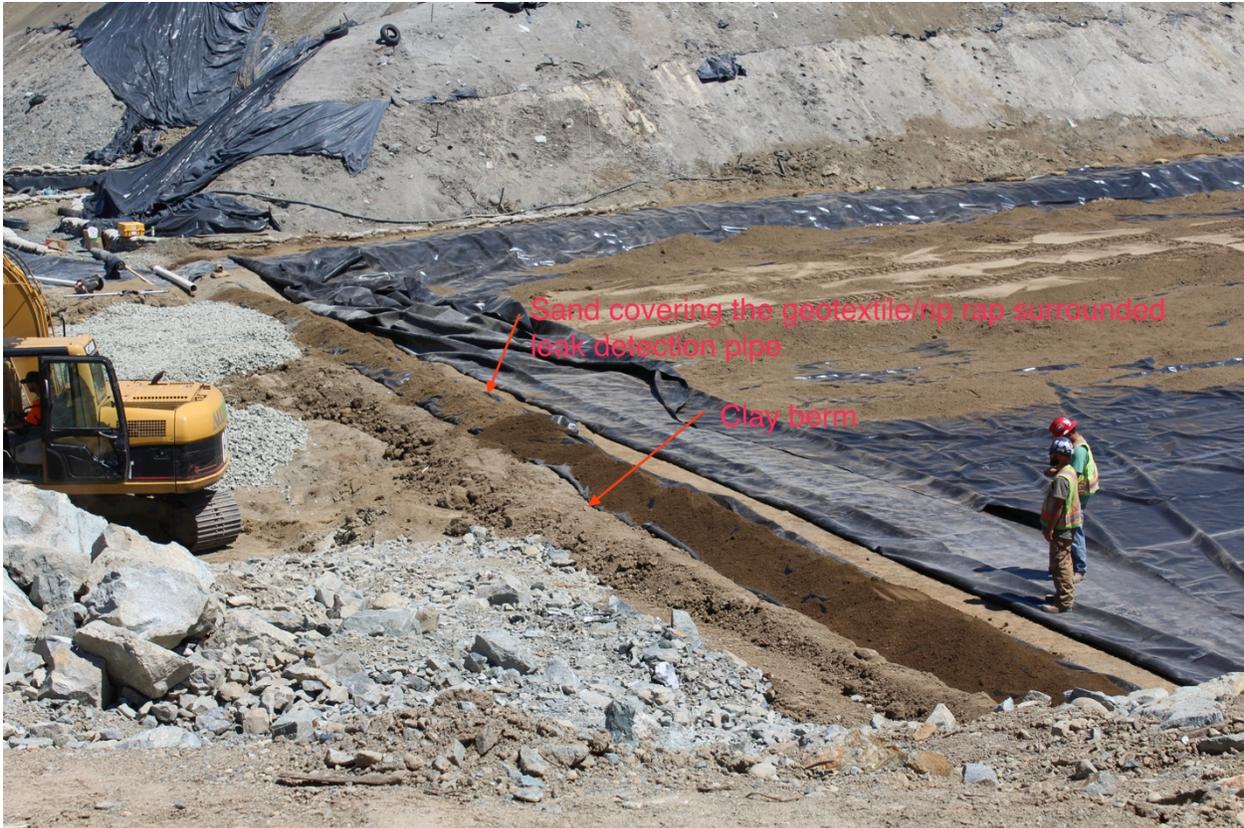
Figure 5 illustrates that once the 'leak detection' pipe is surrounded by rip rap and the geotextile blanket is wrapped, it becomes covered with sand. The berm is then built up with more loose clay till. Finally, the LLDPE liner is folded over everything as seen in Figure 6.

Figure 5. Covering the 'leak detection' system with sand.

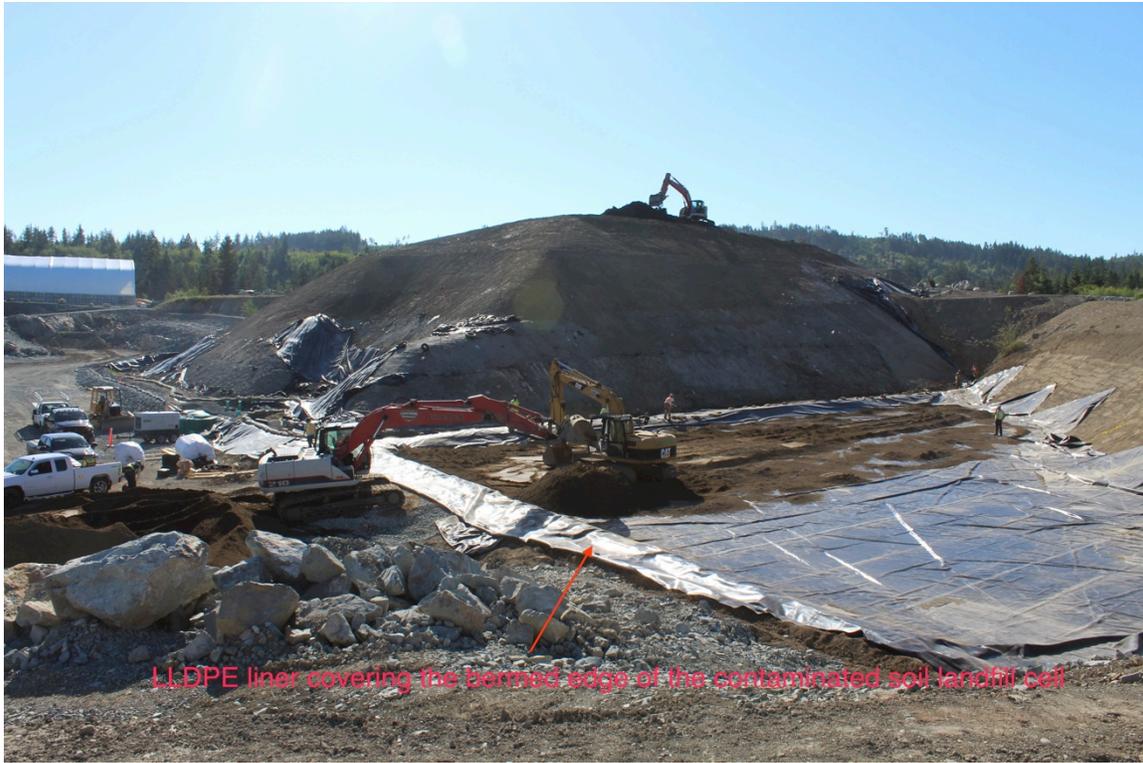
Figure 6 illustrates the LLDPE liner being pulled back over the 'leak detection' pipe assembly and the enlarged loose clay till berm.

Figure 6. Once the 'leak detection' system is completed work will start on the leachate detection system.

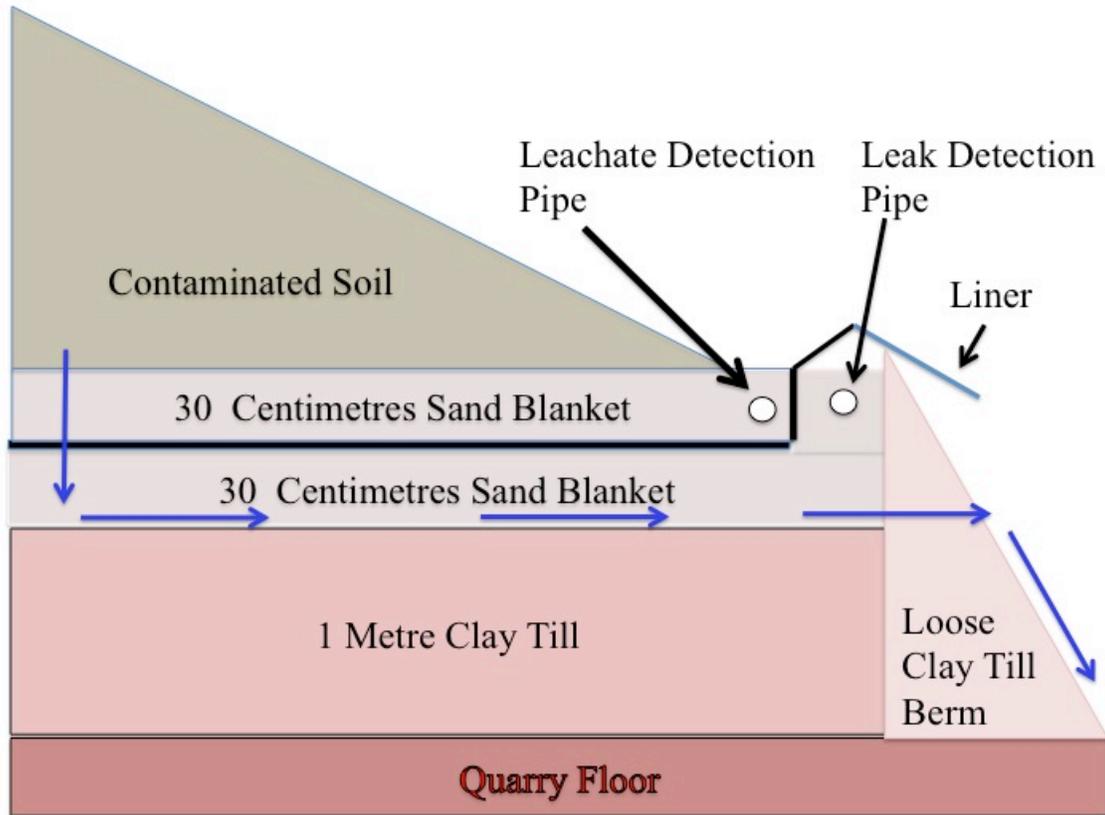
So in fact the 'leak detection' system that has been built by [REDACTED] is illustrated in Figure 7. The blue arrows represent water movement. The leak detection system seems to be designed not to detect leaks. One can only detect leaks because of water passing through the loose clay till berm and onto the floor of the quarry, which of course [REDACTED] says is non-contact rainwater. Figure 8

Figure 7. The so-called “leak detection system” designed by SIRM. The leaks would have to go **uphill** through sand and course crushed rock to enter the leak detection pipe.

It is clear that [REDACTED]'s Leak Detection System will not detect leaks.

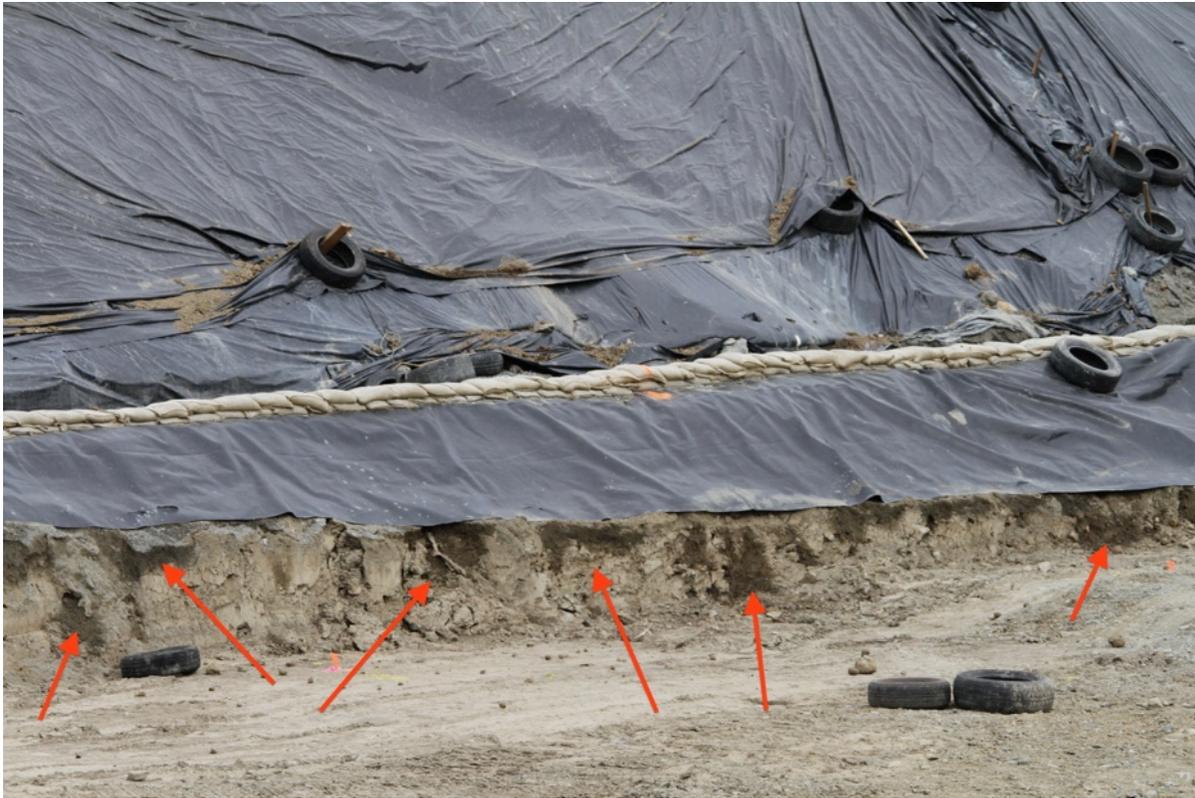
illustrates such wet areas of the berm on the westerly side of the original contaminated Soil Containment Area at 460 Stebbings Road, Shawnigan Lake.

Figure 8. Photo taken in May 2016 of the original Contaminated Soil Containment Area #1 after more than a month without rain. This is a view of the westerly face of the landfill. Clearly seen are wet areas in several locations in the clay berm that lies **below** the LLDPE liner. Similar wet areas persist to the present day, although now hidden by the newly established unfinished Contaminated Soil Containment Area #2.

A more accurate method to test for leaks in the liner system under the contaminated Soil Containment Area #1 would be to take sand and clay till samples from the areas under the liner indicated in Figure 8.

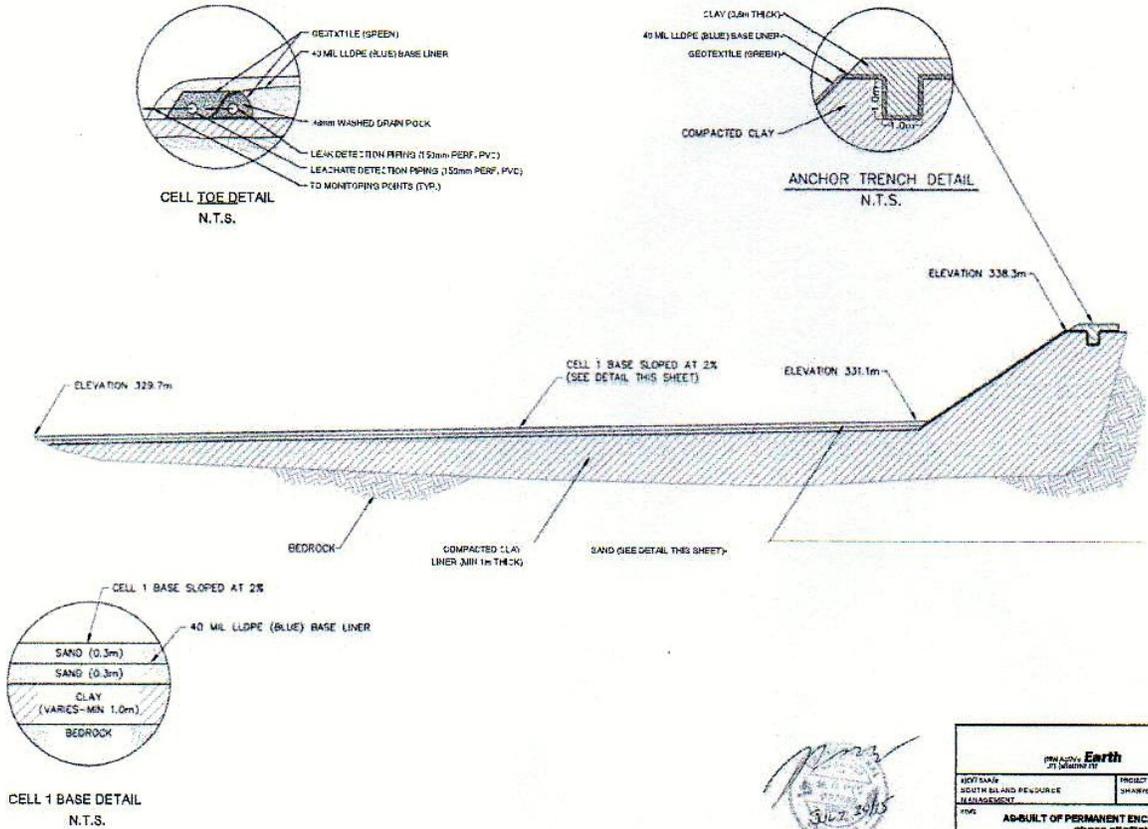
Earth	
PROJECT LOCATION: SOUTH ISLAND PULP MILL SURREY, BC	PROJECT LOCATION: SURREY, BC
AS-BUILT OF PERMANENT ENCAPSULATION CELL 1 CROSS SECTION A-A'	
DATE: 01/22/15	FIGURE 2

Also worrisome is that the Mines Permit, as amended July 17, 2015 has a diagram on page 19 of the amended permit stamped by Active Earth Engineering (AEE) entitled "Cell Toe Detail". This diagram (see Appendix 3) shows an incorrectly positioned Leak Collection system exactly as documented by the Community observers. This diagram was sent by the responsible engineering firm to both the Mines and Environment Ministries on June 30, 2015 as part of the As-Built diagrams for the Contaminated Soil Landfill Permanent Encapsulation Area (PEA), that is, the contaminated soil dumpsite. There are several problems associated with this diagram. One of

which is that a QP, presumably an arms-length professional, has signed off on an incorrectly designed Leak Collection System. The second problem is that no one in the Mines nor in the Environment Ministries noted the incorrect design, even when the Community pointed this out to the Environment Ministry. Why was the Community ignored? Where was the Mines and Environmental oversight? Is the problem, as mentioned above, that many staff are appointed to positions where it is not obvious they have the necessary expertise or is the problem one of Regulatory Capture? Either possibility indicates a major problem.

The upper left corner diagram illustrates the as-built for the leachate and leak collection systems. This leak collection system designed by AEE and built by SIRM completely failed to detect leaks for the reasons indicated in Appendix 2. This system was also signed off by staff in Mines and Environment. Parenthetically, the anchor trench illustrated in the upper right corner diagram was never built even though the as-built diagram would indicate it was – this, too, was pointed out to the Ministry of Environment.
