## **Assessing Fish Passage at Culverts – the method, its metrics and preliminary findings from over 4,000 assessments.**

Richard Thompson, Ministry of Environment , [Richard.Thompson@gov.bc.ca](mailto:Richard.Thompson@gov.bc.ca)

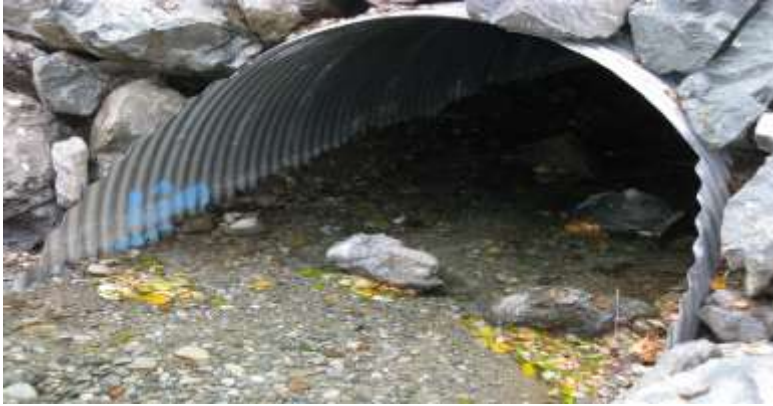
What is Embeddedness? This indicator is a measure of the stream bed material within a culvert (Figure 1). Assessors are asked to determine if a natural stream bed continuously covers the bottom of the culvert and the depth of cover. A culvert with a natural stream bed is assumed to have similar roughness and velocity shadows to allow fish to pass through the culvert as if they were in an undisturbed segment of the stream. The depth of material is an important measure as it relates to the probability of the stream bed being scoured from the culvert exposing the bare culvert which results in velocity increases.

Figure 1: Properly embedded culvert. Streambed is continuous and 40% of culvert diameter.

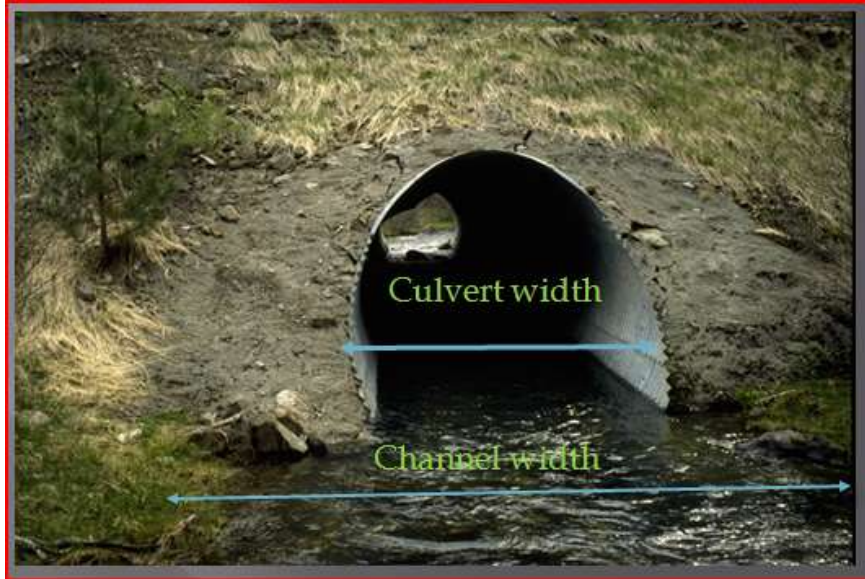
What is stream width ratio? The Stream Width Ratio is simply the ratio determined by stream channel width divided by the culvert width. This ratio is an indication of channel constriction (Figure 3) which results in increased velocities within the culvert.

Figure 3. Stream width ratio.

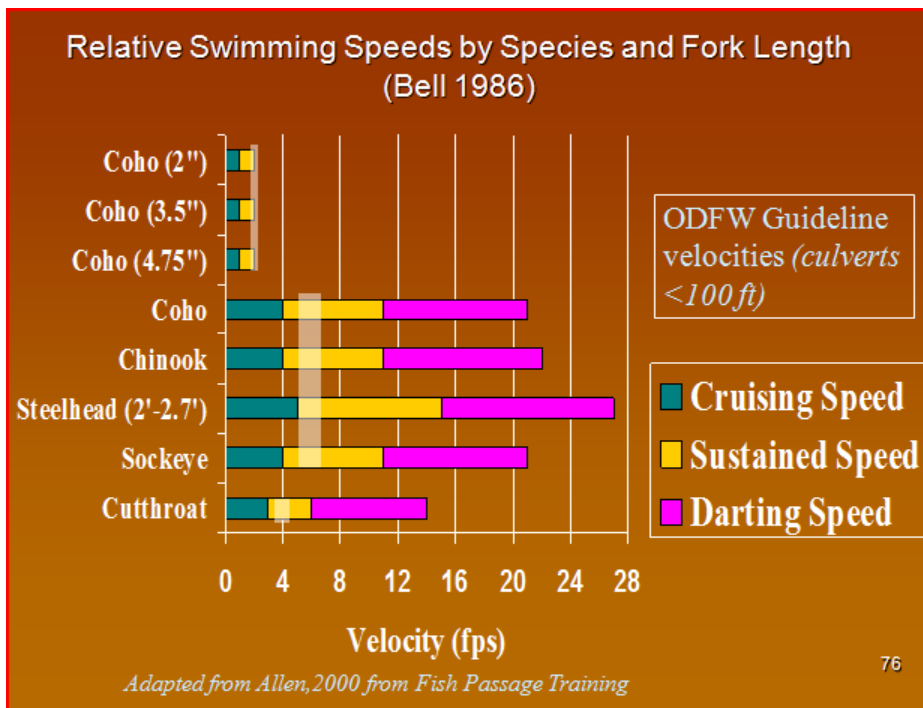
The values associated with each of the indicators in the barrier determination model were developed based on information available on fish swimming ability which is a function of species and size (Figure 5). A juvenile Coho does not have the same swimming ability as an adult Coho similarly an adult Grayling is a weaker swimmer than an adult Steelhead. The indicator scores reflect the best estimation for the passage of a juvenile salmon or small resident rainbow trout.

Figure 5 – Fish Swimming Ability.
