# BIG BAR LANDSLIDE UPDATE

SEPTEMBER 18, 2019

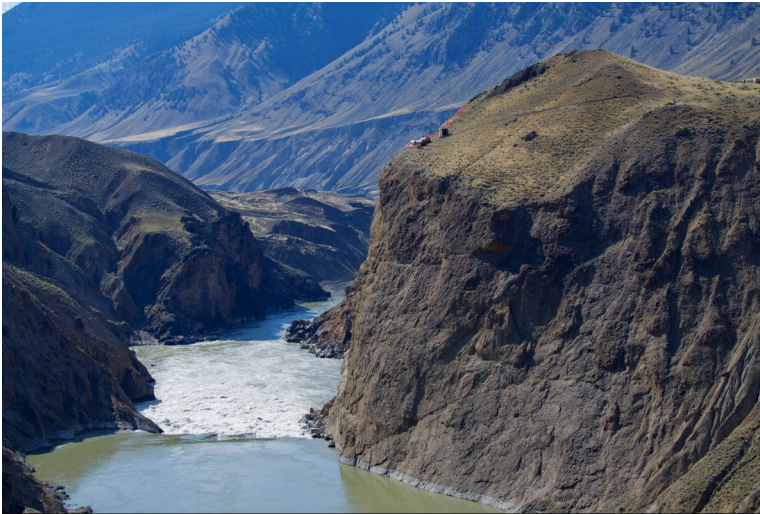
*Big Bar Landslide with scaler site.*

- Scalers are working on the west bank to move debris in preparation for a spider excavator and to secure anchors for highlines. The excavator is a highly specialized piece of equipment that will be lowered down the west slope via cable to an area below the slide to support work on rocks that cannot be manipulated by hand. Once installed, anchors for highlines will allow access to debris mid-river for manipulation.

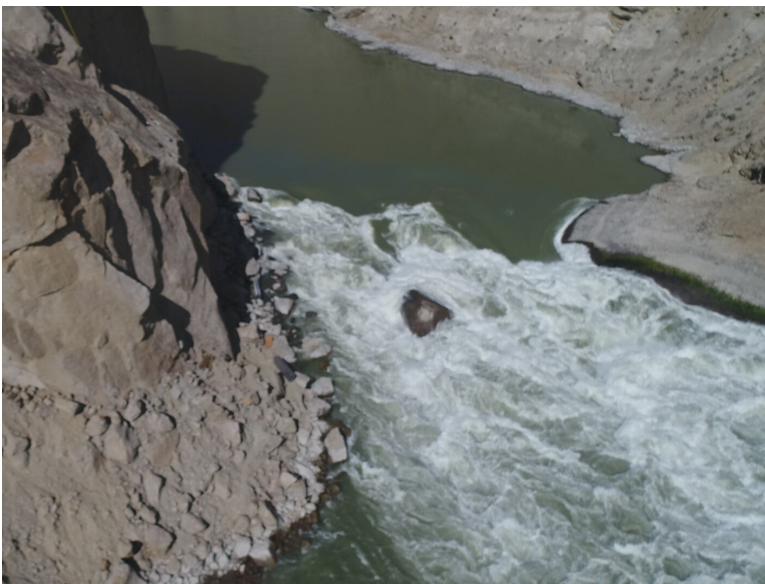
*Big Bar Landslide overhead shot showing large boulder mid-river during low river level.*

- Manual rock manipulation, supported by the spider excavator, will continue to allow natural passage for all species through varying flow levels.
- Scaling and sluicing operations continue as weather conditions allow. Yesterday, scalers were pulled from the east bank due to high winds that created unsafe conditions.
