BIG BAR LANDSLIDE UPDATE

MARCH 22, 2021

EVOLVING SITE CONDITIONS SHIFT FOCUS TO “NATURE-LIKE” FISHWAY PREPARATION

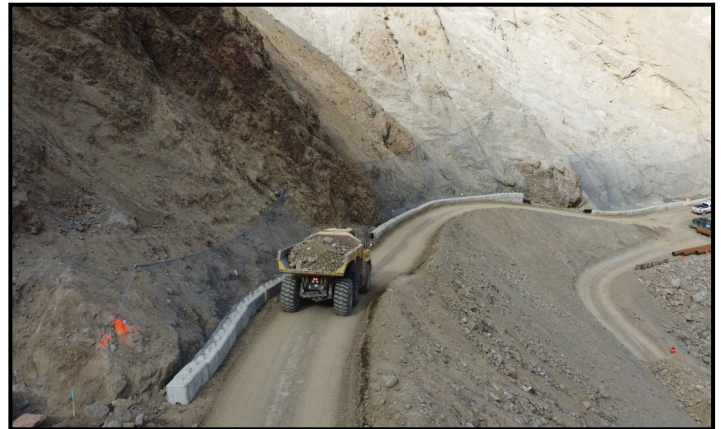
TOP: Trucks haul excavated material down to the West Beach for use in the “nature-like” fishway construction.

Workers are excavating blasted material from the Razorback, with the rock being processed for rip rap and shot rock. Rip rap is essential for constructing the “nature-like” fishway, and the shot rock is used to build up the grade below the rip rap. This helps reduce the amount of rip rap needed for the fishway, as well as minimize disturbance at the Razorback, an area of rich cultural significance.

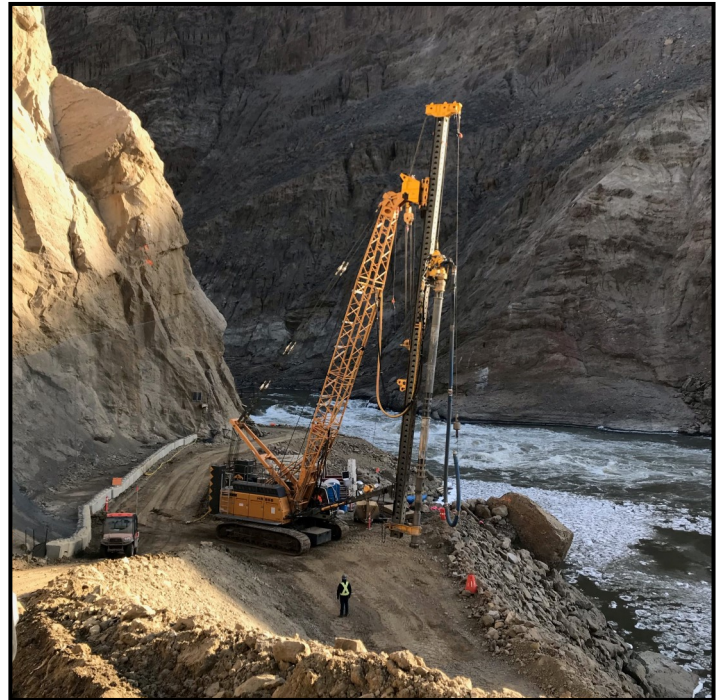
BOTTOM: Crews have started to ‘walk’ the piling rig off site for the season, in advance of spring freshet.

To ensure the safety of the crew and in anticipation of the upcoming spring freshet, piling work for the permanent fishway has concluded for the 2020-21 winter season. Crews are shifting their focus to other priorities ahead of freshet, including the construction of the “nature-like” fishway and preparation of alternative fish transport systems.
