BIG BAR LANDSLIDE UPDATE

APRIL 3, 2020

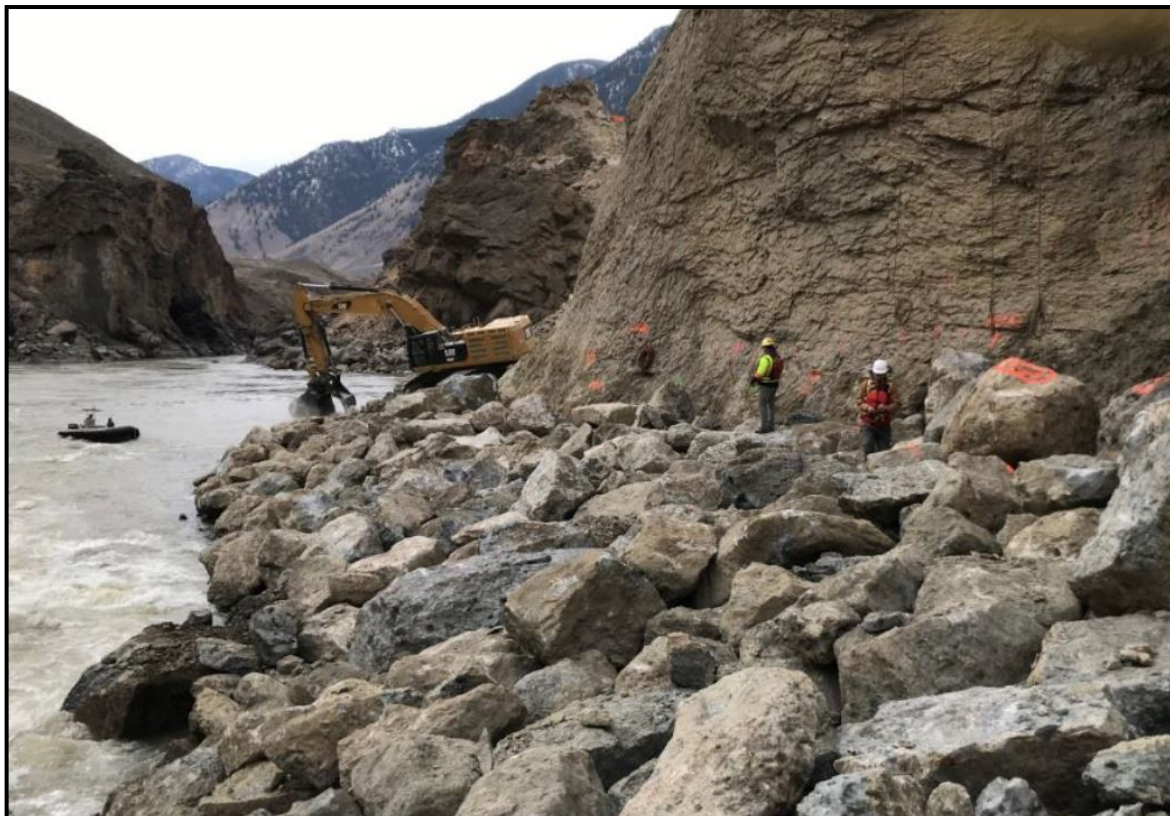
PICTURED: Crews putting the final touches on the “nature-like” fishway, which was completed last week on the west side of the slide site

This week, the “nature-like” fishway on the west side of the Big Bar landslide area was completed. This fishway is constructed of boulders that are approximately two metres in diameter, the positioning and spacing of which will allow fish to pass through the slide area at a range of flow levels.

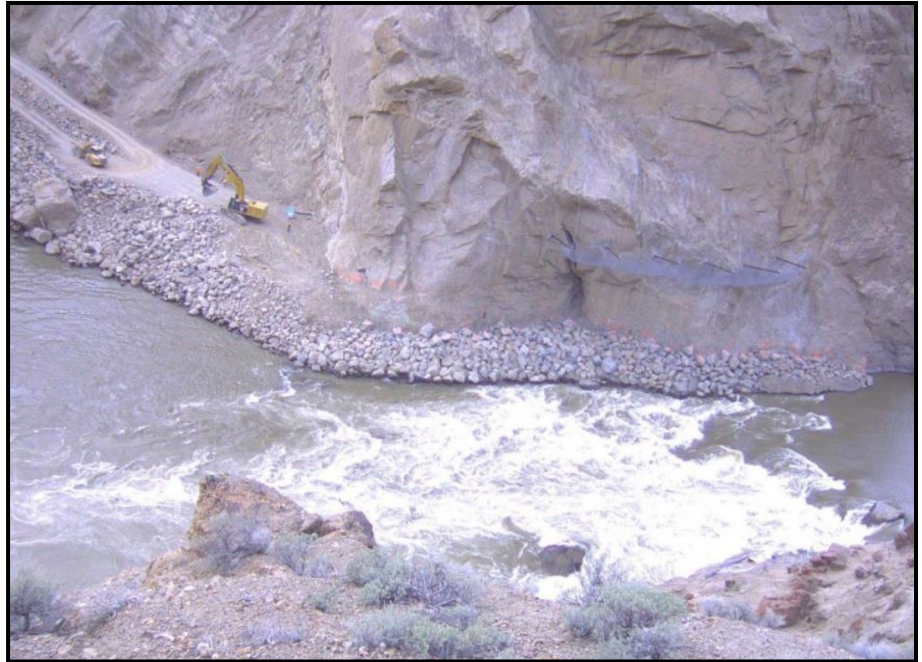
TOP: An aerial view of the “nature-like” fishway, which was completed this week on the west side of the slide site

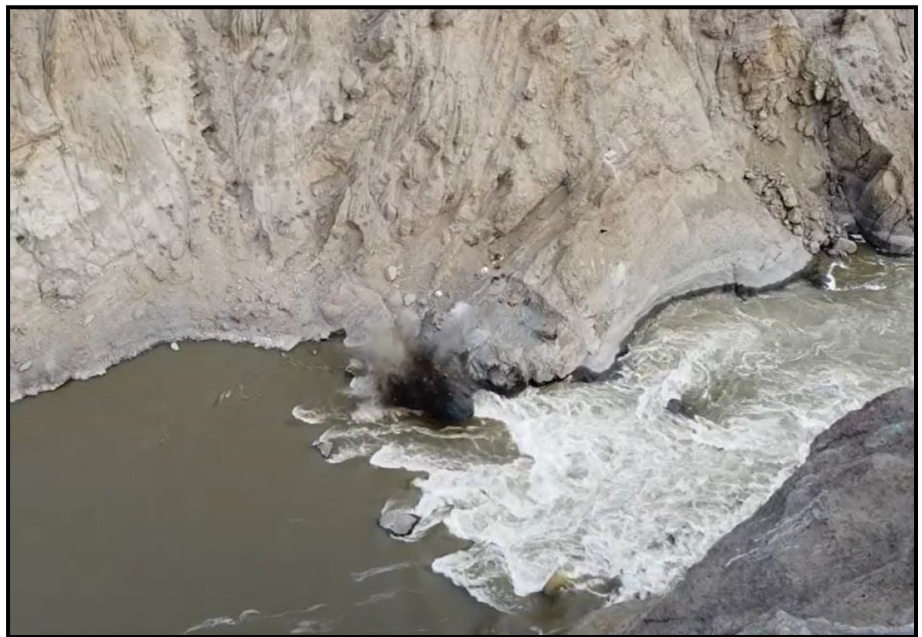
BELOW: Blasting of the north outcrop of the East Toe on March 29, 2020

On March 29, a blast of a rock outcrop at the north end of the East Toe resulted in a noticeable improvement to the water flow. This blast also exposed additional rock, which was subsequently drilled and blasted. A video of this work can be viewed here: twitter.com/DFO_Pacific/status/1246107315624910849
