SUMMARY OF PROVINCIAL WATER QUALITY EFFECTIVENESS EVALUATION RESULTS (2008-2010)

EXTENSION NOTE #22

December 2011

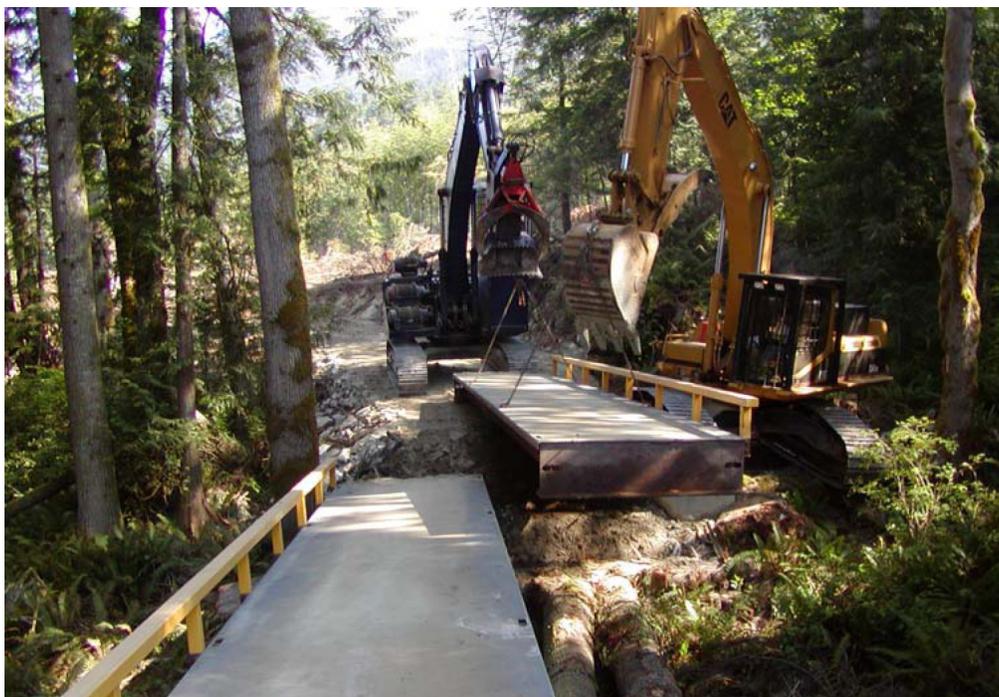
Carefully designed and installed stream crossings result in low erosion potential.

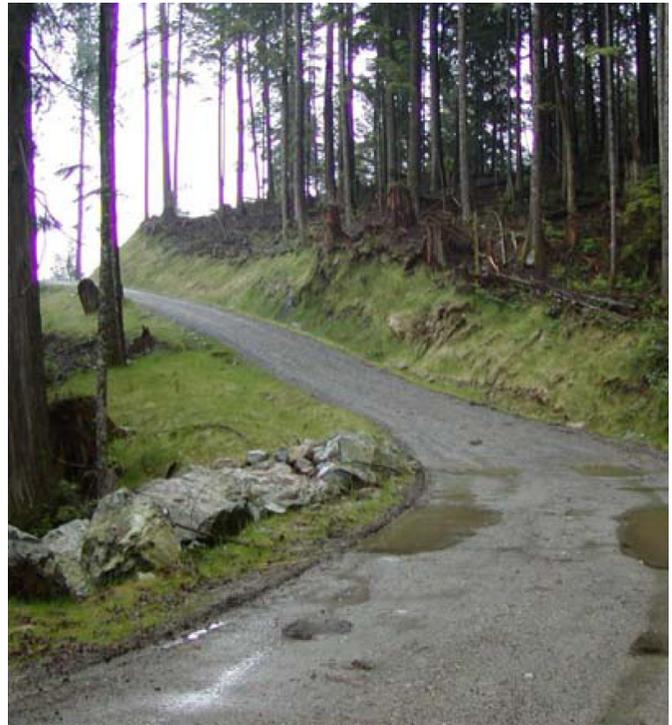
Figure 3. This resource road approaching a stream crossing has incorporated many attributes required to minimize water quality impacts. The cut banks and fill slope are well vegetated, a culvert and ditchblock are strategically located to remove inside ditch water and allow sufficient forest floor to reabsorb the water, a swale is located before the bridge, and the bridge deck itself (from which the photo was taken) built above road grade.
