WATERSHED ASSESSMENTS IN THE KOOTENAY-BOUNDARY REGION: Combining GIS and Ground-Based Methodology with Pour-Point Design

Integrated Monitoring and Assessment, Resource Planning and Assessment Branch
B.C. Ministry of Forests, Lands, Natural Resource Operations and Rural Development

Nordin, L. 2020. Watershed Assessments in the Kootenay-Boundary Region: *Combining GIS and Ground-Based Methodology with Pour-Point Design*.

Ministry of Forests, Lands and Natural Resource Operations, Kootenay-Boundary Region, BC. FREP Report 41.

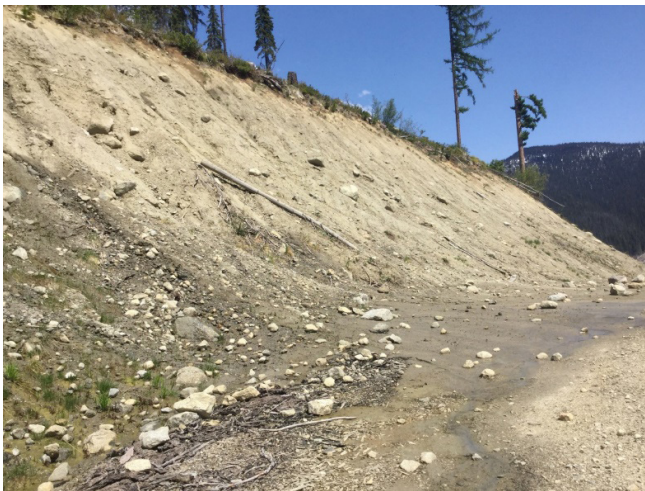
Water quality was measured at 11 stream crossings within the Redfish watershed. No habitat connectivity assessments were completed because all the streams where water quality assessments were completed were either too steep to be fish bearing or the crossing structure was a bridge or arch culvert, indicating fish passage was not an issue. Water quality results based solely on the amount of potential fine sediment that may be transported to streams ranged from *very low* to *high* (Table 16), with 73% of the sites scoring in the *very low* or *low* categories. Two sites ranked as *moderate*, which is below the benchmark for the district and the province for that category (Table 4). One of the sites was ranked as *high* because of mass wasting associated with the road right-of-way (Figure 6).

Figure 6. Redfish water quality site ranked as high.

stable ford crossings may be additional considerations to minimize the impacts from cattle. Crossings that ranked moderate or higher for the potential transfer of fine sediments during the water quality assessments could also be critically reviewed to identify potential improvement strategies, along with those crossings where culverts are a barrier to upstream fish passage. Implementing solutions for these and any other known problem areas would result in an immediate benefit to the overall functioning condition of these watersheds.

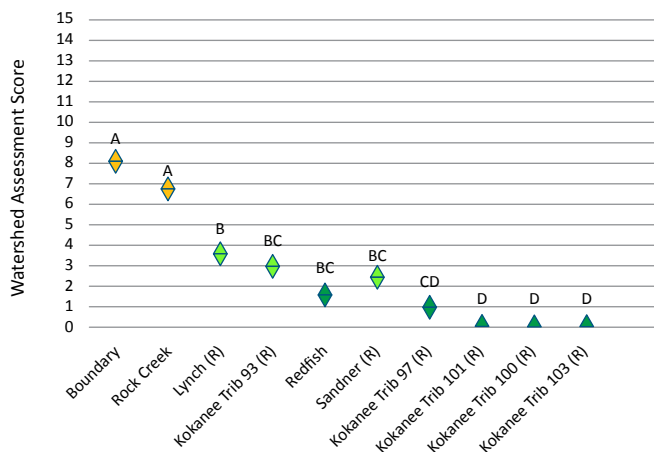
To identify differences between treatment and reference watersheds, the combined score representing ground-based and GIS data for all sub-catchments was entered into a weighted, by proportional area, analysis of variance (ANOVA). The overall weighted cumulative score for each watershed was not included in this analysis to avoid any effects from autocorrelation. Similarities were found between the *not properly functioning* Boundary and Rock Creek watersheds, and these were significantly different from all the other watersheds (Figure 7). Redfish was similar to four of the reference watersheds, but significantly different than Boundary and Rock Creek, indicating that the Redfish watershed is closer to a natural condition.

It should be noted that the similarities and differences shown in Figure 7 are based only on the integrated riparian/stream condition for the watersheds and do not consider the supplementary data reflecting potential effects from: limited habitat connectivity at stream crossings, livestock issues, or continued risk of sedimentation from roads. For example, even though Redfish results were not significantly different from several of the reference watersheds, three of the fourteen water quality sites scored as *moderate* or *high* risk (Table 16) and these problem crossings could be a continued source of sediment to downstream reaches that contribute to domestic water supply. These other factors should be considered when determining whether watersheds are impaired.

Figure 7. Total watershed score reflecting level of impairment for treatment and reference (R) watersheds. Watersheds not connected by the same letter are significantly different. Dark green shading = PFC, light green = FR, orange = NPF.
