Worker Fatality due to Ejected Rock from Rock Crusher

Synopsis

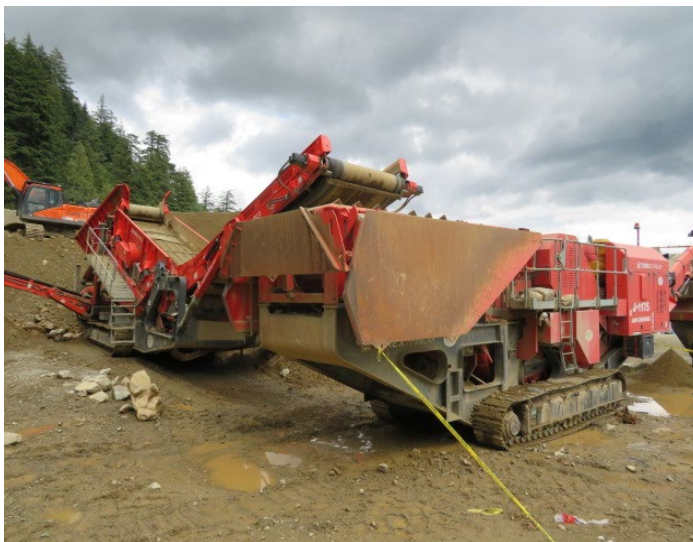
- There is a hazardous area around the rock crusher which workers should not enter while the crusher is operating. There were no barricades or signage preventing workers from entering the hazardous area around the crusher. The worker entered the hazardous area to refuel the crusher while the crusher was operational contrary to manufacture's recommendations of shutting down the machine before refueling.

FIGURE 1. Rock Crusher with Feeder Conveyor

- It was common knowledge that the crusher sporadically ejected rock out of the hopper. The crusher guard² was not in place on the top of the hopper to prevent ejected rocks from exiting the hopper.

The mine manager was ordered to provide training and develop safe work procedures while working in and around the rock crusher. The mine manager complied with these orders. A hazard alert was issued recommending the rock crusher's engineered safety mechanisms are in place before operating the crusher, to identify and guard areas where workers may be exposed to flying rocks, to provide safe working procedures, and to provide training to workers.

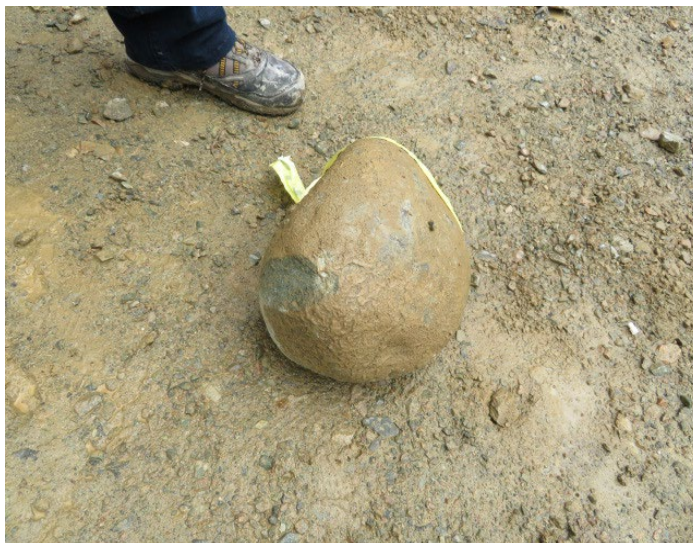
On June 12, 2018, a worker was fatally injured when struck by a rock that was ejected from the hopper of a rock crusher¹ at a quarry in British Columbia. The worker was refueling the rock crusher while the plant was still operating. A 72 cm rock was ejected from the hopper of the rock crusher striking the worker in the back of the head and neck resulting in fatal injuries.

FIGURE 2. Rock which struck worker
