Access over pit face results in recreational ATV accident

Synopsis

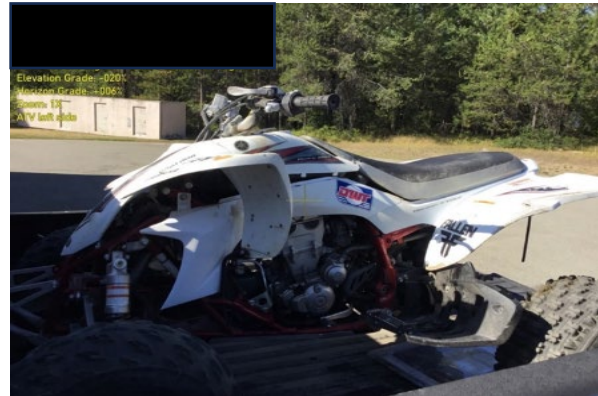
FIGURE 1. ATV

- ATV driver's direction of travel was northerly, eliminating visibility and sun glare as contributing factors.
- The ATV driver was observed to be travelling in a straight line.
- There were no tire skid marks observed before the ATV went over the pit face
- Brakes were found to be in an operable state during examination after the incident.
- Height of the pit face at time of incident exceeded regulations.
- An EMLI Inspector issued an order in 2016 regarding the pit face exceeding height regulations.
- There was a lack of signage or access restrictions along the TransCanada trail warning of the mine site.
- There was unsecured access to the stockpiles.

- To direct the mine to review inadvertent access into its Sand and Gravel Mines from recognized designated recreational trails, implementing signage and access restrictions as needed.
- To direct the mine to review pits for excessively steep and/or high faces, utilizing benching where necessary to gain compliance with the code.

The site contractors installed berms and signage along the TransCanada trail after the incident.
