Tail Pulley Arm Amputation

Synopsis

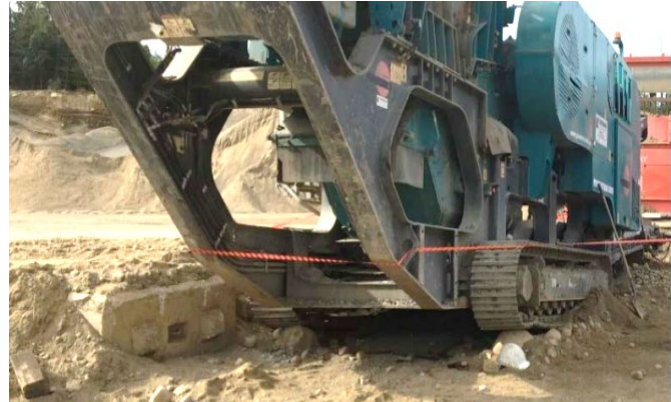
FIGURE 1. Portable Crushing Unit

On Saturday, April 21, 2018, a worker was seriously injured at a gravel pit. The worker was attempting to free stuck rocks in the tail pulley section of a conveyor system of a portable crushing unit. The worker had the engine running to bump the conveyor ahead in between attempting to free rocks trapped within the drum. When the rock was freed from the conveyor, it began to turn, entangling the worker's arm in the tail pulley. As a result of their injuries, the forearm segment of their right arm was amputated.
