Knight Piésold
CONSULTING

Re: Mount Polley Stage 6 TSF Design

This letter is in response to comments by Mr. Chris Carr who has requested the following information before proceeding with the permit conditions for the Stage 6 embankment raise for the Tailings Storage Facility at Mount Polley Mine. Mr. Carr's comments and responses from Knight Piésold are as follows:

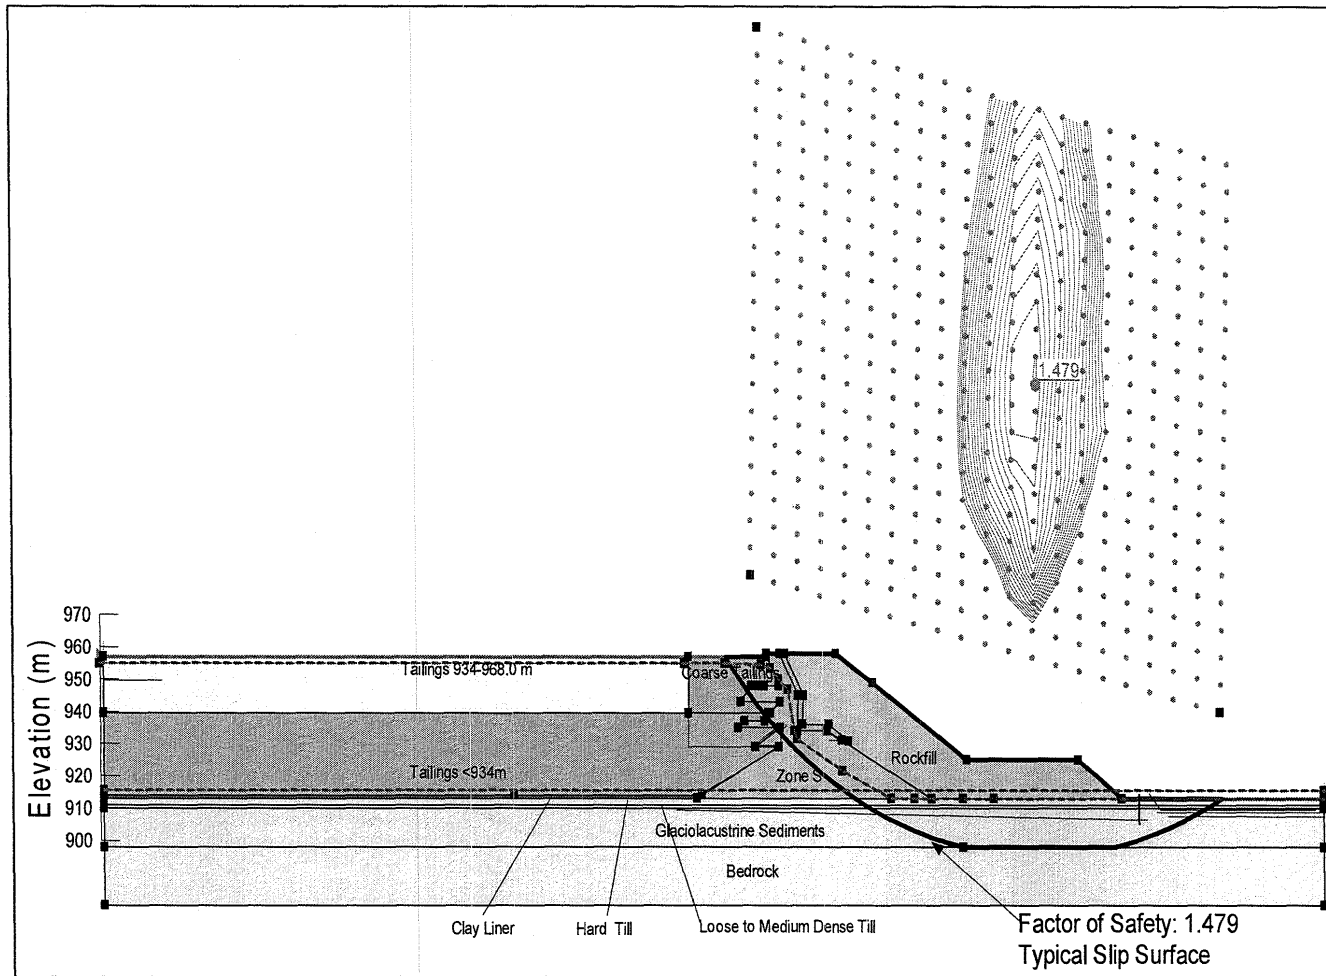
MOUNT POLLEY MINING CORPORATION	
MOUNT POLLEY MINE	
TAILINGS STORAGE FACILITY MAIN EMBANKMENT STABILITY SECTION	
<i>Knight Piésold</i> CONSULTING	PROJECT / ASSIGNMENT NO. VA 101-1/18
	REF NO. VA07-01853
FIGURE 1	
	REV. 0

The cross-section used for the stability analysis for the Main Embankment is shown on Figure 1. The cross-section includes the following:

- The embankment crest was modelled with an embankment elevation of 958 m,
- The downstream buttress was modelled at an elevation of 925 m. The current elevation of the downstream buttress is 917 m. The Stage 6 construction program involves raising the elevation of the buttress to elevation 925 m to ensure that the required Factor of Safety is achieved for the Stage 6 embankment configuration.

- The lacustrine unit at the Main Embankment was modelled with a thickness of 12 m. A study comparing the drained residual strength to the clay content, liquid limit, and effective normal stress was completed by Stark and Eid (1995). The results of the study indicate that the drained residual strength of a material with a clay content ranging from 25 to 50%, with a liquid of 40%, and an effective normal stress of 700 kPa is in the order of 24 degrees. A conservative friction angle of 24 degrees was applied for the lacustrine unit. Subsequent direct shear tests conducted by Knight Piésold also indicate that the peak friction angle of the lacustrine unit is in the range of 21 to 25 degrees, (average of 23 degrees). The average residual friction angle at 20% strain was 22 degrees.

- The stability analysis was completed with the elevated pore pressures in the lacustrine unit (approximately 2.5m above ground) as the piezometers installed in the lacustrine material indicate slight artesian conditions within this material.

The results of the stability analyses indicate that the factor of safety for the Stage 6 TSF Main Embankment for static conditions was approximately 1.48 for a lacustrine friction angle of 24 degrees. A sensitivity stability analysis was also completed using different friction angles for the lacustrine unit. The results of the sensitivity stability analysis are shown on Figure 2. The factor of safety was approximately 1.44 for a friction angle of 23 degrees, the average friction angle from the direct shear tests on the lacustrine unit. The factor of safety for the lower end direct shear test friction angle of 21 degrees was approximately 1.35. The sensitivity analysis also demonstrates that the embankment would remain stable with a factor of safety greater than 1.1 for an extreme lower bound residual friction angle of 15 degrees for the lacustrine unit.

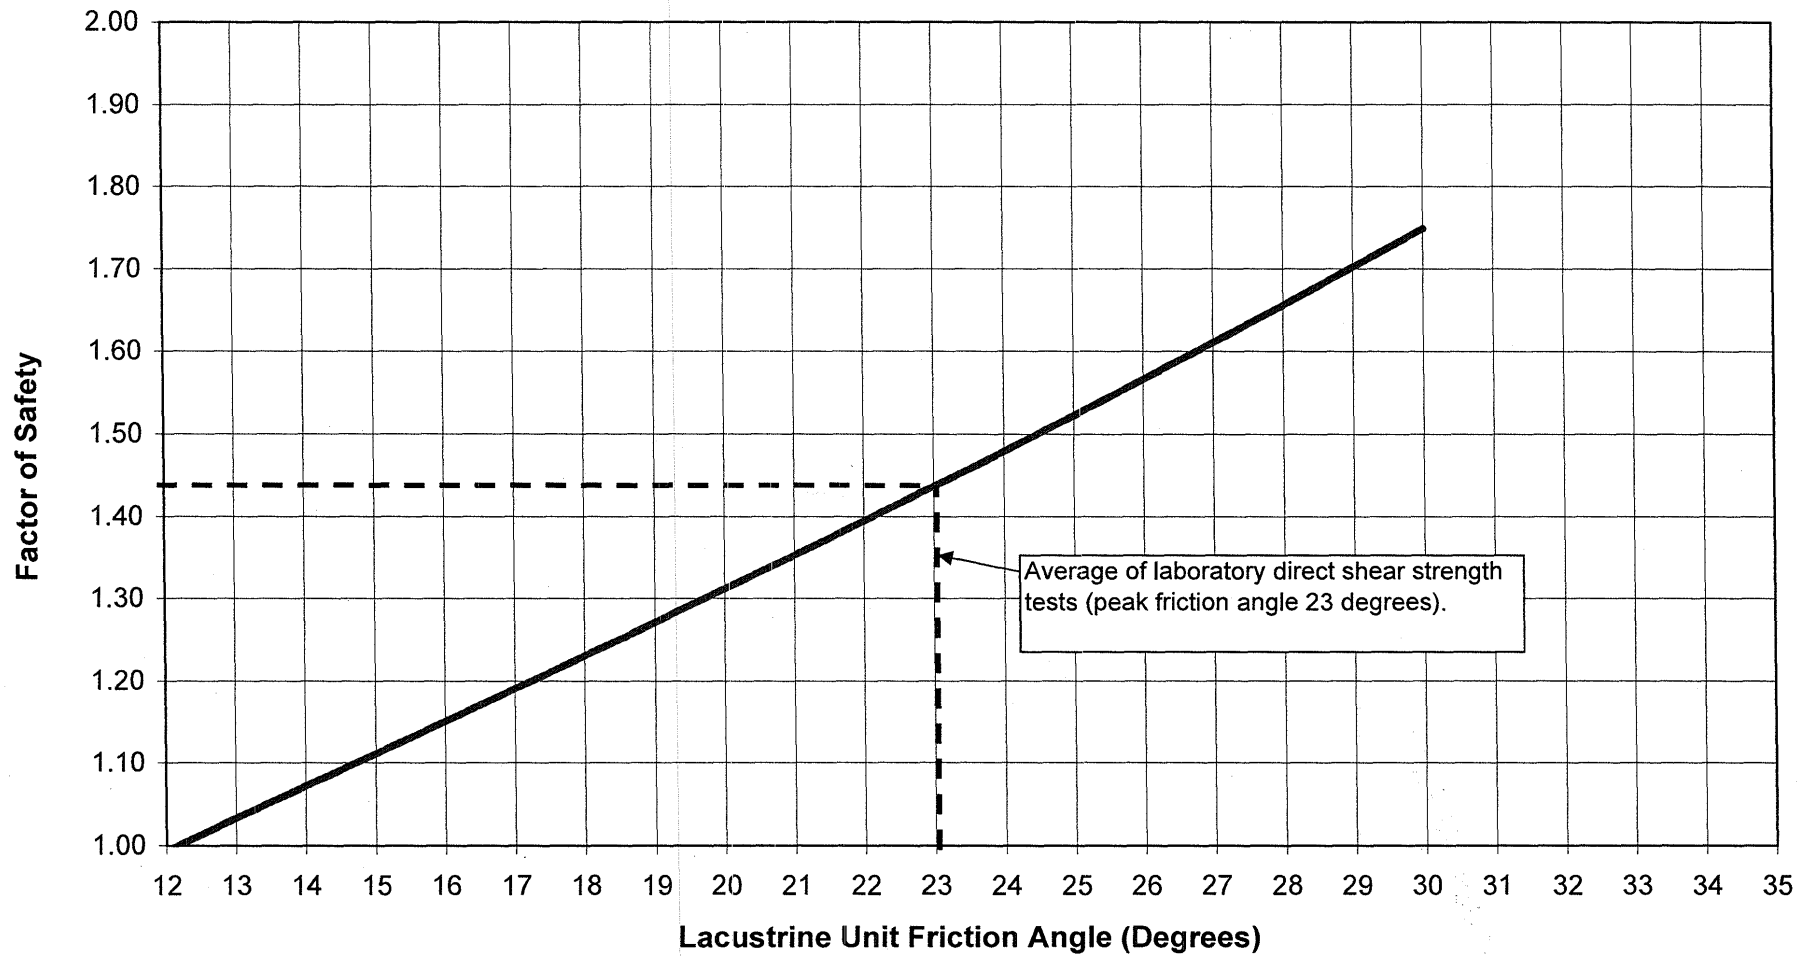
MOUNT POLLEY MINING CORPORATION		
MOUNT POLLEY MINE		
TAILINGS STORAGE FACILITY LACUSTRINE UNIT SENSITIVITY ANALYSES		
<i>Knight Piésold</i> CONSULTING	PROJECT / ASSIGNMENT NO. VA 101-1/18	REF NO. VA07-01853
	FIGURE 2	
		REV. 0

Average of laboratory direct shear strength tests (peak friction angle 23 degrees).

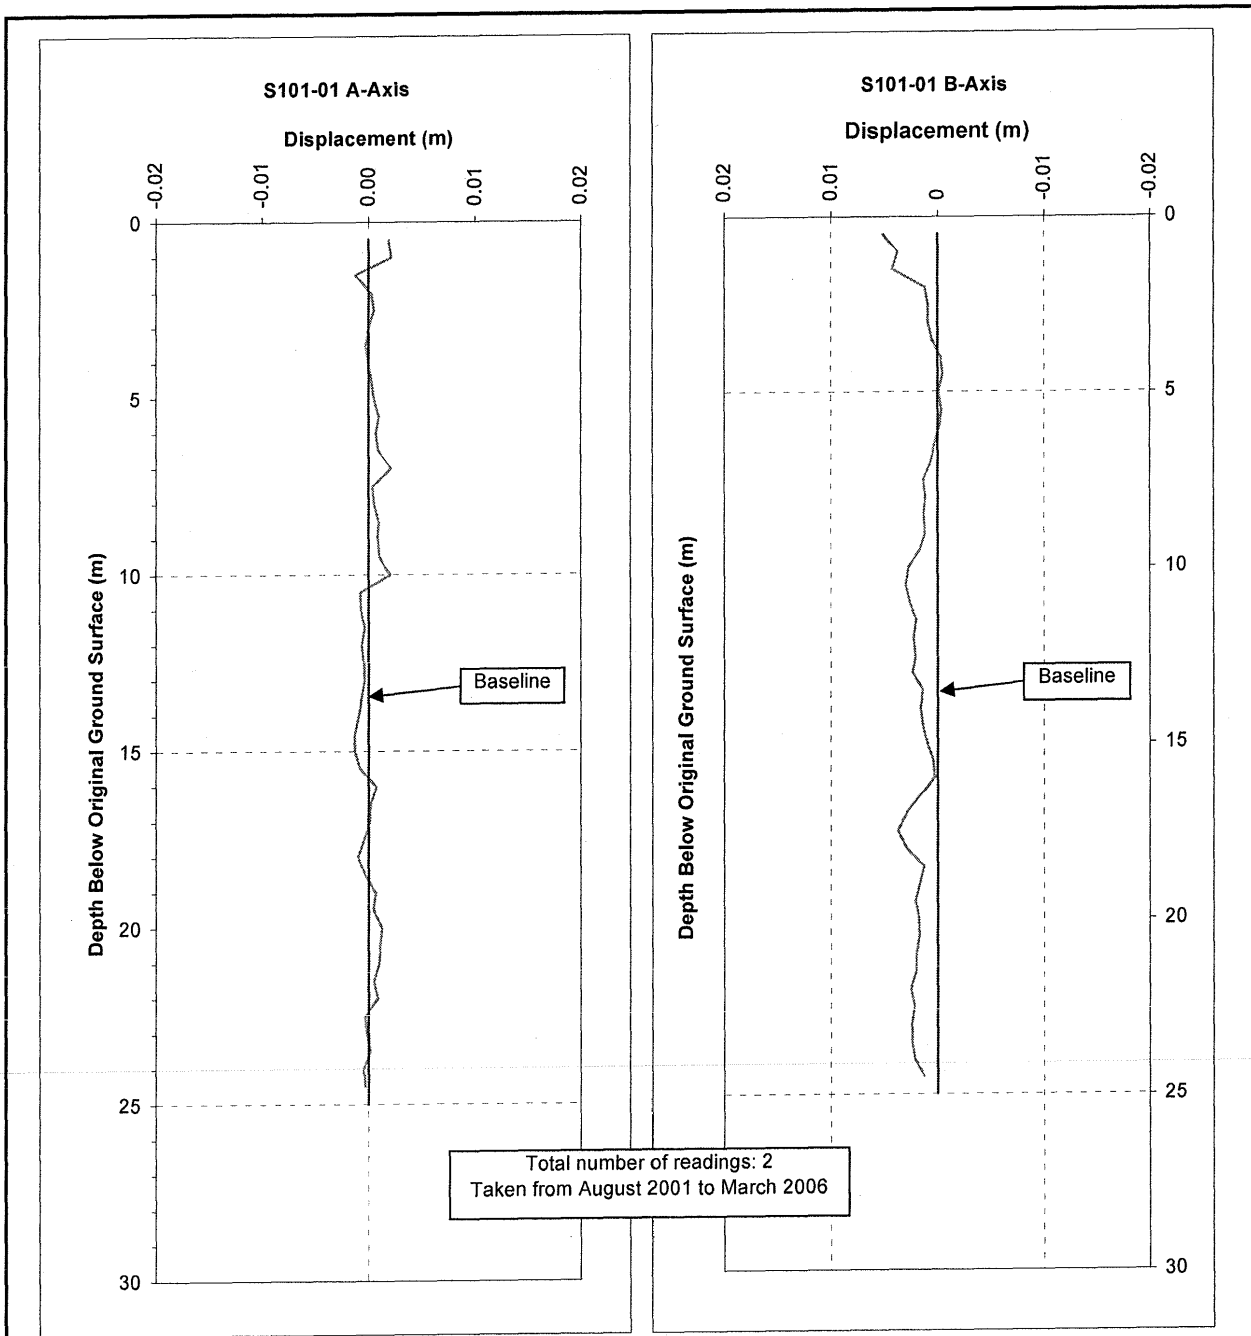
MOUNT POLLEY MINING CORPORATION		
MOUNT POLLEY MINE		
TAILINGS STORAGE FACILITY INCLINOMETER SI01-01 DISPLACEMENT VS. DEPTH		
<i>Knight Piésold</i> CONSULTING	PROJECT / ASSIGNMENT NO. VA101-1/18	REF NO. VA07-01853
	FIGURE 3	
		REV. 0

- 1.) Displacement is relative to the baseline reading taking in August 2001.
- 2.) SI01-01 damaged during Stage 4 construction and is no longer functioning

Three new slope inclinometers were installed downstream of the toe of the Main Embankment during the Stage 4 construction program. One of the inclinometers installed in 2001 (SI01-01) was damaged during the placement of the shell zone material and is no longer functioning. The last reading for SI01-01 was March 2006. There are four functioning inclinometers installed at the Main Embankment.

The results of the inclinometer readings indicate that there have not been any significant deviations measured in the inclinometers since their installation. There were no measurable deformations recorded

in the inclinometers during or after the Stage 5 construction program. The results of the readings for inclinometers are shown on Figures 3 to 7.

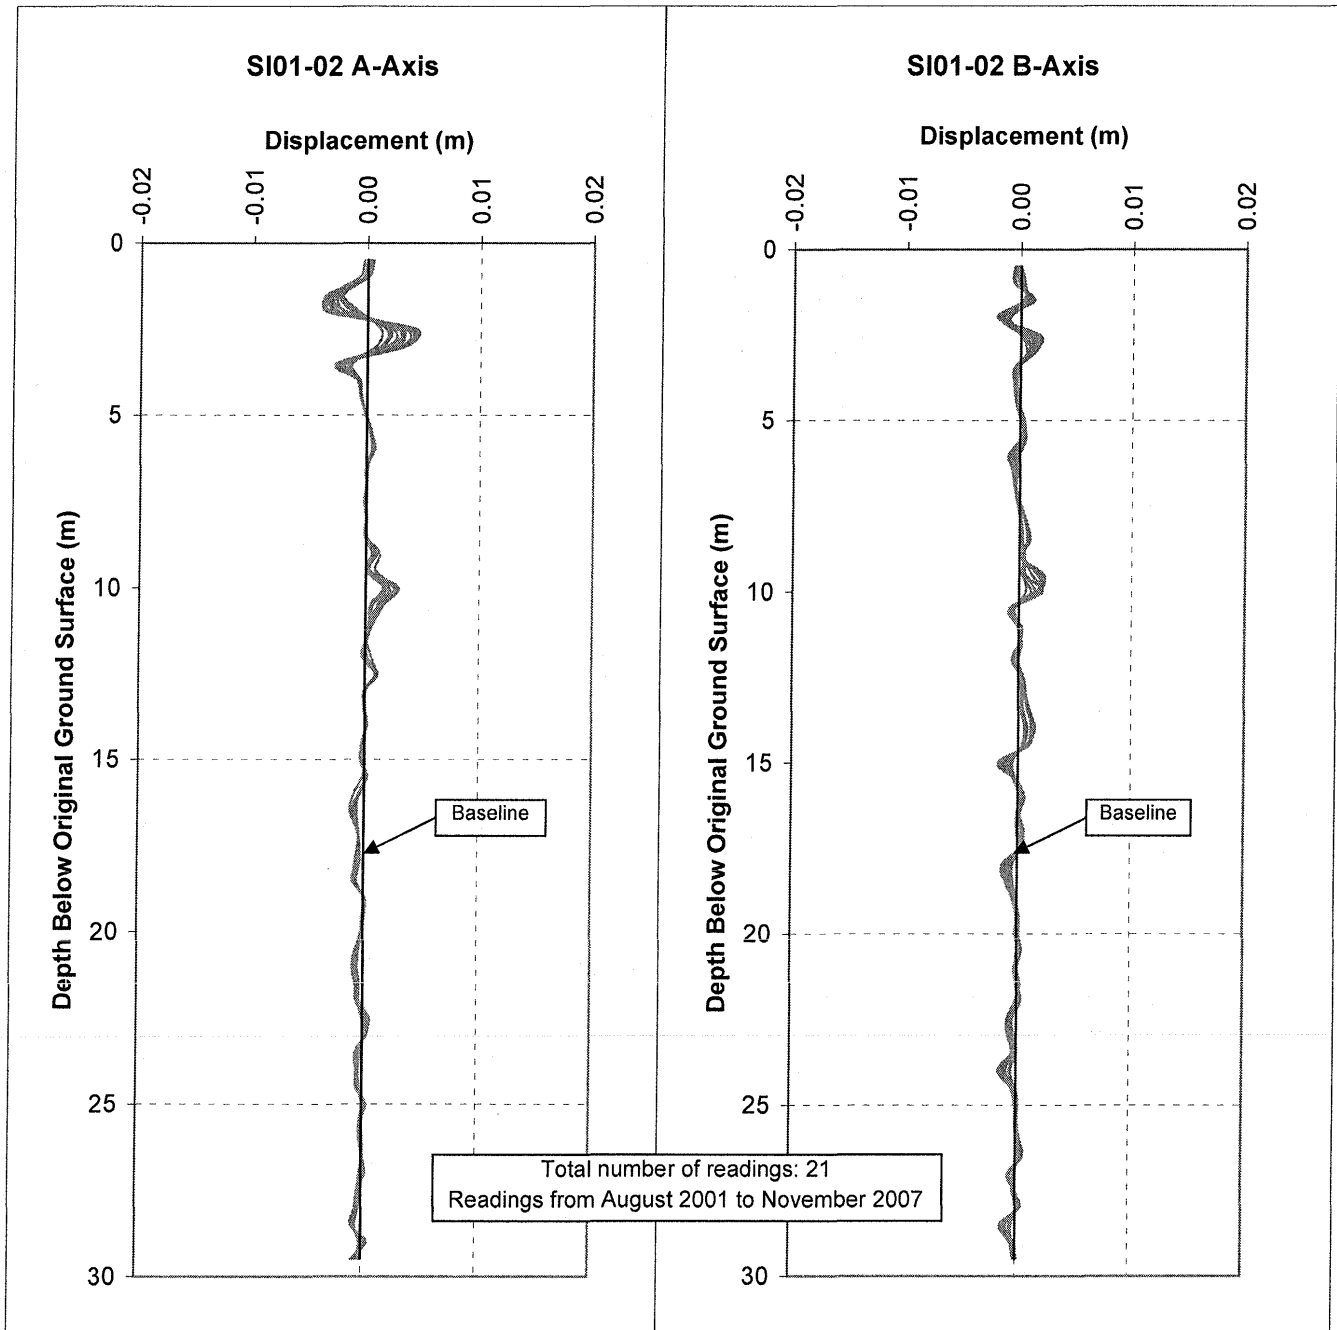
MOUNT POLLEY MINING CORPORATION		
MOUNT POLLEY MINE		
TAILINGS STORAGE FACILITY INCLINOMETER SI01-02 DISPLACEMENT VS. DEPTH		
<i>Knight Piésold</i> CONSULTING	PROJECT / ASSIGNMENT NO. VA101-1/18	REF NO. VA07-01853
	FIGURE 4	
		REV. 0

Notes:
1) Displacement is calculated relative to the initial data set, recorded in August 2001.

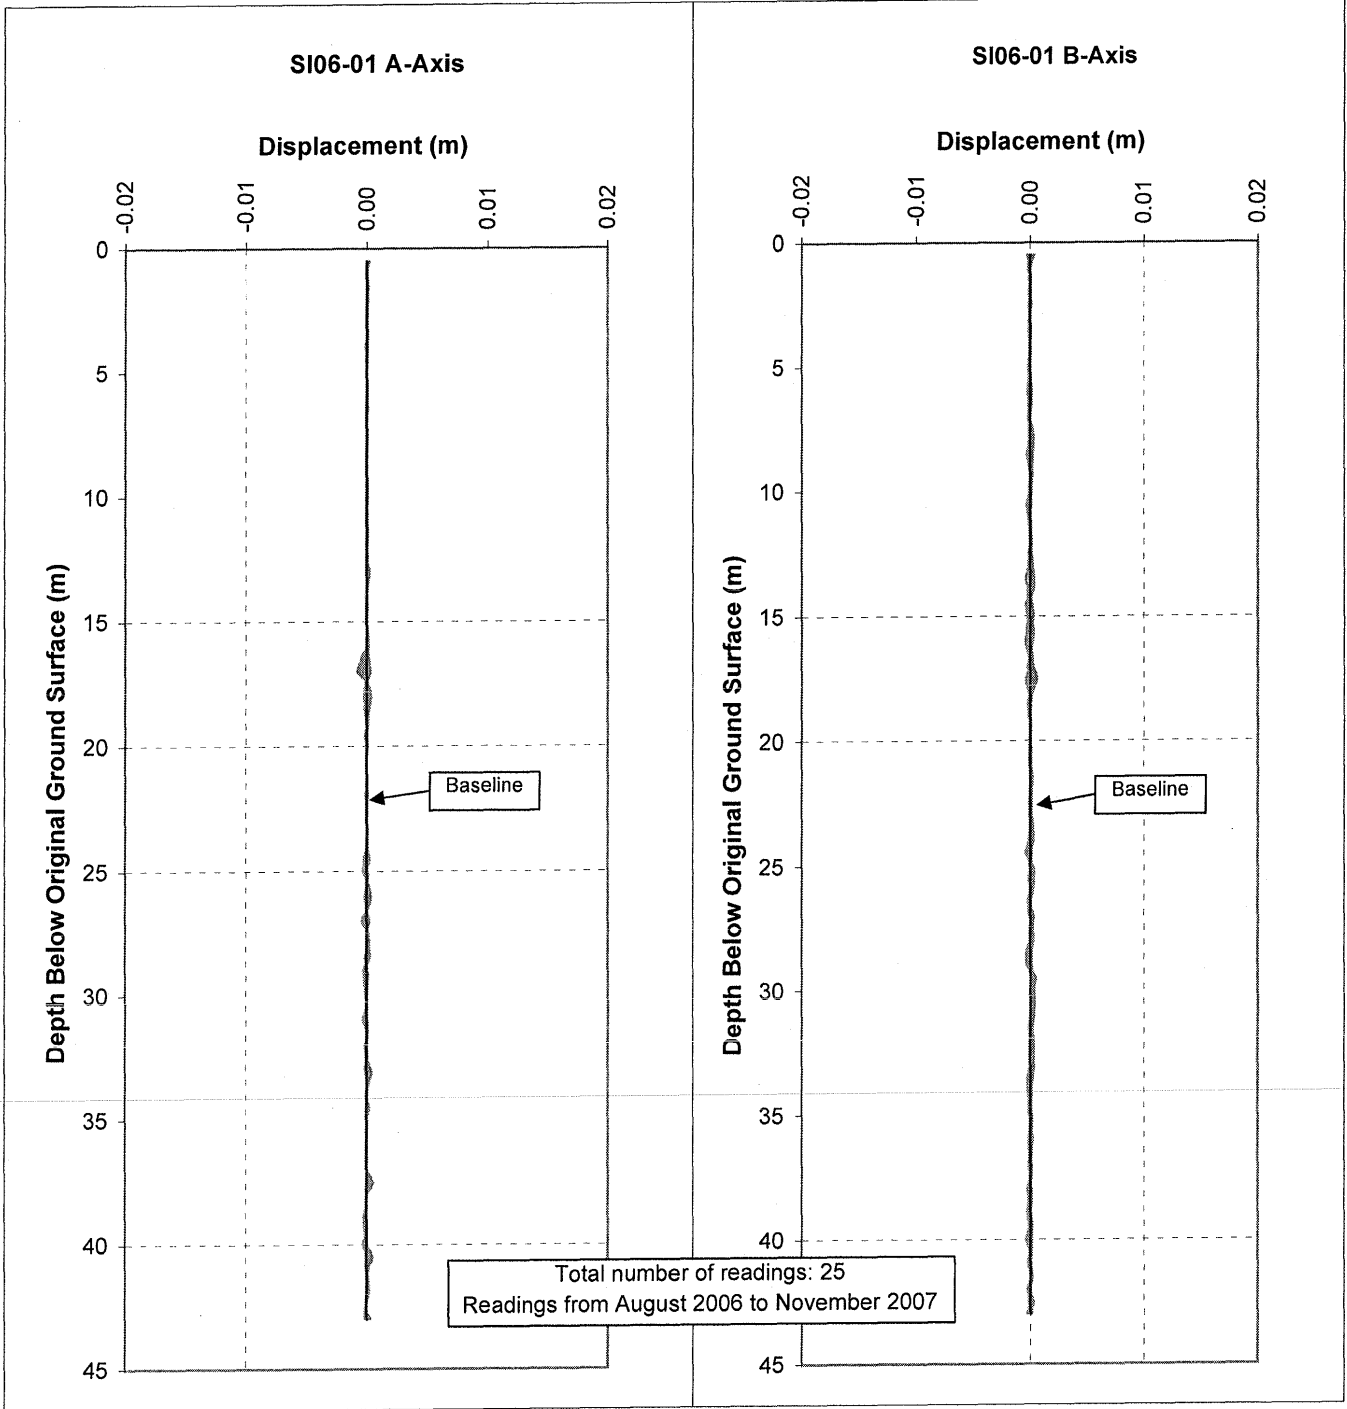
MOUNT POLLEY MINING CORPORATION	
MOUNT POLLEY MINE	
TAILINGS STORAGE FACILITY INCLINOMETER SI06-01 DISPLACEMENT VS. DEPTH	
<i>Knight Piésold</i> CONSULTING	PROJECT / ASSIGNMENT NO. VA101-1/18
FIGURE 5	REF NO. VA07-01853
	REV. 0

1) Displacement is calculated relative to the initial data set, recorded in August 2006.

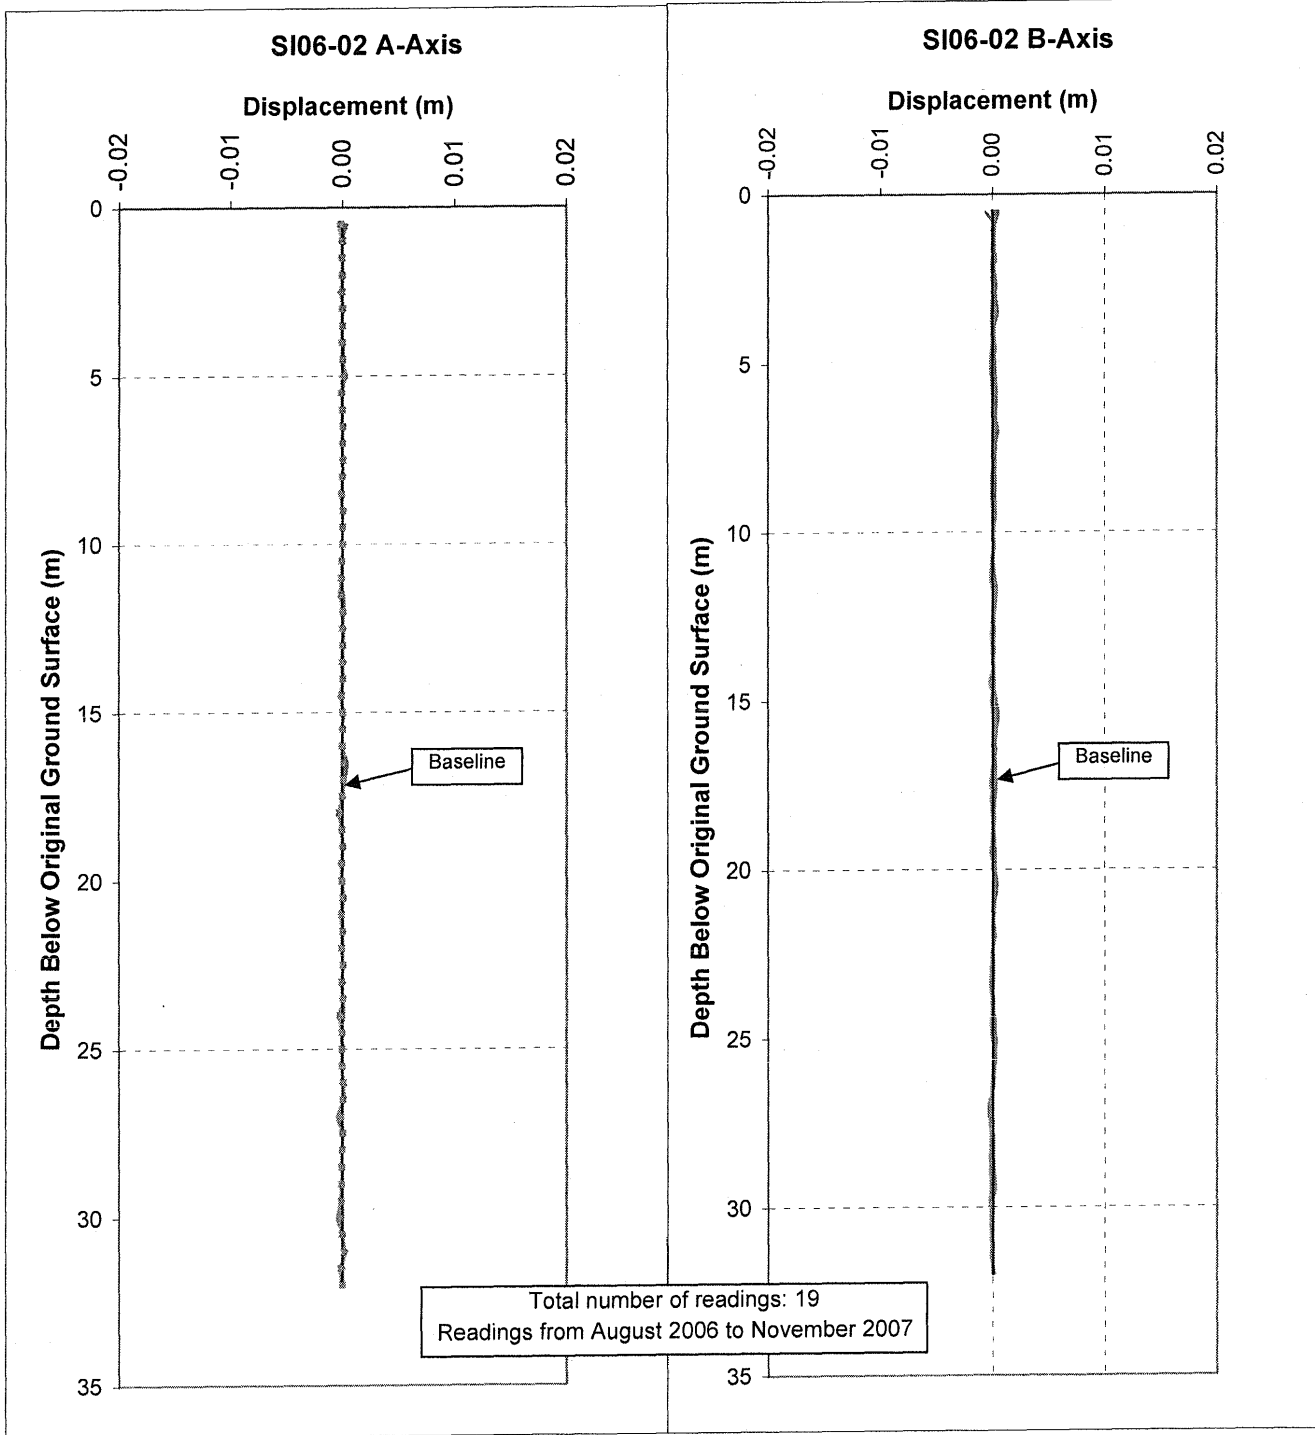
MOUNT POLLEY MINING CORPORATION		
MOUNT POLLEY MINE		
TAILINGS STORAGE FACILITY INCLINOMETER SI06-02 DISPLACEMENT VS. DEPTH		
<i>Knight Piésold</i> CONSULTING	PROJECT / ASSIGNMENT NO. VA101-1/18	REF NO. VA07-01853
	FIGURE 6	
		REV. 0

- 1) Displacement is calculated relative to the initial data set, recorded in August 2006.
- 2.) SI06-02 was blocked by ice burin the winter 06/06/07, therefore, no data was recorded.

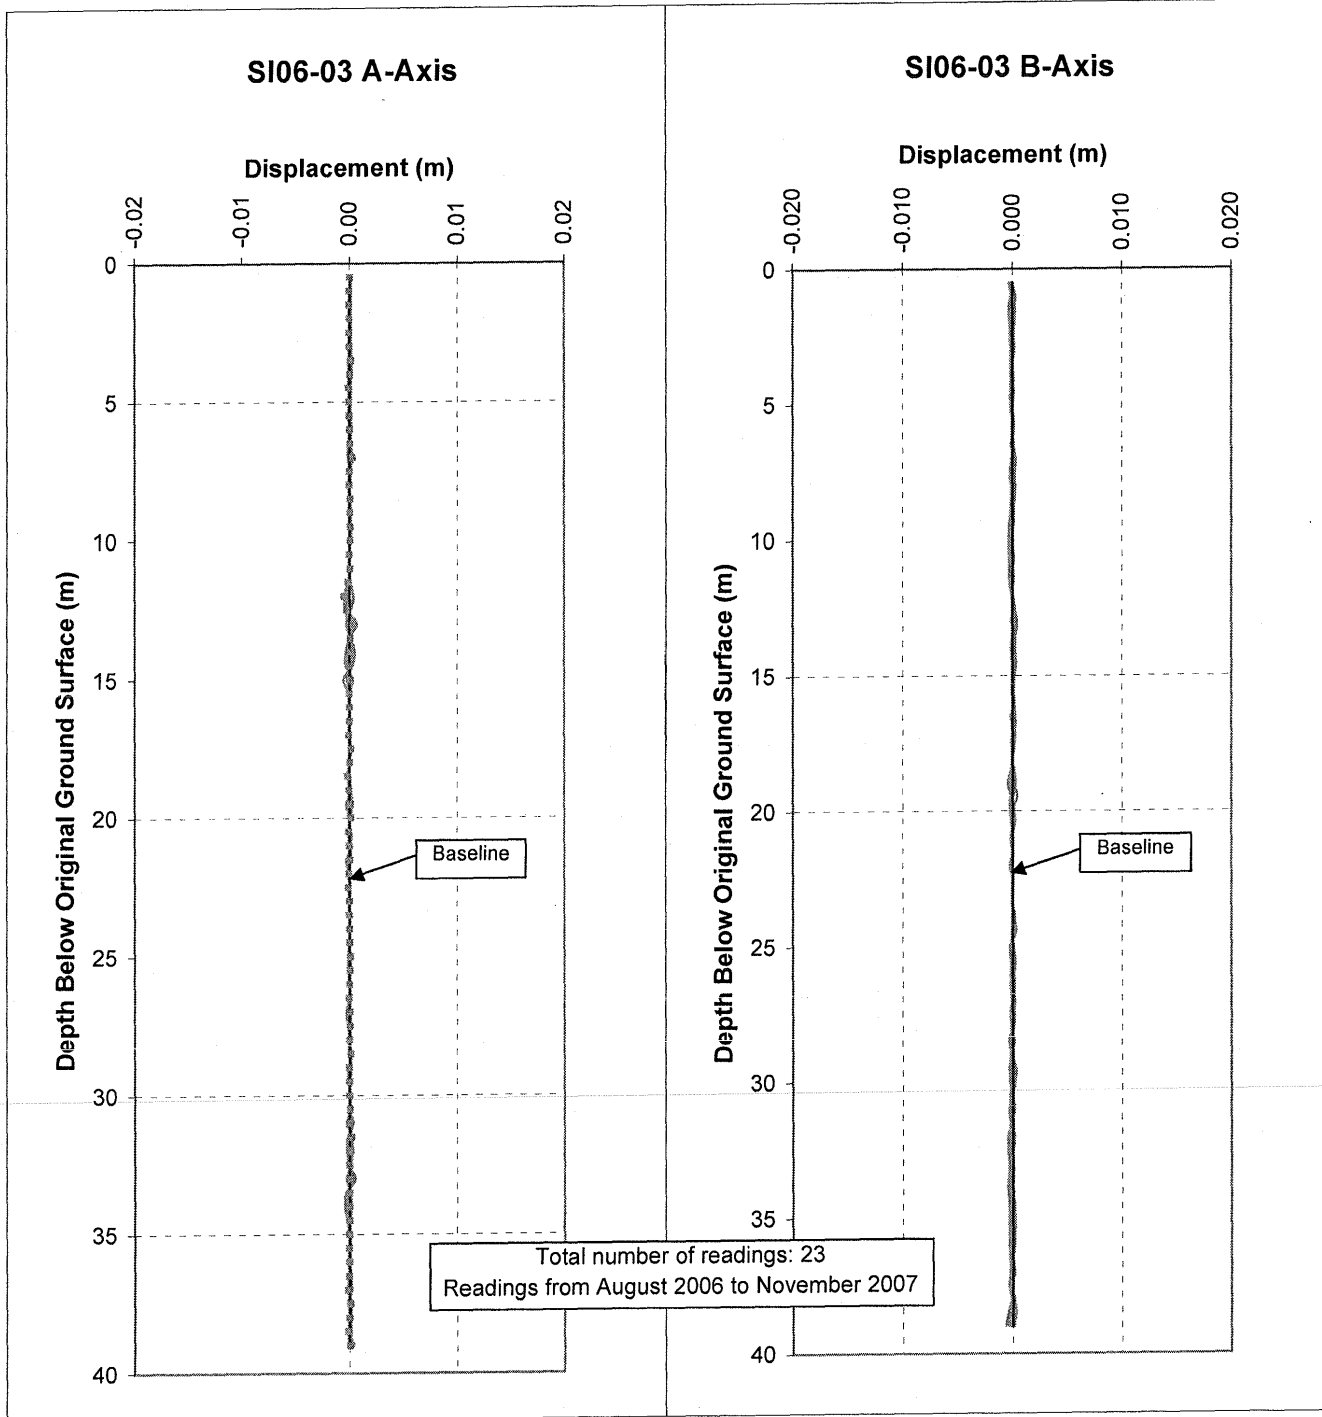
MOUNT POLLEY MINING CORPORATION		
MOUNT POLLEY MINE		
TAILINGS STORAGE FACILITY		
INCLINOMETER SI06-03		
DISPLACEMENT VS. DEPTH		
<i>Knight Piésold</i> CONSULTING	PROJECT / ASSIGNMENT NO. VA101-1/18	REF NO. VA07-01853
	FIGURE 7	
		REV. 0

1) Displacement is calculated relative to the initial data set, recorded in August 2006.

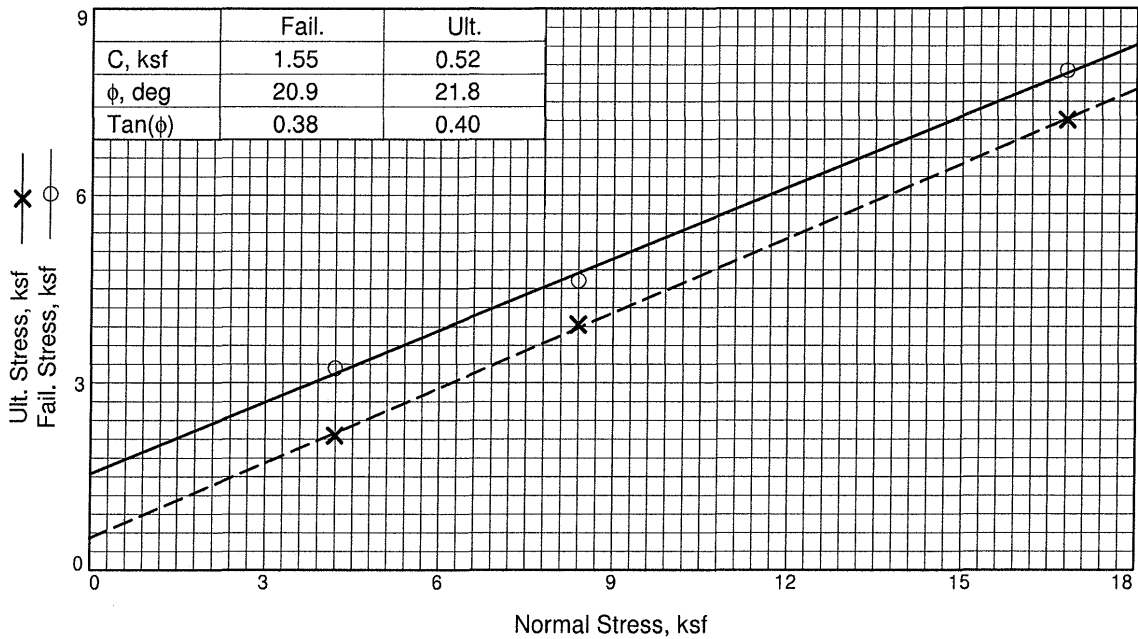
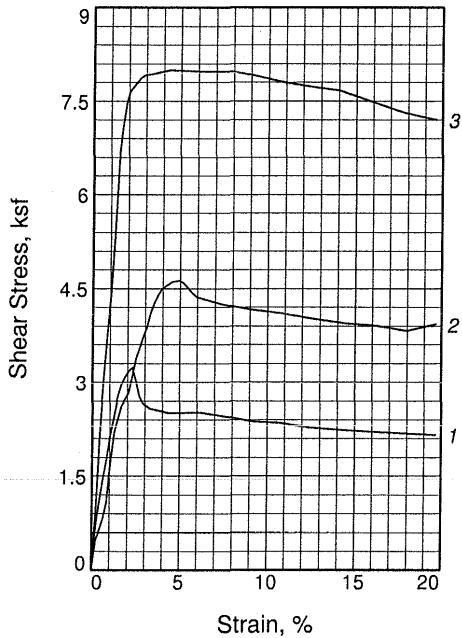
DIRECT SHEAR TEST

Sample No.	1	2	3	
Initial	Water Content, %	20.9	20.9	20.9
	Dry Density, pcf	106.9	105.3	104.7
	Saturation, %	92.3	88.8	87.6
	Void Ratio	0.6351	0.6598	0.6694
	Diameter, in.	2.42	2.42	2.42
	Height, in.	1.00	1.00	1.10
At Test	Water Content, %	18.4	14.0	20.8
	Dry Density, pcf	109.5	109.6	110.5
	Saturation, %	86.2	65.7	100.0
	Void Ratio	0.5958	0.5951	0.5814
	Diameter, in.	2.42	2.42	2.42
	Height, in.	0.98	0.96	1.04
Normal Stress, ksf	4.20	8.40	16.80	
Fail. Stress, ksf	3.23	4.63	8.00	
Strain, %	2.3	5.0	4.3	
Ult. Stress, ksf	2.16	3.93	7.21	
Strain, %	19.7	19.7	19.6	
Strain rate, %/min.	0.08	0.08	0.08

Sample Type: Liner
Description:
Assumed Specific Gravity= 2.8
Remarks: Failure tangents drawn at peak shear stress and approximately 20% strain. Specimens were not inundated.

Two brass tube samples of the lacustrine unit were collected on May 13, 2007. The samples were collected at a depth of approximately 2.5 to 3.0 meters in a testpit excavated downstream of the Main Embankment adjacent to the Main Embankment Seepage Collection Pond. The samples were sent to the Knight Piésold lab for direct shear testing at normal stresses of 400, 800 and 1600 kPa. The lab results are included in Appendix A. The resulting friction angles for the samples ranged from 21 to 25 degrees, with an average value of 23 degrees. The shear strength did not decrease significantly following the peak strength, and the average residual friction angle at 20% strain was 22 degrees.
