Environmental Review of a Portion of Silver Star Mountain Resort

SILVER STAR MOUNTAIN RESORT

CASCADE ENVIRONMENTAL

Date: December 15, 2006

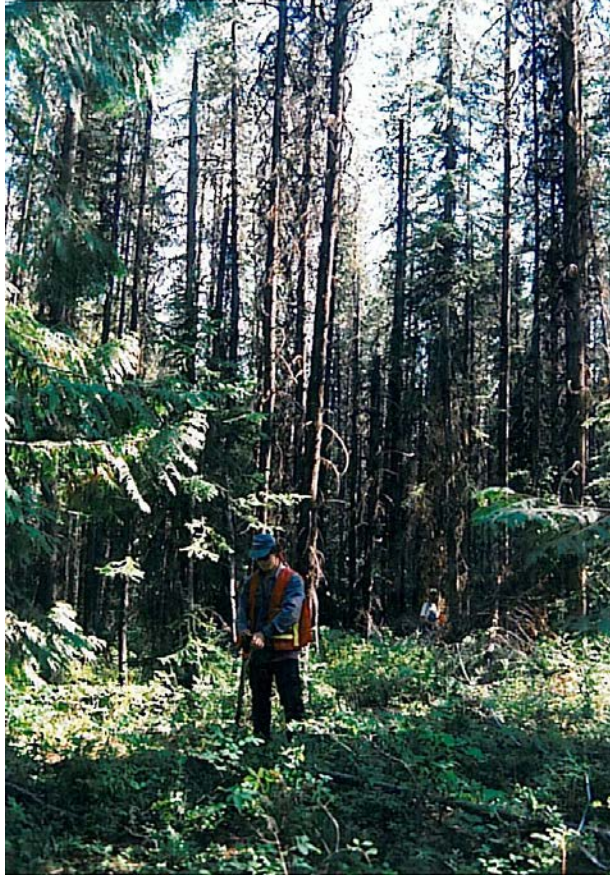
Photo 4: Sample Site 13 ICH mw2, Polygon 9

The polygon 9 complex comprises another depressional trough with a total area of approximately 43 ha. Polygon 9 occupies the southern portion of the trough and contains plot #13. The information gathered at this plot led to a zonal site series assessment of *western hemlock / western redcedar – falsebox – feathermoss*. The structural stage of the mature forest is 6.
