Ministry of Forests, Lands and Natural Resource Operations

Development and Testing of CL-2 and CL-3 Barriers, Rev.1

November 2013

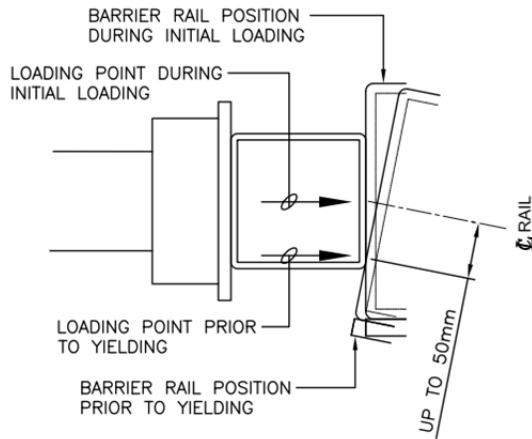
Figure 3-1a
Original Load Application

While evaluating the results of UBC’s initial testing program, we postulated that the height of the applied load relative to the deck varied by up to 50 mm during the test (Figure 3.1a). Given the sensitivity of the barrier capacity to the height of the applied load, we replaced the HSS beam with a steel bars (Figure 3-1b). The new configuration reduces the variation in the testing lever arm to a maximum of 20 mm (typically 10 mm variation at yield load). With the exception of the loading point detail, the experimental set-up remained constant throughout all phases of testing. UBC’s 2010 report, “*Experimental Evaluation of Concrete Decks with Guard Rail Systems*” details the experimental configuration.

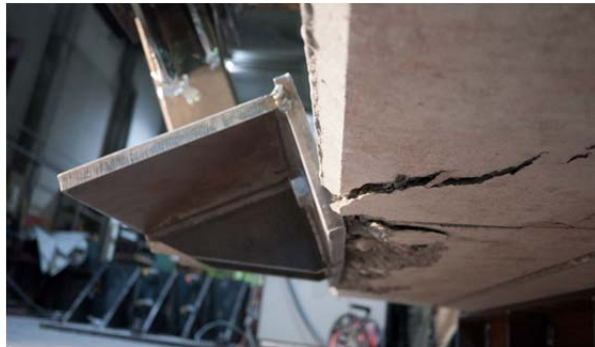
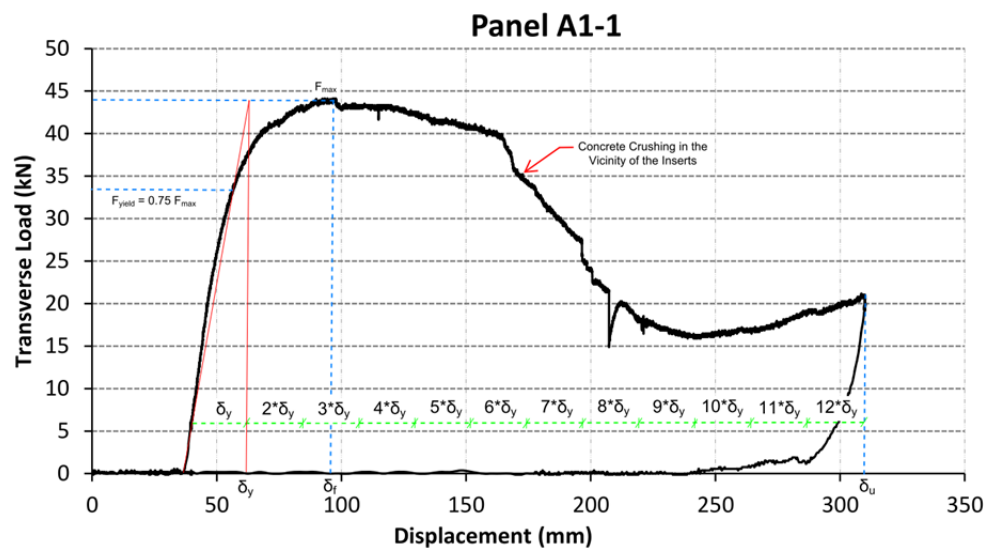
Figure 4-1
Typical CL-2 Specimen Crack Pattern & Load-Displacement Plot

Figure 4-1 presents the typical failure pattern and load-displacement response for the CL-2 barrier connection. The lateral resistance of the system increased until the concrete failed in compression below the bracket. This was followed by concrete spalling on the underside of the panel and extensive rotation of the barrier.

All specimens displayed good displacement ductility characteristics (typically $\mu > 5$), where μ represents the ratio of yield displacement (δ_y) to ultimate displacement (δ_u) suggesting that the tested configuration provides good energy dissipation while retaining load carrying capacity.

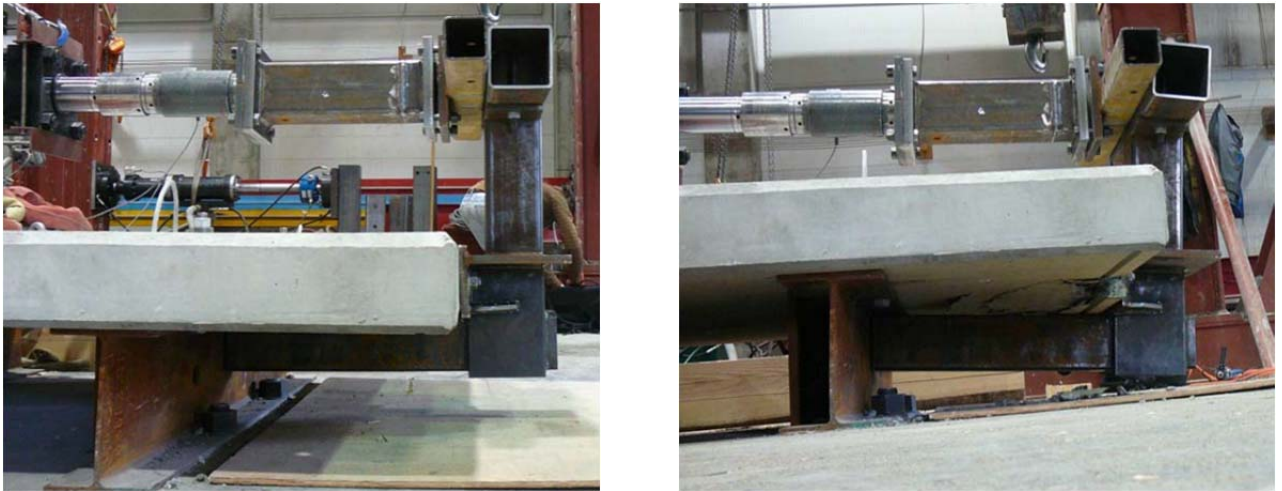
Figure 5-1
Side Mounted Steel Bracket with Knee Brace

During the previous experimental phase, UBC strengthened the HSS Guide Retrofit Rail by adding a 600 mm long knee-brace (Figure 5-1). Full details of the modifications are presented in UBC's 2011 report, "*Experimental Evaluation of Concrete Decks with Guard Rail Systems*".

The modifications resulted in a 230% increase in the lateral resistance of the barrier with the anchor bolts failing in shear rather than the previously observed concrete compressive failure or tensile failure of the anchor bolts. Further, the modified barrier achieved the resistance required to be classified as a CL-3 barrier.

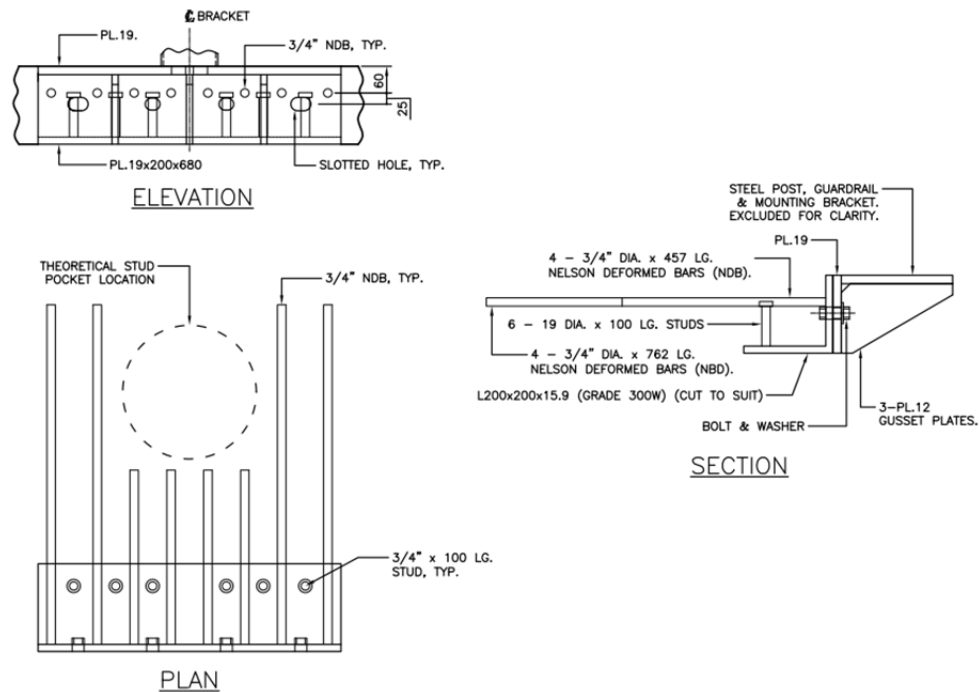
Figure 5-2
Proposed CL-3 Bracket (Post and Rail Details Excluded for Clarity)

Figure 5-2 illustrates the proposed CL-3 side mounted connection. The prototype CL-3 barrier bracket incorporates an embedded angle with vertical headed studs and horizontal Nelson Deformed Bars (NDB's). The embedded angle and vertical headed studs confine the concrete along the edge of the panel resulting in an increased compressive resistance. The horizontal NDB's provide the required tensile resistance.

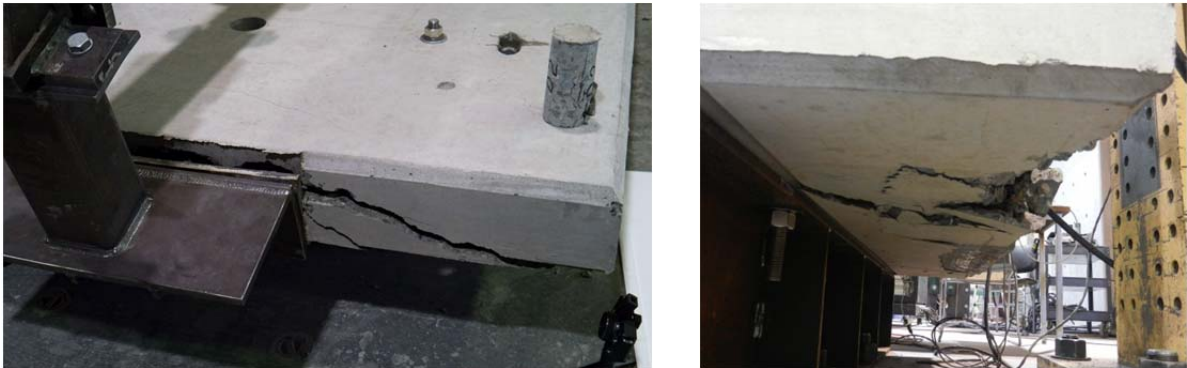
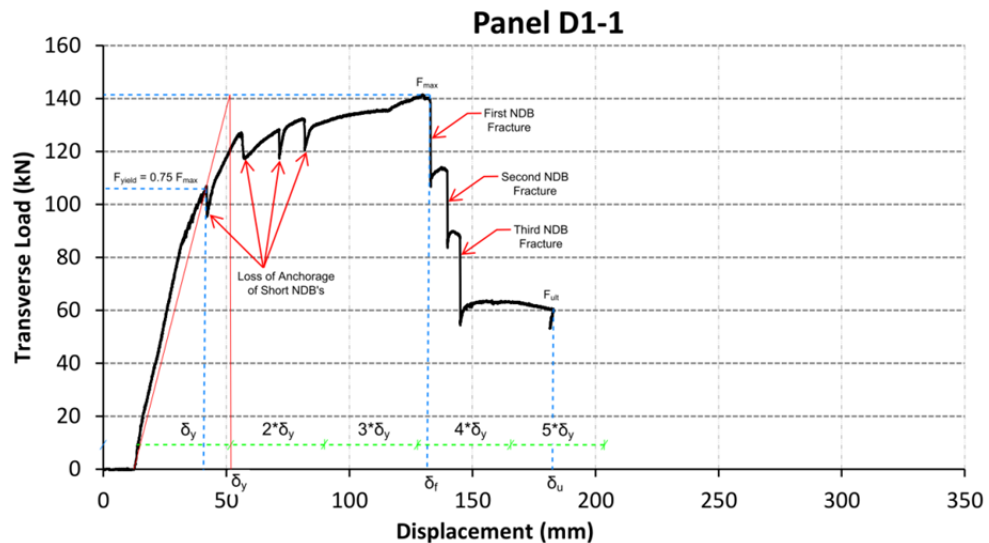
Figure 5-3
Typical CL-3 Connection Failure and Load-Displacement Plot

Figure 5-3 presents a typical failure and load-displacement response for the proposed connection.

During all the tests we heard 3-4 “popping” sounds that coincided with the minor dips in resistance on the ascending branch of the load-displacement plot (Figure 5-3). Based on the load displacement plot and post-failure observations, we believe the “popping” sounds were associated with the bond failure of the four short NDB’s (Figure 5-4).

The connection achieved peak load after the bond failure of the short NDB’s and prior to the fracture of one or more of the long NDB’s at the weld location. The specimens failed by fracturing the long NDB’s and compressive failure of the concrete around the embedded angle.

The load-displacement plot indicates that the connection has residual resistance (i.e. approximately 40% of the peak resistance); this is a good indication of the systems post-failure ductility and energy dissipation characteristics. Some specimens achieved post-failure displacement ductility, $\mu > 4$ (where μ represents the ratio of yield displacement (δ_y) to ultimate displacement (δ_u)); it is likely all specimens would exceed this displacement ductility if the actuator stroke had not been exceeded.

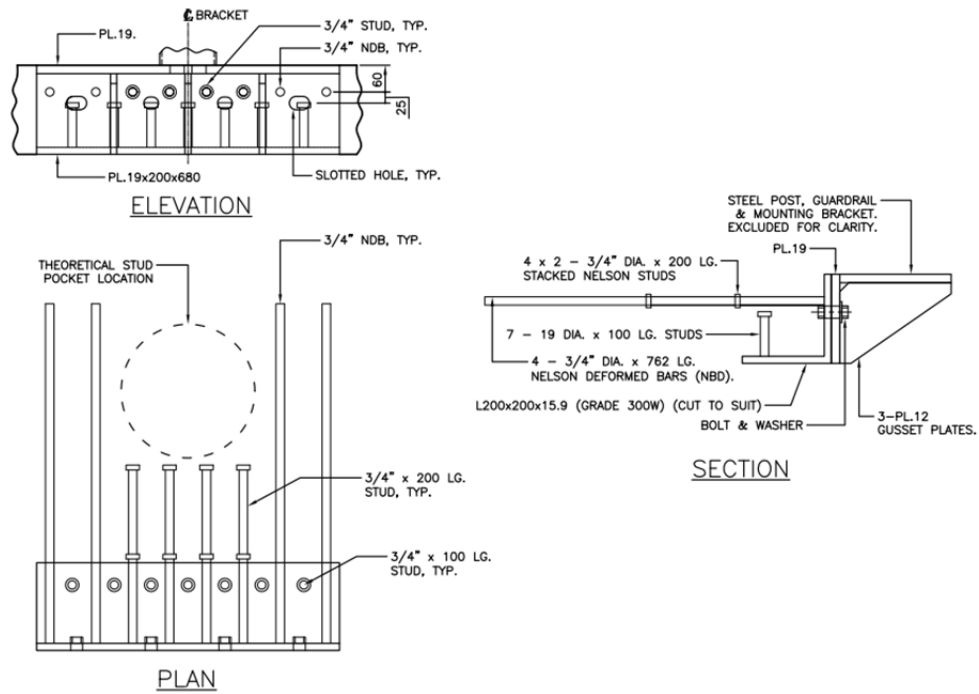
Figure 5-5
Re-Designed CL-3 Bracket

As noted in the previous Section, the experimental findings suggest that if the short NDB's had adequate anchorage (bond length), the connection may achieve a higher peak resistance. To increase the resistance of the four short NDB's we recommended replacing them with four pairs of stacked headed studs (Figure 5-5). To verify this assumption, UBC tested the following panels which incorporated the recommended modifications:

- Panel Type G – 175 mm thick panel with 680 mm wide bracket.
- Panel Type H – 200 mm thick panel with 680 mm wide bracket.

Based on the experimental findings and numerical analysis for the CL-3 barrier connection, we recommend that the Ministry adopt a modified connection that incorporates a combination NDB's and stacked headed studs similar to that illustrated in Figure 5-5. The proposed connection achieves the minimum required lateral resistance for a CL-3 barrier (i.e. 120 kN) for the 175 and 200 mm thick panels.

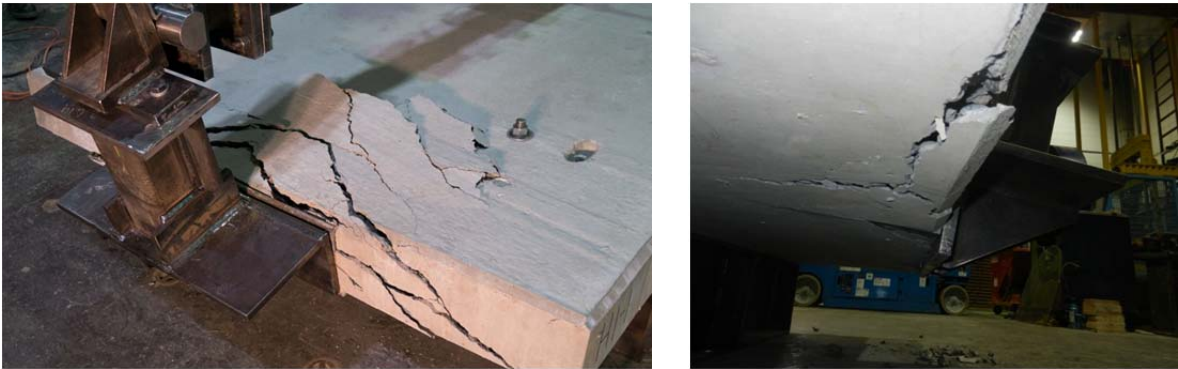
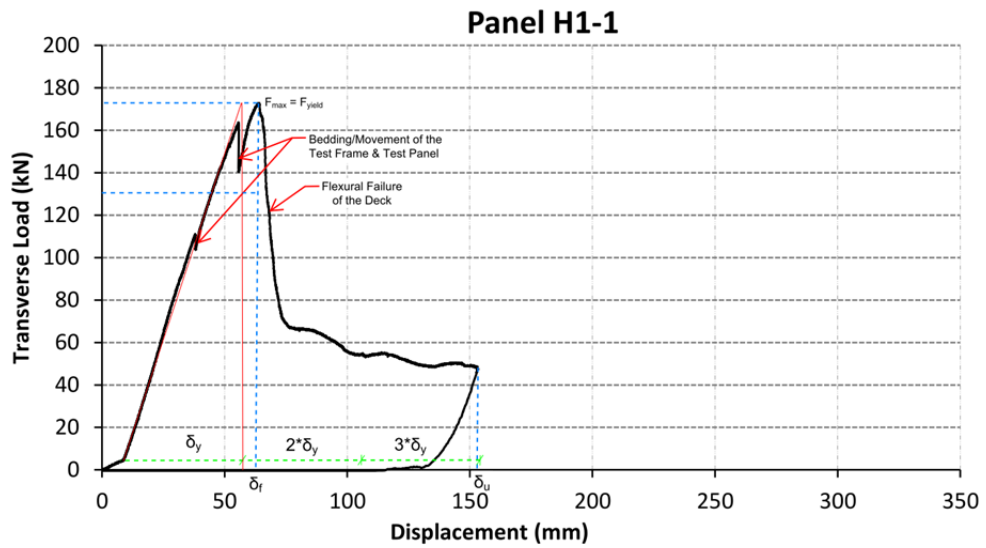
Figure 5-6
Typical Revised CL-3 Failure and Load-Displacement Plot

Figure 5-6 presents a typical failure and load-displacement response for the revised CL-3 barrier connection.

The modified CL-3 barrier connection failed due to yielding/pull-out of the stacked headed studs and NDB's, and the loss of the top cover concrete. This was followed by the compressive failure of the concrete on the underside of the panel and extensive rotation of the bracket. The NDB's did not fracture during any of the tests.

The load-displacement plot indicates that the modified connection has residual resistance (i.e. approximately 30% of the peak resistance); this is a good indication of the systems post-failure ductility and energy dissipation characteristics. The modified CL-3 configuration tests were terminated prior to the full actuator stroke length being achieved. It is likely the specimens would have achieved a post failure displacement ductility, $\mu > 4$ (where μ represents the ratio of yield displacement (δ_y) to ultimate displacement (δ_u)), similar to the original CL-3 configuration. Although the original and modified CL-3 barrier connections display similar post-failure performance characteristics; the modified connection displayed a brittle failure with limited yielding near the peak load.

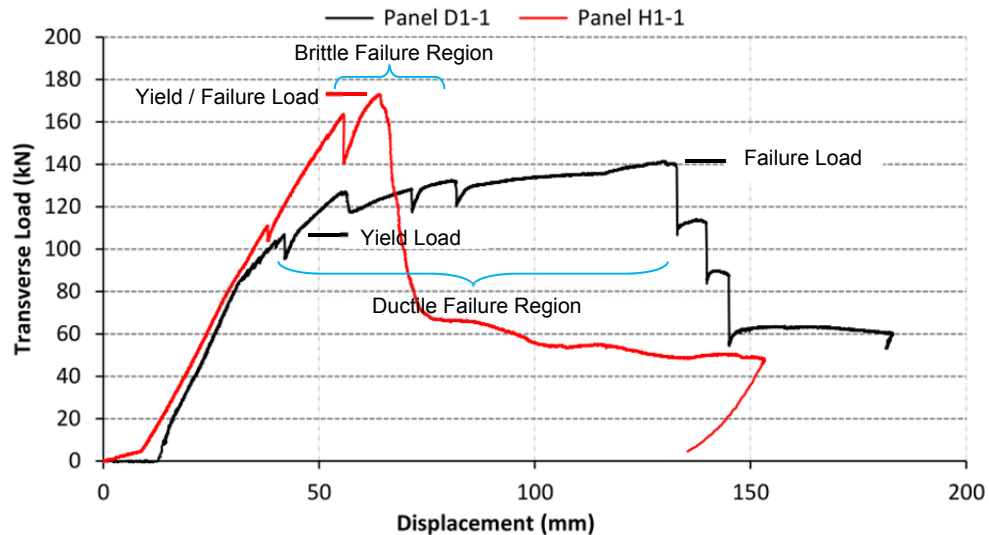
Figure 5-7
Original and Revised CL-3 Configuration Load-Displacement Plots

Comparing the load-displacement plots for the original and revised CL-3 configurations (Figure 5-7), it can be seen that the revised configuration (Panel H1-1) fails in a brittle manner compared to the ductile failure for the original configuration (Panel D1-1). This is typical for the failure of an embedded stud. The failure leads to a sudden drop in resistance, at yield/failure, compared to a prolonged yielding plateau for the original configuration incorporating only NDB reinforcement. The brittle failure is of no concern if the post and rail assembly is designed to yield prior to failure of the bracket.

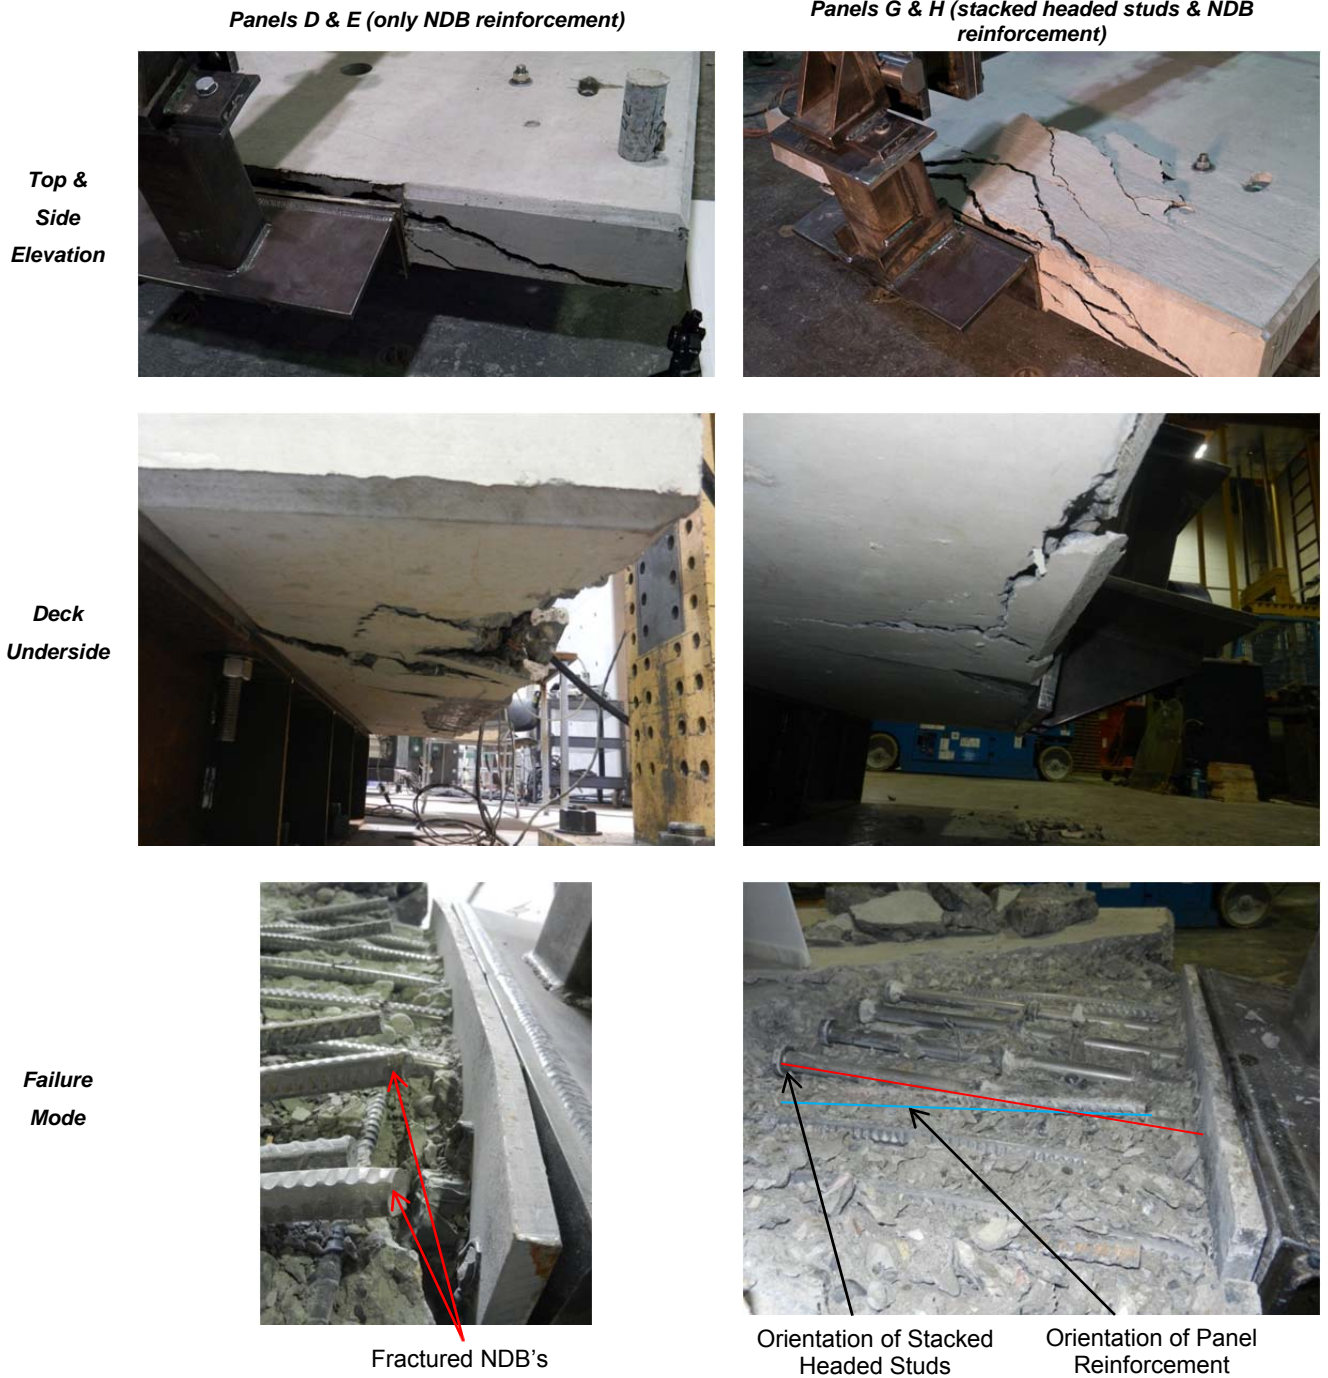
Figure 5-8
Comparison of Original and Modified CL-3 Barrier Connections Failures

Figure 5-8 provides a photographic comparison of the failures of the original and modified CL-3 barrier connections. The change in failure mechanism is highlighted by the extensive cracking on the top surface of the concrete panel for the modified configuration (with stacked studs).

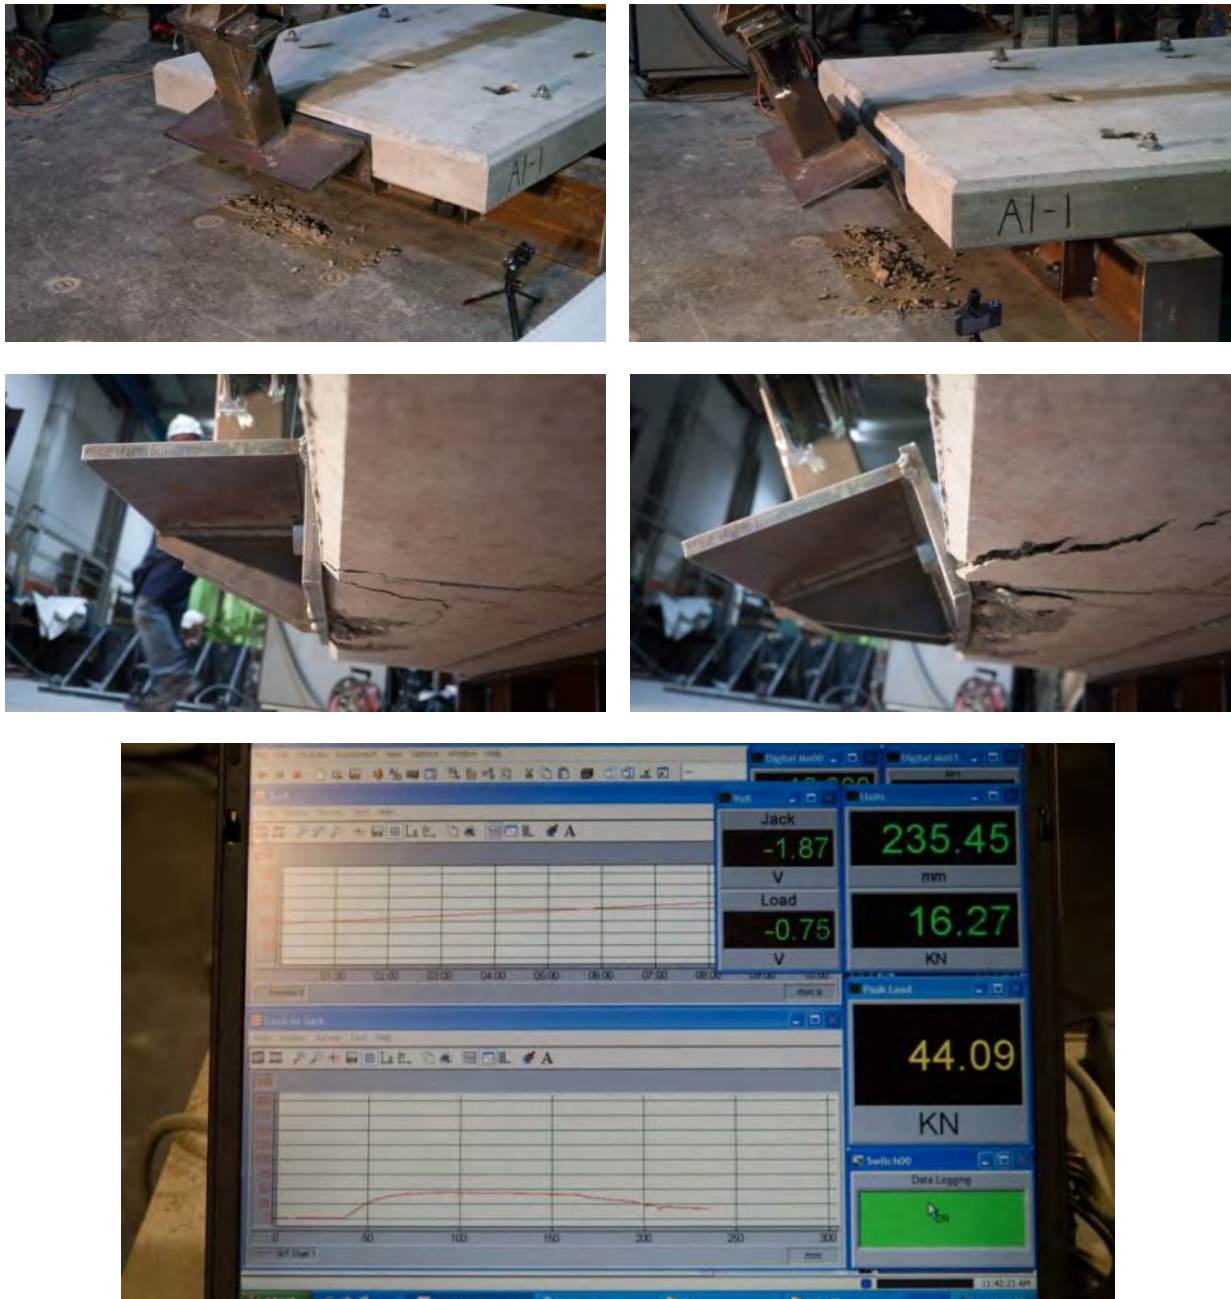
Figure 5: Load/Deflection Curve of Top of Bracket, A-1-1 (Note that initial drop in load corresponded to when the compression concrete on the slab face crushed to the drip groove)

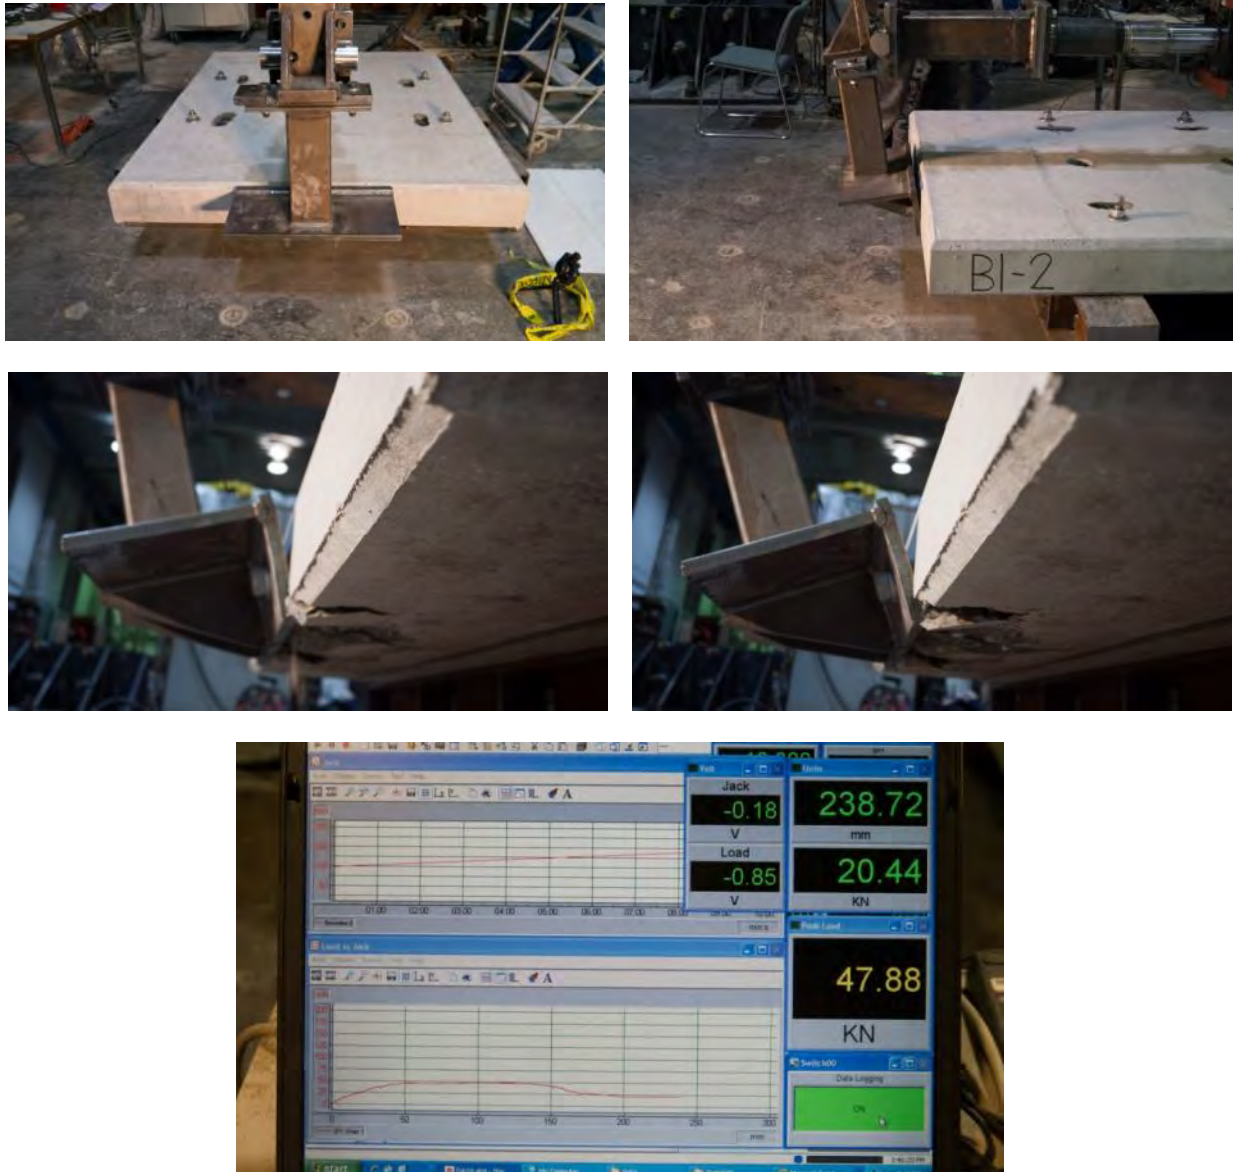
Figure 11: Load/Deflection Curve of Top of Bracket, B-1-2 (Note that drop in stiffness corresponded to when the compression concrete on the slab face crushed to the drip groove, after this point the load was entirely carried by the bending of the bolts. The test was halted as safety became a concern after this point)

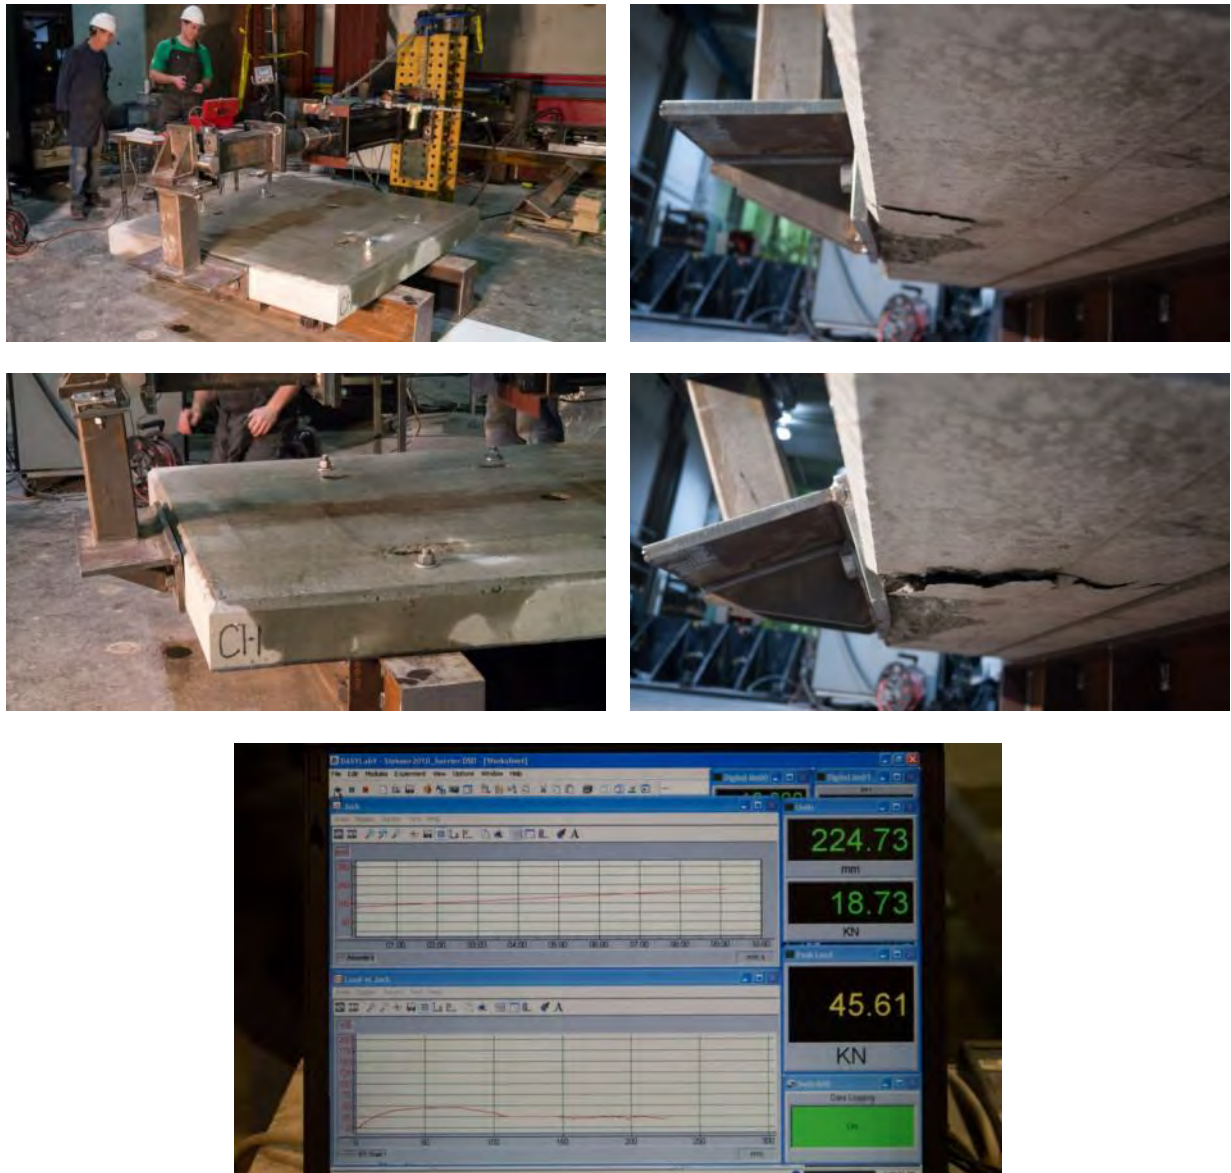
Figure 13: Load/Deflection Curve of Top of Bracket, C-1-1 (Note that initial drop in load corresponded to when the compression concrete on the slab face crushed to the drip groove)

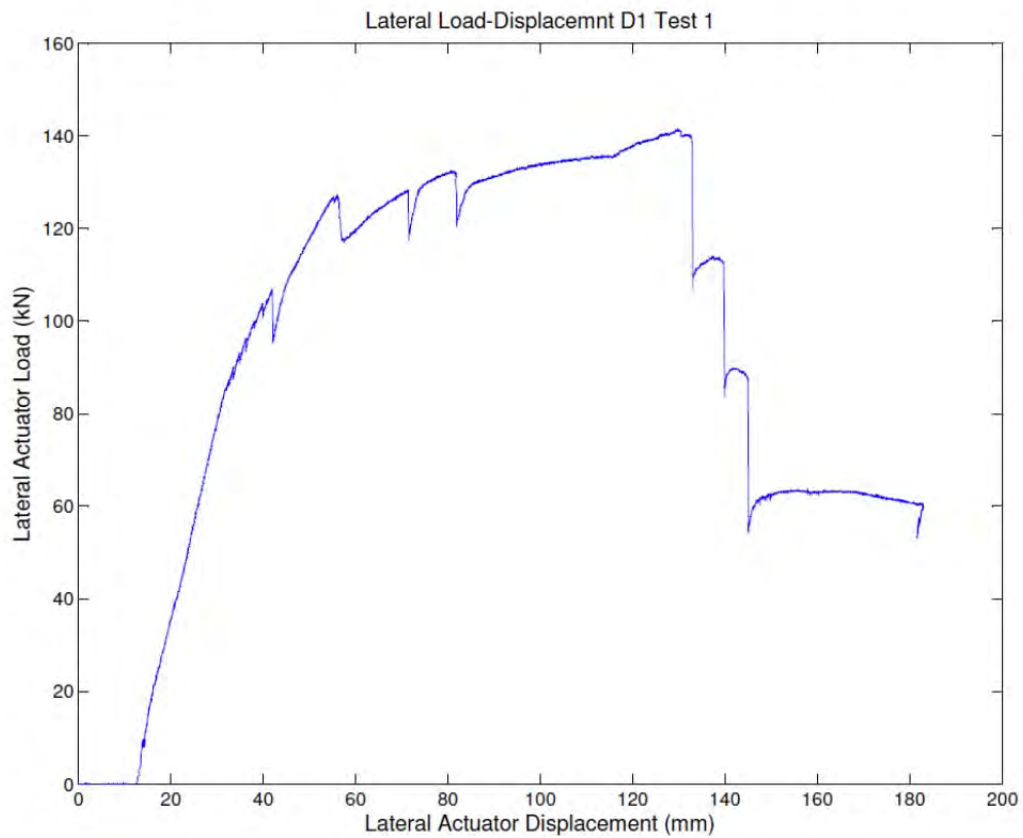
Figure 21: Load/Deflection Curve of Top of Bracket, D-1-1 (Note drops in load correspond to roughly the capacity of one of the four main anchor rods as they fractured in sequence)

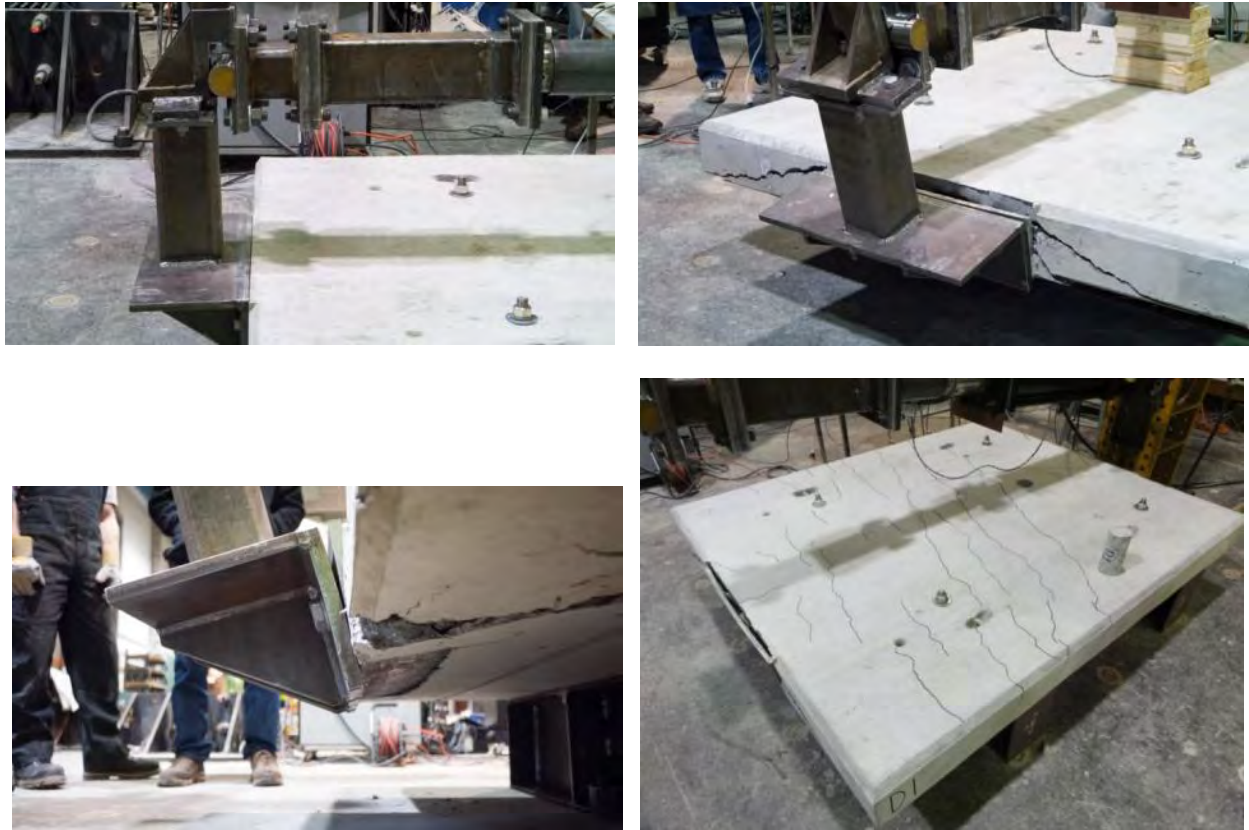
Figure 22: Concrete panel attachment detail failing

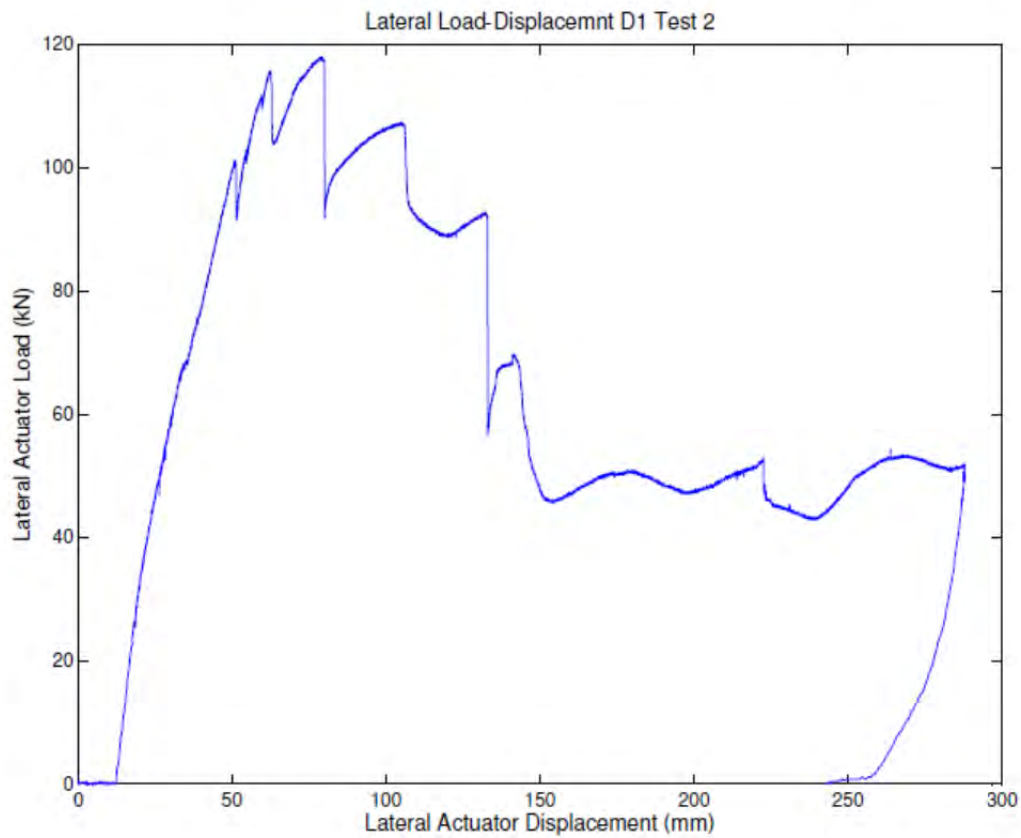
Figure 24: Load/Deflection Curve of Top of Bracket, D-1-2 (Note that the major drops in load correspond to anchor fracture and/or slippage)

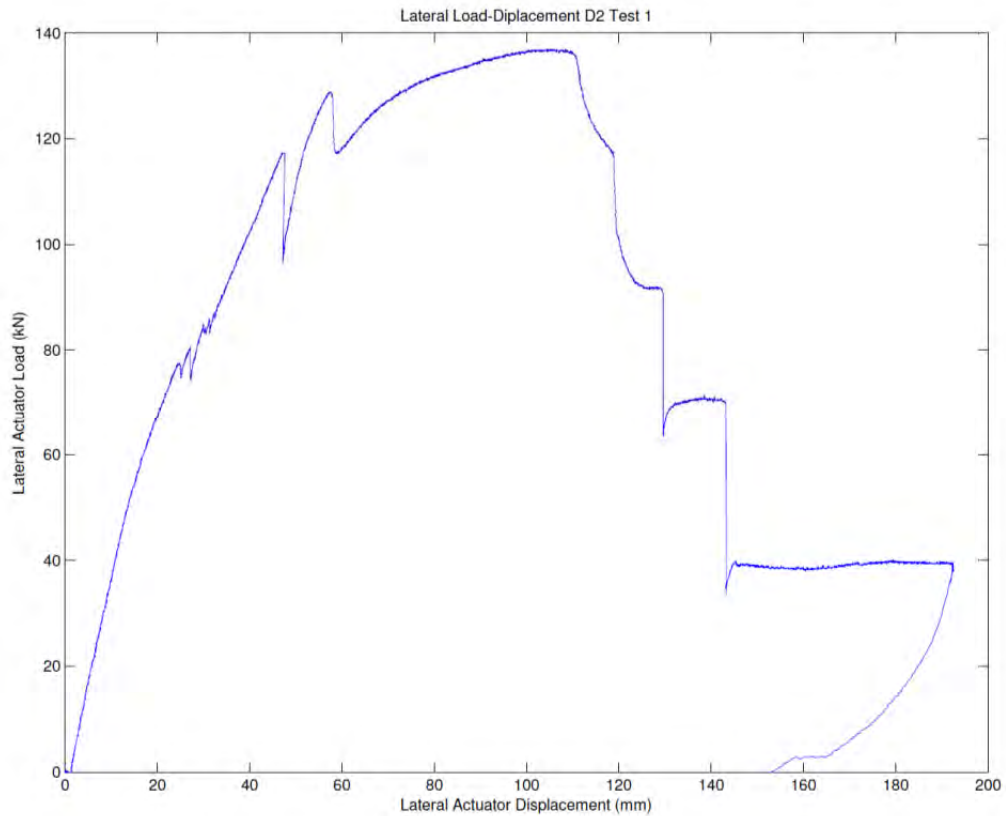
Figure 26: Load/Deflection Curve of Top of Bracket, D-2-1 (Note drops in load correspond to roughly the capacity of one of the four main anchor rods as they fractured in sequence)

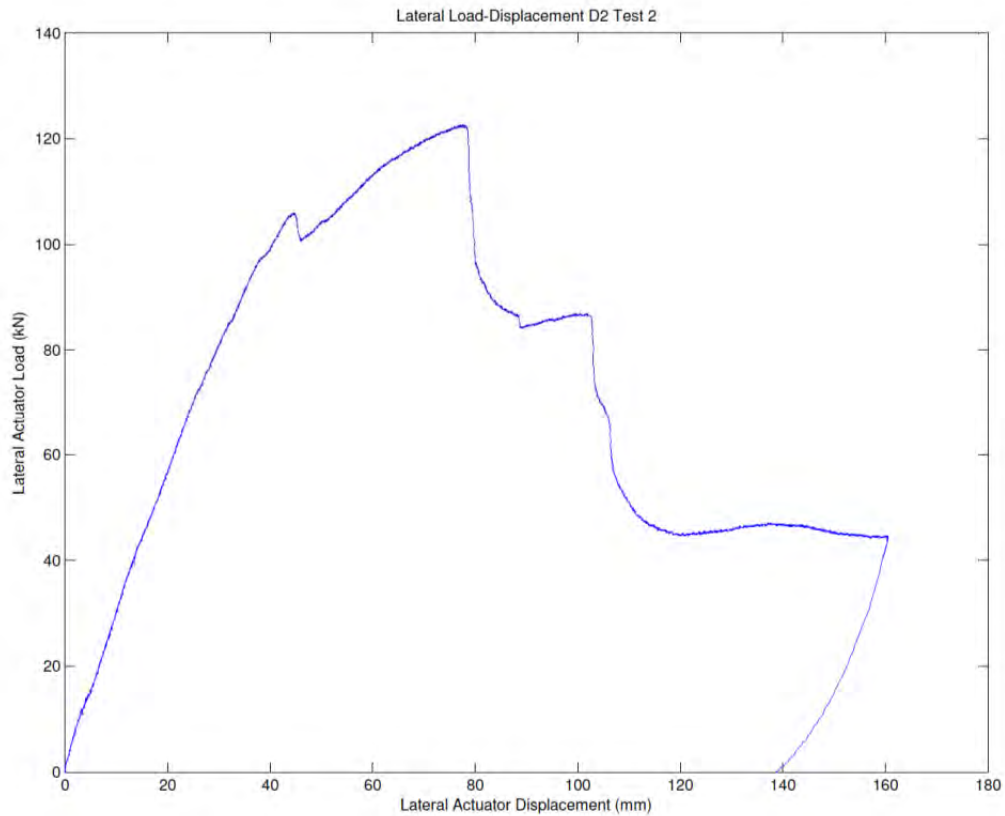
Figure 28: Load/Deflection Curve of Top of Bracket, D-2-2 (Note drops in load correspond to roughly the capacity of one of the four main anchor rods as they fractured in sequence)

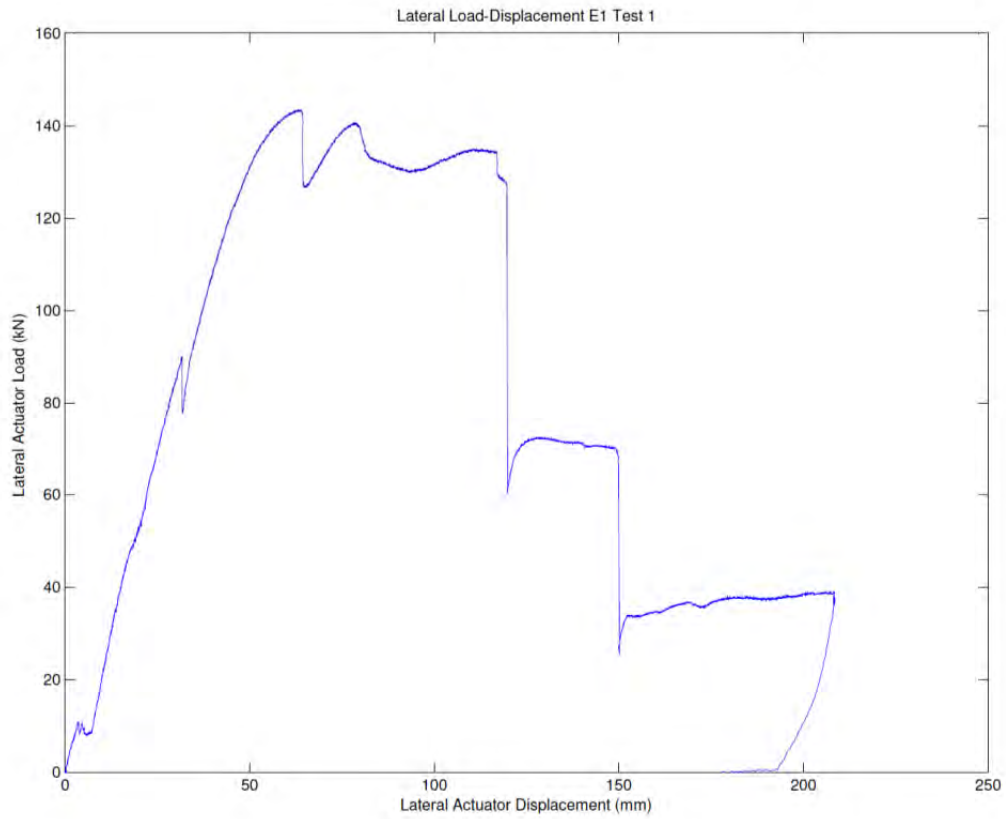
Figure 30: Load/Deflection Curve of Top of Bracket, E-1-1 (Note drops in load correspond to roughly the capacity of one of the four main anchor rods as they fractured in sequence)

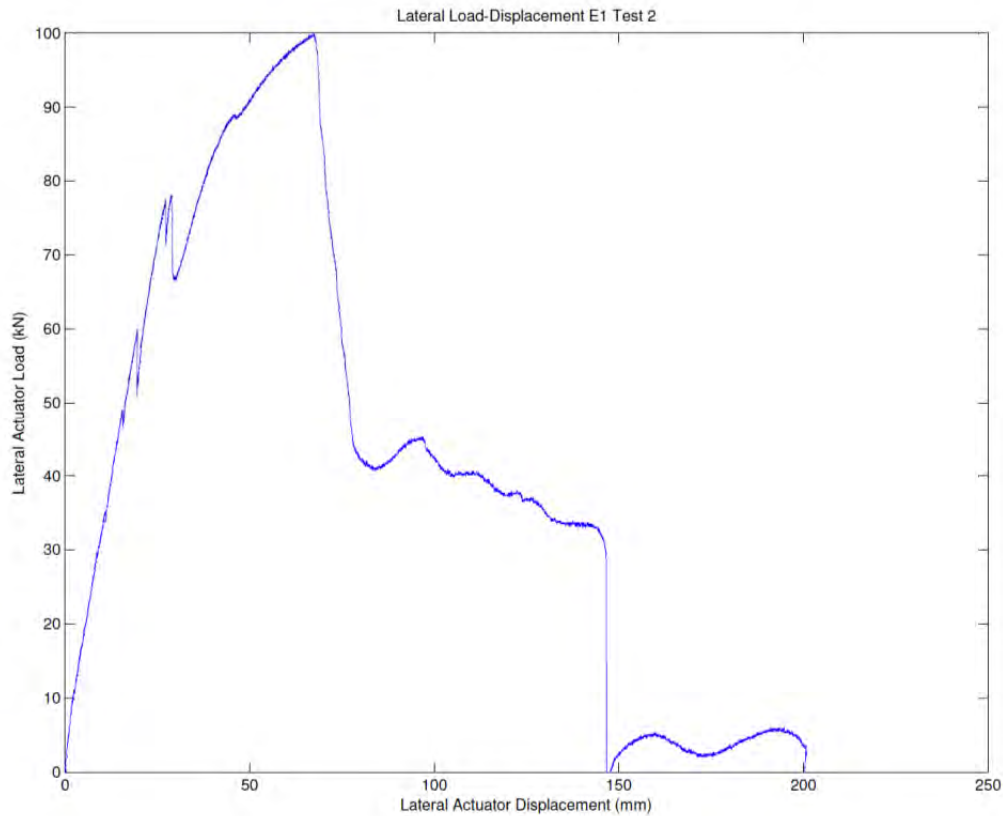
Figure 32: Load/Deflection Curve of Top of Bracket, E-1-2 (Note initial slipping of support apparatus caused initial drops in load during the initial portion of the loading curve. There may have been an initial preload of roughly 50 kN which resulted in the low lateral load capacity of this specimen)

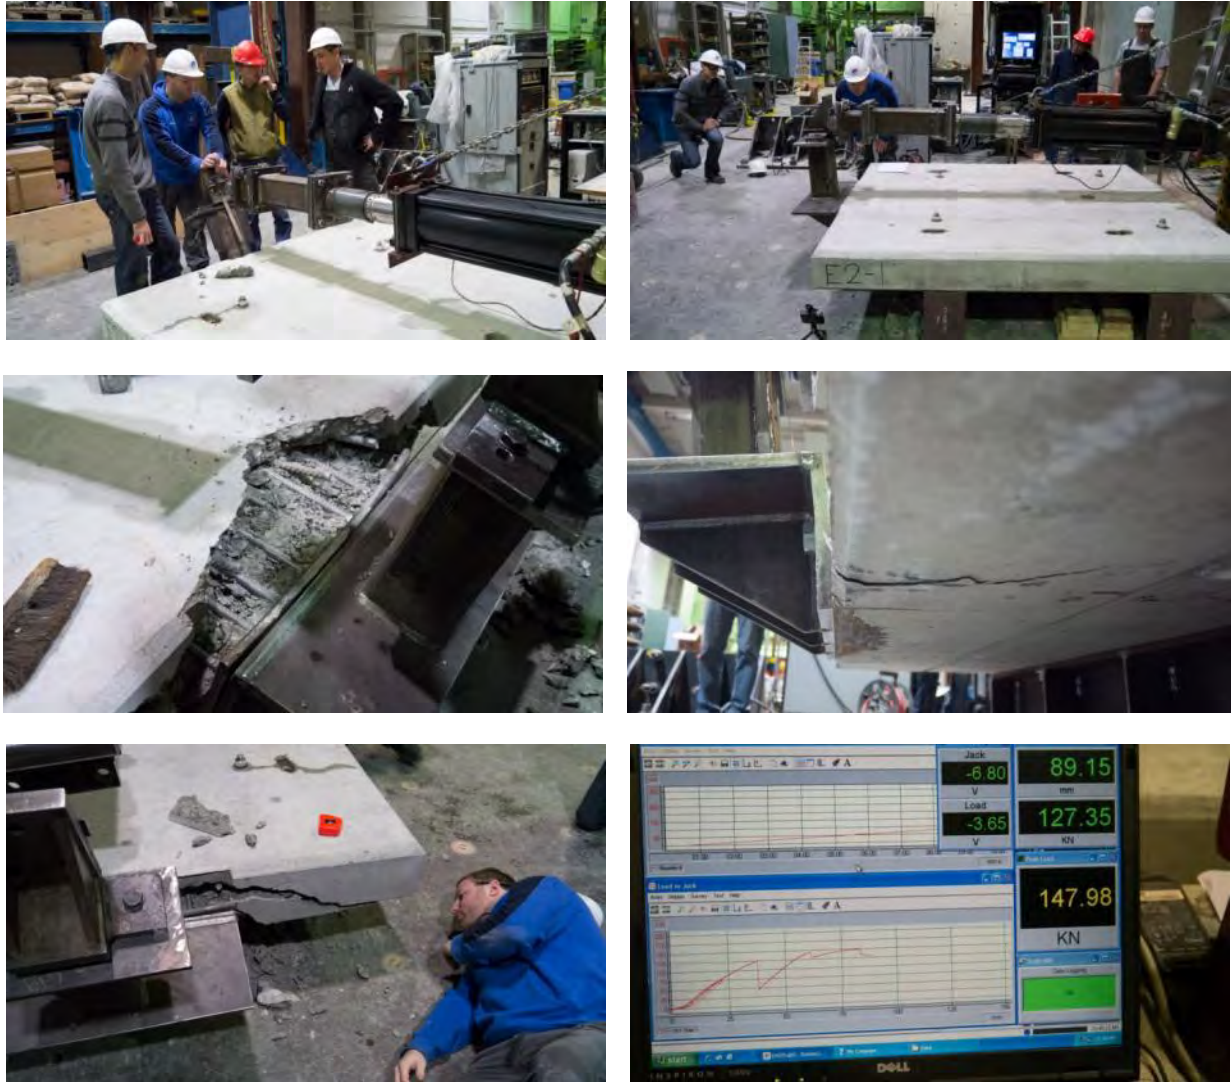
Figure 34: Load/Deflection Curve of Top of Bracket, E-2-1 (Note drop in load of 83 kN at lateral displacement of 39 mm due to panel support apparatus shifting under load)

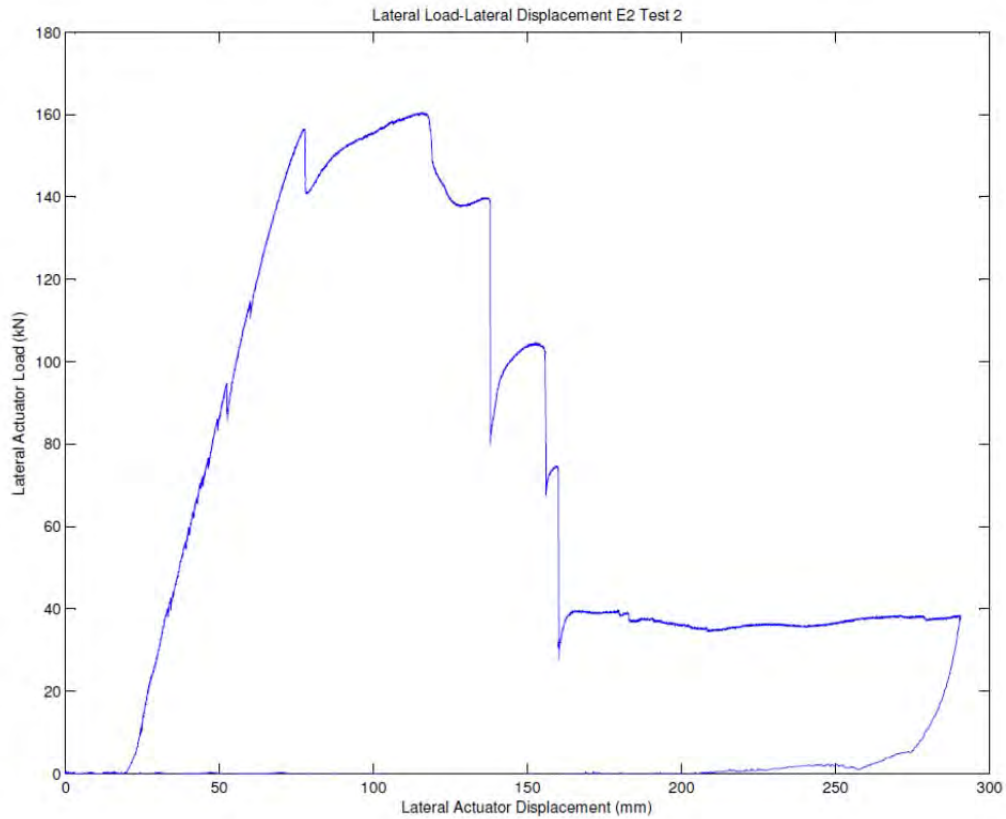
Figure 36: Load/Deflection Curve of Top of Bracket, E-2-2 (Note that the major drops in load correspond to the capacity of an anchor bar as it fractured)
