Ministry of Forests, Lands and Natural Resource Operations

Development and Testing of CL-2 and CL-3 Barriers, Rev.1

November 2013

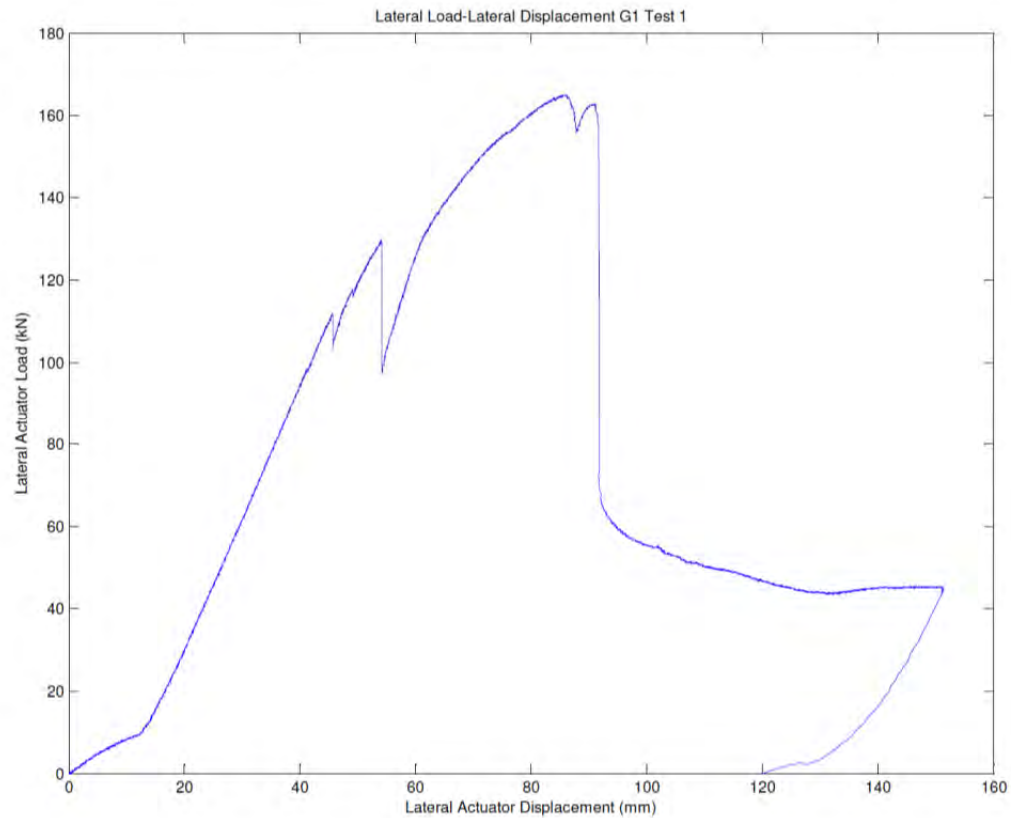
Figure 38: Load/Deflection Curve of Top of Bracket, G-1-1 (Note that the primary failure mechanism was characterized by the concrete cover above the Nelson studs breaking away as the rigid studs reached a critical curvature demand)

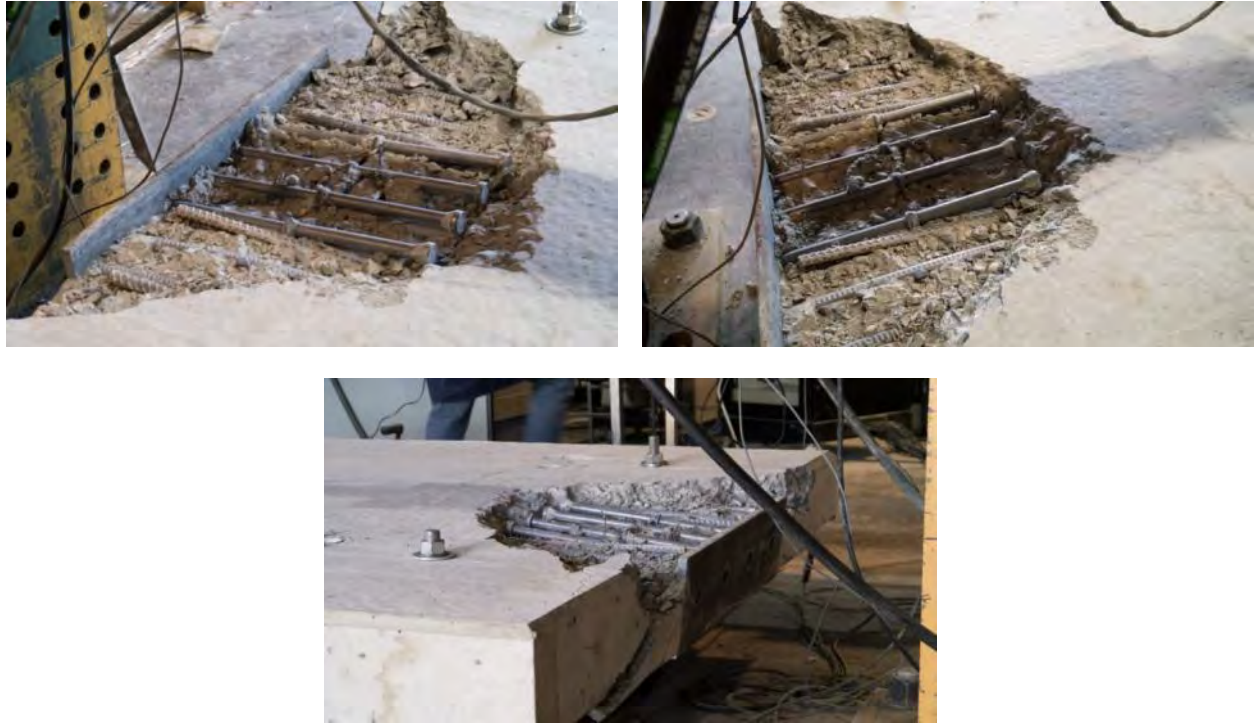
Figure 41: Images from G-1-1, failure inspection after top concrete removal

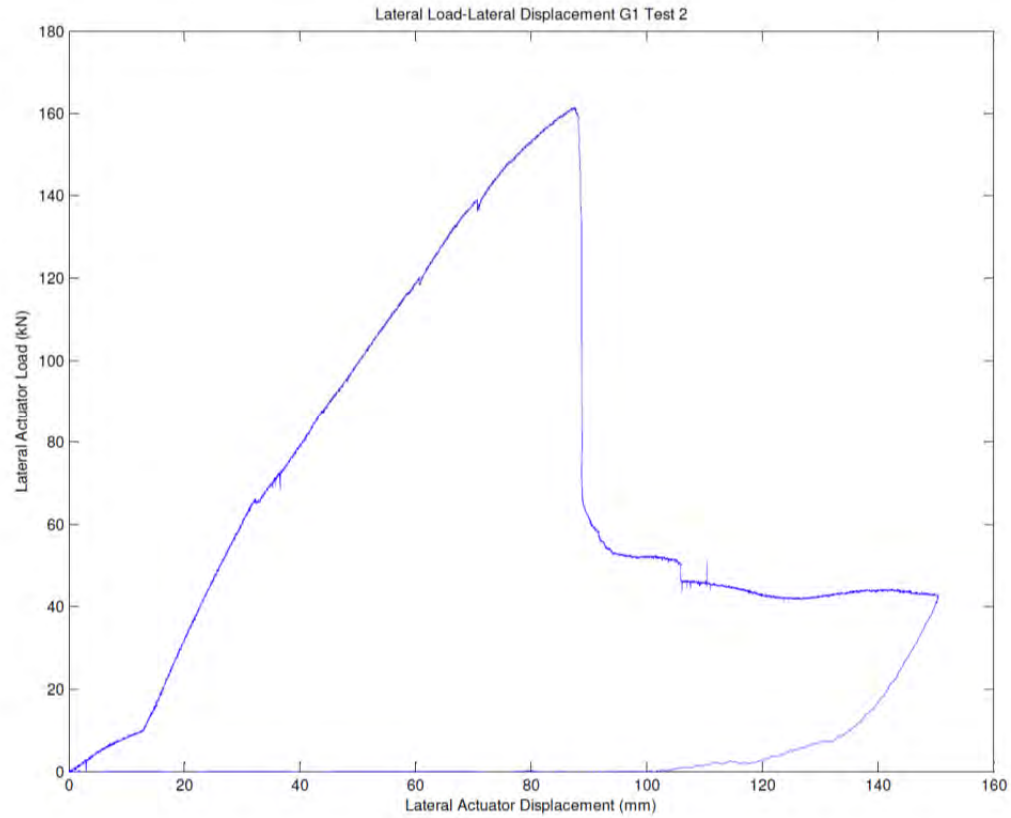
Figure 42: Load/Deflection Curve of Top of Bracket, G-1-2 (Note that the primary failure mechanism was characterized by the concrete cover above the Nelson studs breaking away as the rigid studs reached a critical curvature demand)

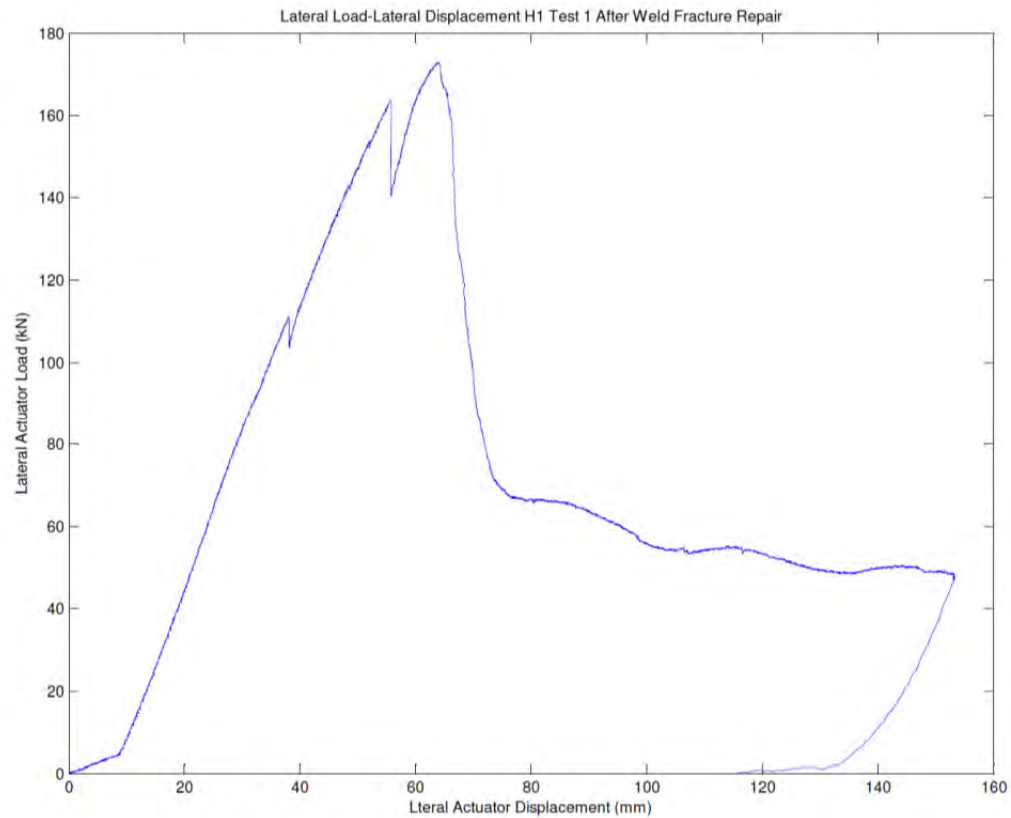
Figure 44: Load/Deflection Curve of Top of Bracket, H-1-1 (Note that the primary failure mechanism was characterized by the concrete cover above the Nelson studs breaking away as the rigid studs reached a critical curvature demand)

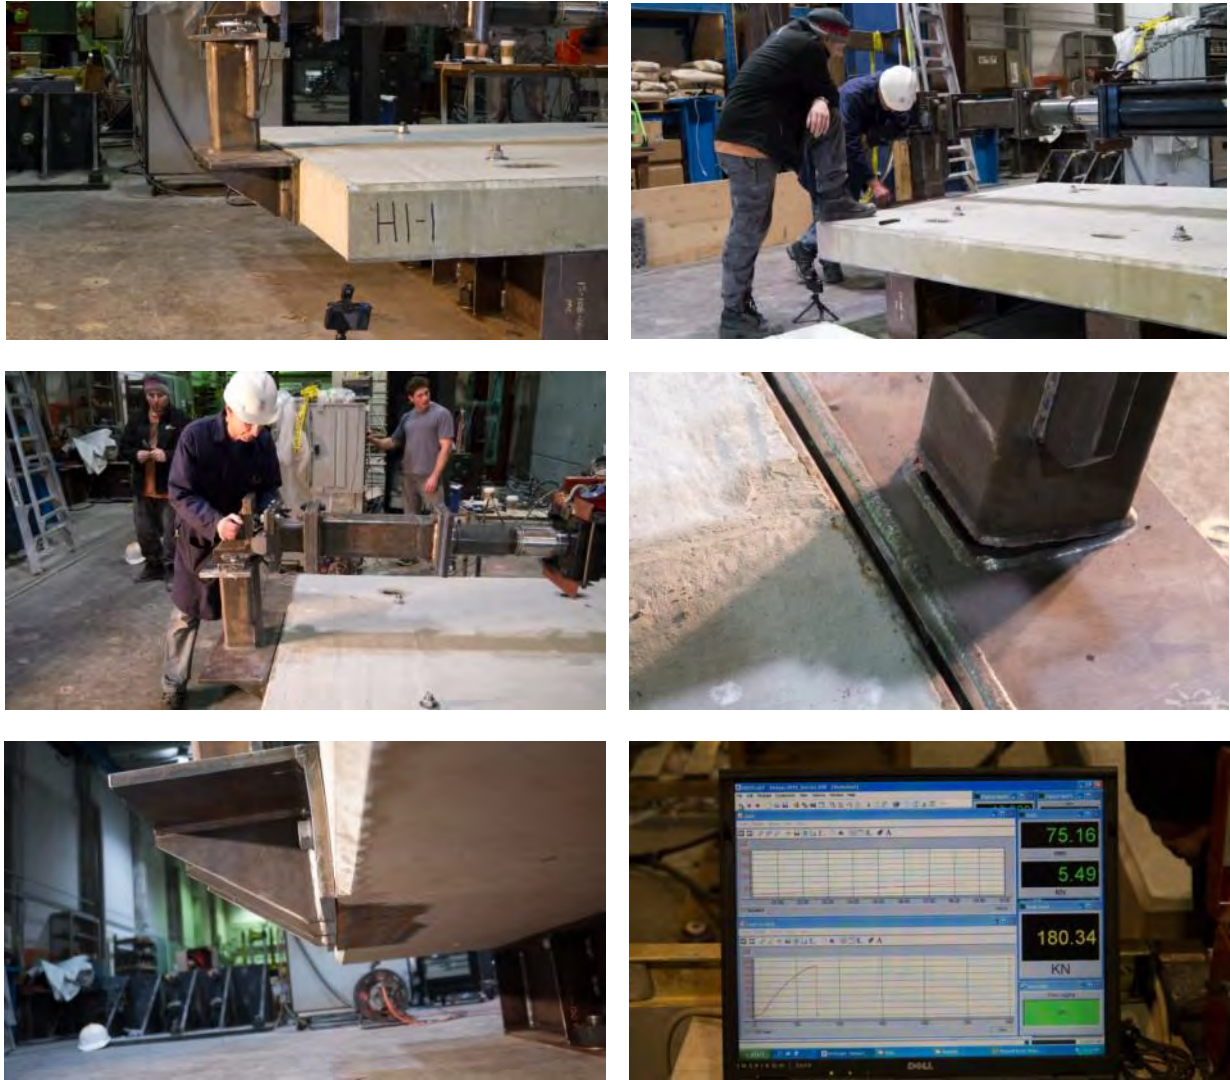
Figure 45: Images from H-1-1 to weld failure at post foot

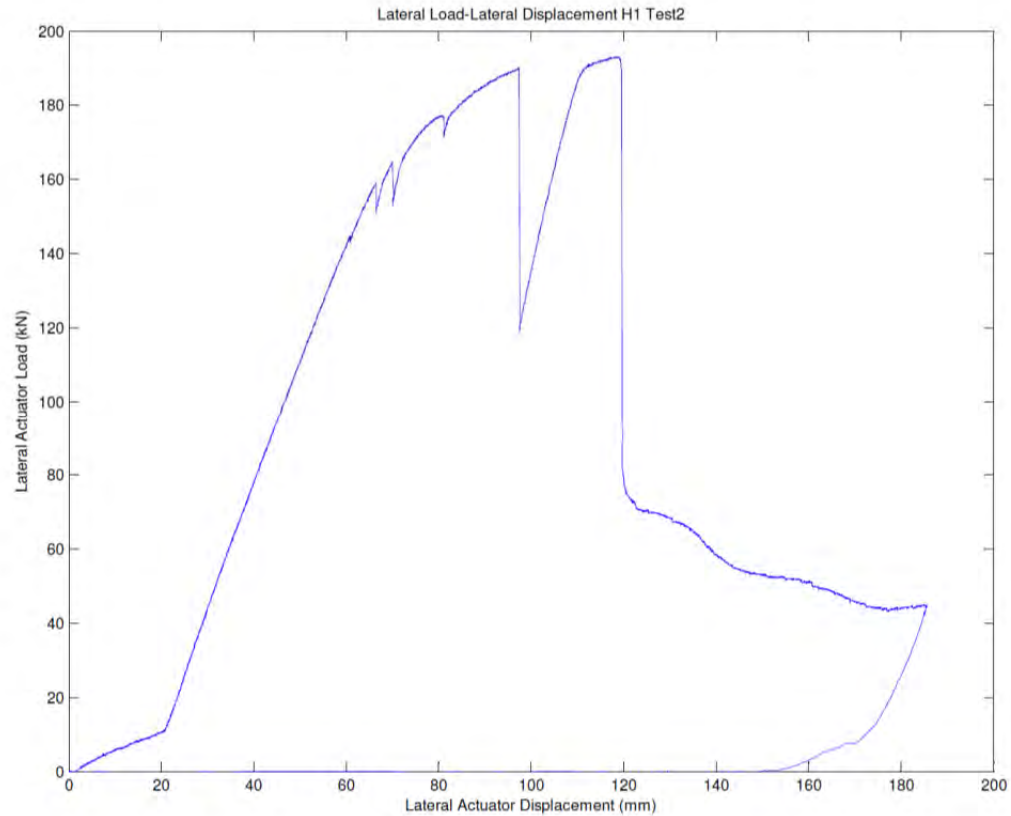
Figure 47: Load/Deflection Curve of Top of Bracket, H-1-2 (Note the major drop in load at 97 mm lateral displacement was caused by the slippage of the support apparatus. Also note that the primary failure mechanism was characterized by the concrete cover above the Nelson studs breaking away as the rigid studs reached a critical curvature demand)

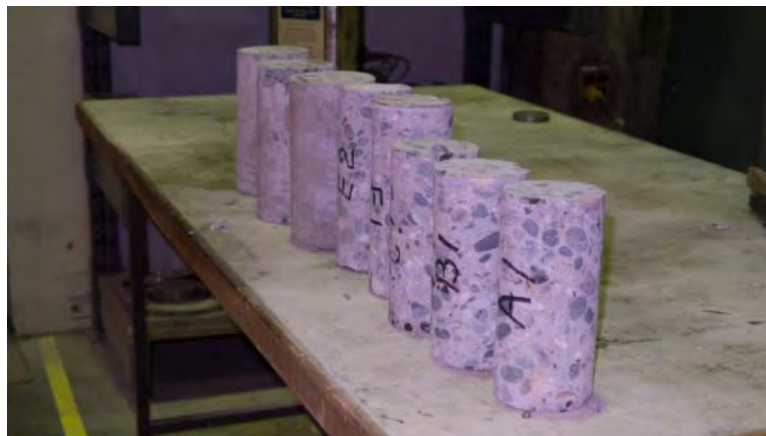
Figure 49: Compression Test Specimen

676D	Originally cast cylinder faces exhibiting columnar type fracture

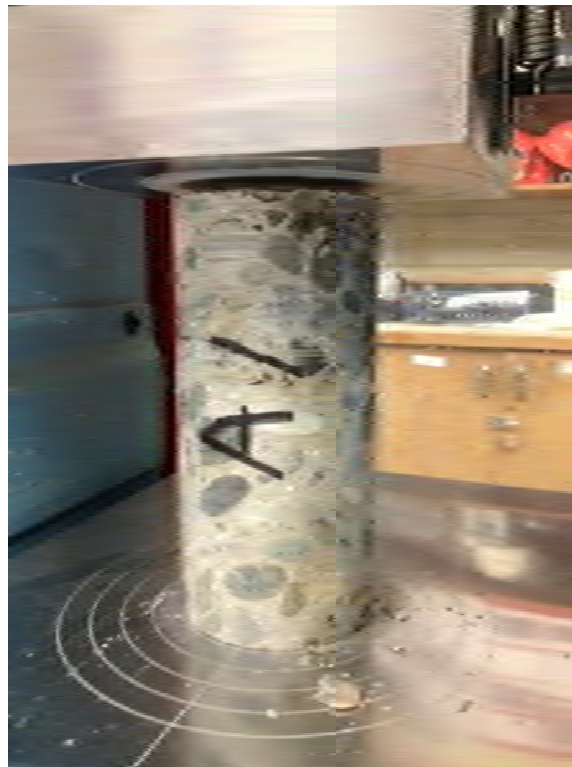
Figure 50: Core Compression Specimen A-1, precision machined compression surfaces

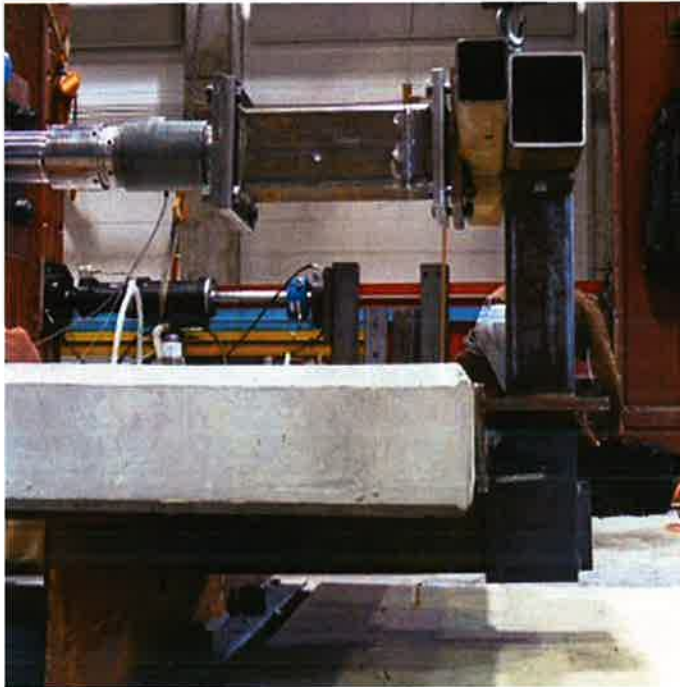
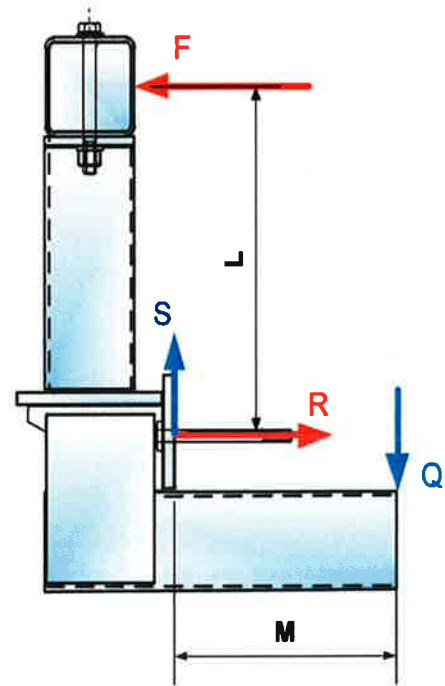
Figure 1
Modified HSS Guide Retrofit Rail

Under transverse loading, the standard side mounted HSS Guide Retrofit Rail reacts in compression against the concrete deck below the location of the bolt insert; this reaction force magnifies the horizontal tension load applied to the bolts as discussed in our Memorandum titled “*Classification of HSS Guide Retrofit Bridge Rail*”, May 2012. The modified HSS Guide Retrofit Rail with knee-brace, transfers the applied transverse force to the bearing location of the knee-brace via rotation about the bolt inserts. The resultant force is resisted by shear in the anchor bolts (as opposed to tension) and the reaction of the knee-brace against the underside of deck (or girder in the case of the experimental test). As a result, the failure mechanism is different to that observed for the side mounted HSS Guide Retrofit Rail, with the anchor bolt inserts punching through the underside of the deck rather than concrete crushing or bolts fracturing as previously observed.

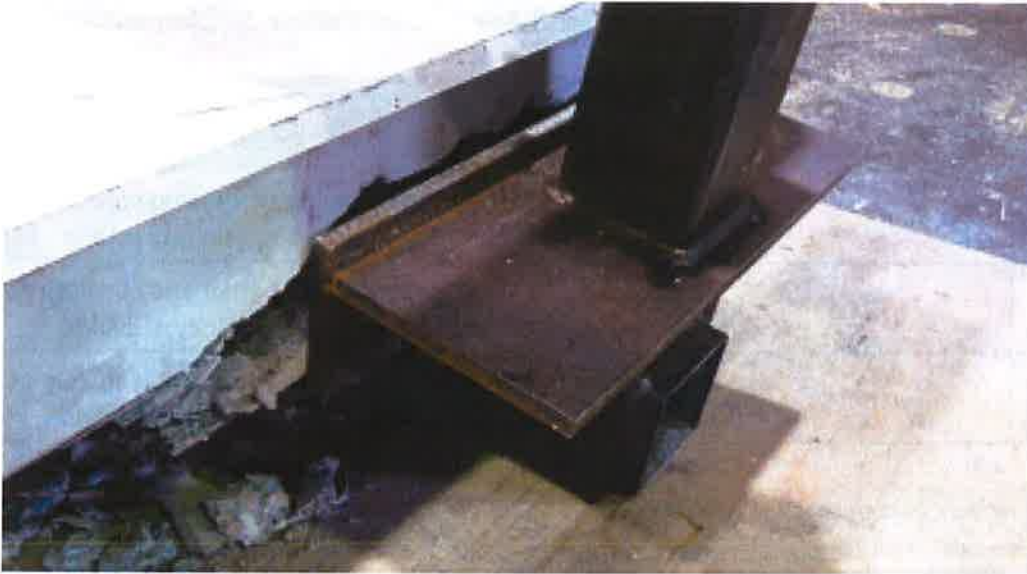
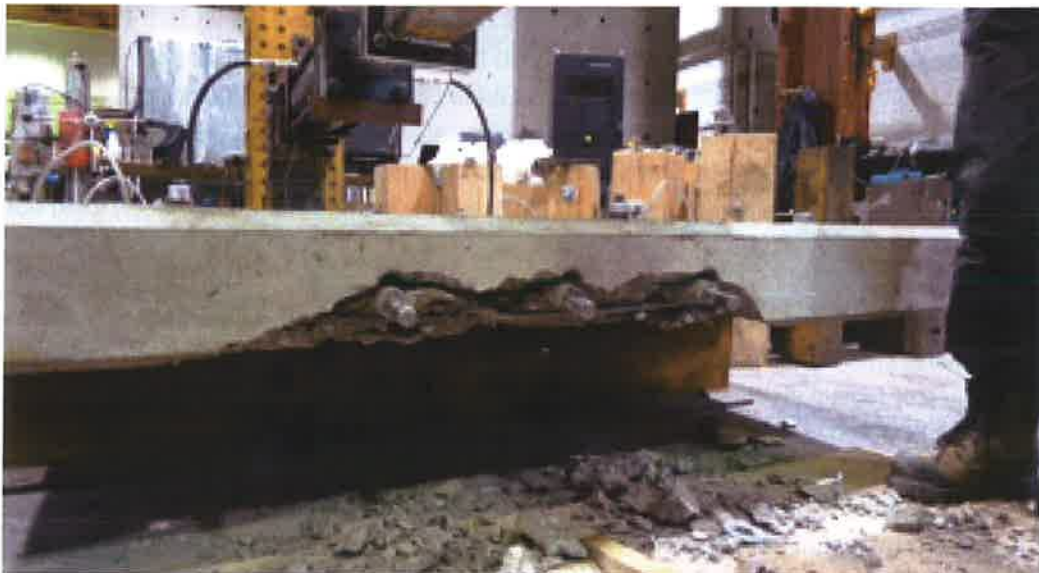
Figure 2
Typical Observed Failure of the Modified HSS Guide Retrofit Rail

Figure 2 illustrates the observed failure mode of the modified HSS Guide Retrofit Rail.
