**PROCEDURES FOR INSPECTION  
AND EVALUATION OF  
GLUED-LAMINATED BRIDGES,  
MINISTRY OF FORESTS**

**Prepared by: Vera Pronker, P.Eng.  
Bridge Engineer  
Engineering Section  
Timber Harvesting Branch**

**Date: November, 1993**

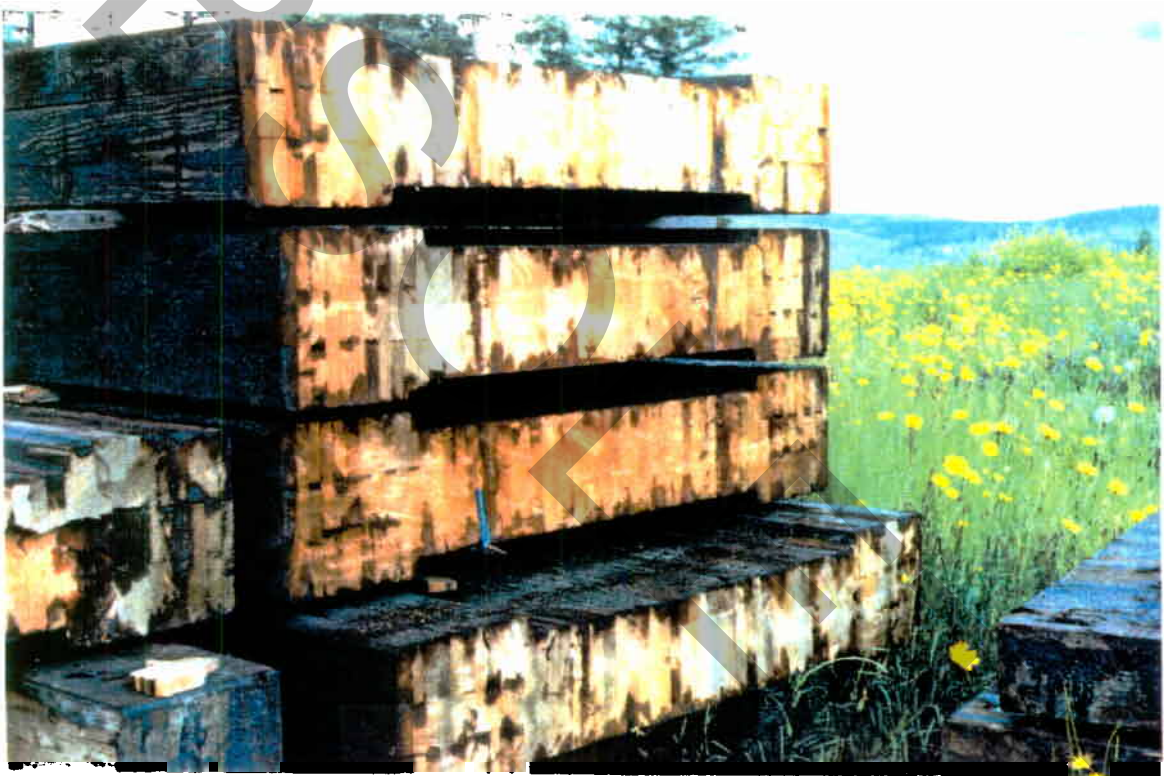
1. Glued-laminated girders that were taken out of service, as a result of consultant's recommendations, due to observed cracks. These girders are now stored in the service yard of Cariboo Forest Region.

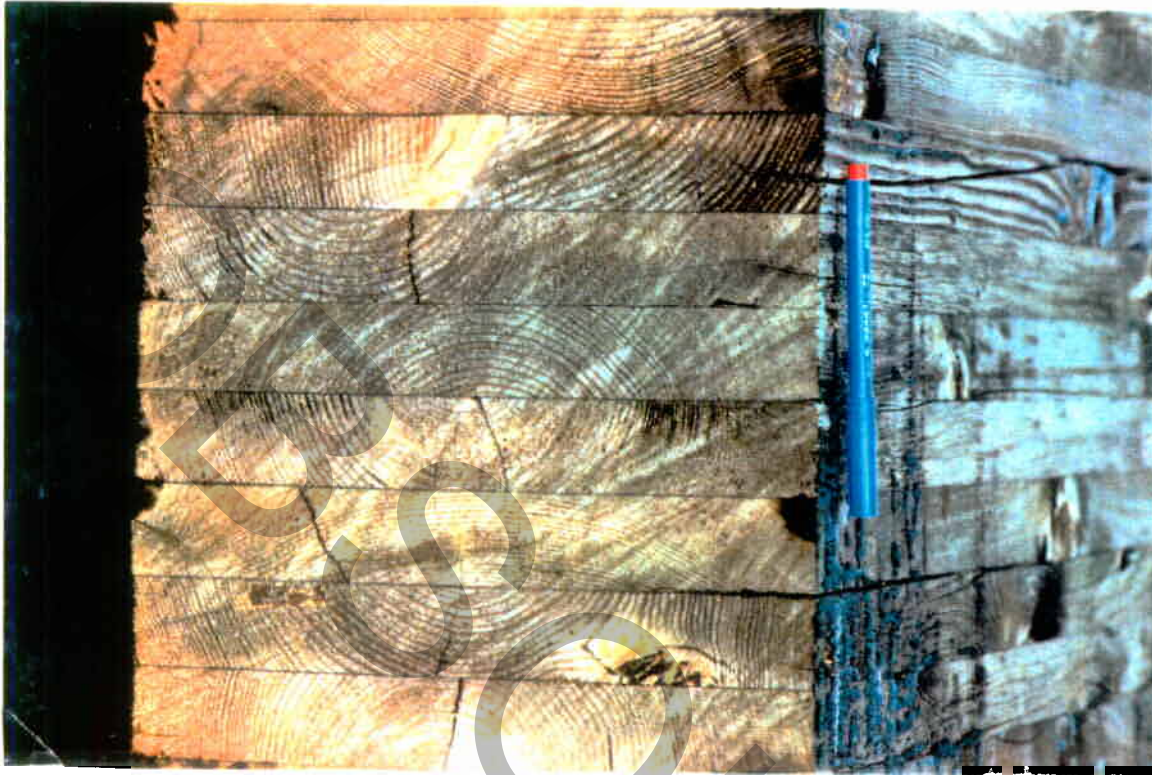
2.

The bridge girders were cut into 20.0 feet long segments for ease of transportation. It is interesting to observe the extent of the surface checking. These surface checks would certainly not reduce the capacity of the girder section !

(R. Foschi, report on Glulam Girder Bridges, 1992: "Structures with full through cracks with length over half the depth should be considered suspect. However, these cracks should not be confused with surface checks or cracks. Coring should be used to probe the depth of existing cracks.")

**Structures with full through cracks with length over half the depth should be considered suspect. However these cracks should not be confused with surface cracks or checks. Coring should be used to probe the depth of existing cracks."**

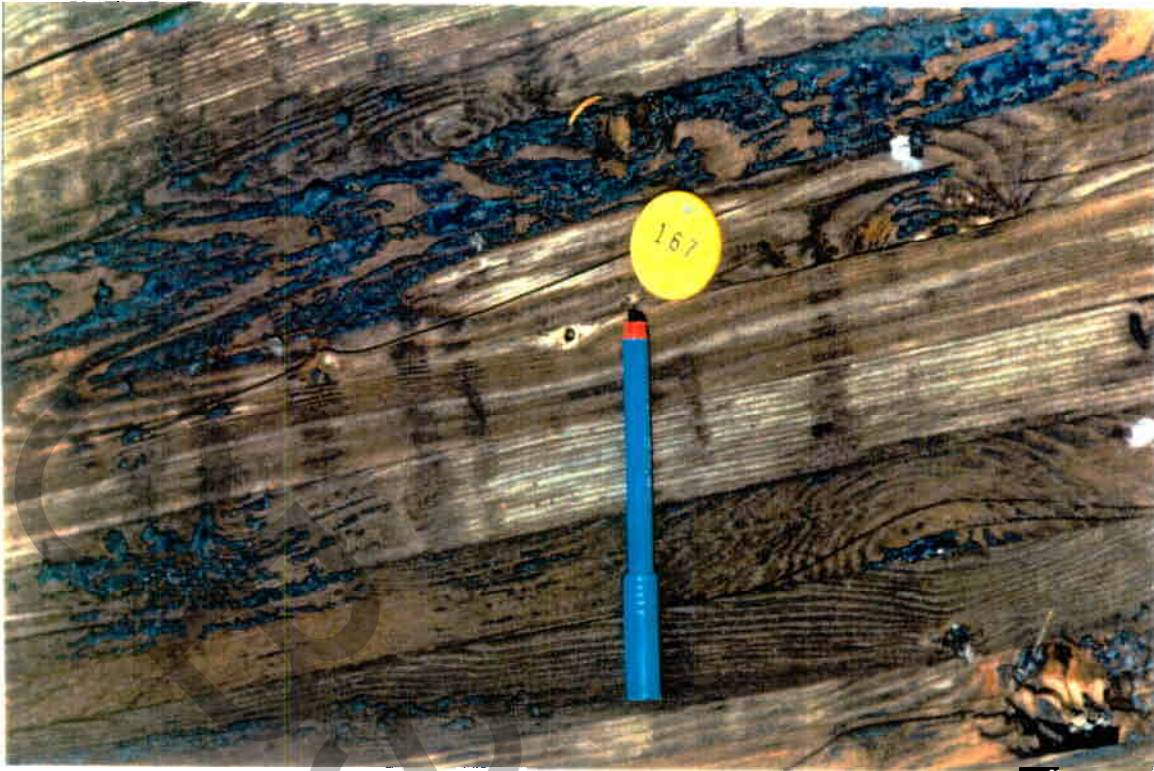
3.  
Cracks were marked by tags by the inspector,  
in order to observe their possible  
propagation with time.

In addition to crack extent, it is useful to try to establish whether or not a crack is stable under load and environmental changes. Cracks can be mapped and tagged, with special tags at the ends, and then revisited at regular intervals. Yearly intervals would be appropriate if the crack is not alarmingly large. A history of the growth of the crack and corresponding load history would assist greatly to determine the cause of the crack. If it grows due to load then it is likely at a critical stress for crack growth and may require a down rating.
