## **Weather thresholds and Operational Safety Planning, Turbid Creek, Mount Cayley, Squamish River Valley, BC.**

Final: March 19, 2013

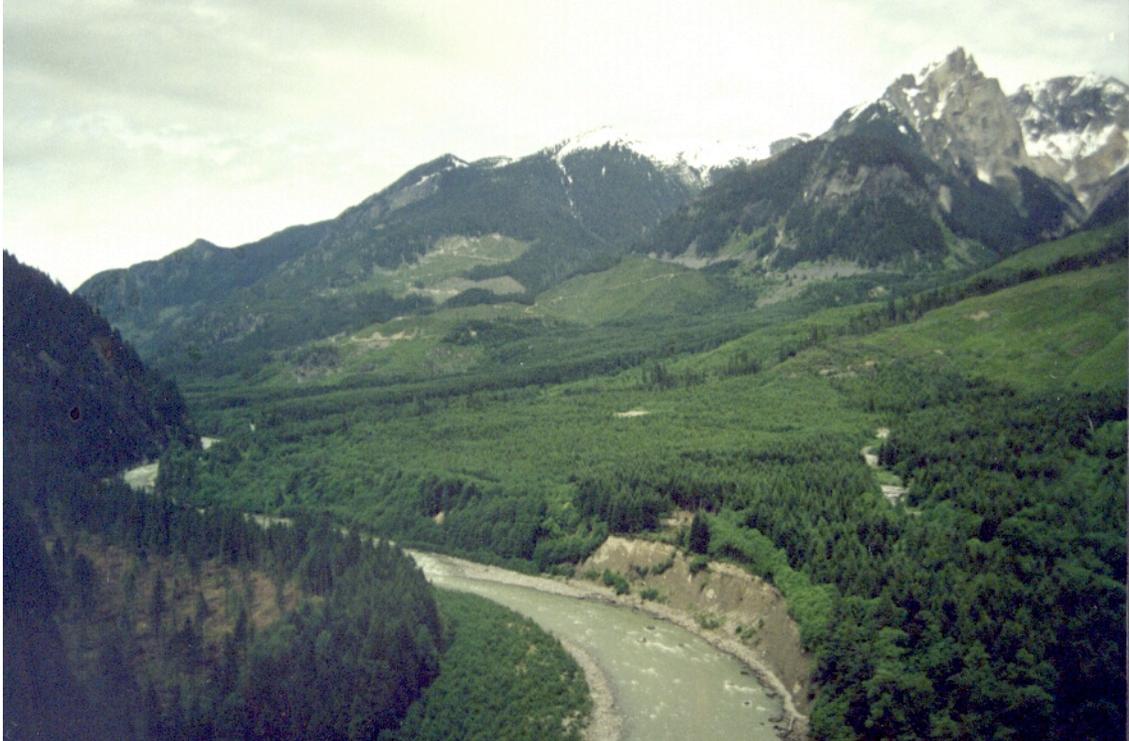
**Figure 2.** View north up Squamish River to Mount Cayley. The river cutbank exposes a 14 m thick sequence of landslide materials deposited primarily by the 4800 year old landslide (Evans and Brooks 1991).

Turbid Creek (Fig. 1), known locally as Mud Creek<sup>1</sup>, drains the southwest slope of Mt Cayley, a Pleistocene stratovolcano located 50 km north of Squamish. The slopes of Mount Cayley have a well-documented history of landslide activity, and there is an extensive colluvial apron filling the Squamish Valley at the foot of the mountain (Fig. 2).

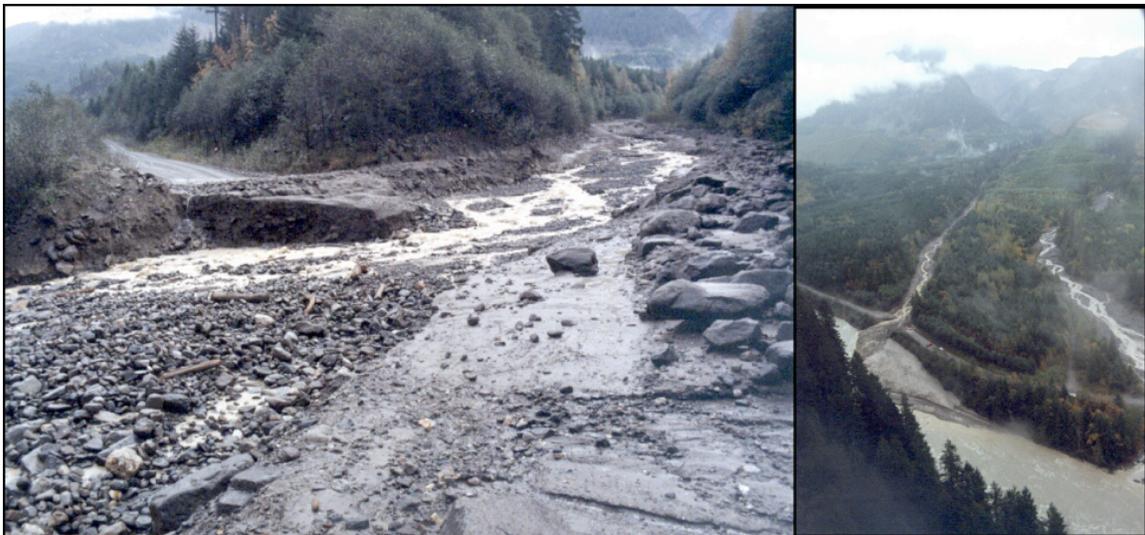
**Figure 3.** Washout at Turbid Creek in 1997. Exact date of occurrence unknown (from photos on file with Friele). Note this is a typical small, channelised event; it destroyed the crossing and filled Squamish River with debris, and may have briefly dammed the river.

The Squamish mainline forest service road (FSR) crosses the debris apron and is frequently washed out at Turbid Creek (Fig. 3), presenting a hazard affecting road users and often leading to stranding of workers and tourists upstream of the washout. Further, washouts fill the road sump and/or damage or destroy the existing crossing requiring maintenance/reconstruction. Reconstruction puts road crews directly in the hazard zone for hours to weeks. Presently, during reconstruction there are no protocols in place for monitoring the hazard nor ensuring a safe work site once an event has taken place.
