INCIDENT NAME

Big Bar Landslide

DATE PREPARED

July 27, 2019

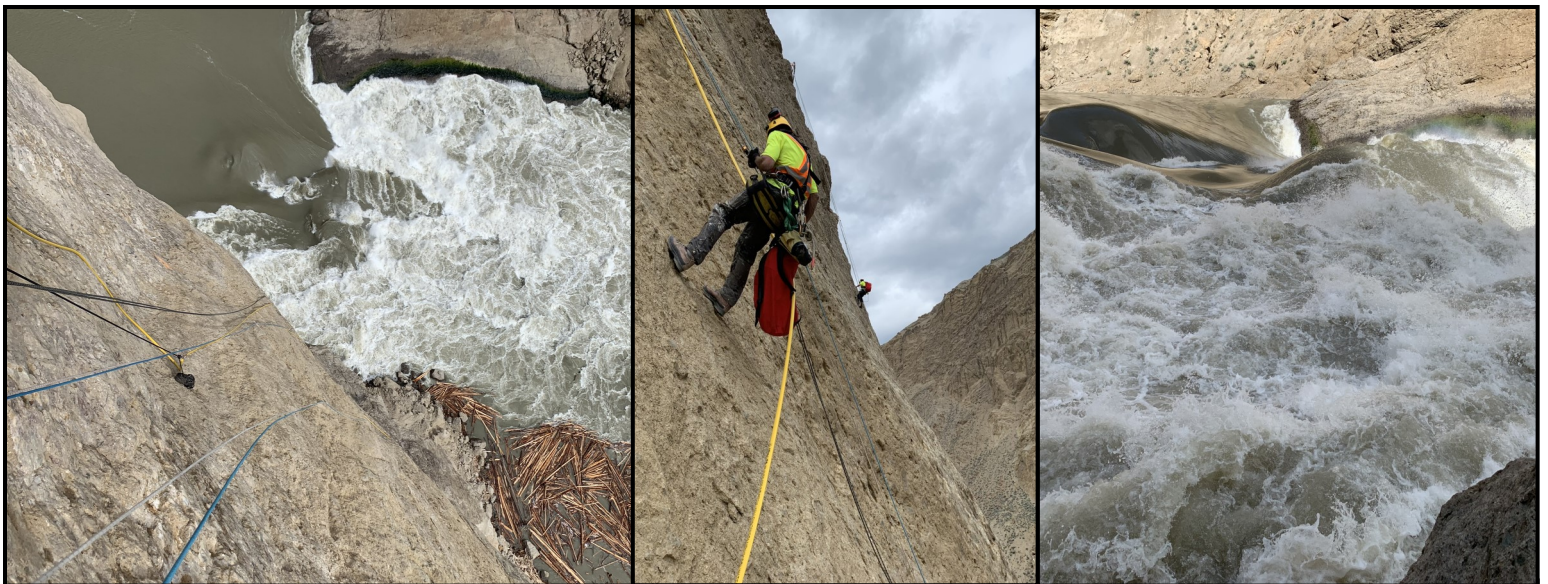
The pictures above show the extreme slope of the landslide face, as well as the rough water conditions in the river below.

- Scaling crews continue to remove rock from the landslide face, with the assistance of helicopter sluicing. Last night we began rock manipulation at the water level and this will continue today. The purpose of rock manipulation is to strategically place rock into predetermined locations in the river, based on river hydraulics, to create a natural fish passage.
