# MOUNT POLLEY MINING CORPORATION POST-EVENT ENVIRONMENTAL IMPACT ASSESSMENT REPORT – KEY FINDINGS REPORT

JUNE 5, 2015

Golder Associates Ltd.  
Suite 200 - 2920 Virtual Way,  
Vancouver, BC, V5M 0C4

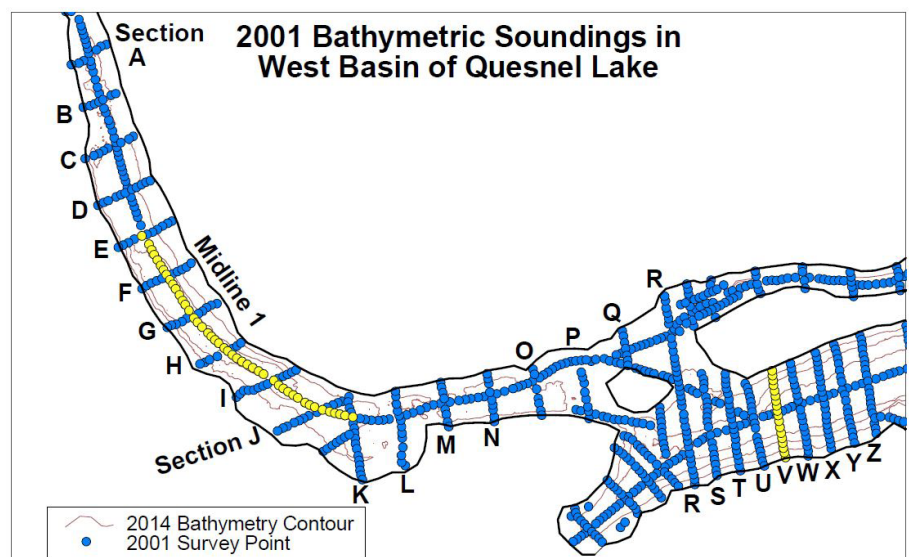
Figure 5: Lake depth profiles (bathymetry) collected in 2001

- Multi-beam Sonar was used to develop a depth profile of the bottom of Quesnel Lake in September 2014 and that was compared with spot measurements of lake depth carried out in 2001 (Figure 5 and Figure 6).
- Sub-bottom profiling is used to identify and characterize layers of sediment or rock under the lake bed. Layers of sediment or rock provide different reflections in the profiles and these can be used to identify areas where sediments have settled. This information was used together with the multi-beam sonar data to estimate where sediments have deposited on the bed of Quesnel Lake (Figure 7).
- A water level gauge, operated by the Water Survey of Canada is located on Quesnel Lake. The gauge recorded a sudden rise in the lake level on August 4, 2014 (Figure 8). By examining the lake level

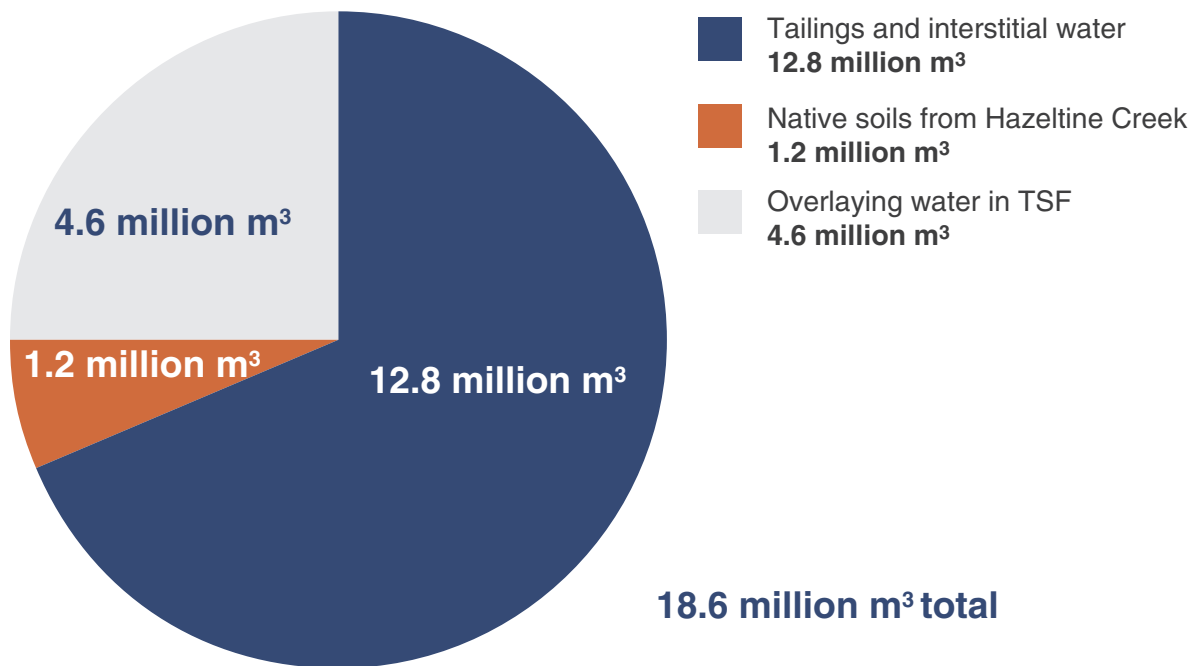
Figure 9: Sediment into Quesnel Lake

Using this information, Tetra Tech EBA estimated that  $18.6 \pm 1.4$  million m<sup>3</sup> entered Quesnel Lake. The breakdown of that material is shown in Figure 9. Most of this material deposited deep in the West Basin, below 100 m depth. The area of that deposit was estimated to be approximately 1.81 km<sup>2</sup>. In some places the deposited material was estimated to be up to 10 m thick; however, those estimates were done soon after the spill and that depth is expected to decrease as the sediments consolidate/dewater/compact with time. For Polley Lake, the pre-tailings dam failure data does not allow an interpretation of post breach data.

This material on the lake bed resulted in a change in the lake bottom habitat and a disruption in the community of small animals that live in the deep lake bed. This impact is part of ongoing studies but early sampling suggests that some recovery of those organisms may have already begun. Sampling of those bottom-dwelling organisms following that deposition and settling of the sediments is necessary to verify expectations that the sediments will recover their function.

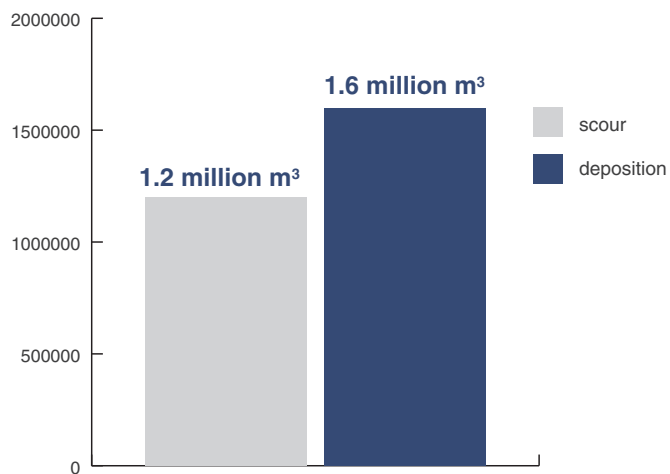
Figure 10: Hazeltnine Creek tailings/soil deposition\*

Following the dam failure, a thick deposit of tailings blocked the outlet of Polley Lake at the Plug area. Tailings deposits in this area near the dam failure location were the thickest, measuring > 3.5 m in some areas.

Figure 10 is a simple graphic showing the extent of eroded material and deposited material along the Hazeltine Creek Channel. The deposition occurred primarily near Polley Lake, and the erosion occurred predominantly in the middle reaches of Hazeltine Creek. The debris flow carved a new valley, wider and deeper, along the entire length of Hazeltine Creek by removing sediments from the creek bed, and soil and forest from the floodplain.

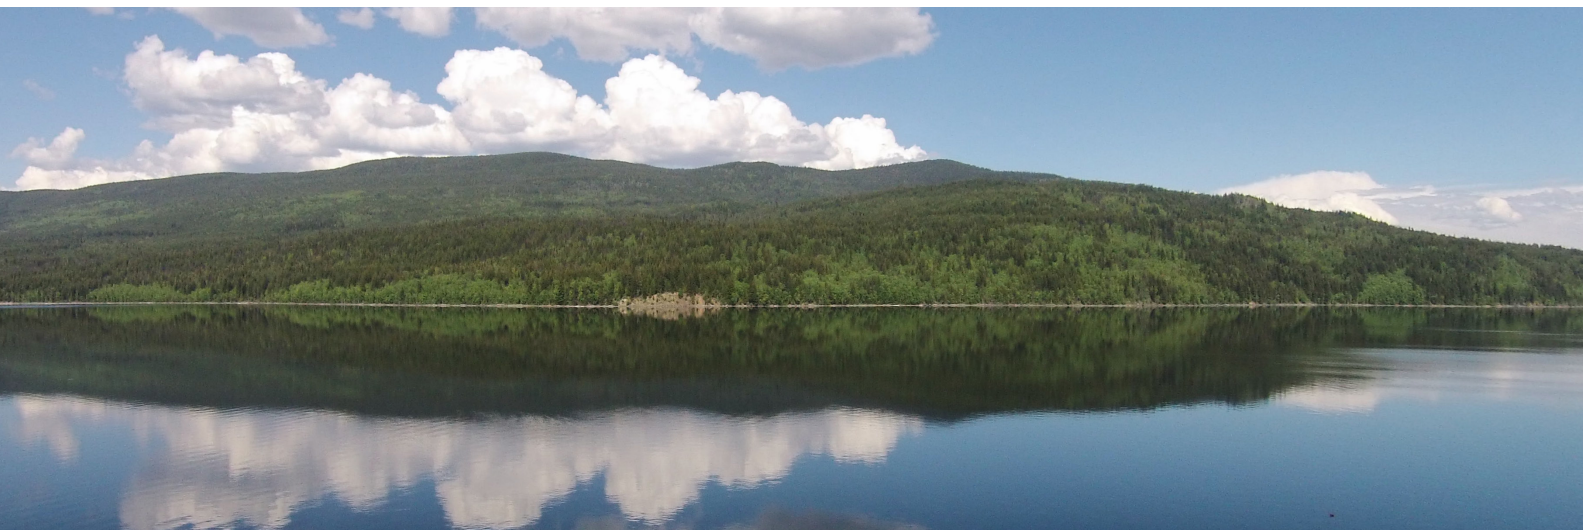
Quesnel Lake as viewed from the air, at the mouth of Hazeltine Creek, May 20, 2015

The water in Hazeltine Creek is now running clear and the turbidity of the main body of Quesnel Lake is in the range of pre-event conditions. There is still a slight increase in turbidity near the bottom of Quesnel Lake and that is expected to clear, but the main body of the lake has returned to normal conditions and is expected to stay that way into the future.

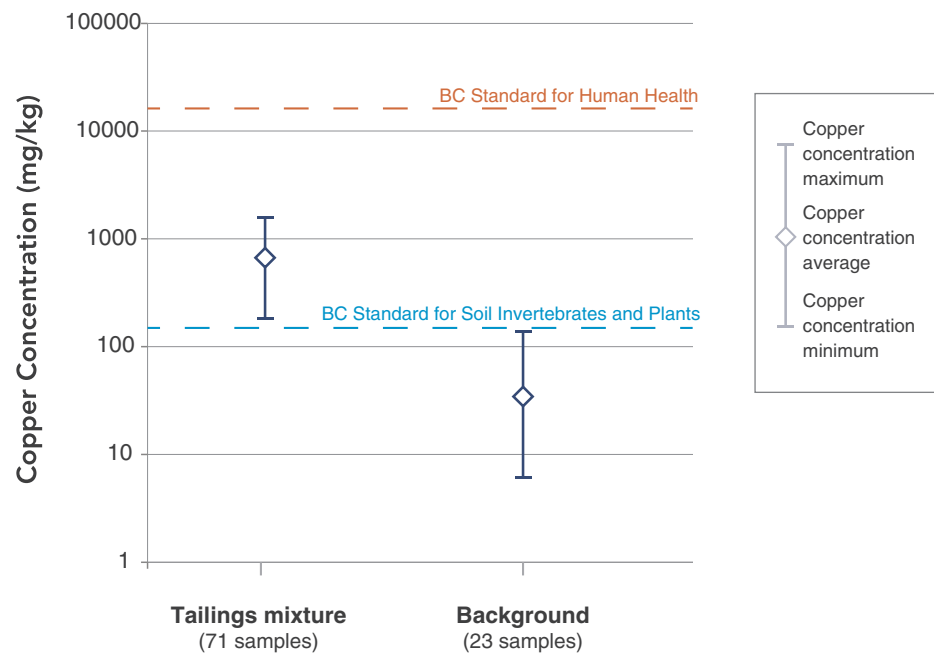
Figure 12: Copper concentrations in the tailings mixture from Hazeltine Creek area compared to background soil

Eighty-eight samples of the tailings soil mixture and twenty-three background soil samples were collected from 18 transects along the Hazeltine Creek channel to evaluate the quality of the tailings mixture in the soil impact assessment. Consistent with the mineral mixture of the tailings discussed previously, the concentrations of copper in the tailings mixture are higher than in the native soil alone, and higher than the BC Soil Standard for the protection of soil invertebrates and plants. The copper concentration in soil is far below the standard for the protection of human health meaning that the tailings mixture is safe for direct human contact.

Based on these studies, the data indicate that the quality of the mixture of tailings and soil deposited in the Hazeltine Creek flood plain and surrounding forest has changed from pre-dam failure conditions. The copper concentrations are higher, the soil pH is higher, the deposited mixture is layered in some areas based on the sand and silt content, and the nutrient content of tailings mixture is lower.

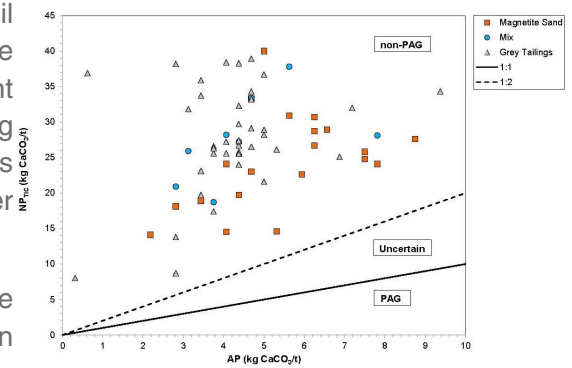
Figure 13: Acid rock drainage (ARD) potential is assessed using neutralization potential ratios

However, studies to date have shown that the tailings will not cause acid-generating conditions and the copper and other metals in the tailing mixture are tightly bound and would not leach into water. These studies indicate that the metals may not be available for uptake to plants and other soil-dwelling biota. Further assessment of the impact of the tailings mixture to terrestrial plants and animals will be conducted in the Ecological Risk Assessment.

All of the samples collected along Hazeltine Creek showed very low potential for ARD.

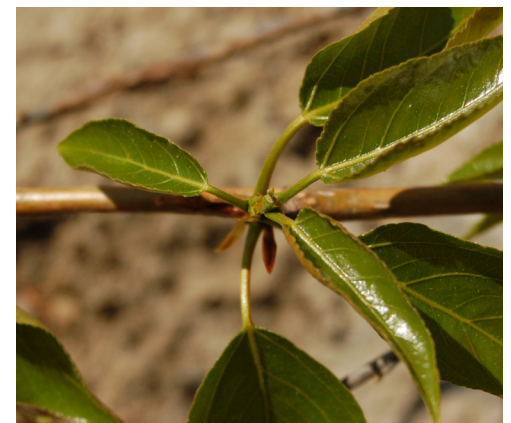
Vegetation planted in lower Hazeltine Creek shows early signs of successful growth

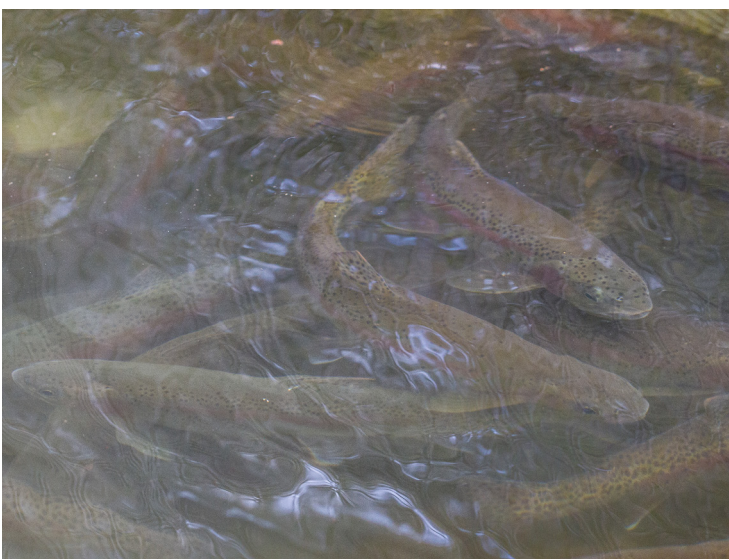
Rainbow trout gathering at the fish fence at the outlet from Polley Lake to Hazeltine Creek in spring 2015

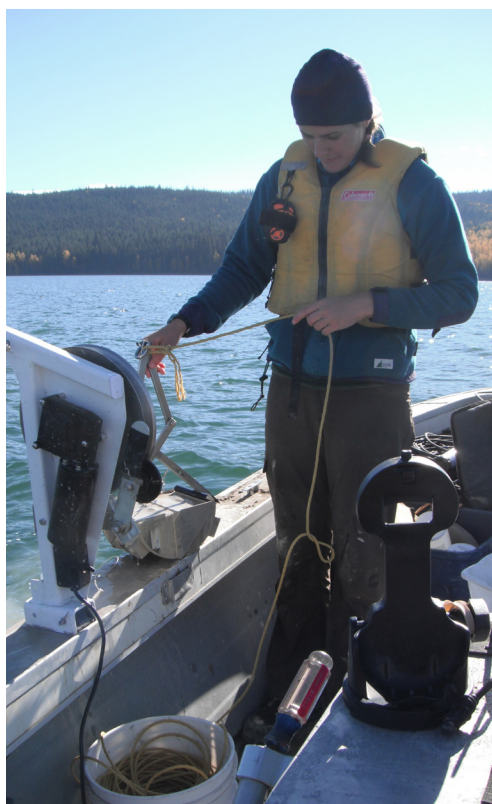
A scientist retrieves a sediment sample from the bottom of Quesnel Lake using a Petite Ponar device

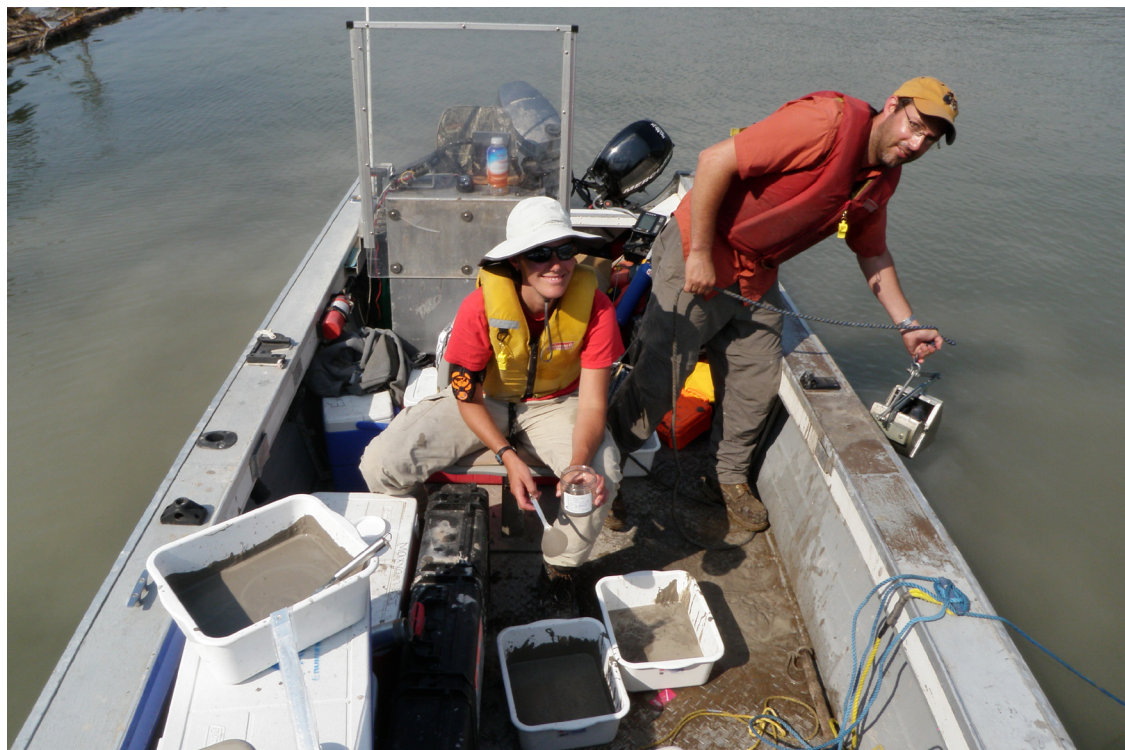
Sediment sample collection on Quesnel Lake near the mouth of Hazeltine Creek

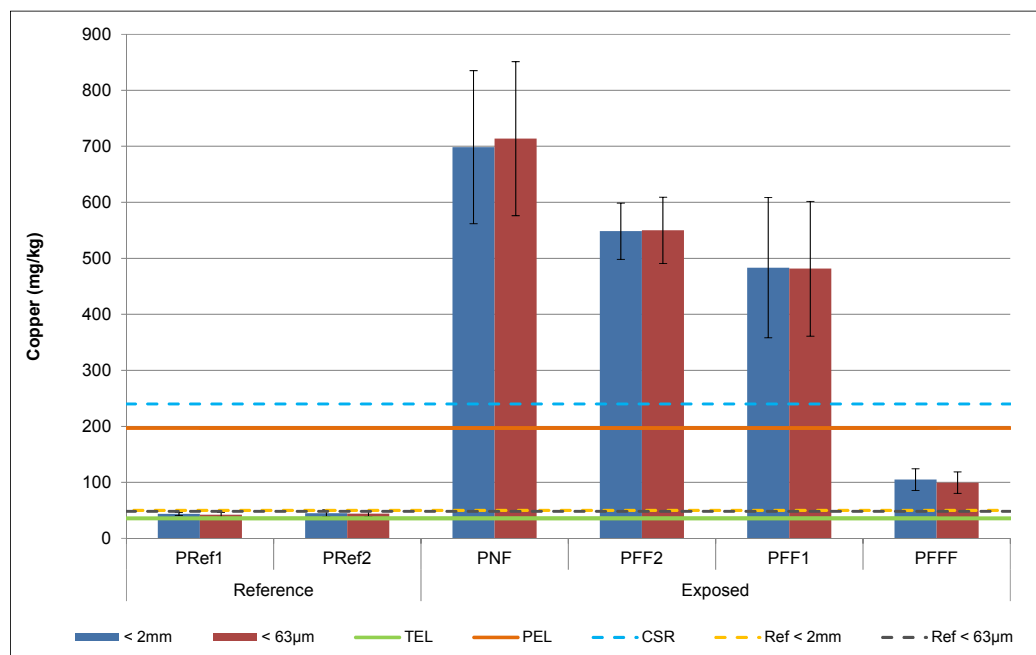
Figure 17: Mean copper concentrations ( $\pm t^*SE$ ) in sediment from profundal sampling areas in Quesnel Lake, Mount Polley Mine, 2014

As expected, the sediment locations closest to the dam failure had higher concentrations of copper than samples taken more distant from the TSF. Sediments in Quesnel Lake near Hazeltine Creek had concentrations of copper (Figure 17) that exceeded the provincial sediment quality guidelines and are higher than background concentrations. Consistent with the findings of the soil quality assessment, the sediments also exhibited low nutrient content and low concentrations of organic carbon content. Several studies conducted in collaboration with the geochemical assessment indicated low potential for bioavailability of metals (including copper) to benthic-dwelling organisms in the lakes and river. Therefore, although copper concentrations in sediment exceed provincial guidelines, the copper and other associated metals are not expected to be harmful.

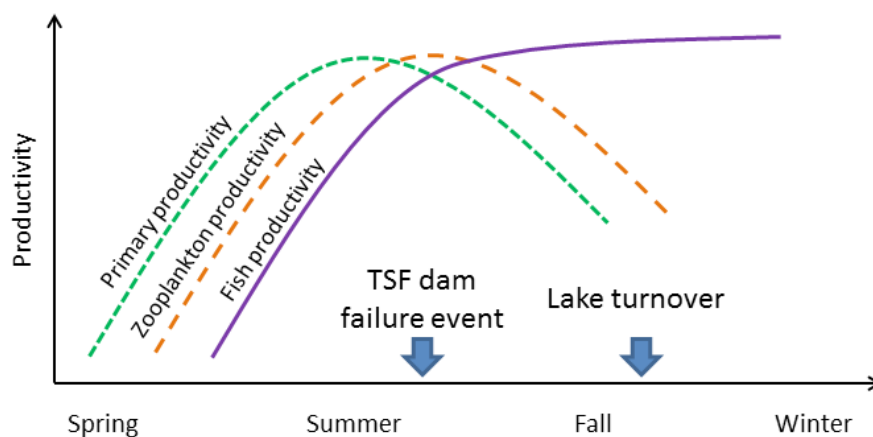
Figure 18: A conceptual lake productivity model under normal conditions showing rise of populations and, after a lag time, rise of their consumers' population/size

Figure 18 shows a generalized conceptual diagram of the dynamics of lake productivity starting in the spring. As the days become longer, the intensity of light energy becomes greater and water temperatures begin to warm, phytoplankton, which are the single-celled small plants that live freely in the water column begin to grow and multiply. The phytoplankton are grazed by zooplankton which begin to increase in size and number as their food supply becomes greater. The zooplankton are eaten by fish, which grow. By late summer and into fall, the phyto- and zooplankton begin to decrease in number as light energy begins to decrease and as fish prey on the zooplankton. The TSF dam failure occurred in late summer; however, because the debris flow was denser than the lake and it sank to the bottom below the zone where light significantly penetrates, the impact on phytoplankton may have been less than had it happened at a different time. When the lake overturned in fall, the cloudy water would have been capable of decreasing photosynthesis by reducing light but this happened in mid-November (winter) when photosynthesis is reduced because of lower light availability and colder water temperatures.

The debris flow would have also brought added nutrients to the lake in August and these nutrients, which are naturally low in Quesnel Lake would allow a larger crop of phytoplankton to grow. While studies carried out did not indicate a larger population of zooplankton based on individual “grab” samples, data provided by Fisheries and Oceans Canada did identify a notable increase in size and abundance of juvenile sockeye salmon. Their size may indicate that nutrients washed into the lake could have increased their food supply.

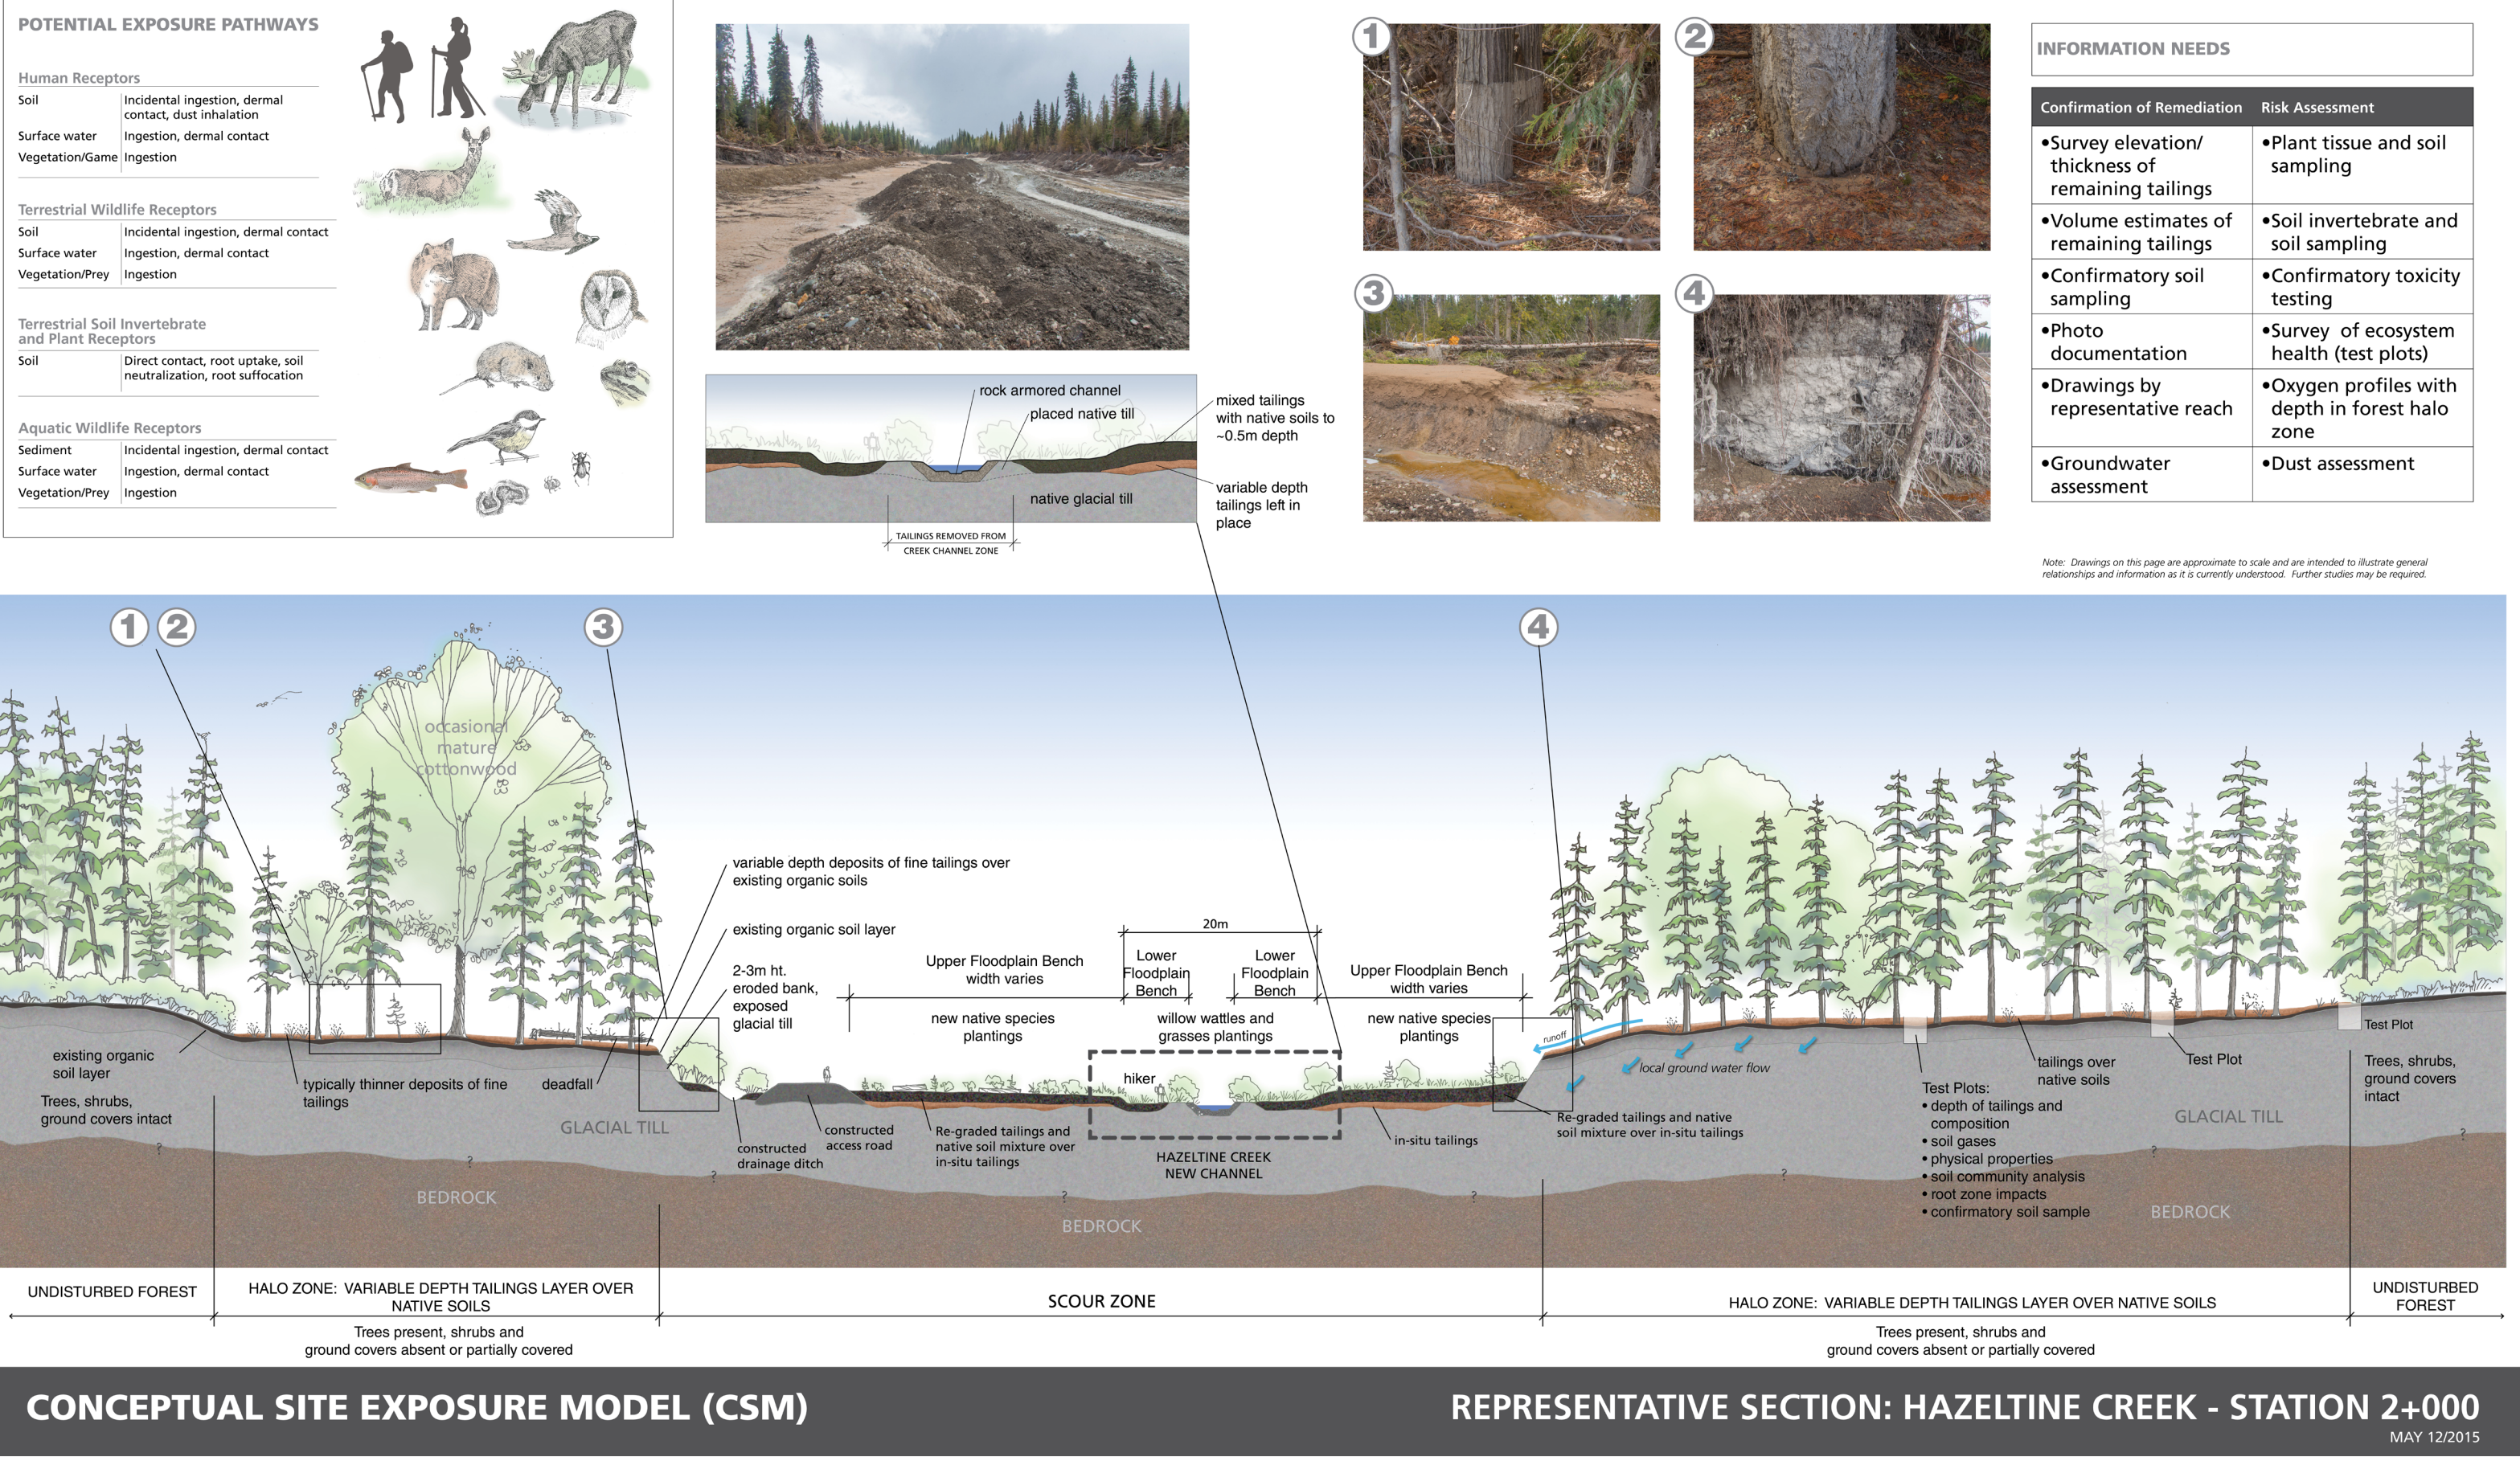
Figure 20: Conceptual Site Exposure Model (CSM) - Representative Section: Hazeltine Creek Station 2+000

This process has been started and is reflected in the Conceptual Site Exposure Model (Figure 20). A sampling and analysis plan to obtain the data needed to understand contaminant exposure and potential effects has been started. The results from the long term tests, for example, the geochemistry test results that we not yet available at the time of writing the PEEIAR, will be incorporated into the risk assessment. Essentially, the Human Health and Ecological Risk Assessment will pick up from where the PEEIAR left off, adding data to support a longer term assessment of risk to both people and the environment.
