BC Ministry of Transportation and Infrastructure
Old Spences Bridge
2012 Inspection Report

2013 December 6

Our Ref: 2024-RPT-GEN-002-1

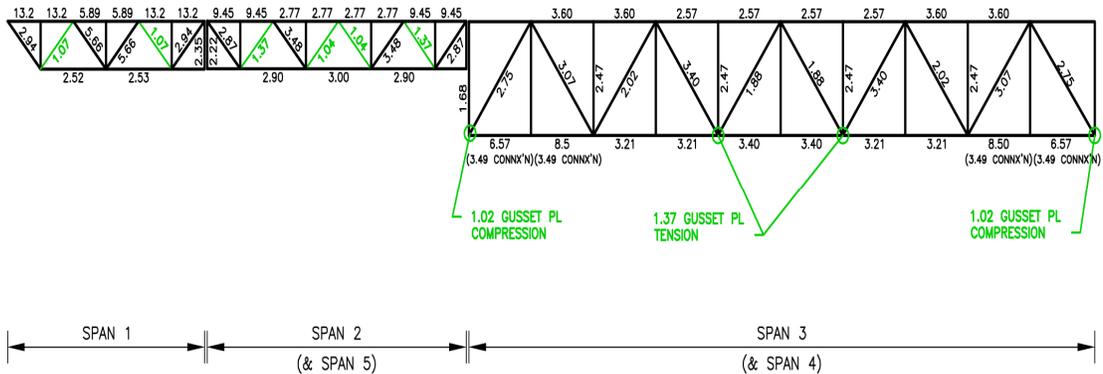
Figure 4: Truss Member LLCF's and Connection Focus Areas

While all of the bridge members were reviewed during the inspection, the focus of the inspection was on the members identified in the 2012 Load Evaluation Report as having a Live Load Capacity Factor (LLCF) equal to 1.5 or less. These components are identified in Table 1 and are also shown in Figure 4 and Figure 5 as having an LLCF between 1.0 and 1.5 (shown in green), or an LLCF less than 1.0 (shown in red).

As illustrated in Figure 4, the 2012 Updated Load Evaluation Report noted a concern with the capacity of the uncorroded gusset plates at the following locations:

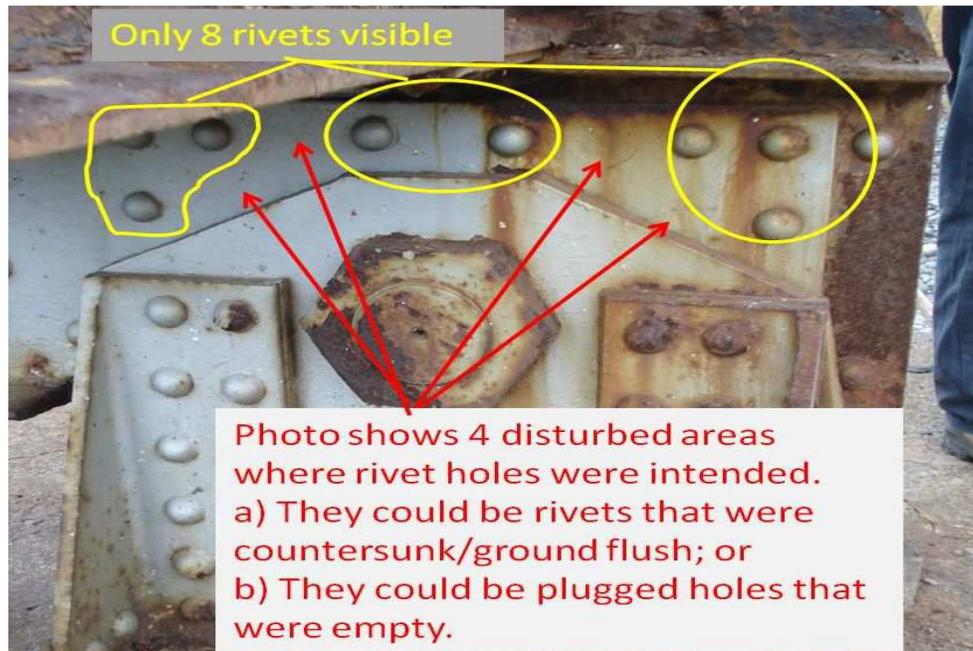
Figure 6: Pier 2 Bearing Focus Area (Identified in the Load Evaluation Report)

Item	Focus Areas
Stringers	<ul style="list-style-type: none"> • Areas of section loss and heavy corrosion on top flange.
Floorbeams	<ul style="list-style-type: none"> • Areas of section loss and heavy corrosion on top flange. • Areas of section loss in the web above bearing supports on the top chord.
Main Truss Members	<ul style="list-style-type: none"> • Diagonals and connections as identified in green; refer to Figure 4. • Secondary Batten plates on top and bottom chords (areas of section loss). • Gusset plates to vertical members (section loss). • Gusset plates to diagonals (areas of section loss along the length of the gusset plate immediately above the bottom chord channel).
Lateral Load Carrying Members	<ul style="list-style-type: none"> • Members with section loss and advanced corrosion, refer to Figure 5. • Section loss in gusset plates.
Bearings	<ul style="list-style-type: none"> • Number of rivets in Pier 2 bearings, refer to Figure 6. • Condition of anchor bolts.
