**TRAFFIC OPERATION AND  
SAFETY REVIEW AT LEE  
ROAD AND HIGHWAY 19A  
PARKSVILLE, BC**

**INSURANCE CORPORATION OF BRITISH COLUMBIA  
MINISTRY OF TRANSPORTATION**

May 2007

H-08182.00

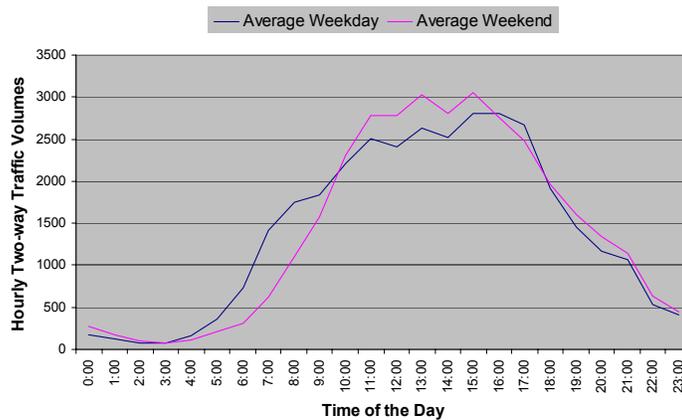
**FIGURE 2.10 AUGUST 2005 HOURLY TRAFFIC PROFILES IN THE AREA**

FIGURE 2.10, which illustrates the general hourly traffic profile of the area in August 2005, suggests that the average weekday and weekend peak hour traffic volumes occur between 1200 and 1700 hours in the afternoon period. Vehicle turning movement counts covering the peak hour periods on Saturday, 12 August 2006 and on Wednesday, 16 August 2006 for the study intersection, which have also been provided by the Ministry for this study, were selected for analysis. Analysis of the traffic counts found that the peak hour vehicle turning movement volumes occurred from 1600 to 1700 hours during the weekday (Wednesday), and from 1200 to 1300 hours during the weekend (Saturday).

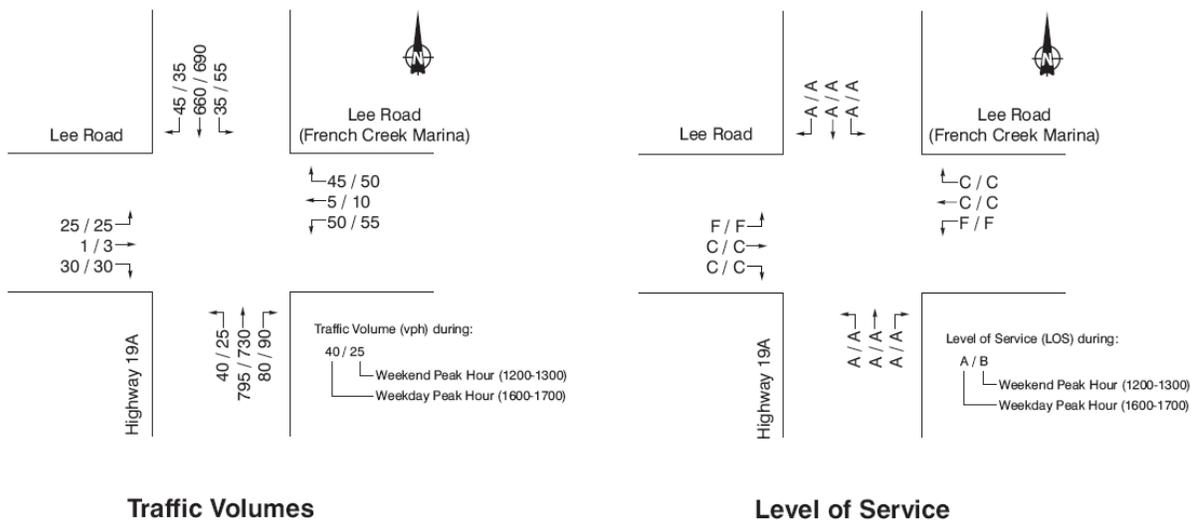
**FIGURE 2.11 WEEKDAY AND WEEKEND PEAK HOUR TRAFFIC CONDITIONS**

FIGURE 2.11 summarises the weekday and weekend peak hour traffic volumes of the study intersection. The existing operational performance of the study intersection was assessed in terms of Level of Service and was also shown in FIGURE 2.11.

The intersection performance analysis as presented in FIGURE 2.11 was conducted using the computer simulation software, Synchro, developed by Trafficware and based on the methods outlined in the Highway Capacity Manual issued by the Transportation Research Board in 2000. The estimated queue lengths from the Synchro analysis are summarised in TABLE 2.1 for the two critical left-turn movements on Lee Road eastbound and westbound. Maximum left-turn queue length was estimated to be about 39 metres (around six to seven vehicles) during the weekend peak hour.

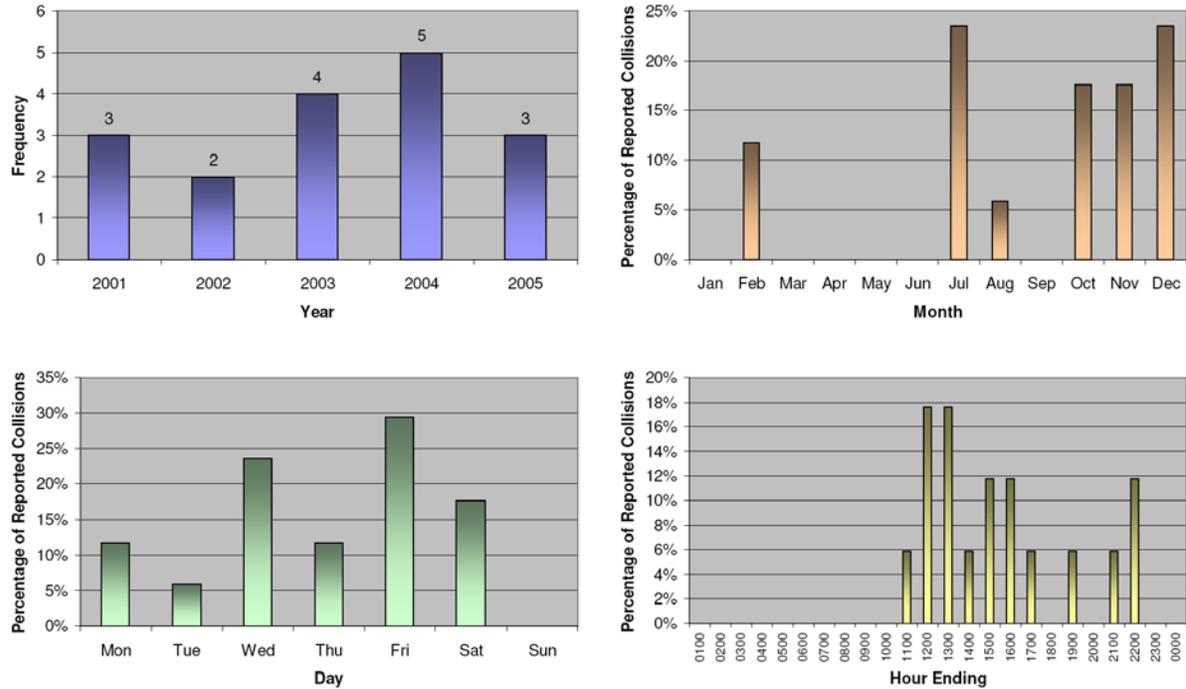
**FIGURE 3.2 TEMPORAL DISTRIBUTIONS OF COLLISIONS**

The annual frequency of collisions varies from two to five collisions during the study period. An examination of the collision rate in the area of the study intersection has been conducted by ICBC staff in 2005. This previous examination indicated that the collision rate at the study intersection was close to the average collision rate for similar roadways on a rural conventional highway, and was far below the critical accident rate. As a further check, it is estimated that the intersection has an average collision rate range of between 0.27 and 0.68 collisions per million entering vehicles per year. This estimated average collision rate is 10 to 60 percent lower than the typical collision rate of 0.75 collisions per million entering vehicles per year for an unsignalised intersection in the Lower Mainland area.

A random fluctuation of collisions in the temporal patterns of year, month, and day is also noted. Moreover, due to the low collision frequency at this intersection, the temporal patterns as presented in FIGURE 3.2 do not contribute any significant meaning in terms of collision trends. However, the collision distribution by hour ending which indicated that collisions were most likely occurred during the afternoon and late evening hours, probably corresponded to the time periods with high traffic volumes. These collision clusters at the time periods with high traffic volumes also suggest that the operational capacity of this intersection could be a contributing cause of those left-turn crossing and rear-end collisions when exiting from the French Creek Boat Harbour on Lee Road westbound.

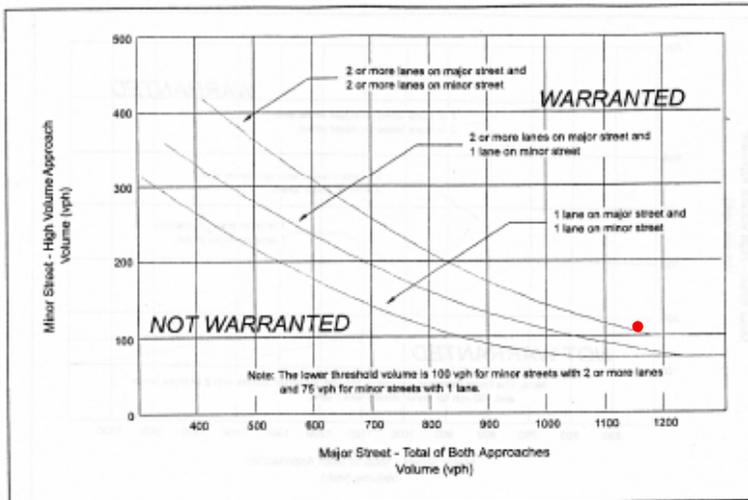
Figure 4. Warrant 9: peak hour volumes 2

Warrant is Satisfied? Yes

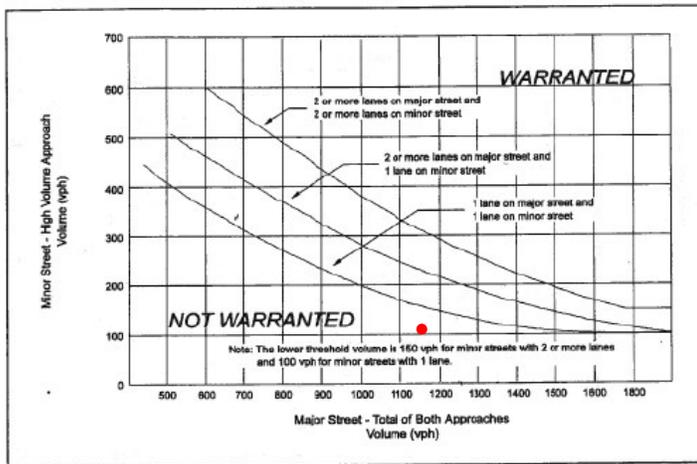
Figure 3 Warrant 9: peak hour volumes 1

Warrant is Satisfied? No
