BC DAM SAFETY ANNUAL REPORT

2012/2013

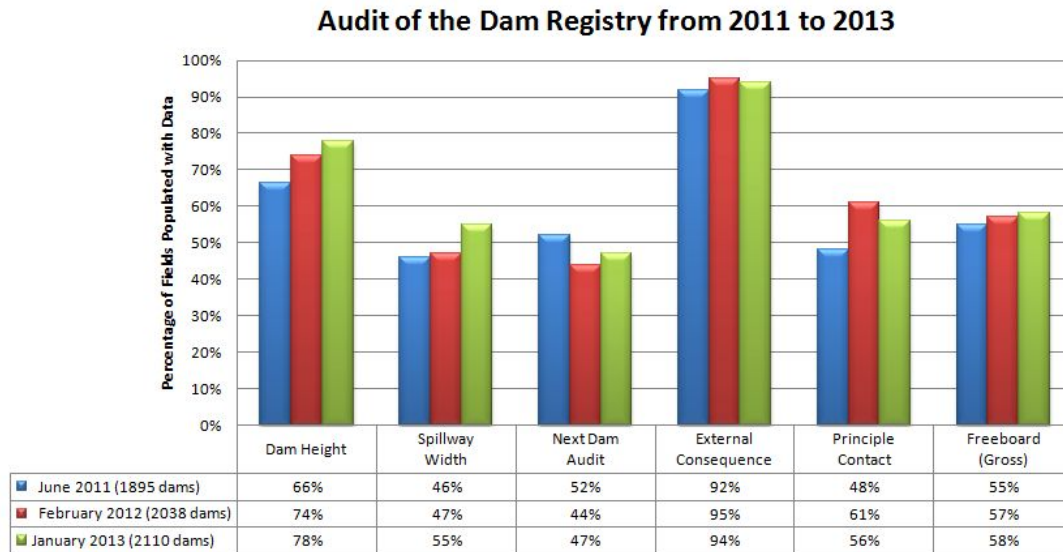
4. *Reviewing record keeping practices (Recommendation #1)*: In 2011/12, a misinterpretation of the dam registry data led to reporting that there was a large improvement in the updating of data in the registry by dam safety officers that year. However, a recent analysis of the data over the last two years reveals that progress varied from none to more modest improvements depending on the type of data considered (Figure 2). Dam safety officers are required to keep the information current for regulated dams and continue to update the database with additional information following dam site visits. Regions with large numbers of dams and insufficient resources are challenged in updating dam information in the registry.

Figure 2: Audit of 6 dam safety parameters in the Dam Registry as a measure of progress in updating of the database by the Dam Safety Officers.

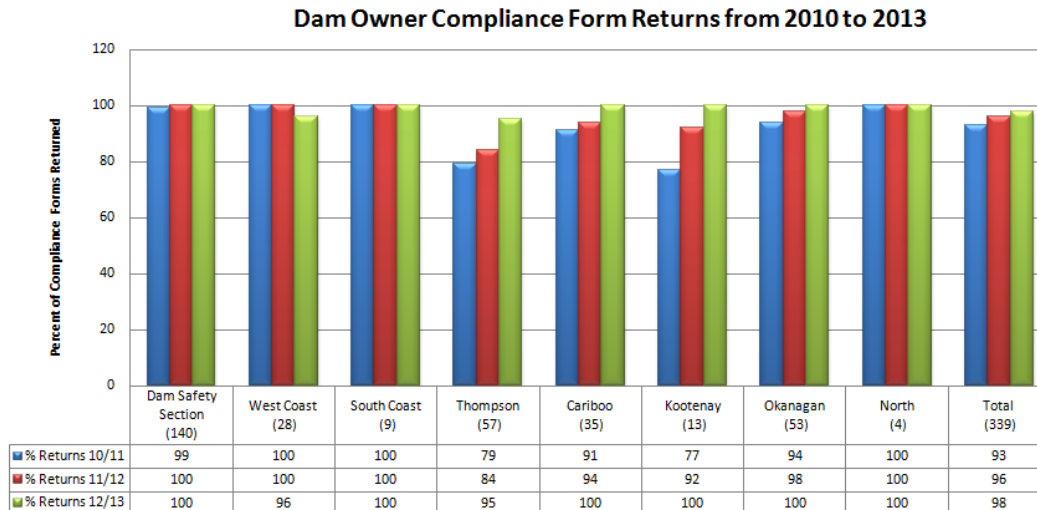
Each successive year since 2005, annual reporting by dam owners has improved substantially. Total returns in the last three years have plateaued in the high ninety percentage range overall (Figure 3). These increases are a result of efforts made by Dam Safety Program staff in directly contacting individual dam owners to ensure they return their compliance forms. For those dam owners that have not returned their forms, follow up is being done by Dam Safety Officers, sometimes with the assistance of Natural Resource Officers, to ensure that the forms are completed. A strategy will be developed in 2013/14 for a more effective means to ensure timely return of the completed forms by dam owners without the exceptional effort of staff in contacting non-compliant dam owners.

Figure 3: Percent of dam owners returning the completed Dam Inspection Compliance Forms. (Note: numbers in brackets are the total number of High, Very High, and Extreme Consequence Dams in each administrative unit for 2012/13.)

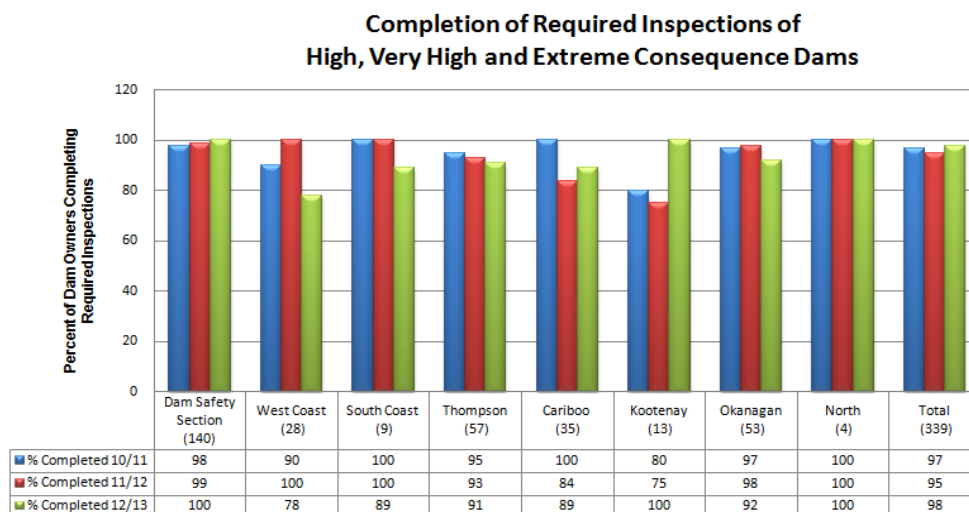
Over the last three years, based on the number of forms which dam owners have returned for their dams, the overall provincial percentage of dams where owners had completed the required formal inspections has been maintained at or above 95% (Figure 4). For 2012/13, there was a decrease in the number of dams where owners had completed the required inspections in the West Coast, South Coast, Thompson and the Okanagan regions. Where dam owners are not meeting their obligations, staff follow-up to ensure dam owners understand the regulatory requirements.

Figure 4: Percent of dam owners that returned their Compliance Form and indicated that they had completed the required annual dam inspections. (Note: numbers in brackets are the total number of dams for each administrative unit in 2012/13.)

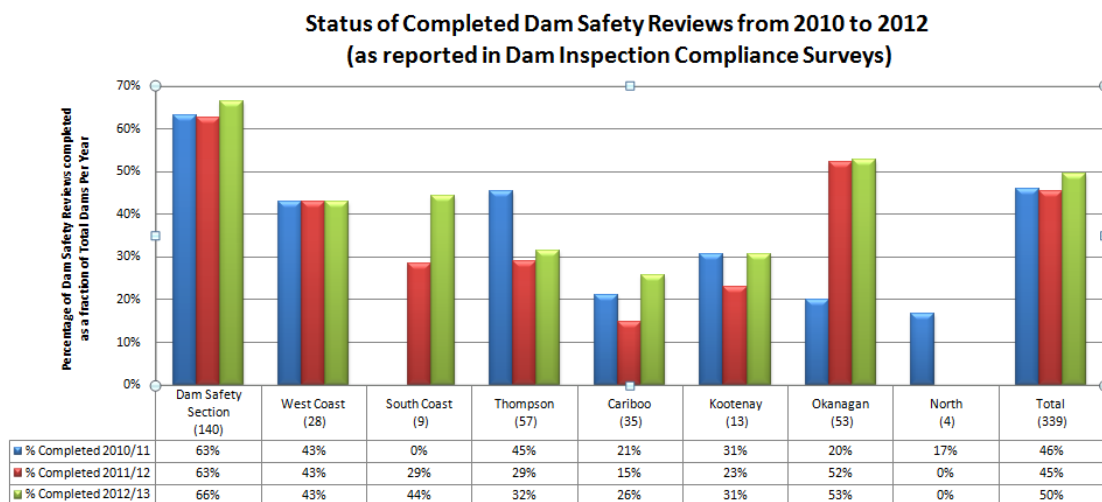
Dam safety reviews are comprehensive formal evaluations of dams conducted by a qualified engineer every 7 years for extreme consequence classification dams and every 10 years for high and very high consequence dams to determine whether an existing dam meets current engineering standards. Despite annual notification since 2009 by the Comptroller of Water Rights regarding this regulatory requirement, the number of dam safety reviews completed expressed as a percentage of the total number of dams considered in the compliance survey remains low (Figure 5). Reporting of completed dam safety reviews for major dams (>9m high) has shown a slight improvement (3%) over this time period. Fewer than 50% of dam safety reviews for smaller dams (<9m high) in the regions have been completed, except for the Okanagan which is above 50%. Overall, there is a small improvement of about 5% over the past three years for completed dam safety reviews.

Figure 5: Percent of dams owners having Dam Safety Reviews for their dams. (Note: numbers in brackets are the total number of dams for each administrative unit in 2012/13.)

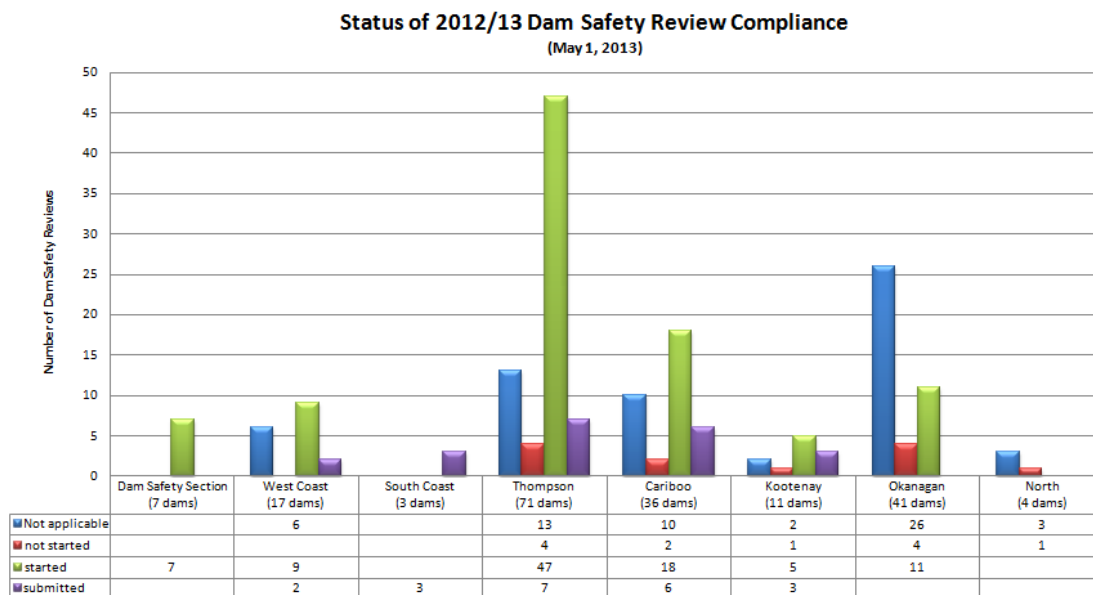
As of May 1st, 2013, dam safety officers across the province have resolved the dam safety review status of dams which had been included in the non-compliance project (Figure 6). About 32% of the dams considered were “not applicable” to the project for a number of reasons: Dam Safety Reviews were completed and updates not required yet; dams were being decommissioned; dams were currently undergoing redesign/rehabilitation; the failure consequence rating of the dam was incorrect and was being reclassified to low; or dams were under legal review. At this time, 51% of the dams were confirmed by their owners to have dam safety reviews underway, and another 11% have reports completed and submitted by professional engineers. The remaining 6% of the dams are still non-compliant. Most of these dams are administered by different levels of governments and funding for dam safety reviews are being solicited at this time. There are two dams in the Cariboo region whose owners have not responded. Enforcement action is underway in getting these remaining two dam owners to comply. The Dam Safety Review compliance and enforcement project will continue until all dam owners are compliant.

Figure 6: Status of Dam Safety Reviews for dams Identified as requiring Dam Safety Reviews.

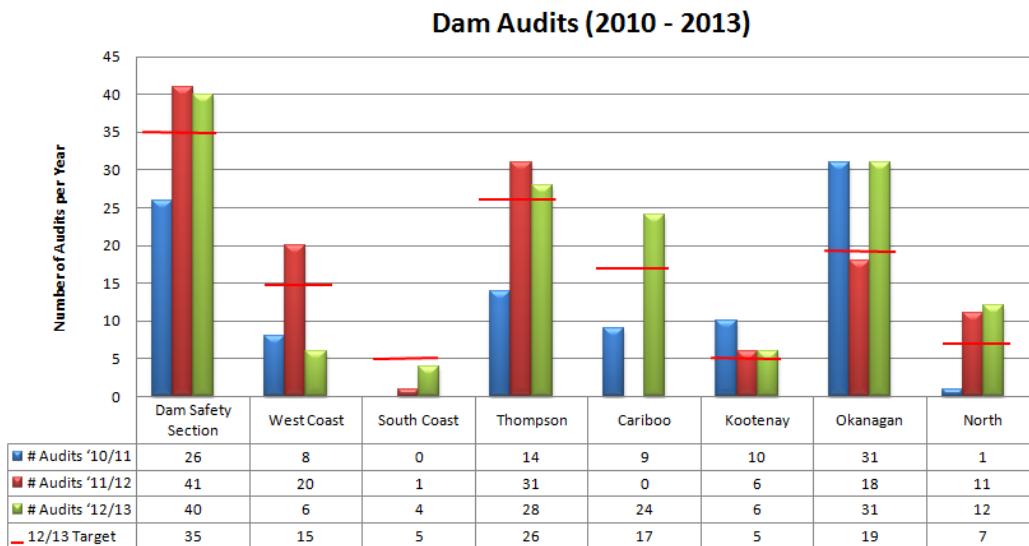
In 2012/13, new Dam Safety Officers added to the Dam Safety Program resulted in more dam audits being completed. This is evident with the major dams, managed by the Dam Safety Section in Victoria and the Cariboo, Okanagan and Northern regional dams where the targets have been exceeded by 14%, 41%, 63%, and 71% respectively (Figure 7). Overall, the provincial target was exceeded by 15%. Increase in dam audits are also attributable to efficiencies gained when a large number of dams belonging to one dam owner are completed together as is the case with some major dam owners. Target numbers vary over the years due to new dams added or existing dams deleted from the auditable pool of dams when consequence classification changes for a dam or dams are built or removed. As a result, the average number of dams over the auditable period for different consequence classes is used. In some years, the target is not met and the shortfall is addressed in a subsequent year as is apparent with the Okanagan and Thompson regional dams and with the major dams audited by the Dam Safety Section in Victoria.

Figure 7: Number of audits completed by Dam Safety Officers compared to the target number of audits over the last three years.
