Re: Third Party Review – Quesnel-Hydraulic Road/Slide

# Independent Review of Feasibility of Temporary Access Quesnel-Hydraulic Road landslide

*Quesnel, BC*

20397030-001-R-Rev0

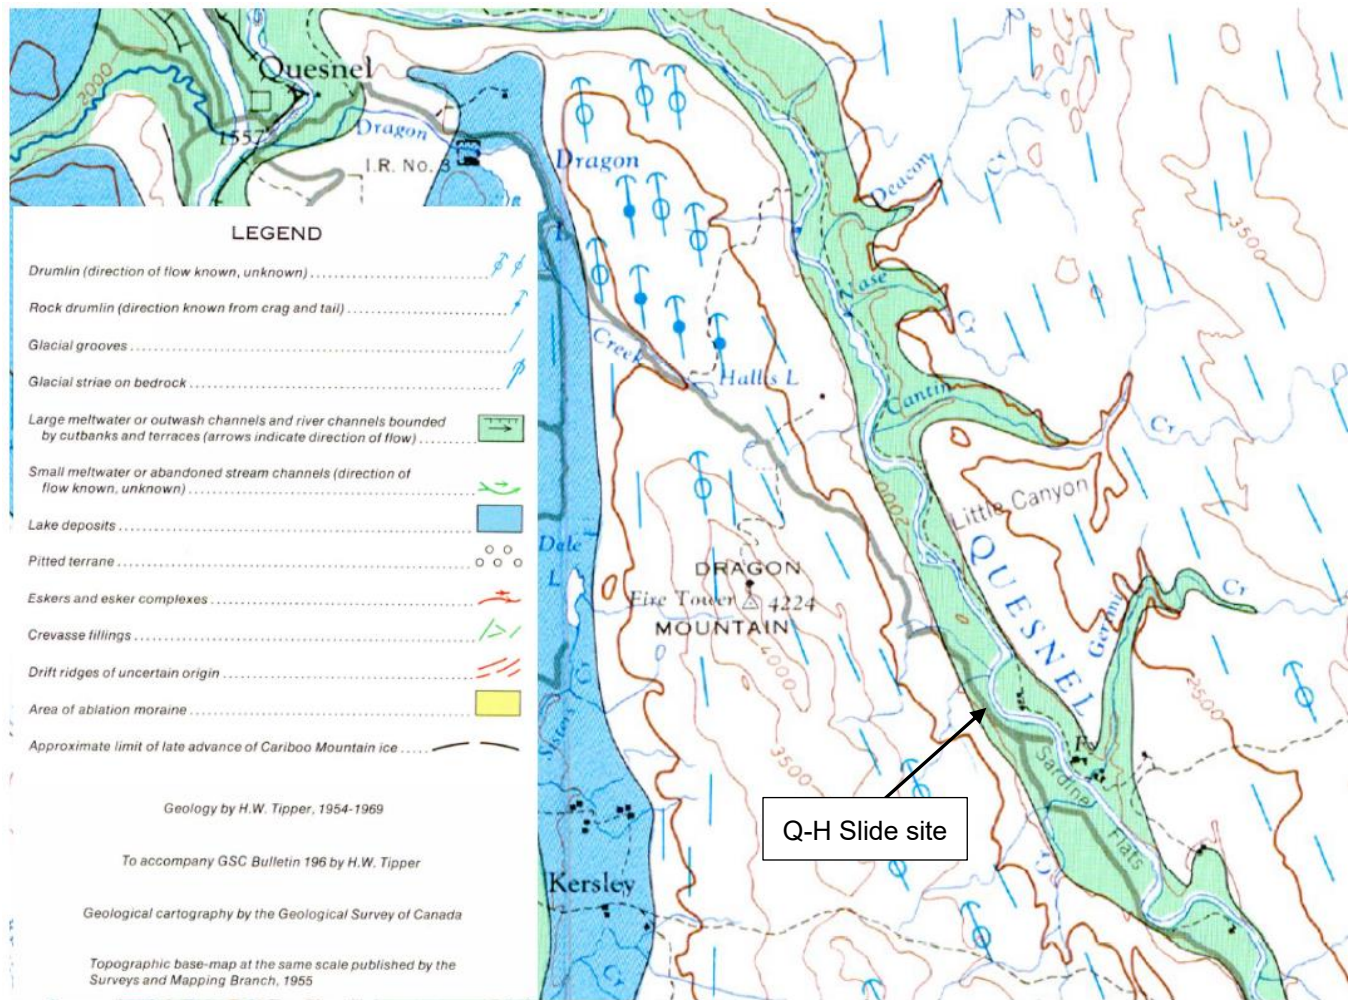
**Figure 2: From Map 1290A, Surficial Geology – Quesnel, Tipper, 1971. Mapped at 1:250,000 scale**

The Quesnel River currently occupies a broad outwash channel with banks rising to over 200 m above river level in places. No bedrock exposures were noted at the site and drillholes have been advanced in soils to depths of over 45 m in the bank around the Q-H Slide site with no bedrock observed.

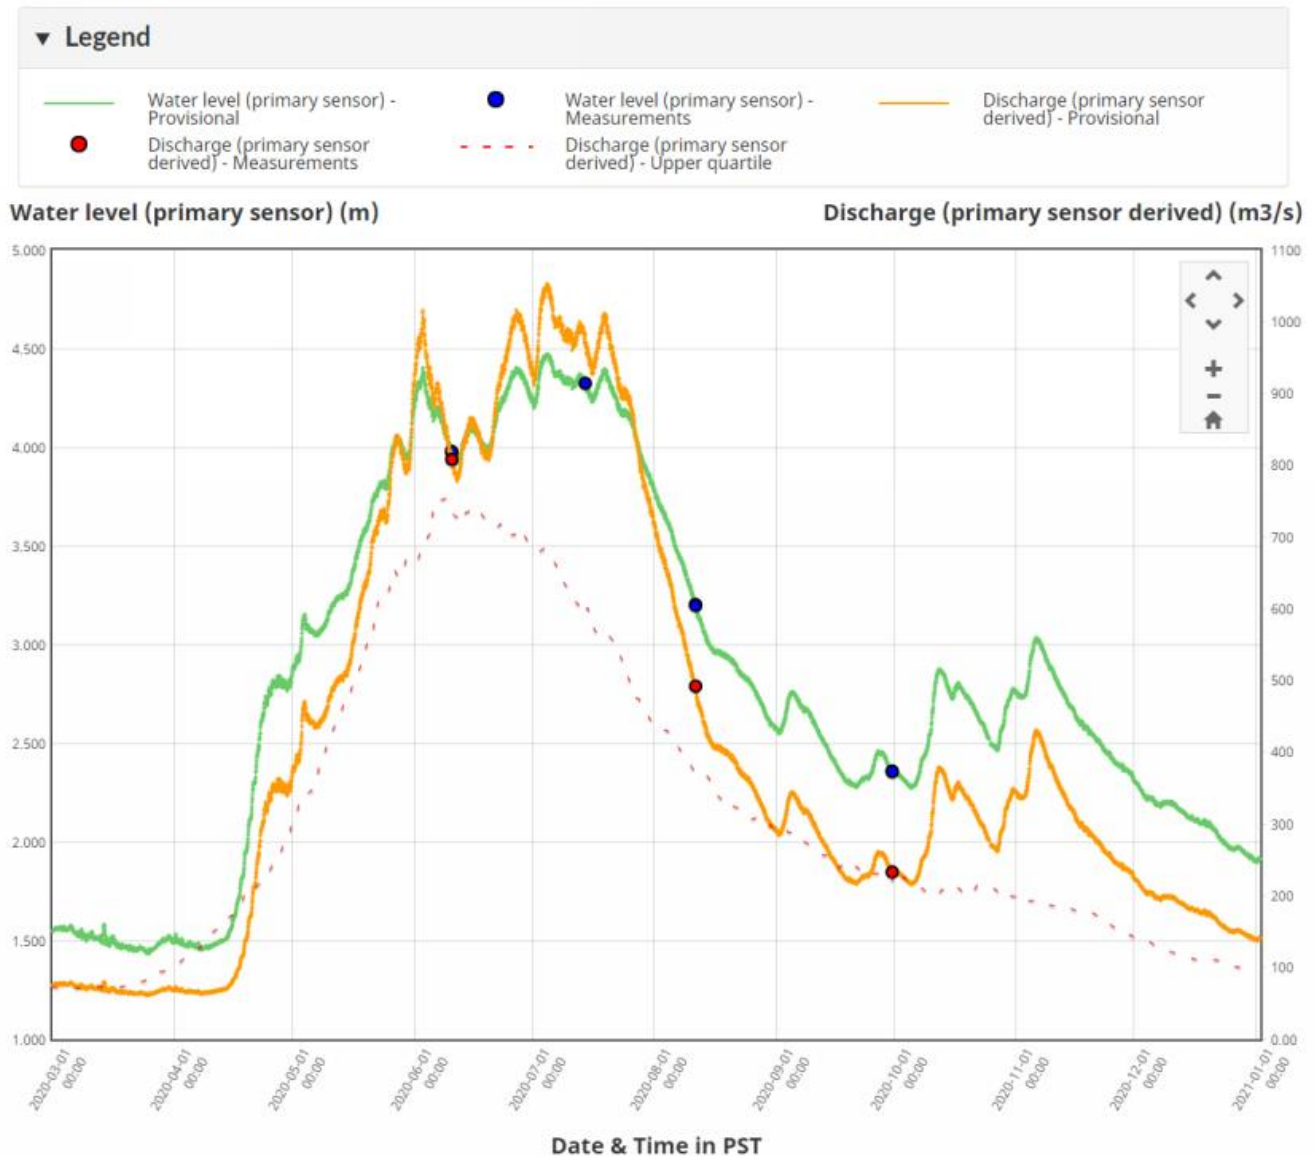
**Figure 3: Quesnel River near Quesnel Discharge and Stage Hydrograph**

Figure 3 shows that the Quesnel River was flowing well above the statistical upper quartile discharge from mid-April to September of 2020, and again from October 2020 into 2021. The river also experienced a large drop in flows from mid July to mid September, corresponding to a roughly 2 m drop in water level as measured at the gauge site. This drop in discharge is consistent with the seasonal freshet cycle. However, the increase in discharge in the fall of 2020 appears to be larger than normal as discharge over the 83-year gauge records do not show a corresponding fall increase before winter.

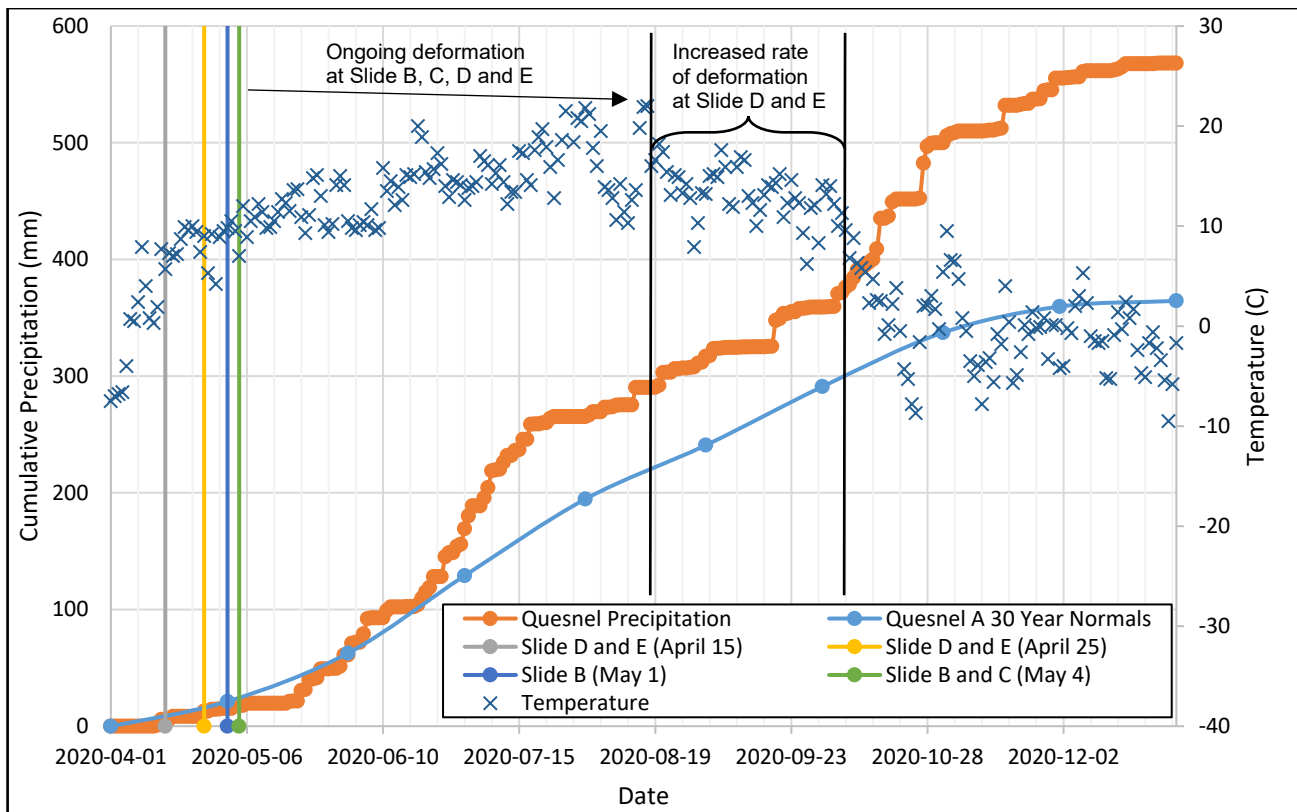
**Figure 4: Quesnel Climate Data**

Figure 4 shows mean daily temperatures climbing above freezing starting in the first week of April. This preceded cracking in the road shoulder at slide site D and E first observed on April 15<sup>th</sup> and assessed on April 18<sup>th</sup>. The assessment suggests the ground was still frozen in shaded areas as of April 18<sup>th</sup> but may have been beginning to thaw in more exposed locations.

Precipitation tracked the 30-year normal before increasing in late May. Heavy rainfall continued from late May into July, tapered from mid July through September, and increased again from October through November. This precipitation resulted in the high freshet and seasonally high fall discharges recorded at the Quesnel River near Quesnel gauge presented in Figure 3.

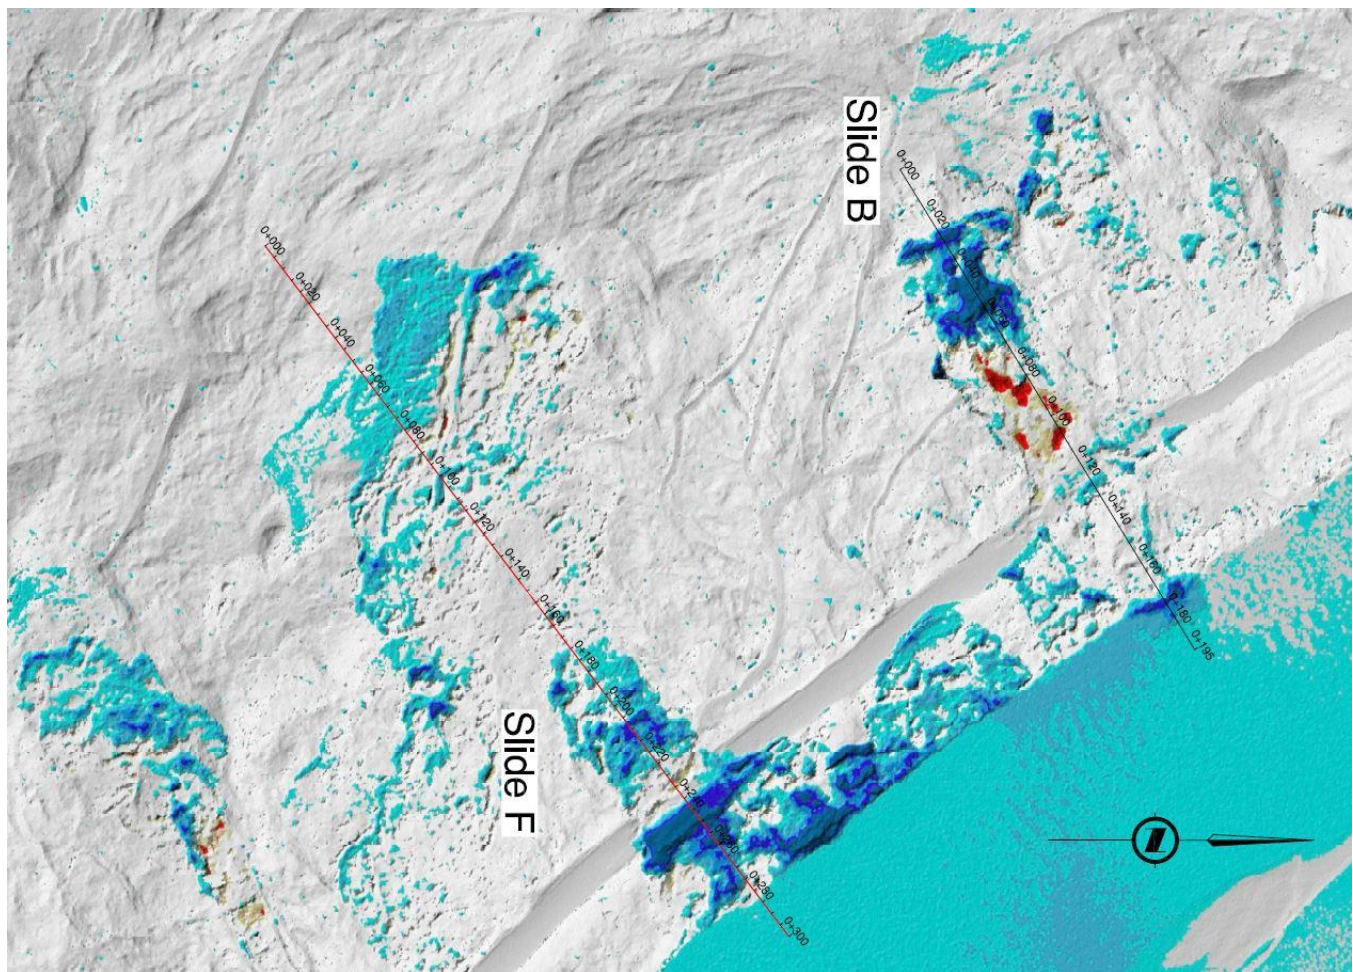
**Figure 5: Plan of cut sections for slides F and B (Provided to Golder by MoTI on 26 January 2021)**

Golder used Geostudio 2020 SLOPE/W software to develop a two-dimensional model of the Q-H Slide. Model sections were based on two cross sections provided to Golder by MoTI that were cut through Slide B and Slide E/F, as shown in Figure 5. The most recent LiDAR surface, obtained 7 November 2020, was used to create the ground surface of both model sections.

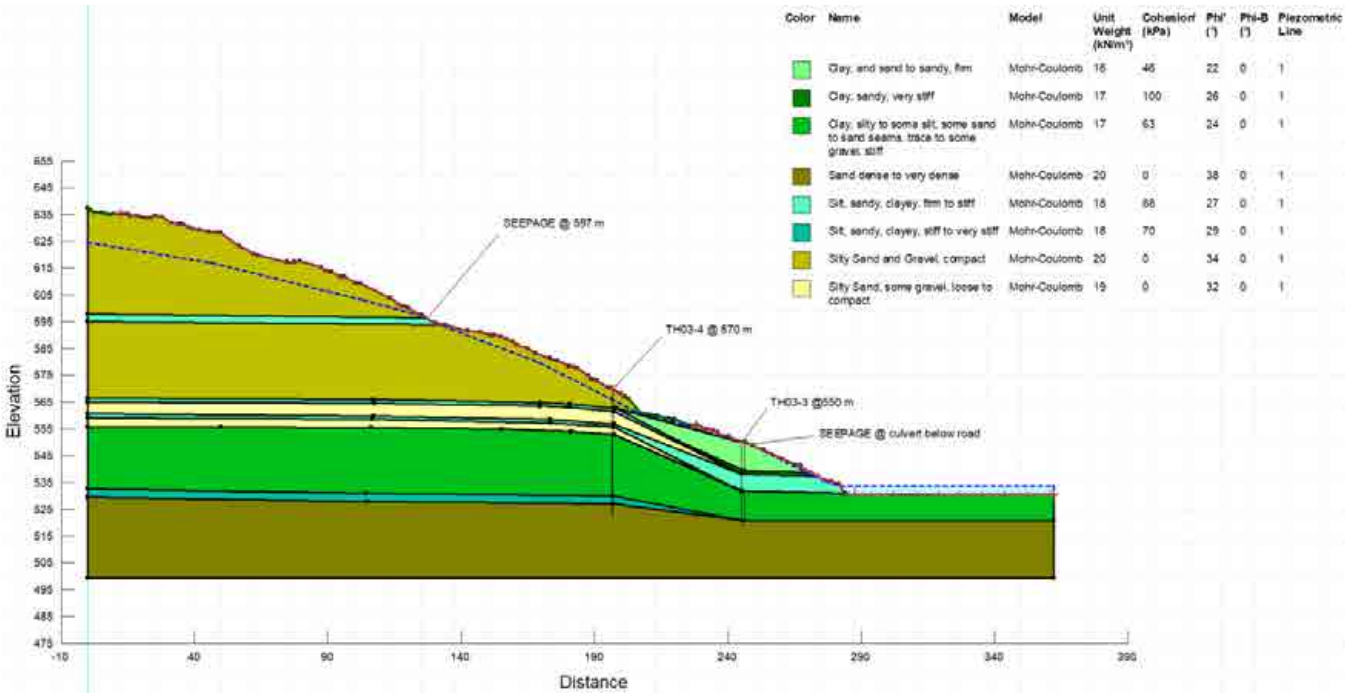
Figure 6: Slide F Model Section- Stratigraphy

Soil information used to develop Slide F model section was compiled based on historical data from test holes TH03-3 and TH03-4 reported in GeoNorth (2004). The test hole data was plotted downhole through the cross section and similar soil types were connected between boreholes. Where similar soils were not present between boreholes Golder assumed the stratigraphy “pinched out” throughout the entire horizontal distance between the two boreholes. The stratigraphy was assumed to be relatively horizontal both up and downslope of the boreholes because the geological history of the area indicates glacier retreat leaving ablation till, lake sediments and meltwater channel deposits. A sandy silt layer of firm to stiff consistency was drawn in the model at approximately 597 metres above sea level (masl) based on visual observations during the reconnaissance. Site-specific groundwater table elevations are not available at this time. A likely scenario of the phreatic surface was approximated to daylight at the observed seepage zone near the top of the slide (597 masl) and then persist underground throughout the rest of the slide area, daylighting again at river elevation. For the purposes of the model the water table is approximately equal to the phreatic surface. The Slide F model cross-section and stratigraphy can be seen in Figure 6.

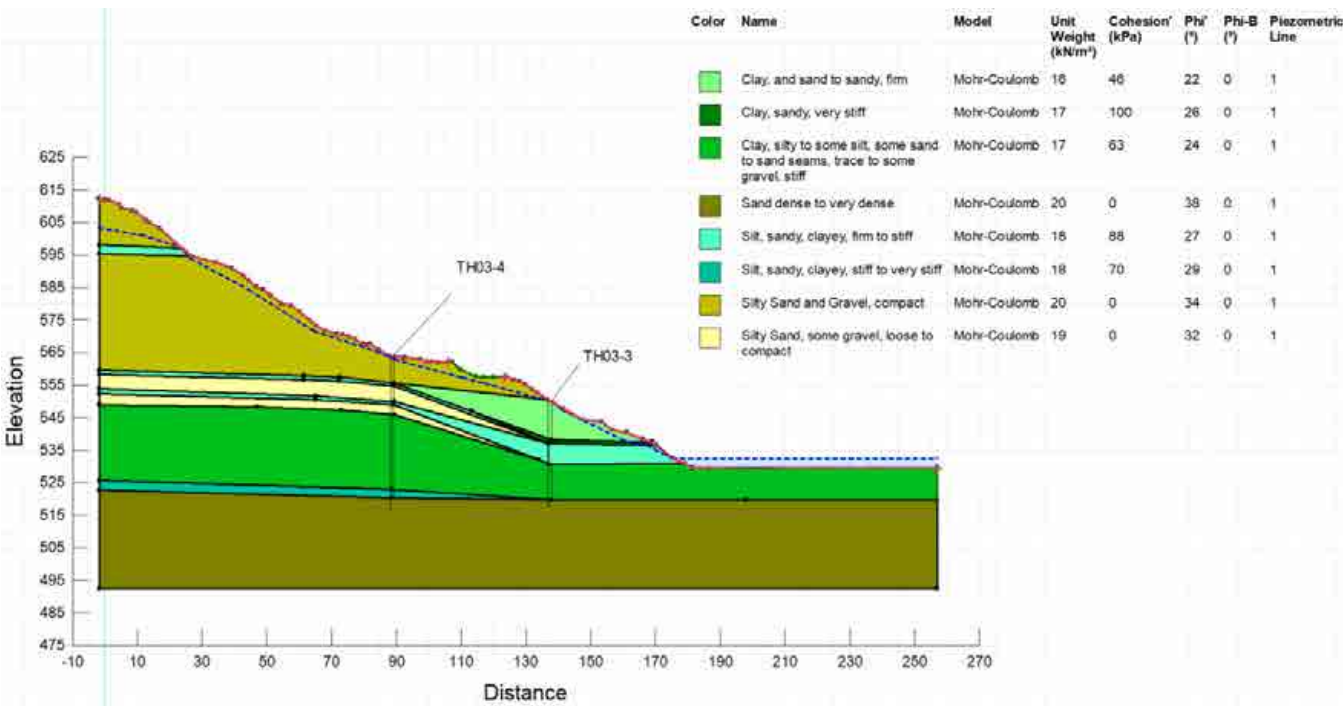
Figure 7: Slide B Model Section - Stratigraphy

Site-specific drillhole data was not available for Slide B. Therefore, the soil stratigraphy for the Slide B model was based on a projection of the stratigraphy from the Slide F model section. The Slide B model cross-section and stratigraphy can be seen in Figure 7

Golder acknowledges the soils information available for the Q-H Slide at this time is limited and therefore the assumed stratigraphy in the model may or may not be representative of the actual ground conditions at the site. Furthermore, it is common, especially in areas of historical landslide activity, that soil conditions vary between and on either side of boreholes. Further geotechnical investigation and laboratory testing should be conducted to refine the model prior to design.

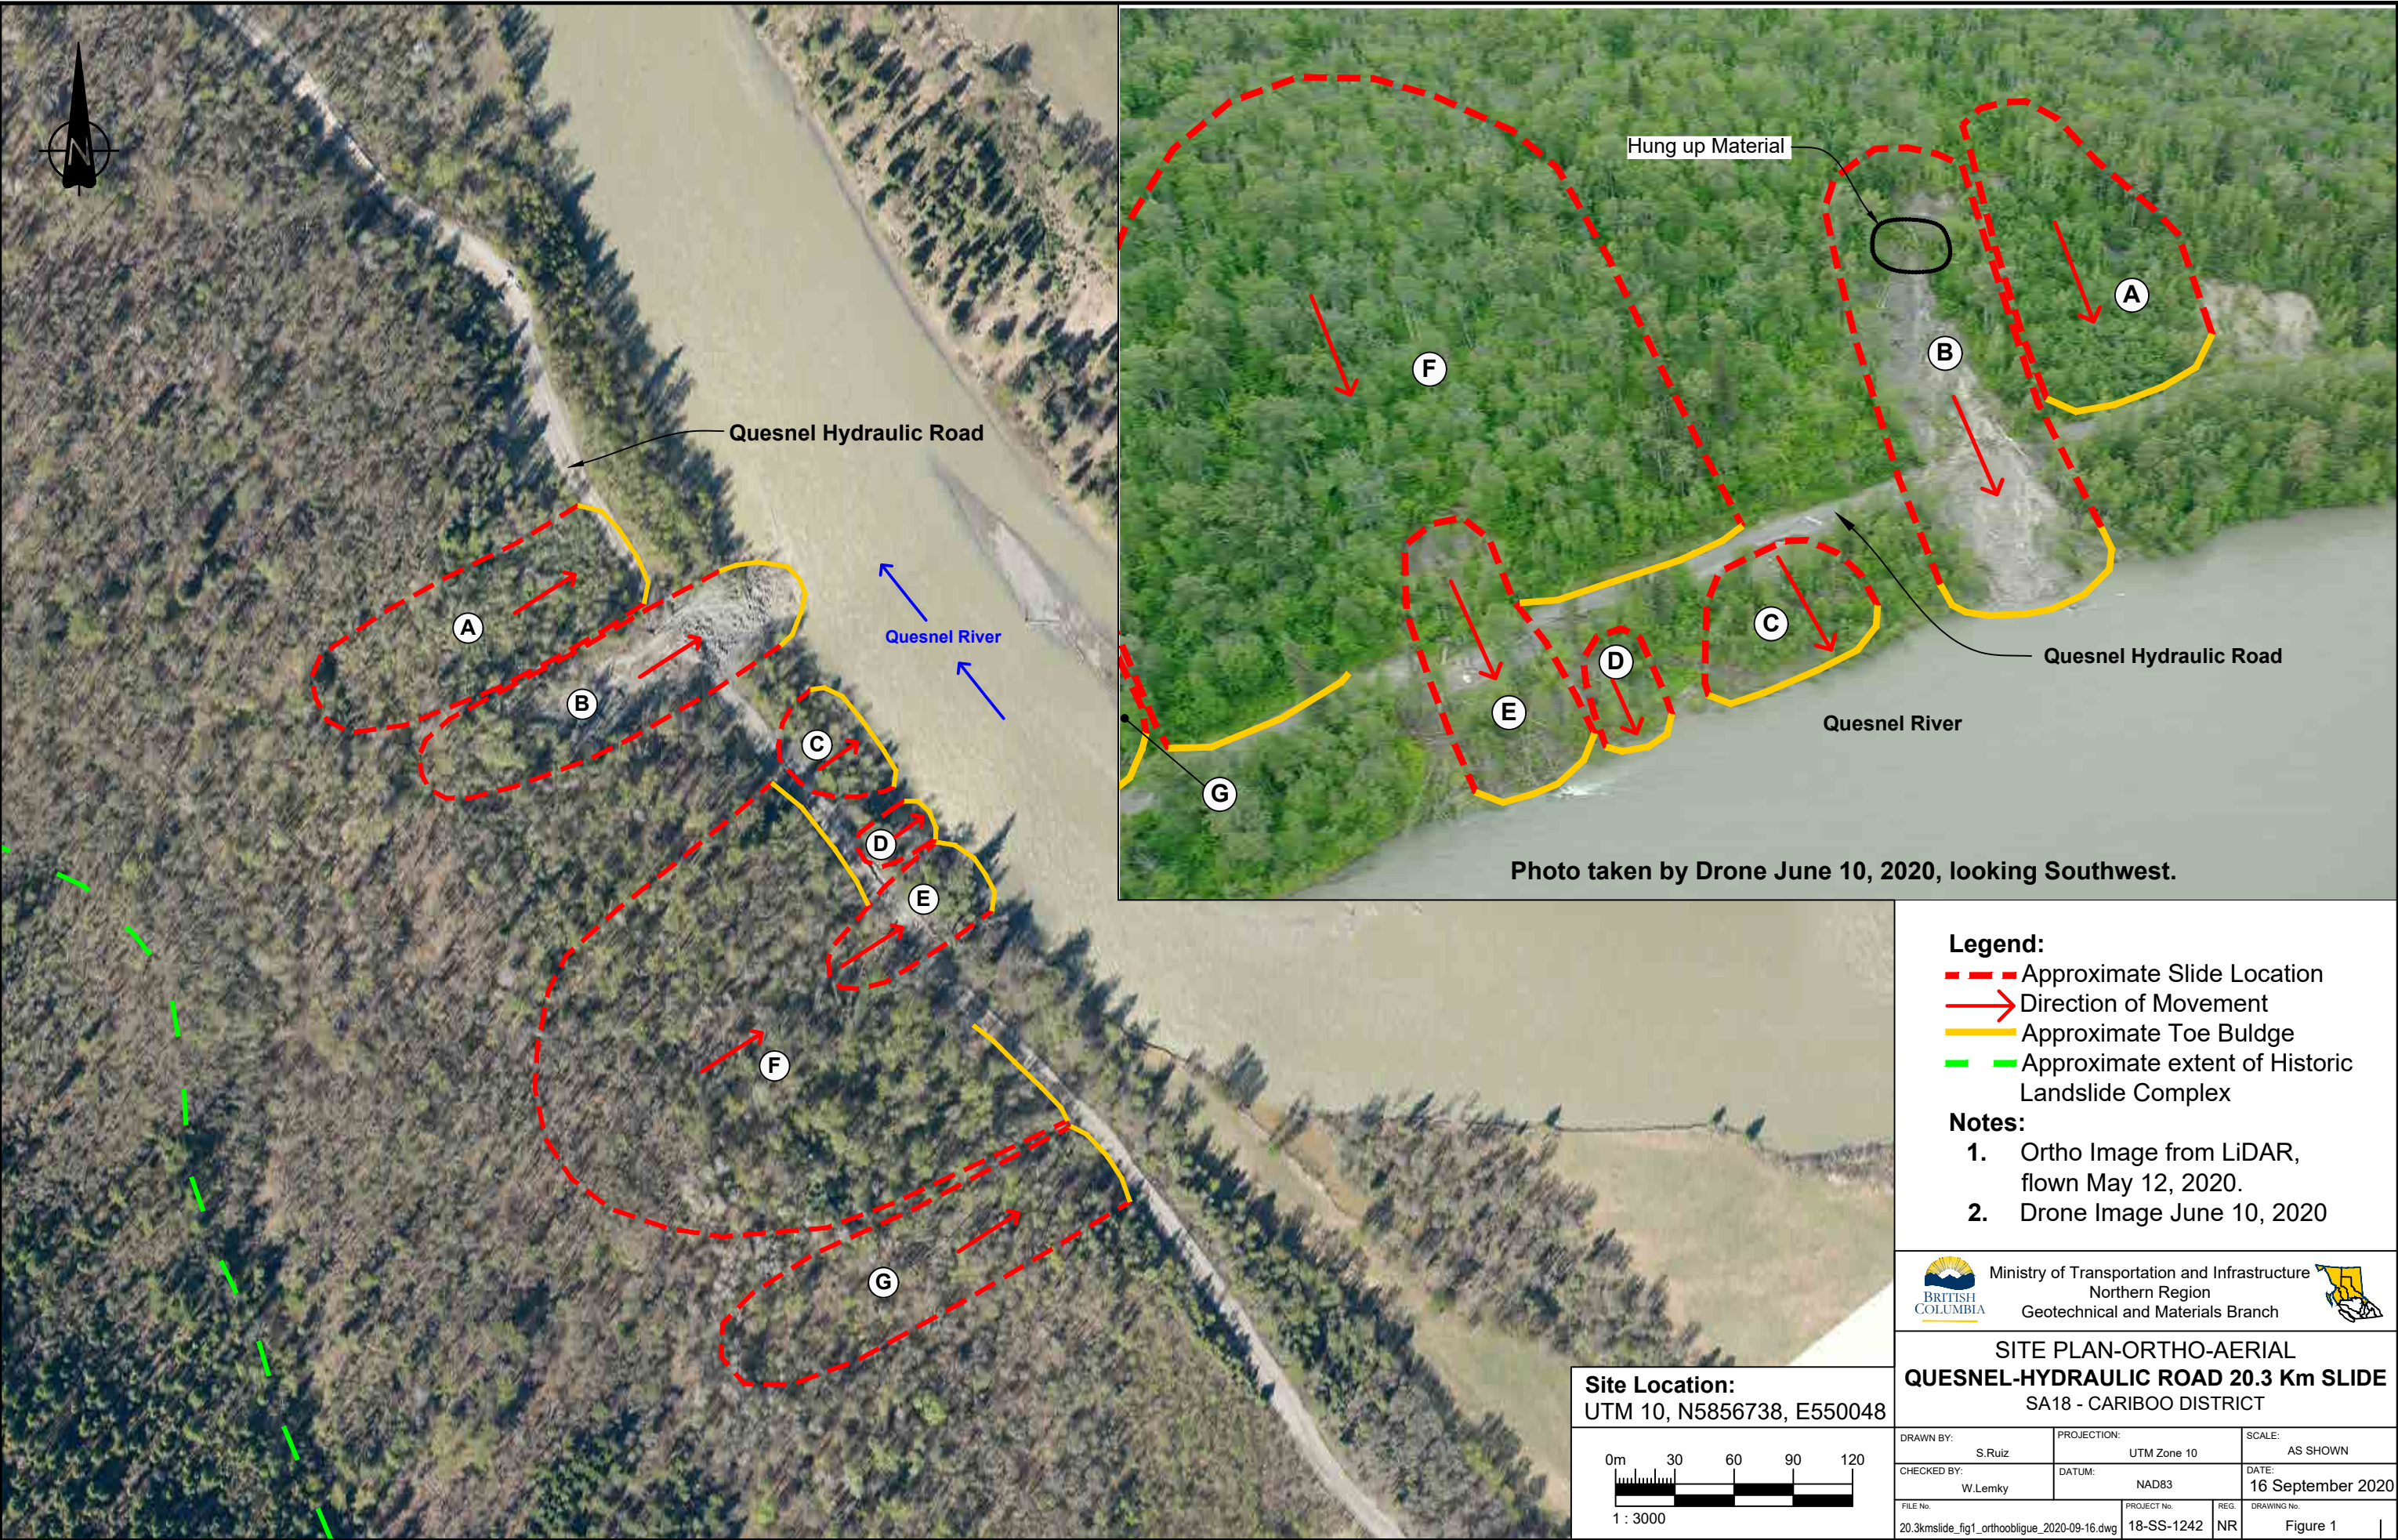
Photo taken by Drone June 10, 2020, looking Southwest.

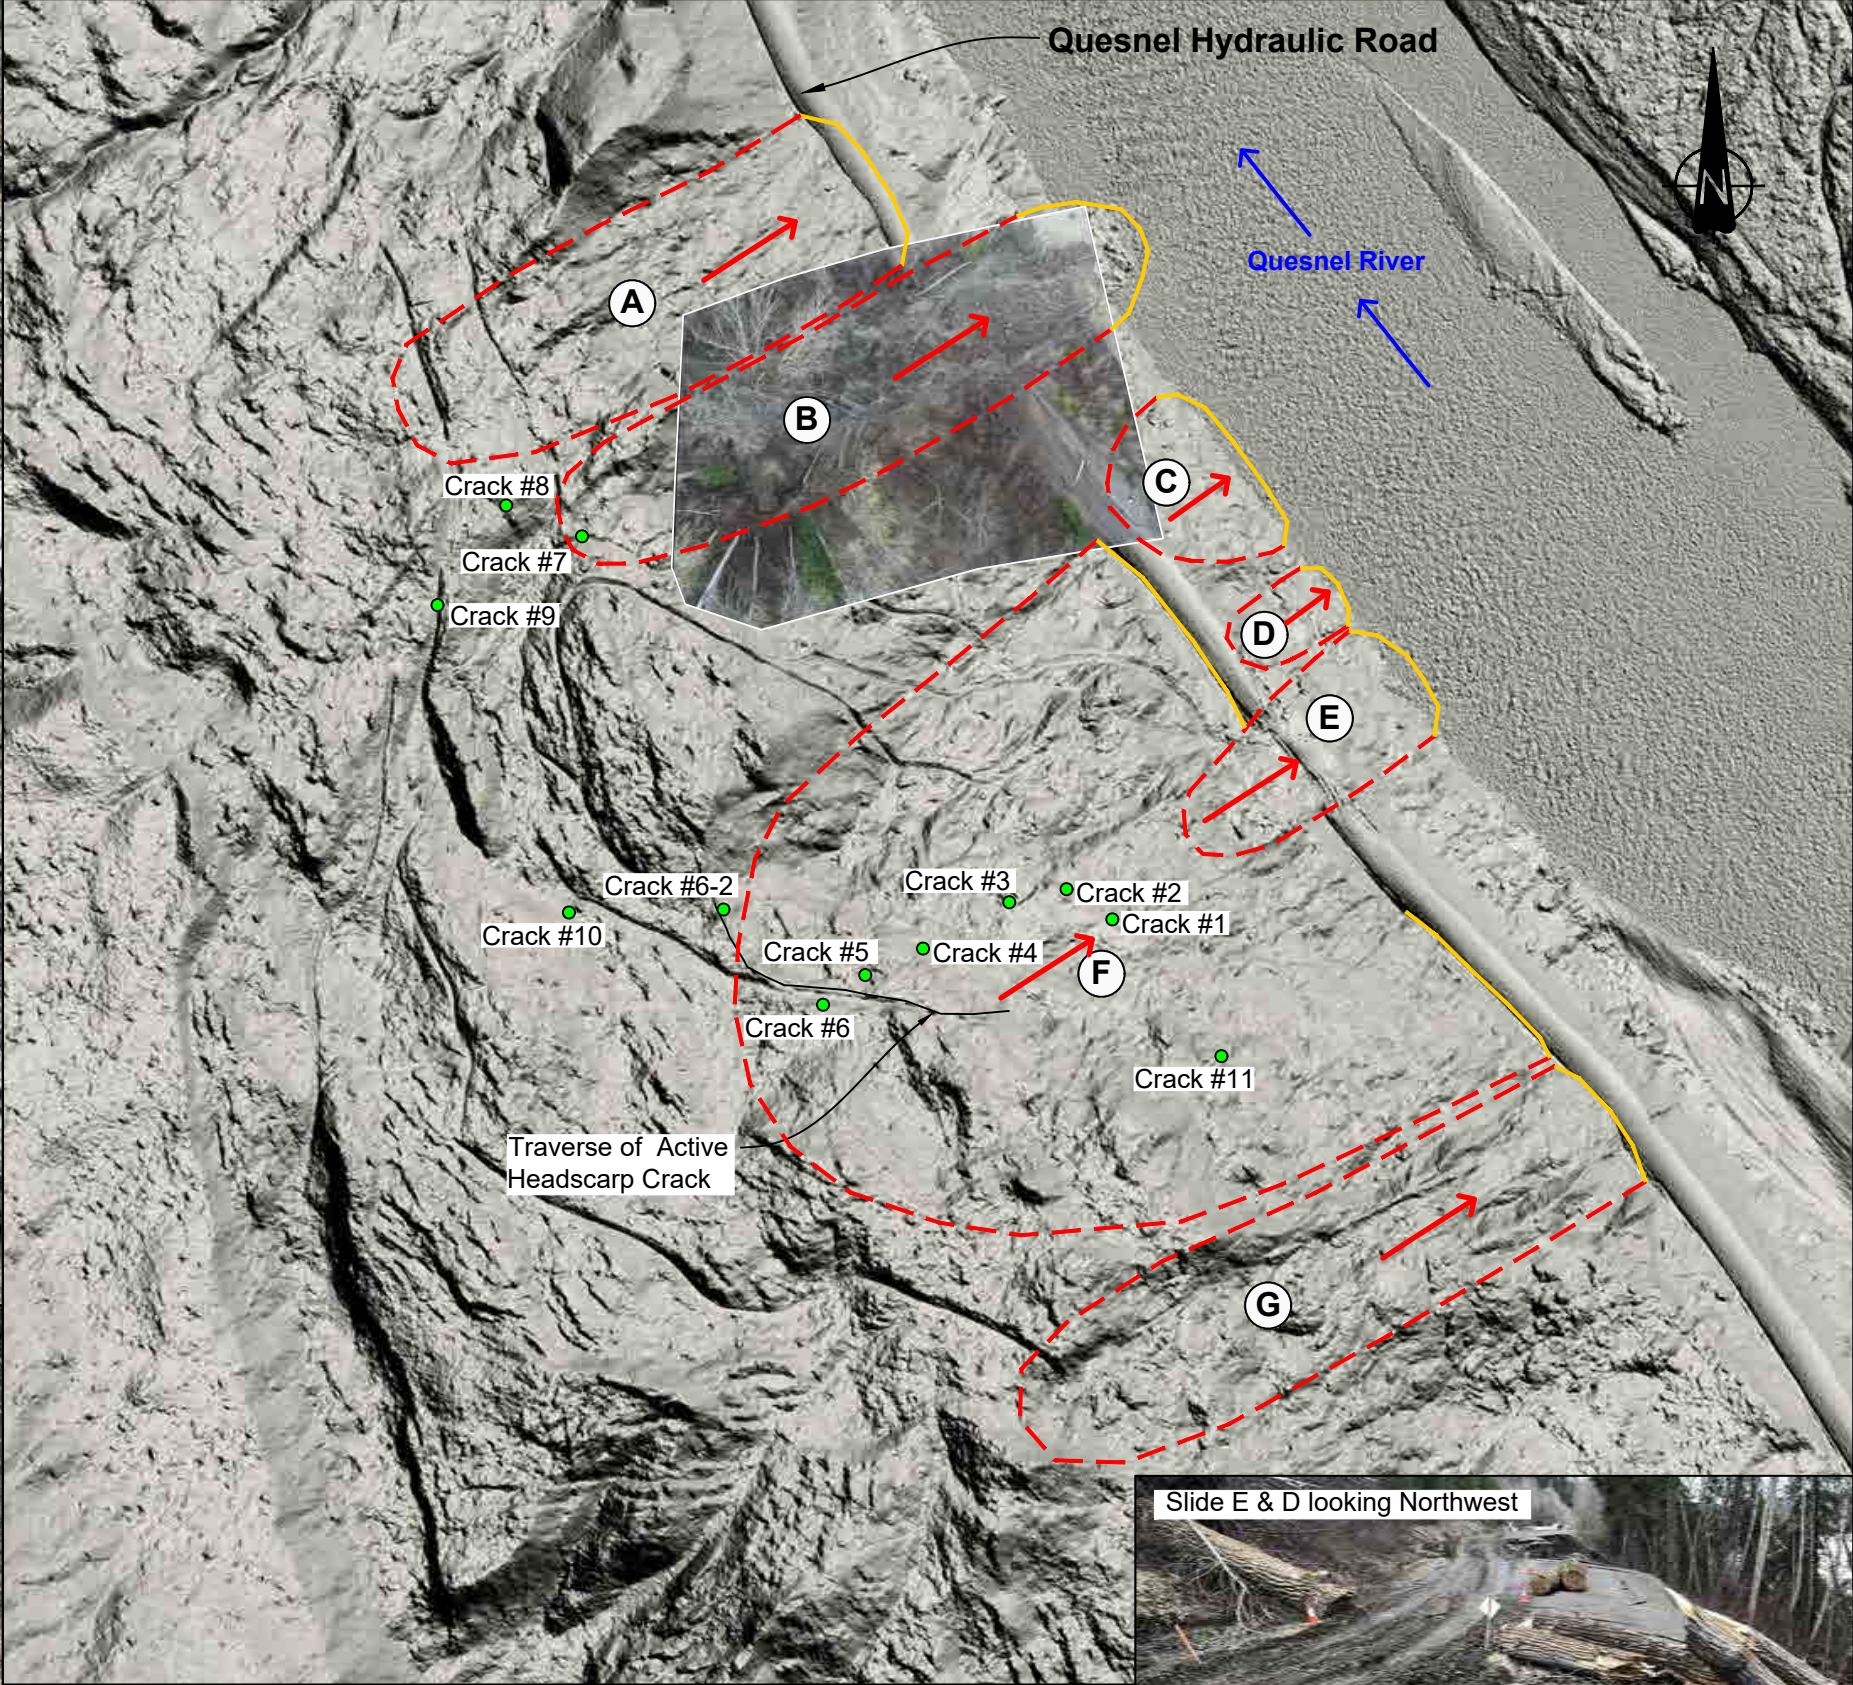
Slide D and E looking Southeast
