APPENDIX D

Shawnigan Research Group (SRG) Information Submissions
May 31, June 08, June 13 & June 21, 2017

The Contaminated Soil Waste Landfill Site Is Leaking

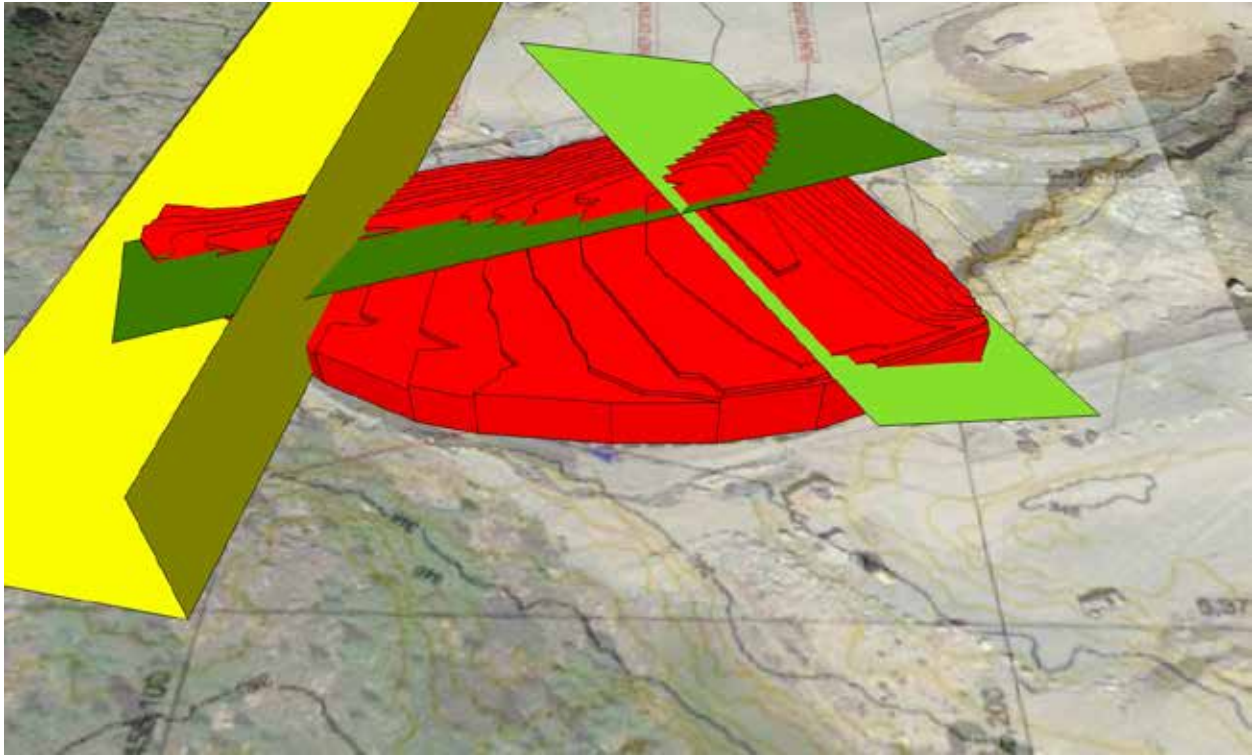
Fig 7

In Fig 7, a yellow buffer 50 m wide with a vertical face has been added. Of course, the face cannot be vertical. Rather, it must satisfy the 3H:1V rule.

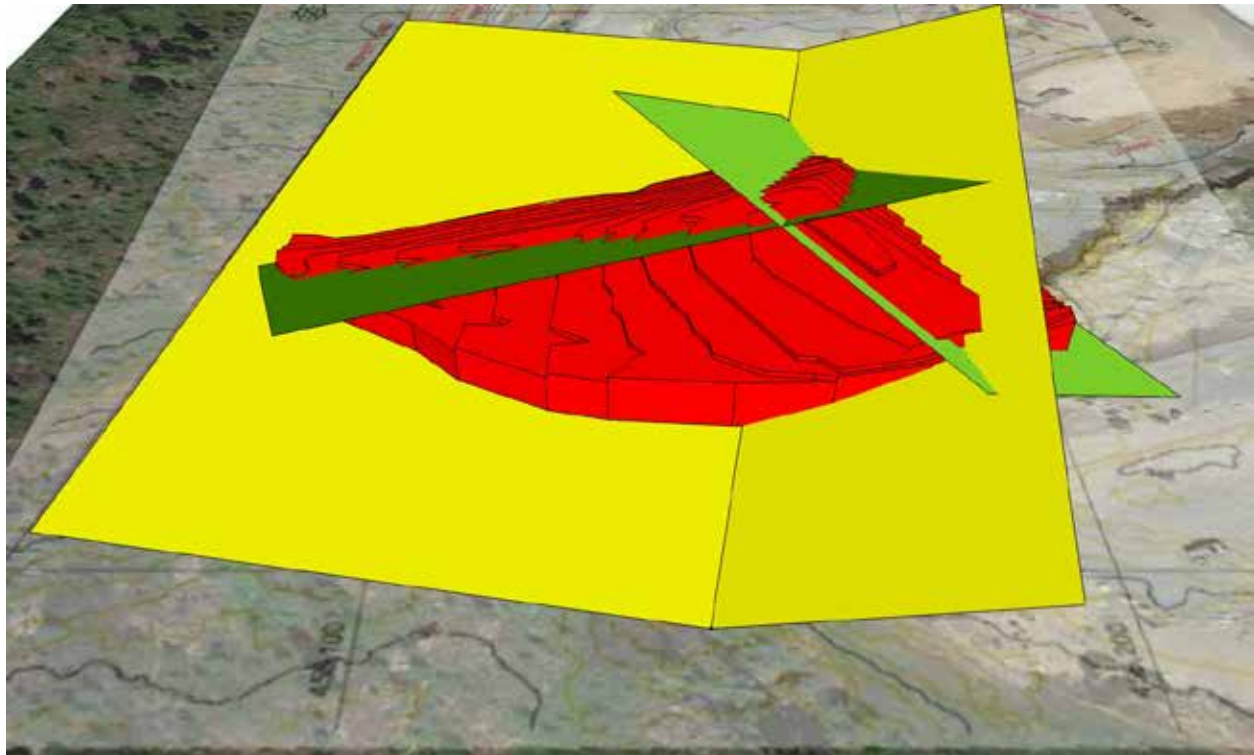
Fig 9

Section 3.8 of the LCMSW, ENVIRONMENTALLY SENSITIVE AREAS, requires of buffer of 100 m of this regional park.

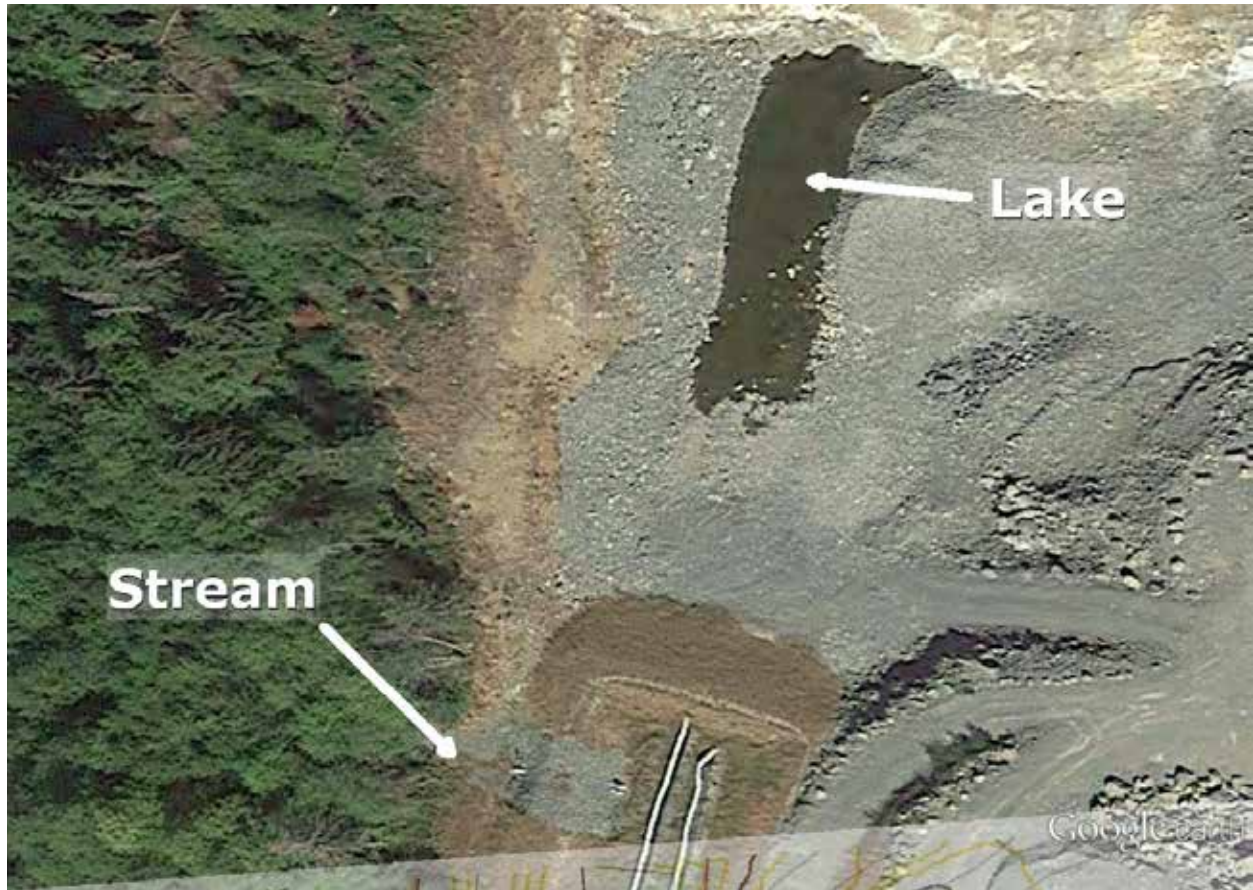
Fig 10

The companies have stopped sampling water where water leaves the quarry. Water has been present in the land and has been flowing out of this stream ever since the company pumped the lake dry in the summer of 2015. The lake is clearly fed by ground water and by leachate from the waste pile year round. The lake water runs across the bedrock, through the riprap and out the stream by the settling pond.

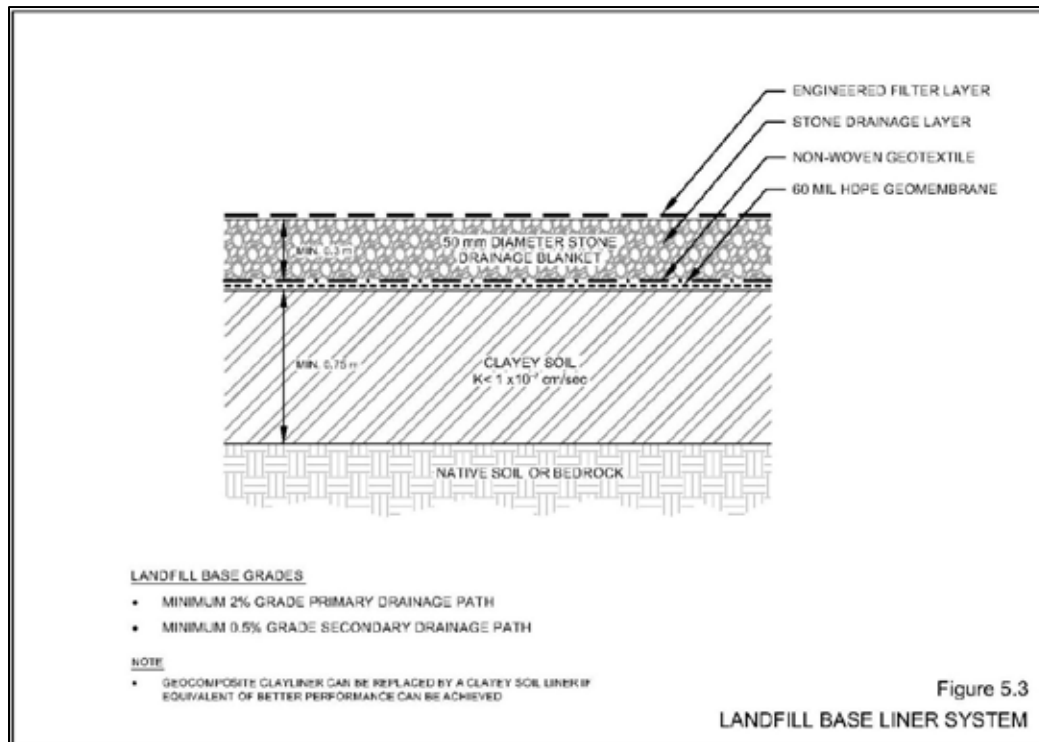
Fig 11 shows the full specification for the "Landfill Base Liner System", as found in Figure 5.3 of the LCMSW. This site lacks the non-woven geotextile above the 60 mil base liner. It also lacks the 50 mm diameter stone drainage blanket layer.

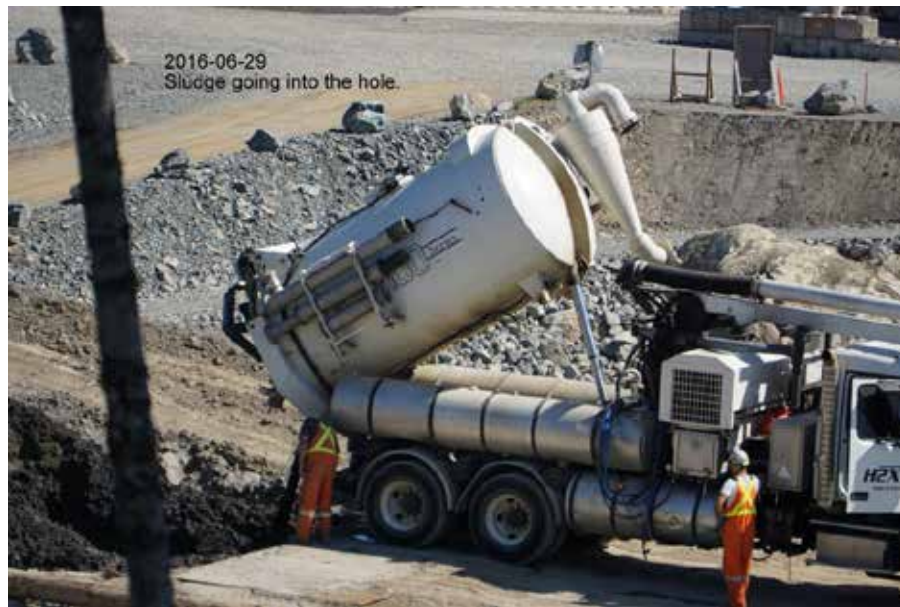
IMAGE 2B: Very often the leachate collected in the upper contact water pond was dumped into a pit at the loading zone of the PEA and then mixed with the contaminated soil. An nice example of a futile cycling event.

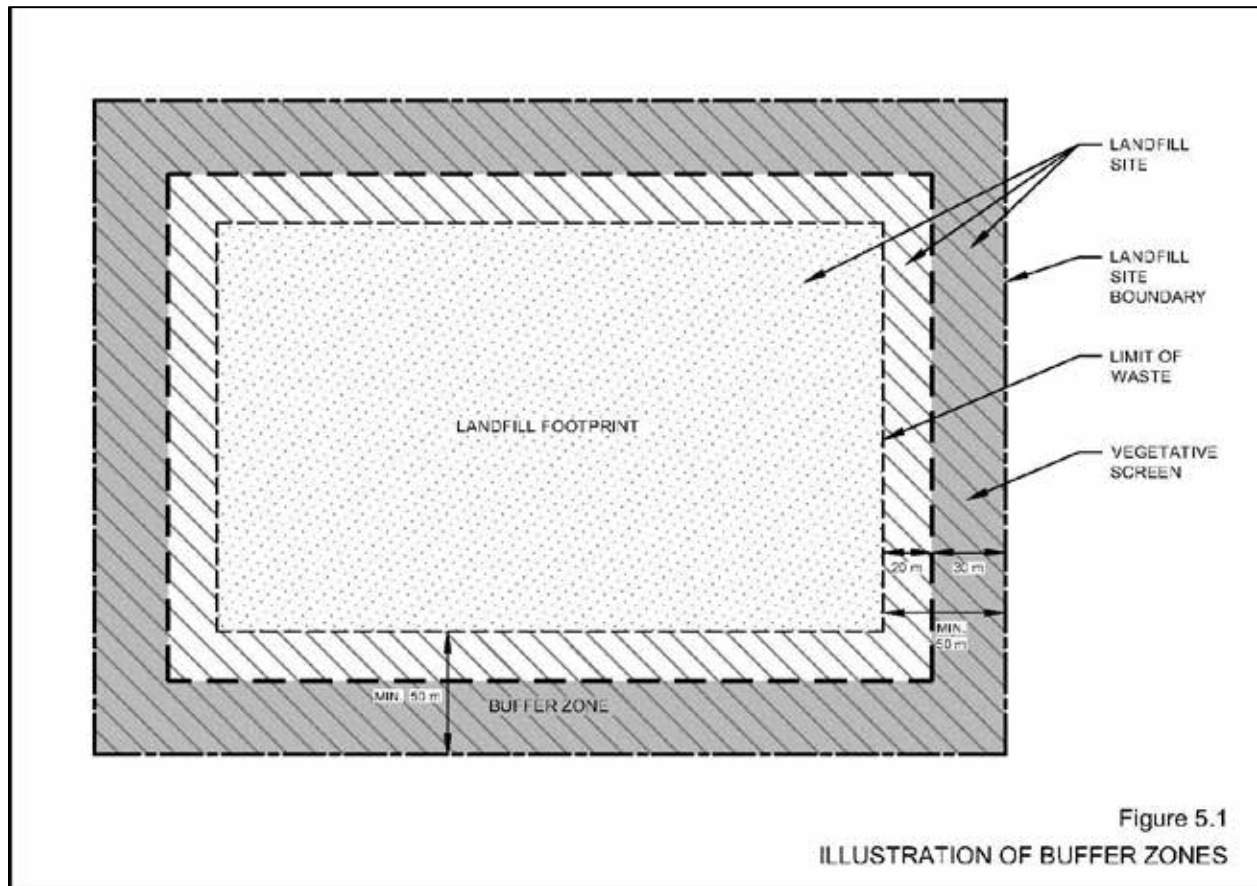
No specific mention of any of these buffer zones in DOX.

[Review - Landfill Closure under Landfill Criteria for Municipal Solid Waste](#) shows that a large part of the landfill lies in the 50m buffer zone. Refer to that document for an explanation of that contravention of the LCMSW.

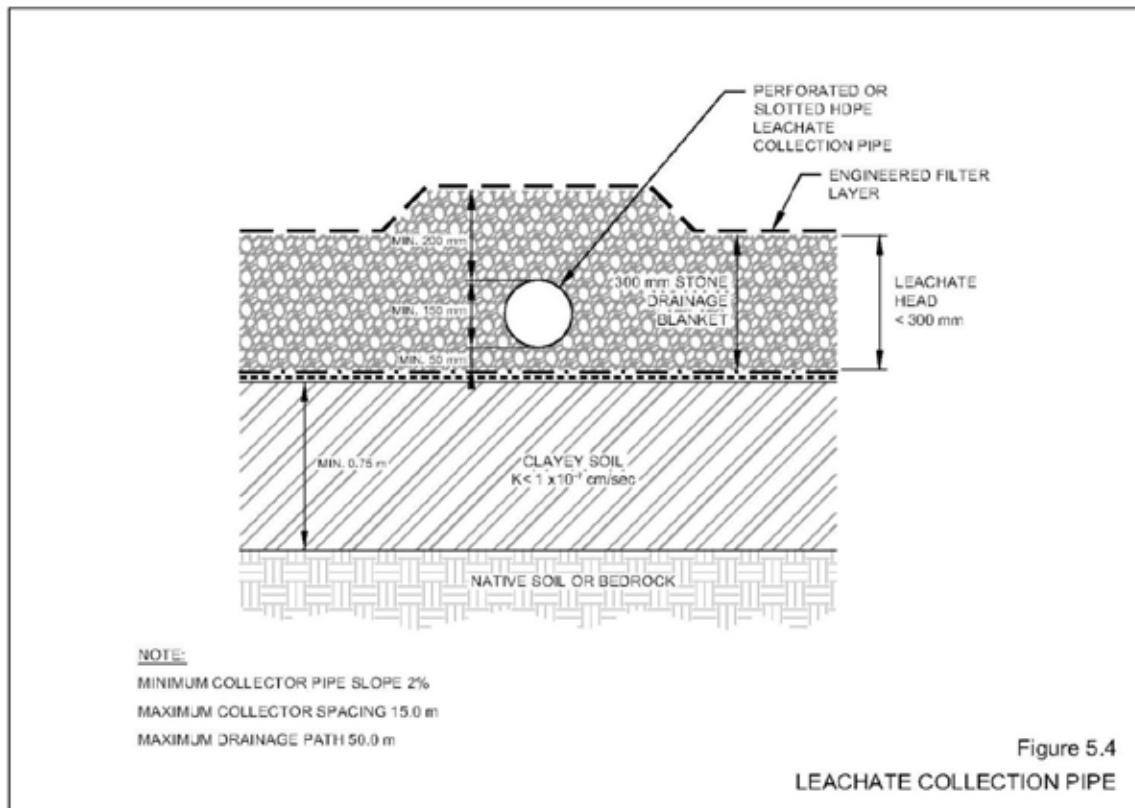
This figure indicates a maximum length of 50 m and separation of 15 m.

The run of the single pipe is 110 m with the collection tanks in the middle. At least one of the pipes must have a run in excess of 50m.

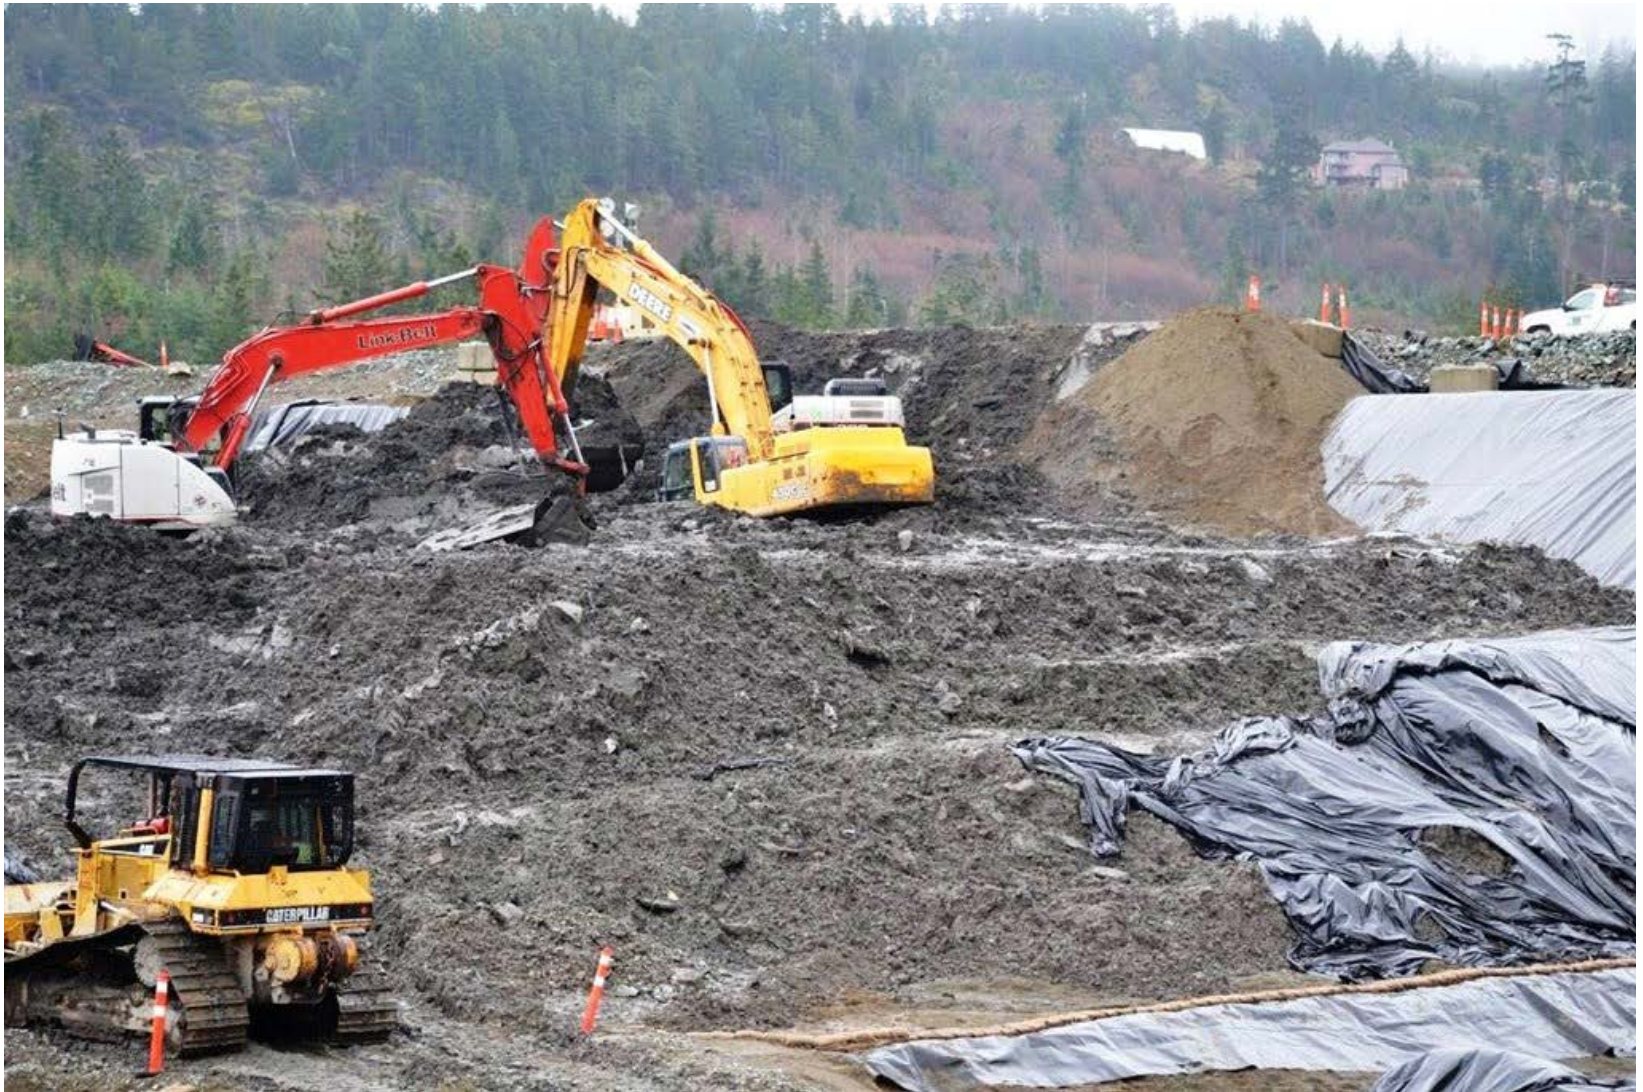
2015-11 Stuck in the Muck

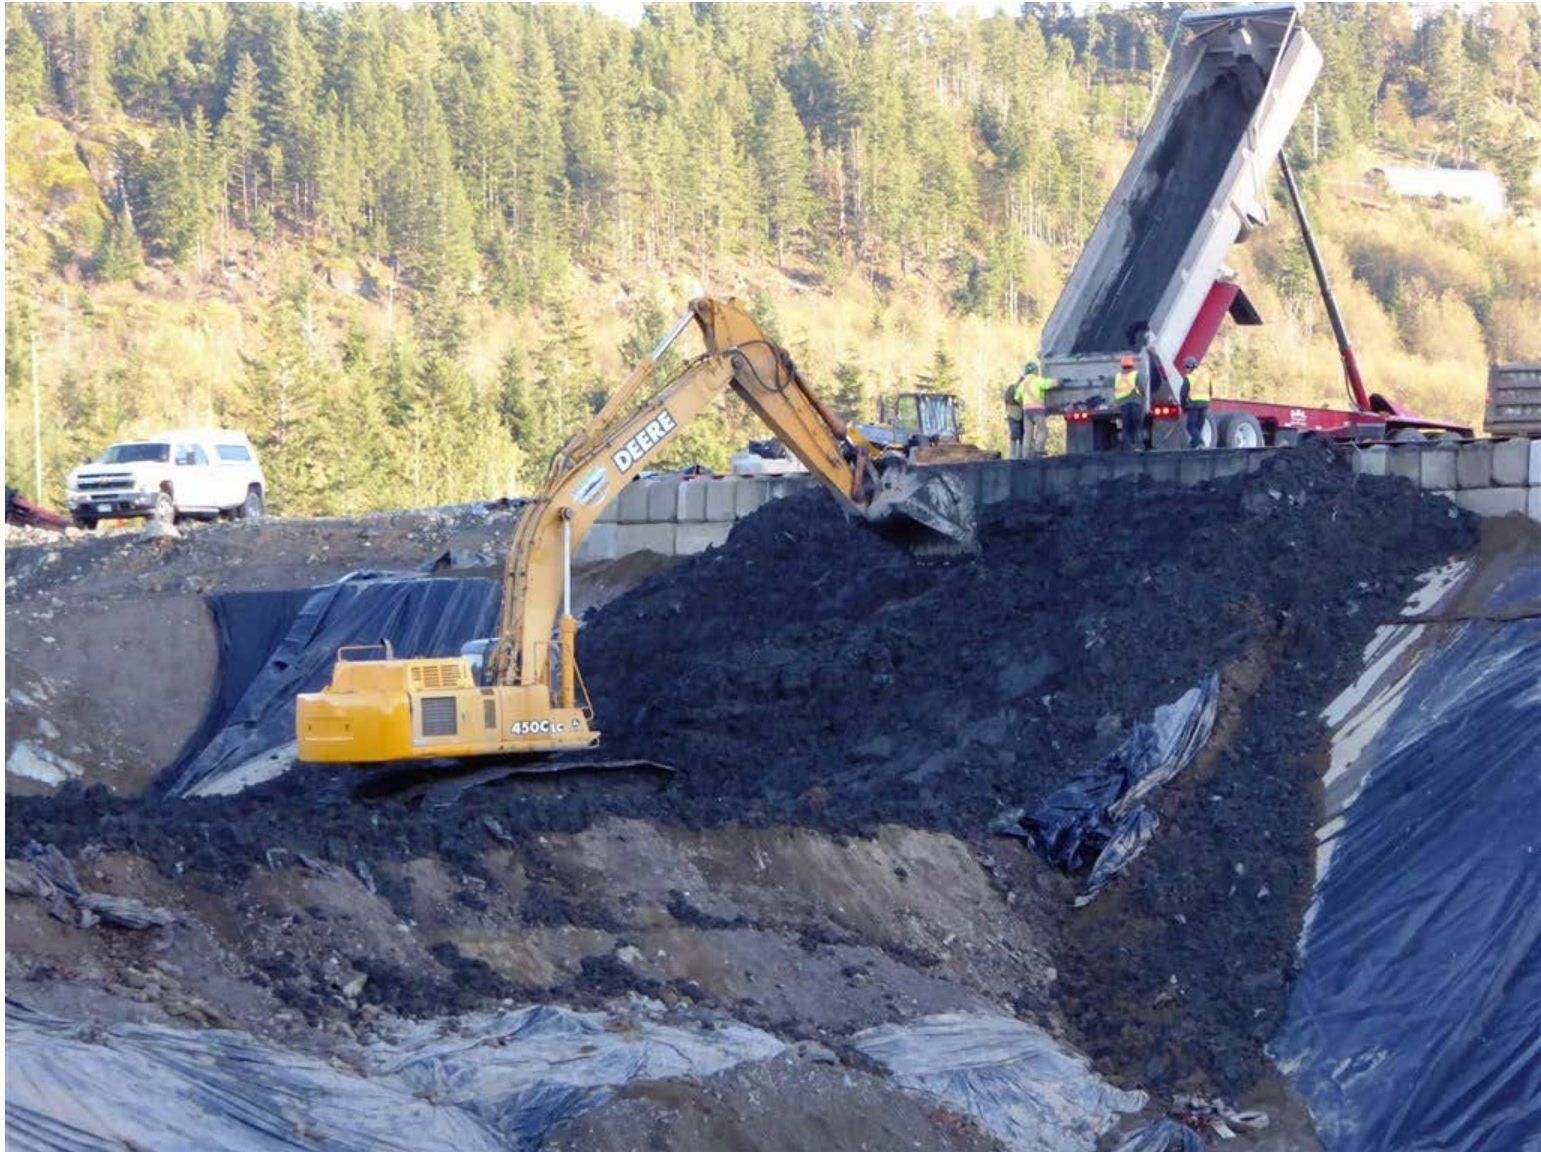
2015-11-09 Dumping on Liner

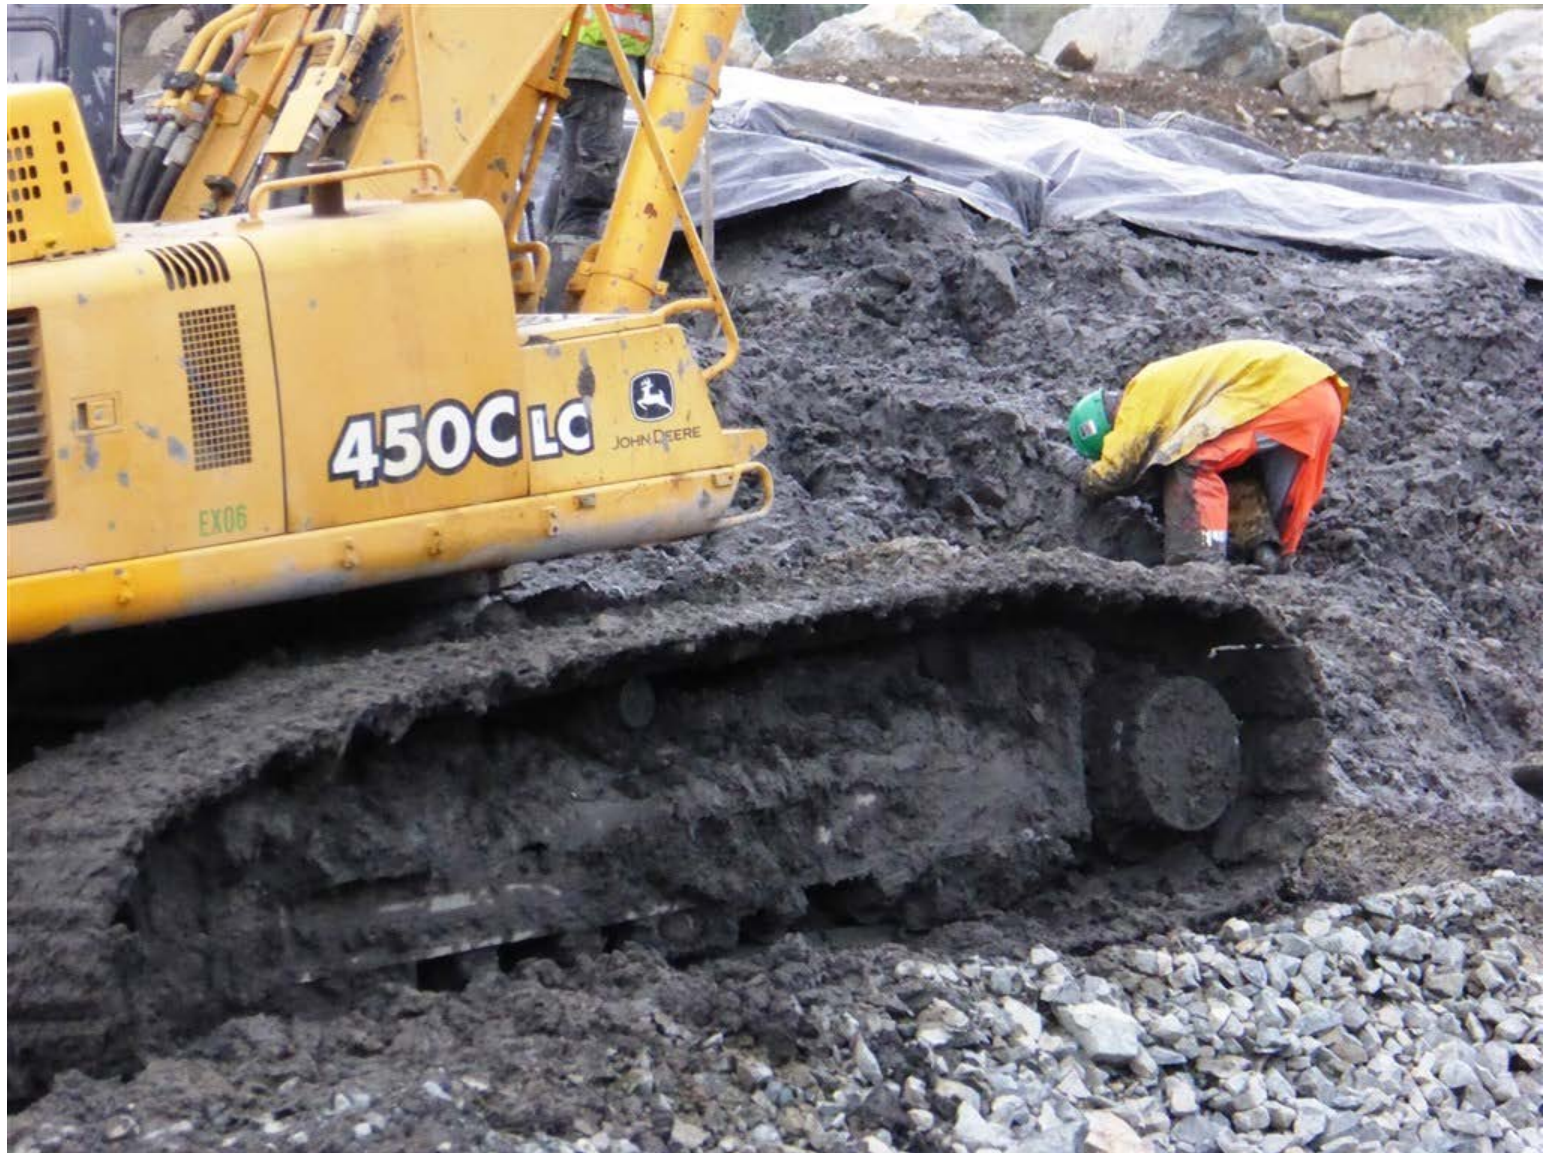
2015-11-13 Saturated Soil

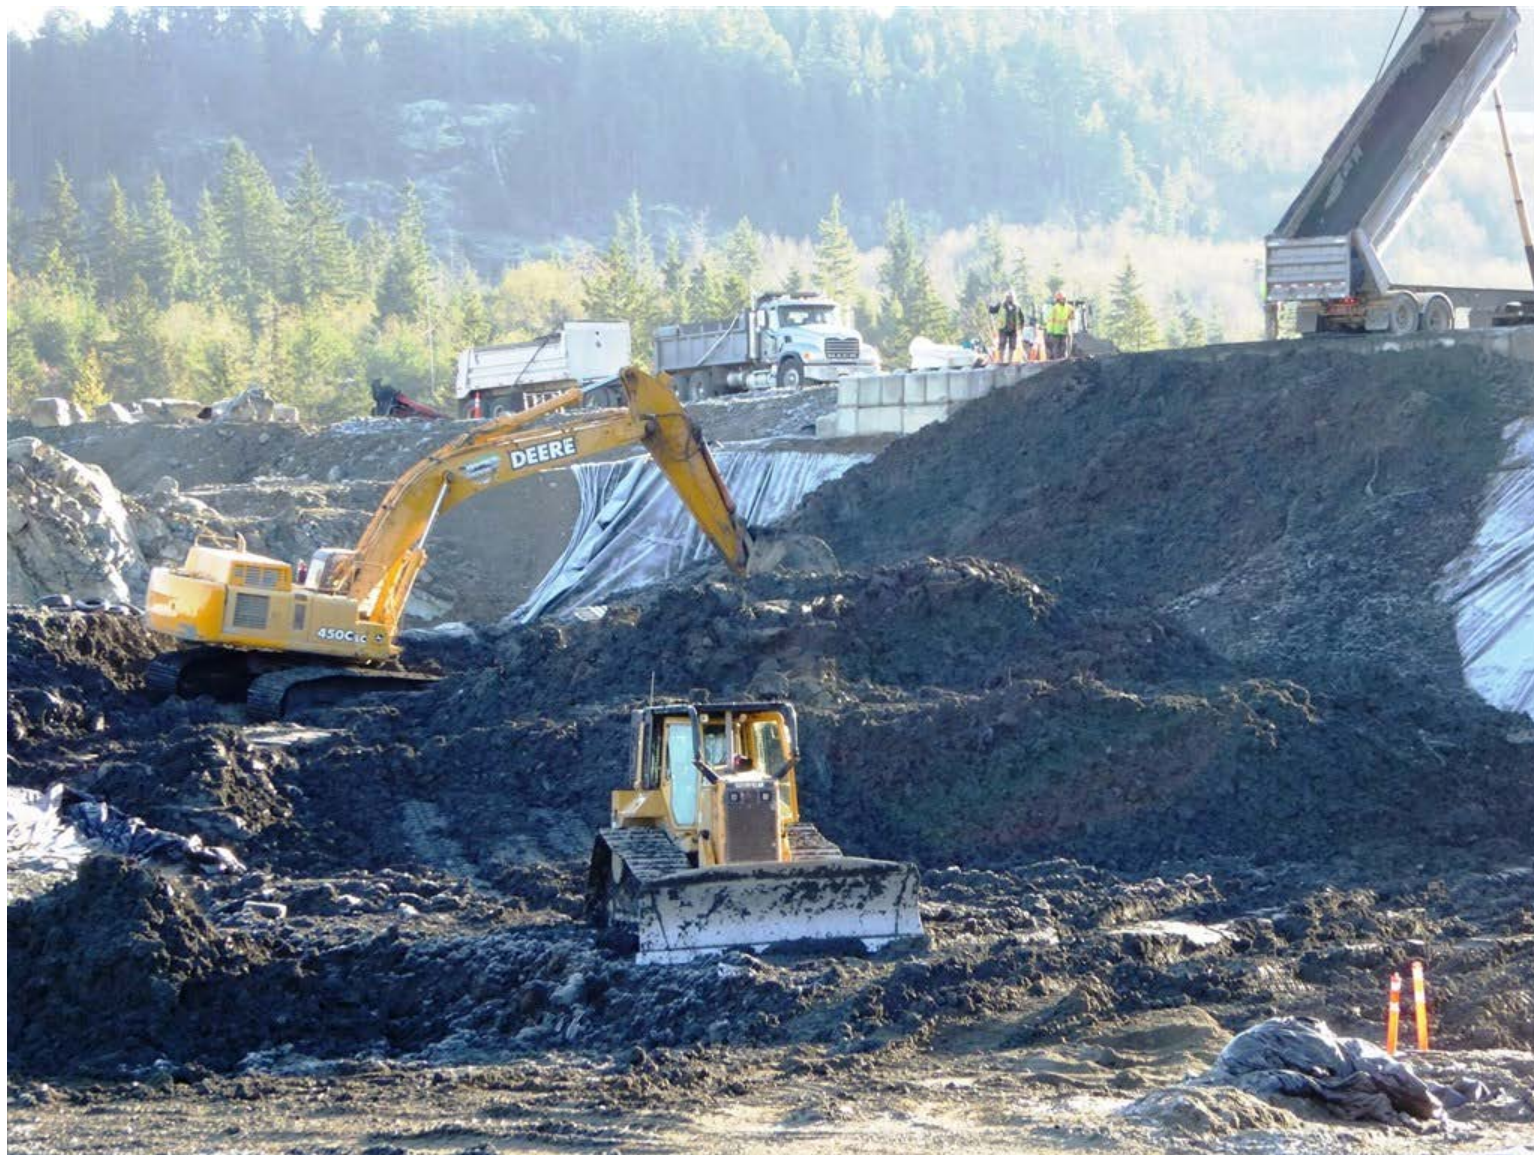
2015-11-20 Machines on Liner

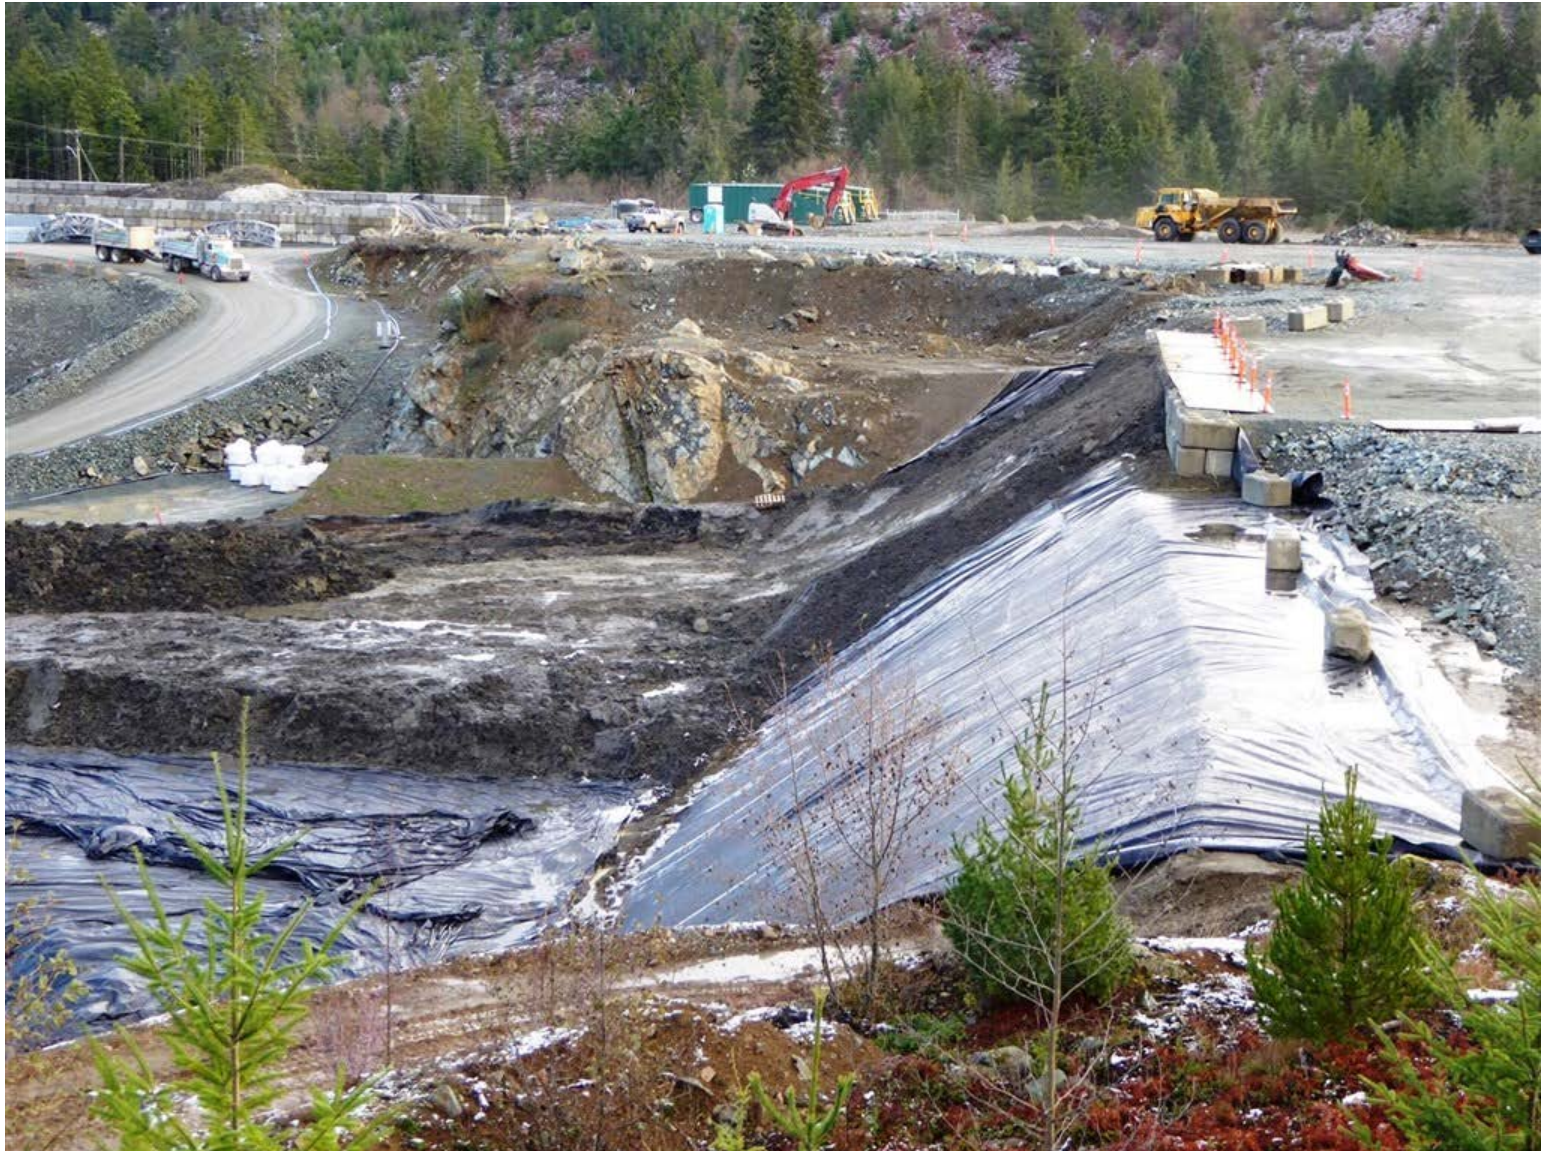
2015-11-24 Dumping on Liner

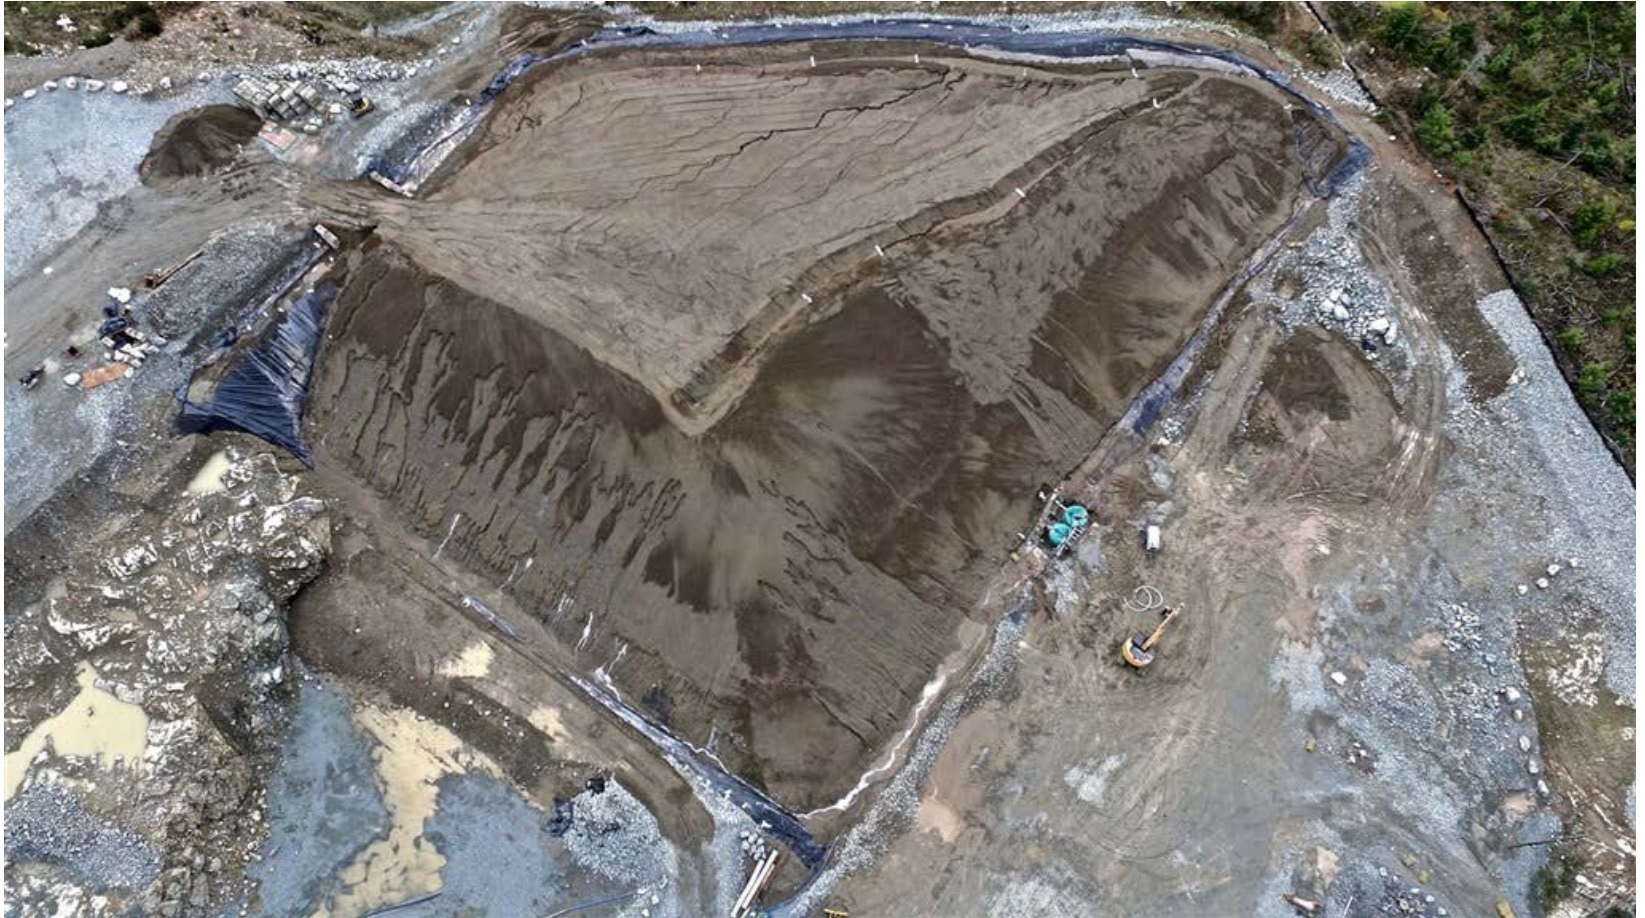
2016-10-09 100,000 Tonnes

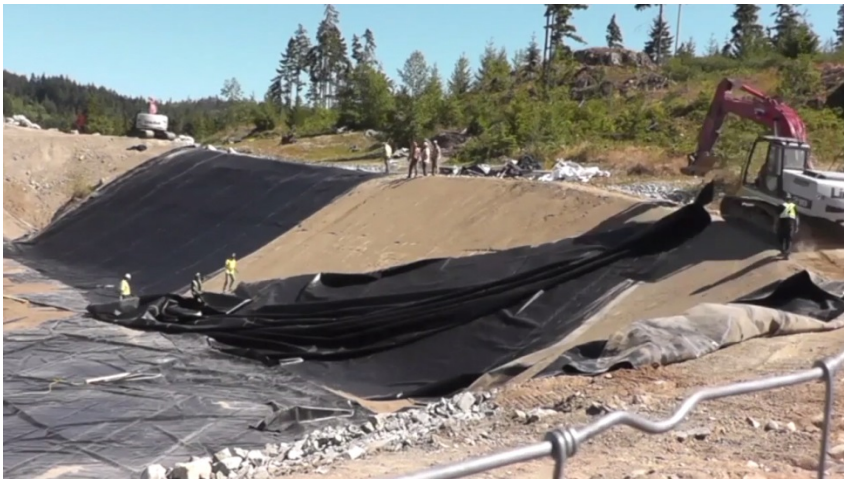
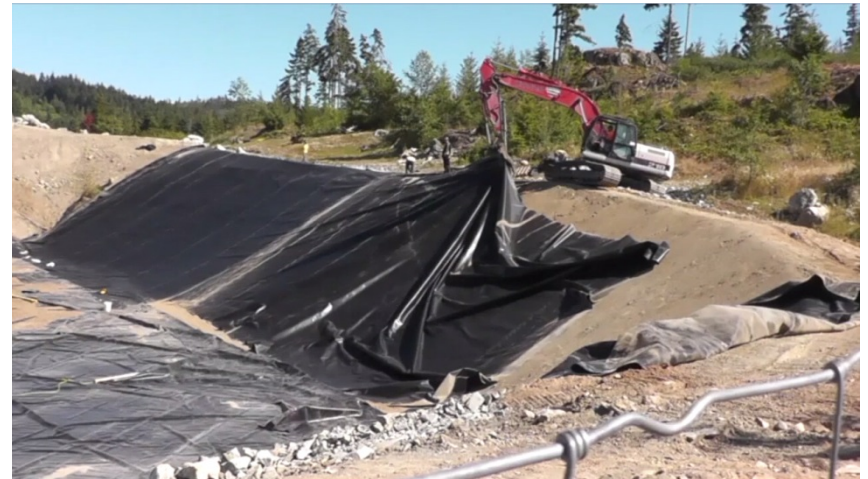
Rowe - Figure 10 - Wrinkles in a geomembrane

“Common problems associated with the installation include covering the geomembrane liner when there are too many wrinkles present”

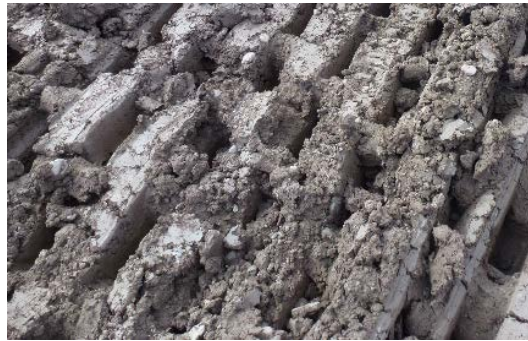
Figure 4. Compaction of clayey soil that is too dry (i.e., water content less than optimum +1%)

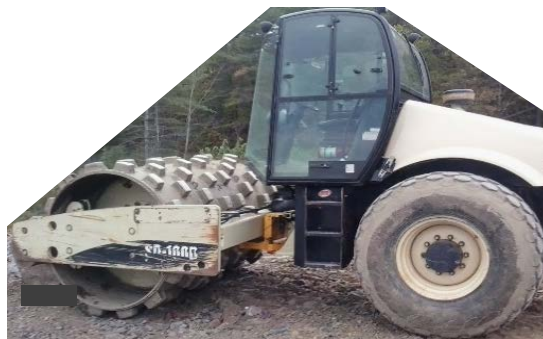
Figure 5. Equipment with pads that are too small and a mass too small for compacting a typical 150 mm CCL lift

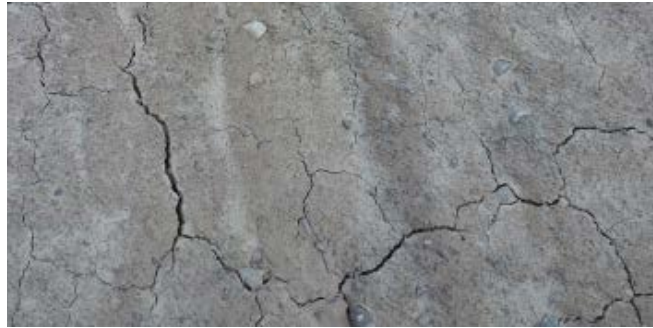
- Allowing clay to desiccate. Even shallow desiccation substantially increases interface transmissivity and potential leakage when the CCL forms part of a composite liner (Fig. 6). Desiccation is particularly problematic if the geomembrane is left exposed to the sun (i.e., without timely covering) since the heating of the geomembrane in the sun increases the risk of desiccation and the presence of the geomembrane hides the desiccation from view. Composite liners with a CCL below the geomembrane need to be covered in a very timely manner by the protection layer and drainage layer. The designer should anticipate if this may not be possible. In that event, a potential solution involves placing a coated GCL between the CCL and the geomembrane. If the slopes will be left exposed for a prolonged period, then the use of a coated GCL (coating facing up) minimizes (but does not eliminate) the risk of problems. Careful consideration also must be given to stability.

Figure 6. Desiccation of a compacted clay liner

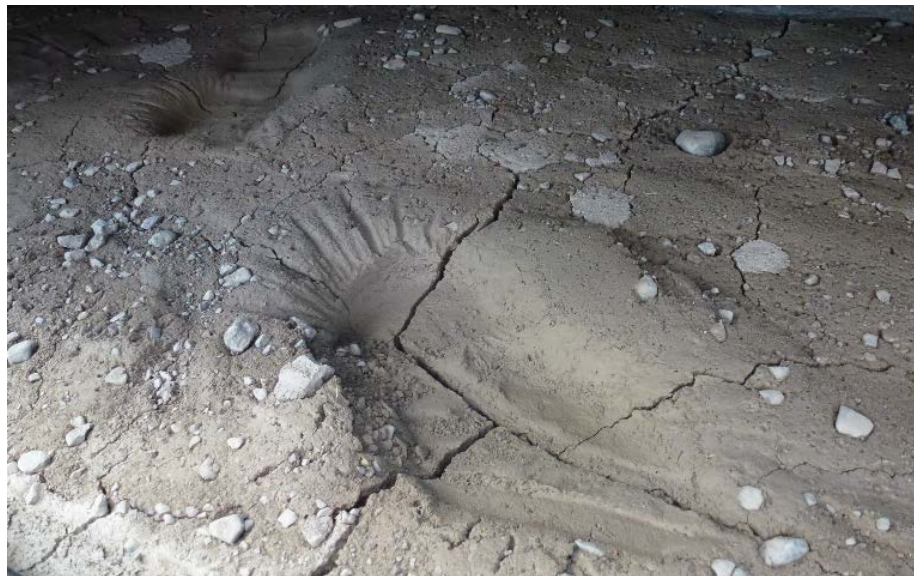
- Placing a geomembrane or GCL on a subgrade that has protruding stones, rocks or other objects, and/or is rutted and/or yielding. An inadequate subgrade may compromise the GCL and/or geomembrane performance. A subgrade may be damaged by rainfall events making it wet, soft or eroding it (e.g., Fig. 7) and this must be repaired before liner material is placed. Isolated angular gravel in the subgrade (Figs. 7 & 8) may cause problems for a GCL or geomembrane placed directly over the subgrade [45].
- Placing a GCL and not covering before heavy rain or placing it in wet areas. Premature hydration makes the GCL susceptible to bentonite squeeze-out if subjected to any non-uniform pressure and also shrinkage if it subsequently dries.

Figure 7. Inadequate subgrade for either a GCL or geomembrane (i) too soft (note footprint in upper left), (ii) too irregular, and (iii) too much protruding gravel.

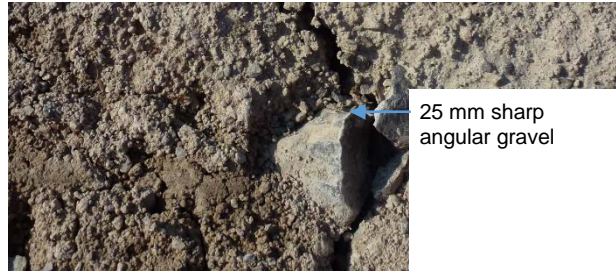
Figure 8. Sharp angular stone in subgrade below where a geomembrane had been place

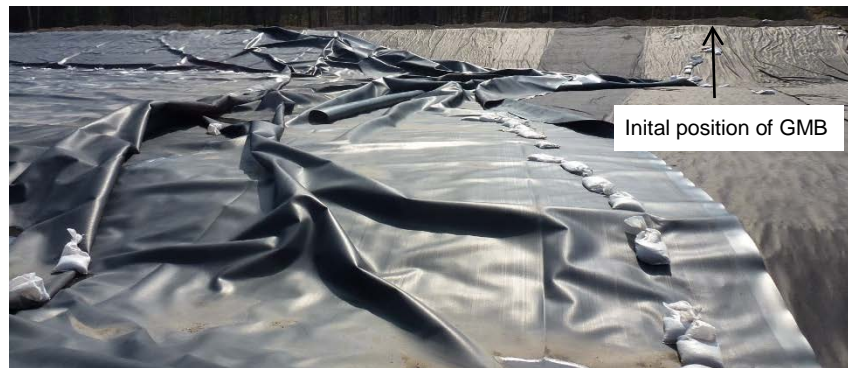
Not adequately anchoring/ballasting a placed geomembrane against wind up-lift (Fig. 9). Once up-lifted and folded (e.g., Fig. 9) the geomembrane is compromised and cannot be re-used.

Figure 9. Geomembrane (GMB) that had been picked up and moved by the wind.

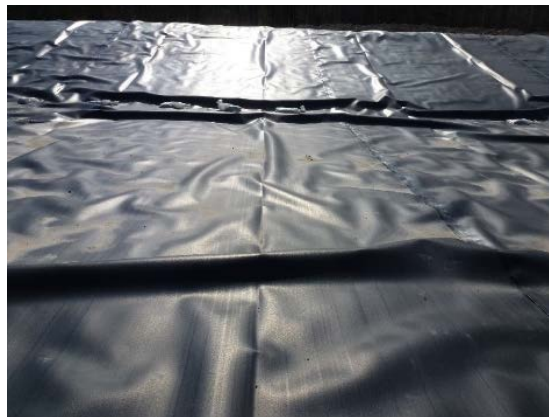
Covering the geomembrane liner when there are too many wrinkles present (Fig. 10).

Figure 10. Wrinkles in a geomembrane

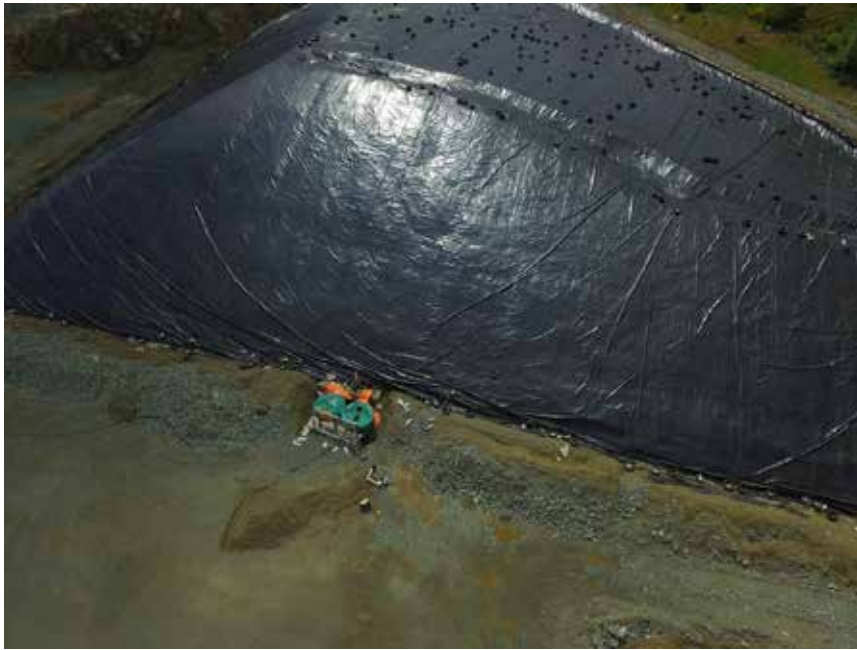
Image 1

Drone pictures of the Temporary Encapsulation Area (TEA) show that the entire surface has folds. These folds have appeared after the cover was installed. We believe they are growing as the contaminated waste pile continues to shrink. Folding is happening because the waste pile is shrinking through leaching of water and through biological activity in the dredgeate.

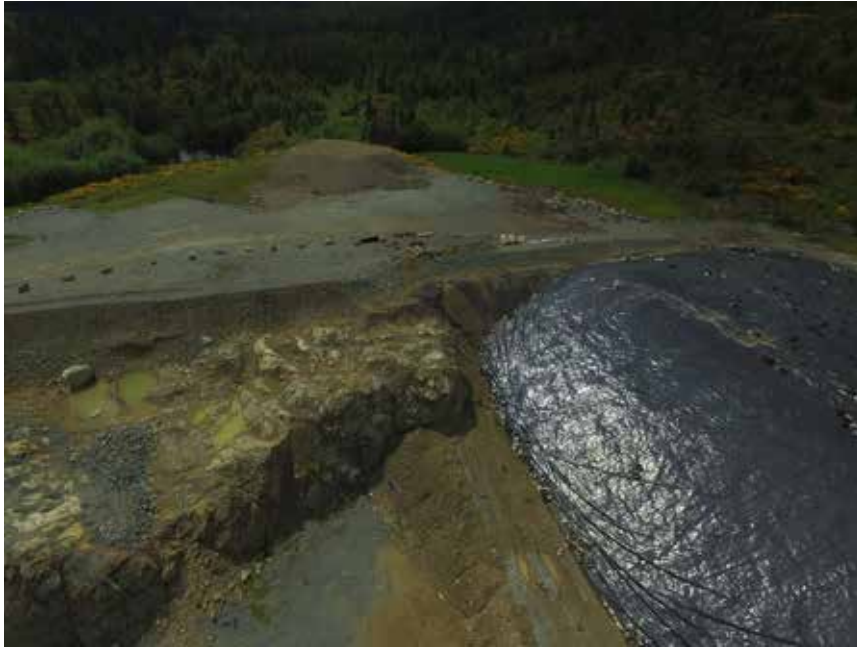
Image 3

We do not know how much the waste pile will finally shrink. Saturated soils can lose as much as 30% of their volume during drying.

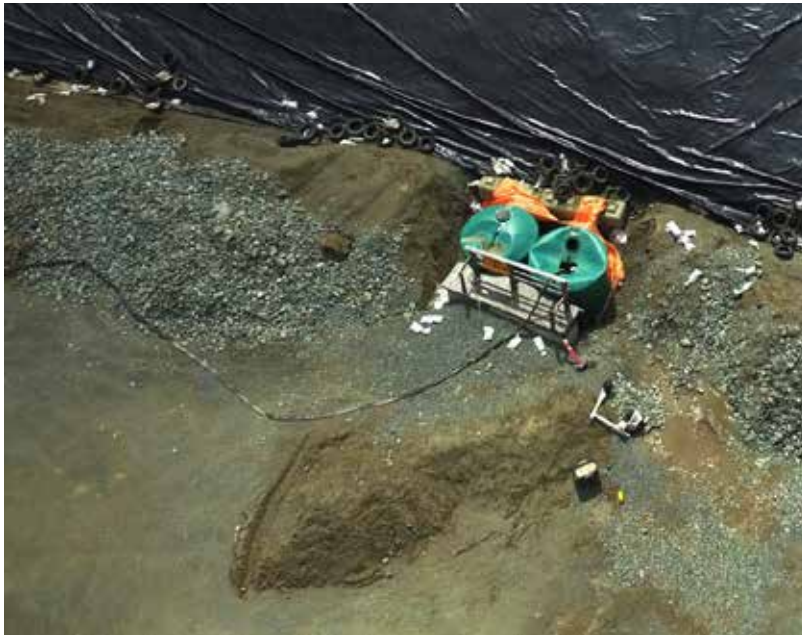
Recent drone pictures show that hoses are still connected to the leachate collection tank. It is possible that a submerged pump is still present in that tank.

Leachate collection tank, hoses

We ask that the submerged pump be removed from the leachate collection tank. We ask that all hoses be removed.

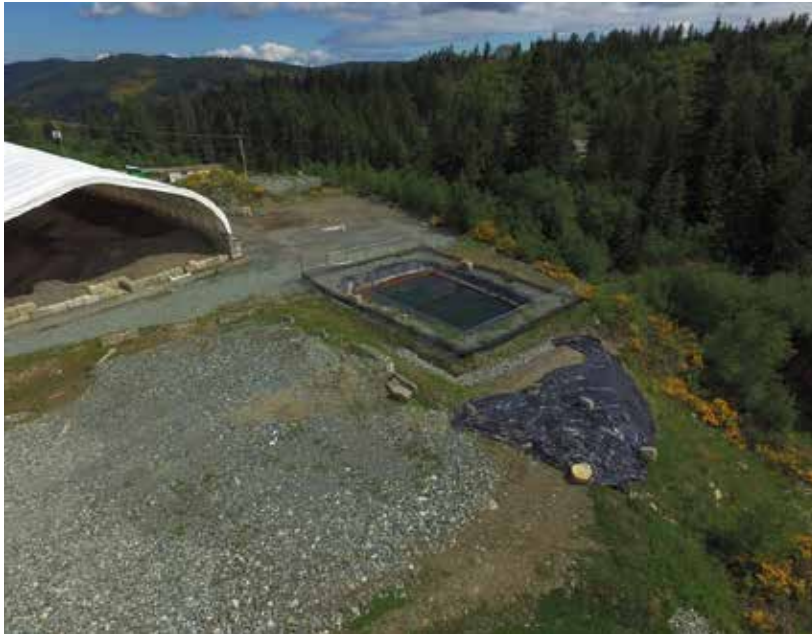
The leachate collection holding pond on the upper level still contains water. We ask that the contact water holding pond on the upper level be emptied and that water be treated as contact water. We ask that the contact water holding pond be decommissioned, the fencing and piping be removed, the hole be filled in with clean fill.

Contact water holding pond

We further ask that the contact water collection system for the Soil Management Area be replaced by a holding tank similar to the one at the TEA. We ask that water here be treated as contact water under the ASPO.
