# **Ministry of Energy and Mines**

## **Mount Polley Tailings Dam Failure**

### ***A Summary of Opinions in Support of CIM Investigation***

**Mount Polley Tailings Dam Failure**  
**A Summary of Opinions in Support of CIM Investigation**

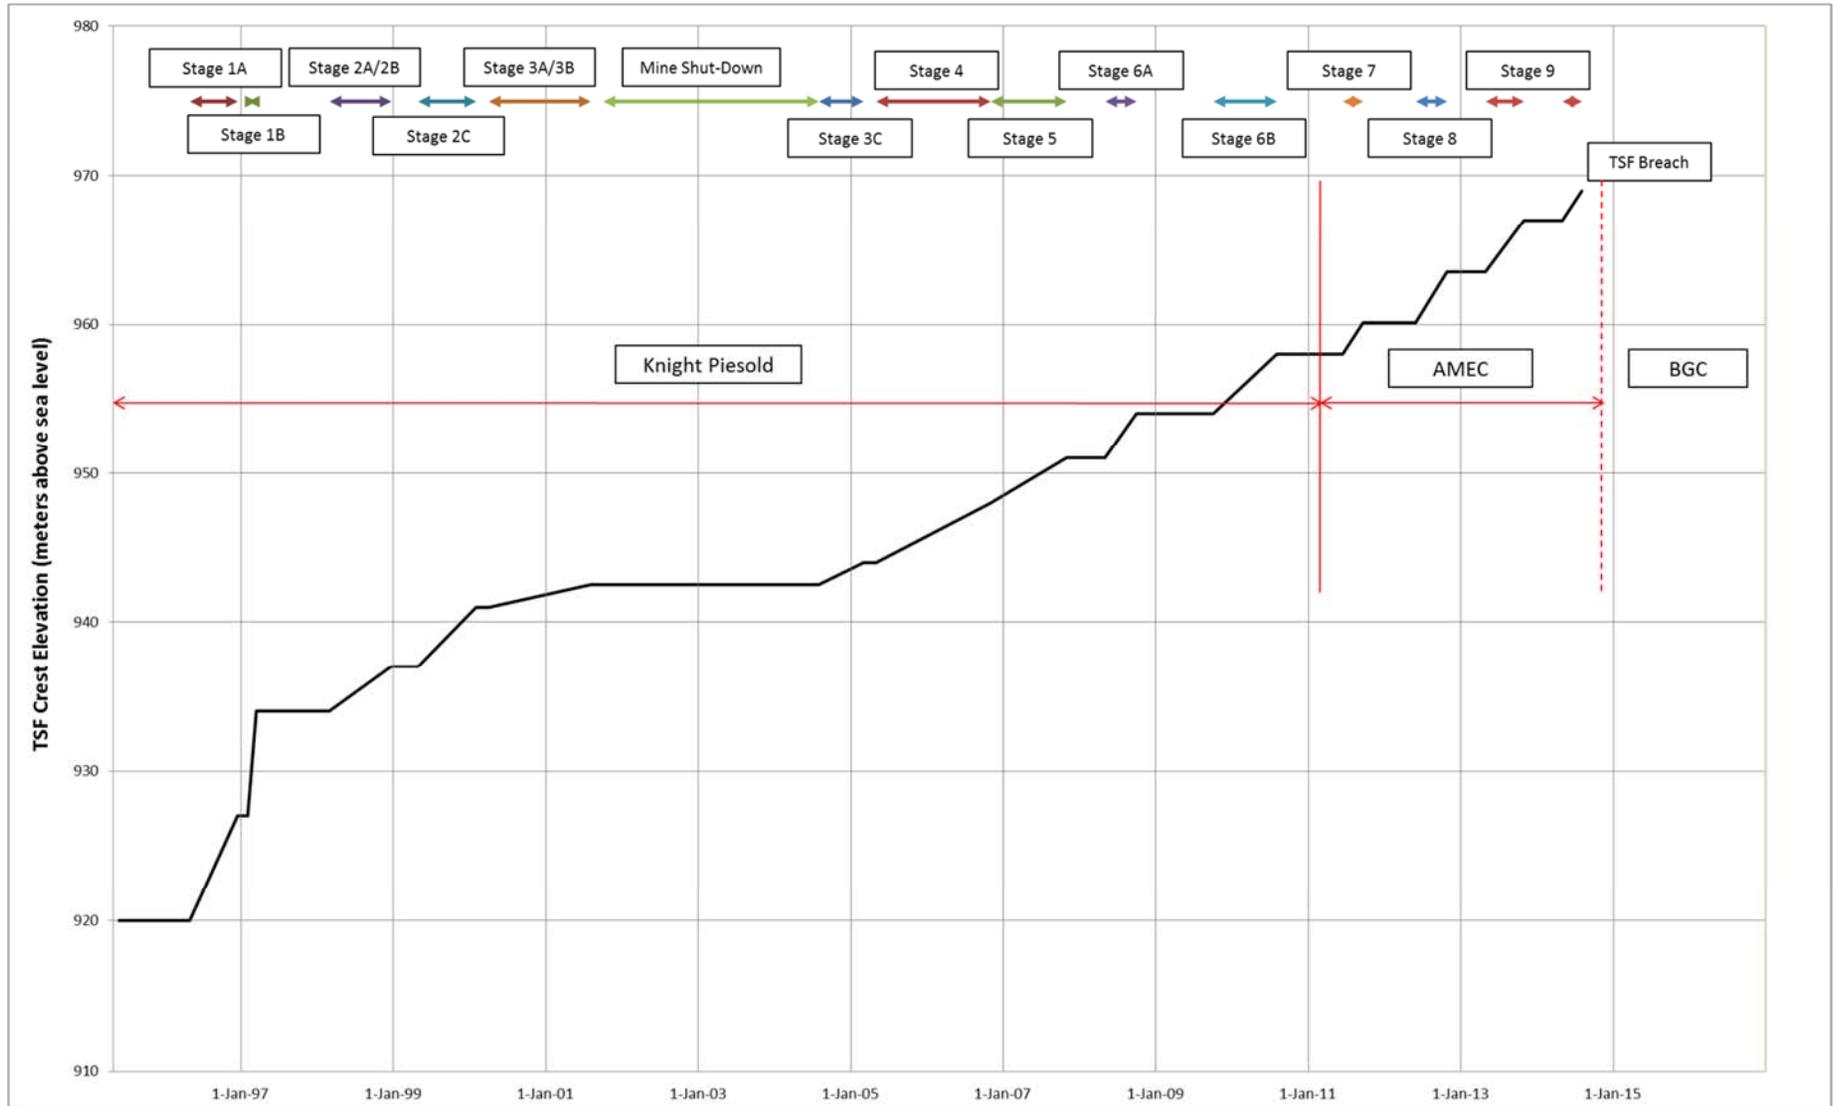
Figure 3.1 Timeline Summary of Project Stages

BGC started carrying out engineering projects on the TSF in 2012 and were transitioning to become the EOR for the Stage 10 construction, scheduled to begin in August 2014. A timeline summary of the dam raise stages and corresponding engineering firms is presented on Figure 3.1.

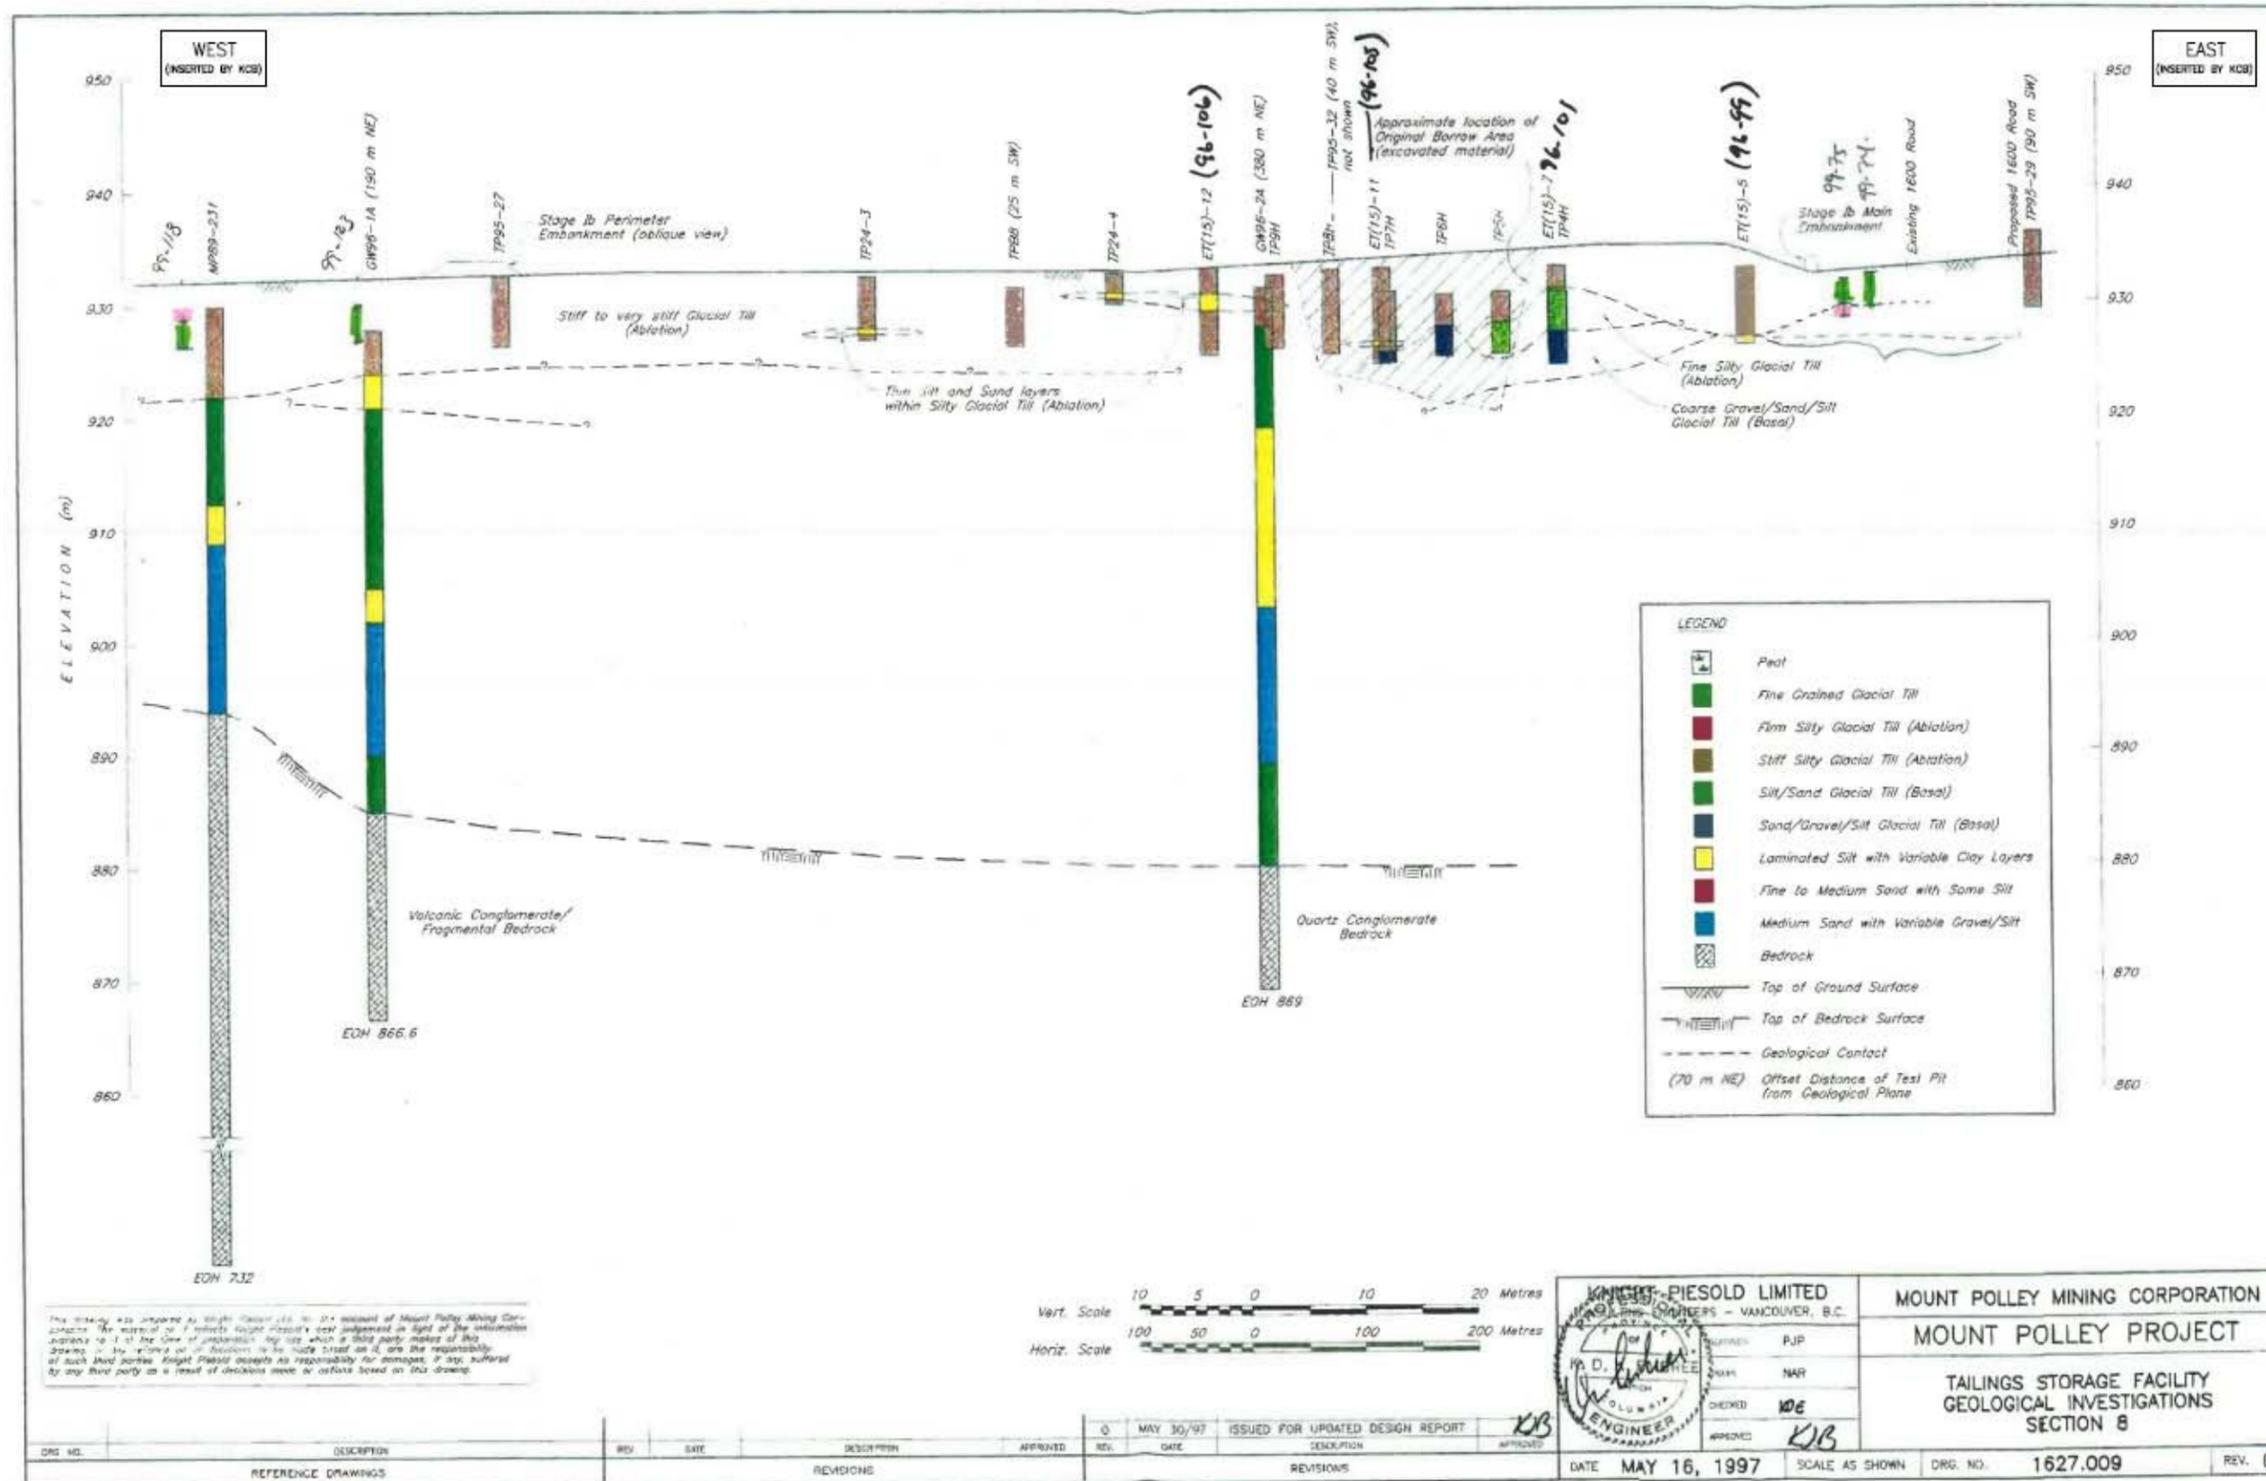
Figure 3.3 KP Geological Section Perimeter Embankment Area – Section 8 (KP 1997b)

A geological cross-section (Section 8), looking northwest to southeast, across the Perimeter Embankment is shown on Figure 3.3. The location of the section is shown in plan on Figure 4.2. The cross section (Section 8) identifies the presence of glaciolacustrine soils within the upper tills.

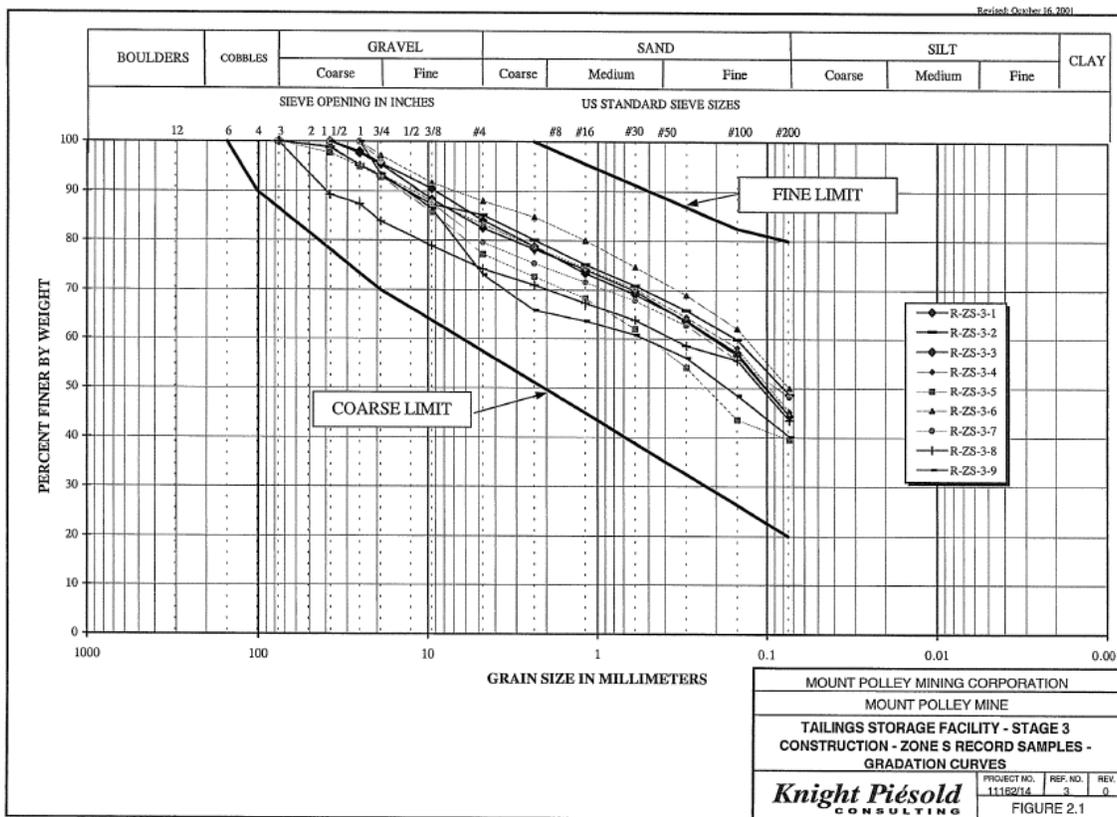
**Figure 3.10 KP Zone S (Core) Specifications with Gradation Record Results (Stage 3) (KP 2001)**

Zone S gradation criteria remained unchanged throughout Stages 1 through 6 and are shown on Figure 3.10, with typical gradations of samples collected during construction.

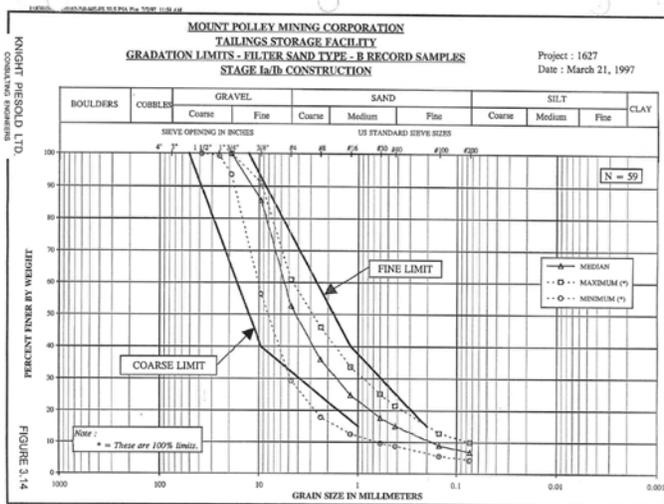
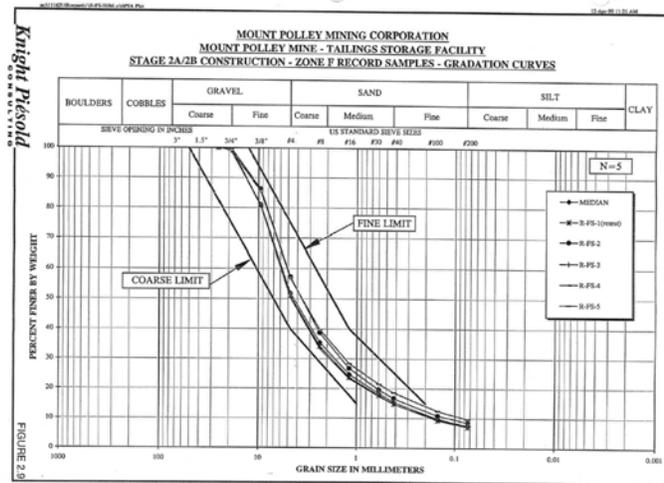
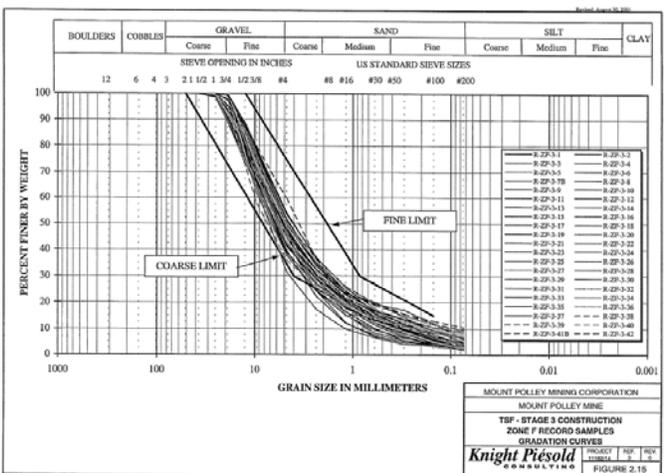
**Figure 3.11** KP Filter Zone Specifications (for Stage 1 (top) (KP 1997c), Stage 2 (middle) (KP 1999b) and Stage 3 (bottom) (KP 2001) with Gradation Record Results

The gradation specification for the filter zone was modified three times during KP’s tenure as design engineer. Different filter design was used for Stages 1, 2 and 3 through 6. Gradation envelopes are shown on Figure 3.11 along with typical gradation curves from samples of Zone F collected during construction. It is noted that placed material was often coarse of the design envelope.

An internal review of the filter criteria was undertaken by KP (2005c) which compared the design envelope to commonly used design guidelines. The analysis concluded that the filter design did not meet the filter criteria as it was too broadly graded and allowed a too high percentage of fine material. Broadly graded filters may be susceptible to internal instability and filters with high fines content may develop and sustain open cracks. Both of these issues can lead to loss of core material through the affected filter. It was also noted, however, that the reduction of the hydraulic gradient across the dam core considerably reduces risk of core erosion even with filters that do not meet recommended criteria. Recommendations from the study included: maintaining a low phreatic surface upstream of the core through toe drains, monitoring the phreatic surface within the embankments to ensure gradients are low, modifying the filter gradation specifications in areas where hydraulic gradients may be high and adopting other measures to reduce hydraulic gradients across the core. A comparison of filter specifications before and after this memorandum was issued indicates that the filter specifications were not changed.

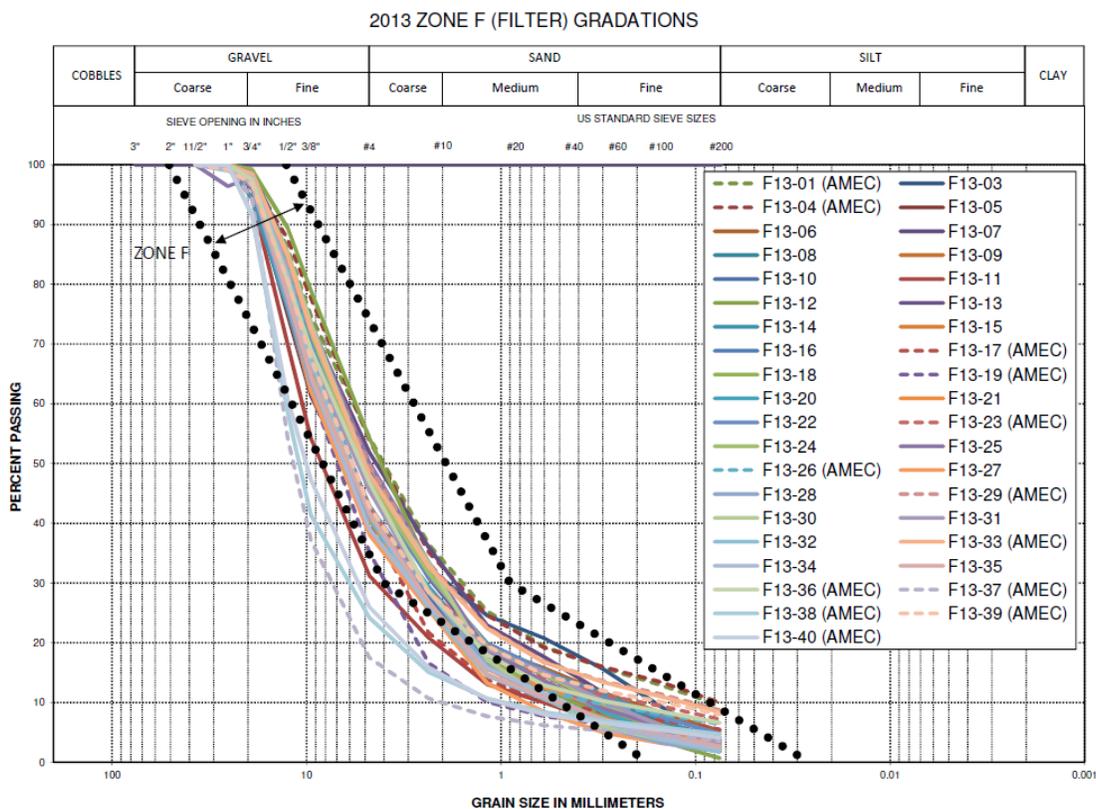
**Figure 3.12 AMEC Filter Specifications and QC Data – 2013 (AMEC 2014a)**

AMEC specifications for the filter zone are shown on Figure 3.12. The gradation envelope is the same as was adopted by KP for Stages 3 through 6. As noted in the figure, the filter zone gradation was often coarser than specified, based on 2013 construction records.

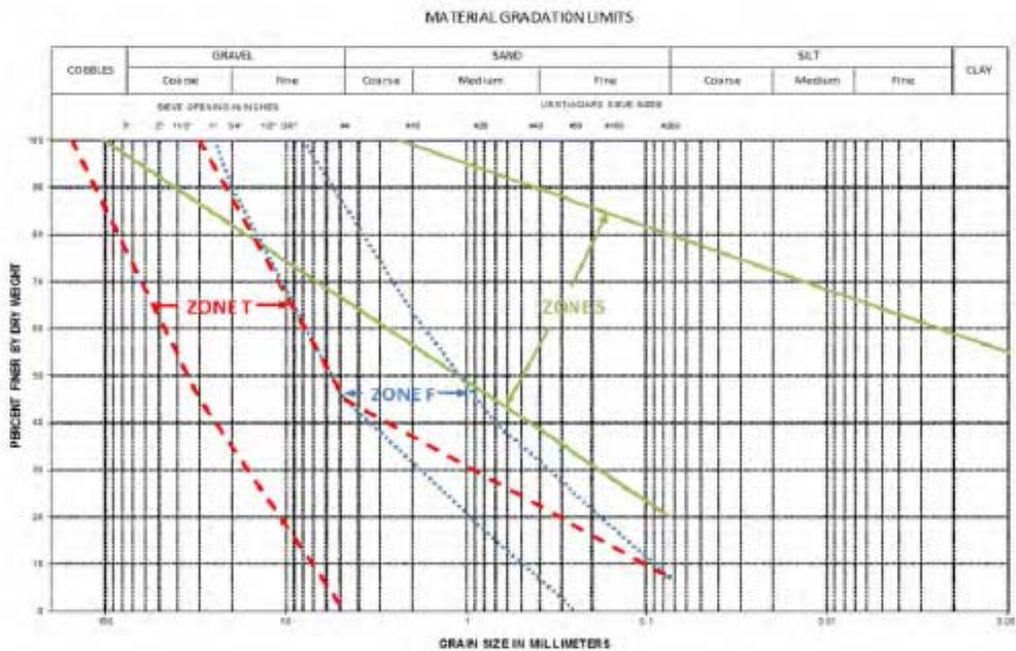
**Figure 3.13 BGC Filter and Core Zone Specifications (BGC 2014)**

BGC specifications for the filter zone are shown on Figure 3.13. BGC identified that previous filter criteria used did not meet the specification for control of segregation and, accordingly, increased the minimum sand size fraction from 30% to 45% (BGC 2014, pg. 60).

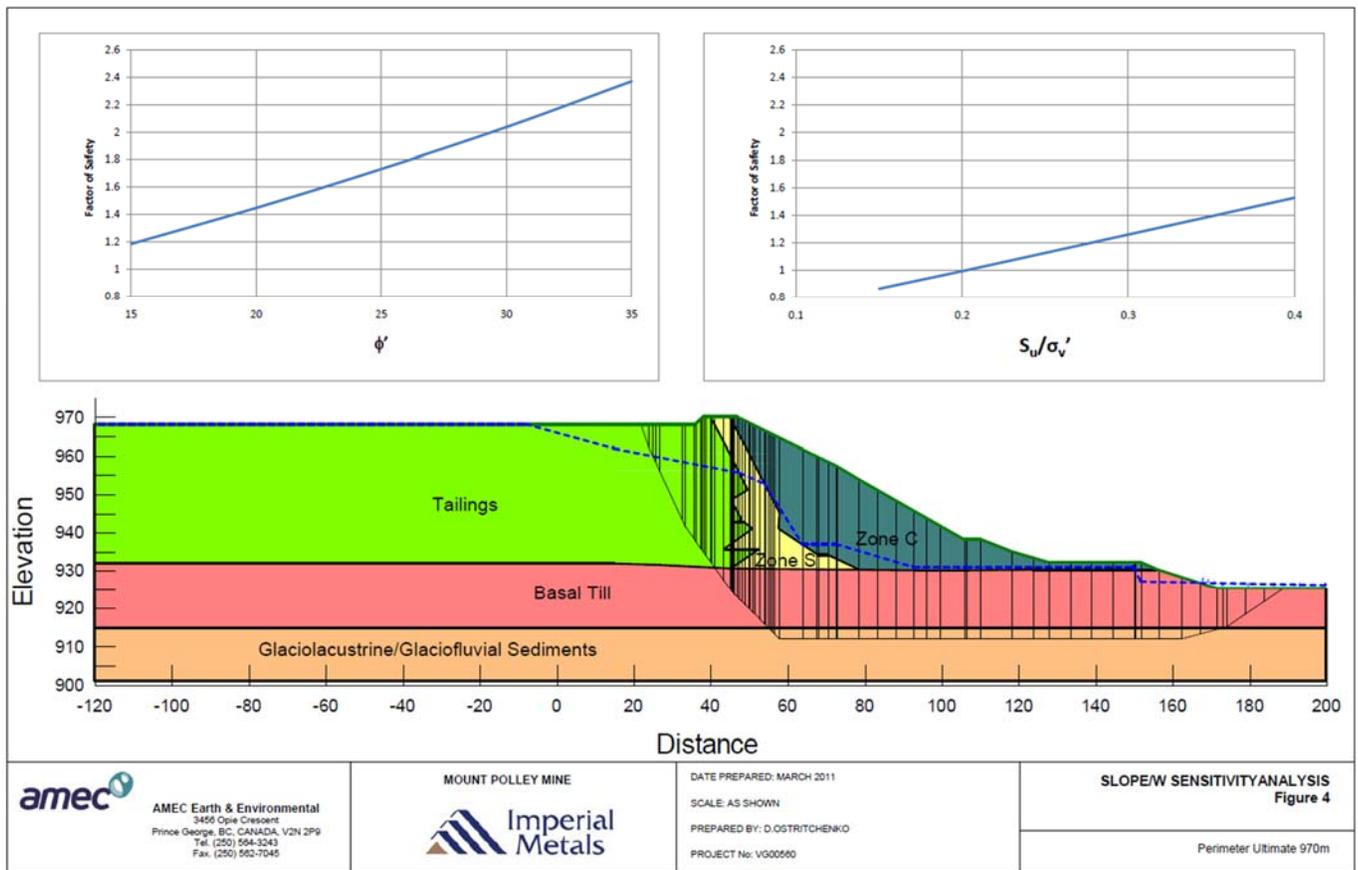
Figure 3.14 AMEC Undrained Strength Analysis – PE - El. 970.0 m

For the undrained sensitivity analysis, the undrained strength ratio ( $S_u/\sigma'_v$ ) was varied from 0.1 to 0.4. The effective slope for the analysis is approximately 2H:1V. FoS from the undrained analysis ranged from 0.95 to 1.68 for the Stage 7 case and 0.86 to 1.53 for the 970 m case. The results for the El. 970.0 m case are shown on Figure 3.14. Only the results are reported with no conclusions discussed or recommendations.

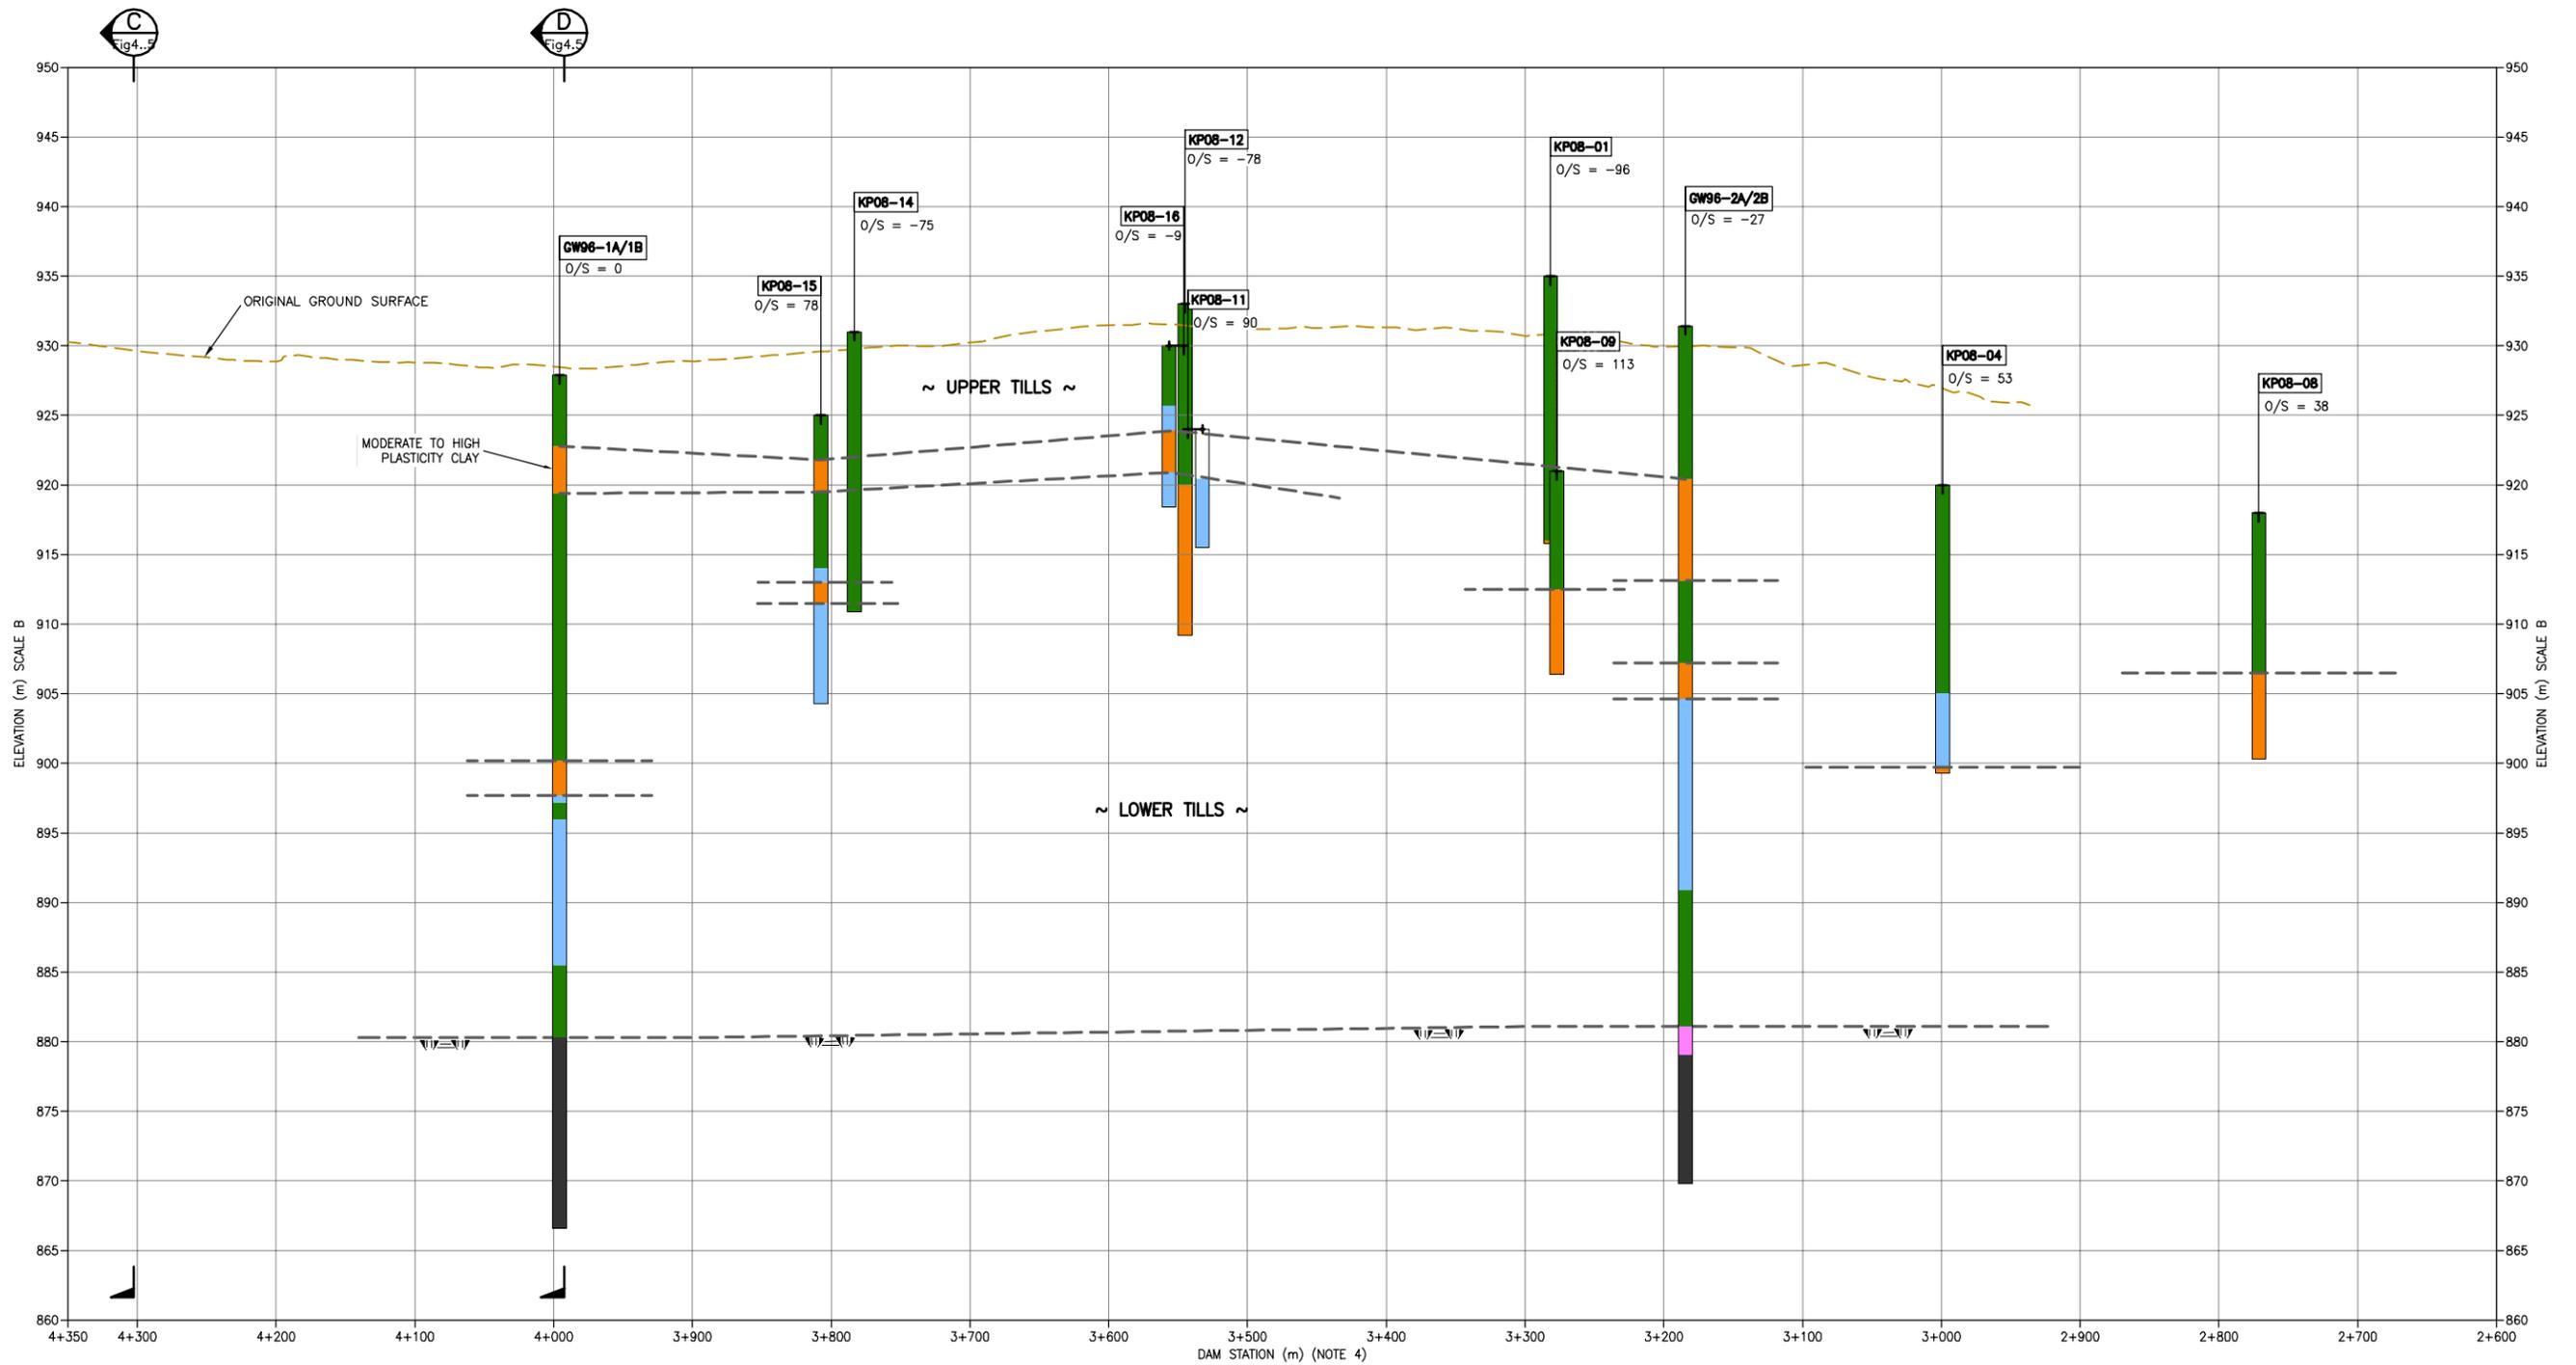
SECTION B  
SCALE A

The location of the PE site investigation drill holes and test pits is shown on Figure 4.2. Profiles along the length of the PE are shown on Figure 4.3 and Figure 4.4. Sections through the PE are shown on Figure 4.5.

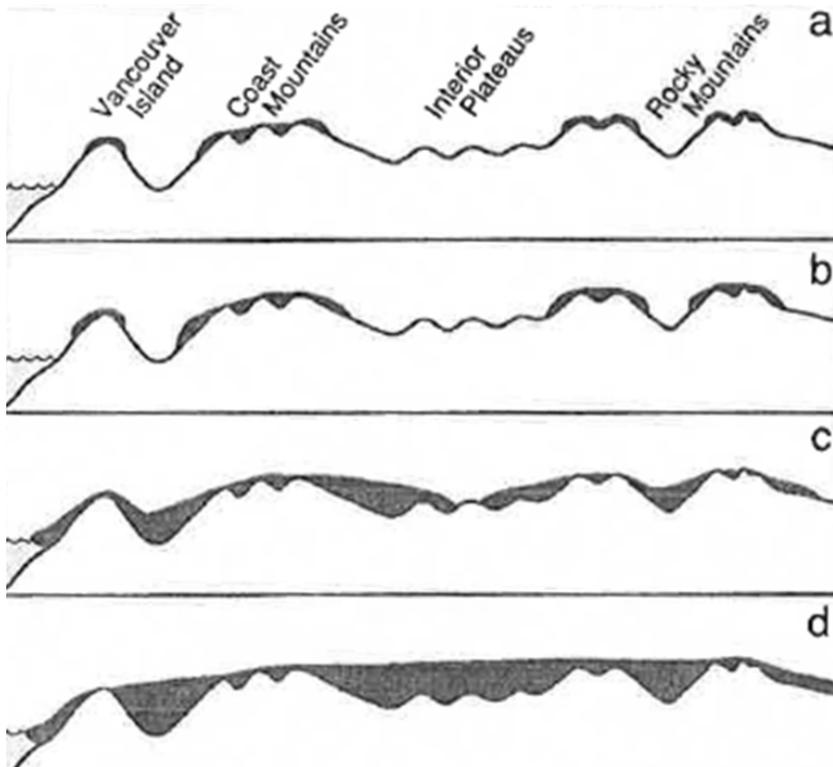
**Figure 4.6 Development of the Cordilleran Ice Sheet (from Fulton, 1991)**

A schematic showing the formation of the Cordilleran Ice Sheet is shown on Figure 4.6. At its maximum extent the top of the ice was approximately El. 2500 m.

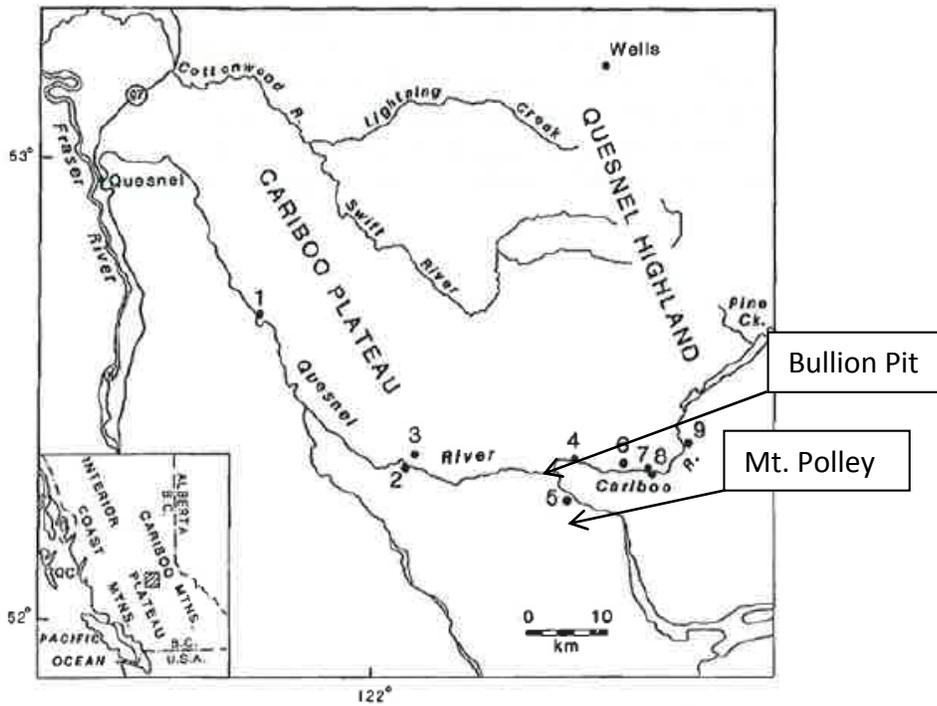
**Figure 4.7 Study Locations (Shown as Numbers) in the Quesnel and Fraser Valleys (Clague, Hebda and Mathewes, 1990)**

Several studies have been undertaken to understand the glacial history of the Interior Plateau. Of particular note are those that have focused on the glacial history of the Quesnel and Cariboo River Valleys, due to their proximity to Mt. Polley. The study area locations are shown on Figure 4.7. The glacial history of the Bullion Pit area (Clague, Hebda and Mathewes, 1990) was studied and a stratigraphic section is shown on Figure 4.8.

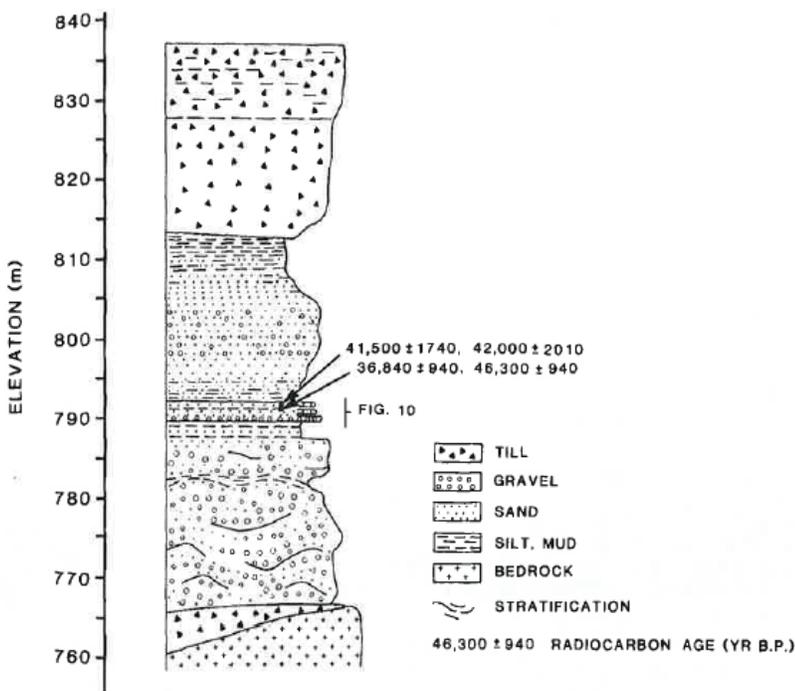
**Figure 4.8 Stratigraphic Section at Bullion Pit (Clague, Hebda and Mathewes, 1990)**

There is evidence to suggest that two glaciations occurred within these valleys; the penultimate glaciation (>35,000 bp) and the Fraser Glaciation (10,000 bp to 25,000 bp). Glaciolacustrine and glaciofluvial sediments were deposited in the valleys during glacial advance and retreat. The glaciolacustrine deposits associated with the penultimate glacial retreat are described as mainly “massive and stratified silt, sand, gravel, and minor diamicton” (well graded soil) (Clague 1991). Structures within these sediments include folds, faults and sedimentary dykes that are both syndepositional (occurred during deposition) and post-depositional (Clague 1991). The second package of glaciolacustrine sediments were deposited at the end of the Fraser Glaciation, and consist of laminated sand, silt and mud. This unit resembles the sediments deposited after the penultimate glaciation but “lack the pervasive deformation and complex intertonguing of lithologies typical of the latter” (Clague 1991).

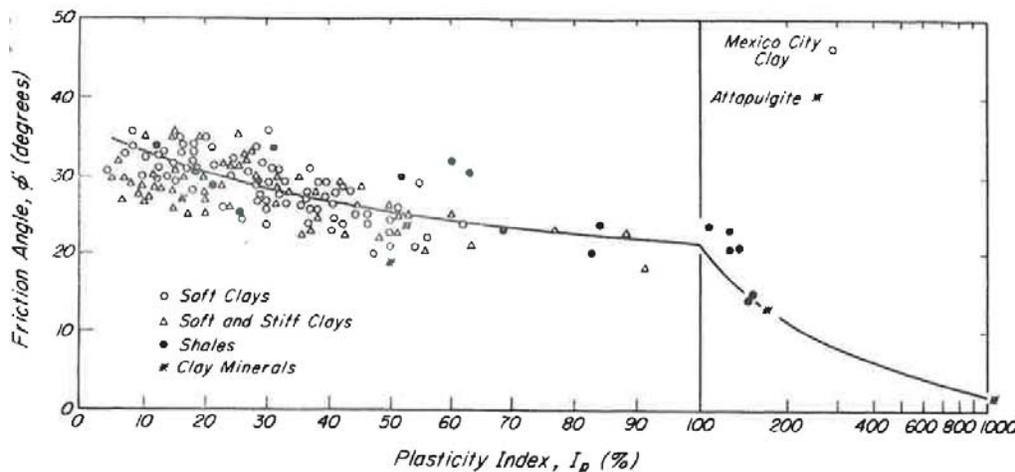
**Figure 4.9** Correlation between Peak Friction Angle and Plasticity Index (from Terzaghi et al. 1996)

KCB reviewed the empirical correlations published by Terzaghi et al. (1996) for peak friction angle ( $\phi'_p$ ) of cohesive soils (Figure 4.9) and by Stark and Hussain (2013) for residual ( $\phi'_r$ ) friction angle (Figure 4.10). These correlations relate frictional strength to a soil's index properties. Index properties from the glaciolacustrine testing were used in estimating design parameters and no attempt was made to try to separate out the limited data from the upper glaciolacustrine units.

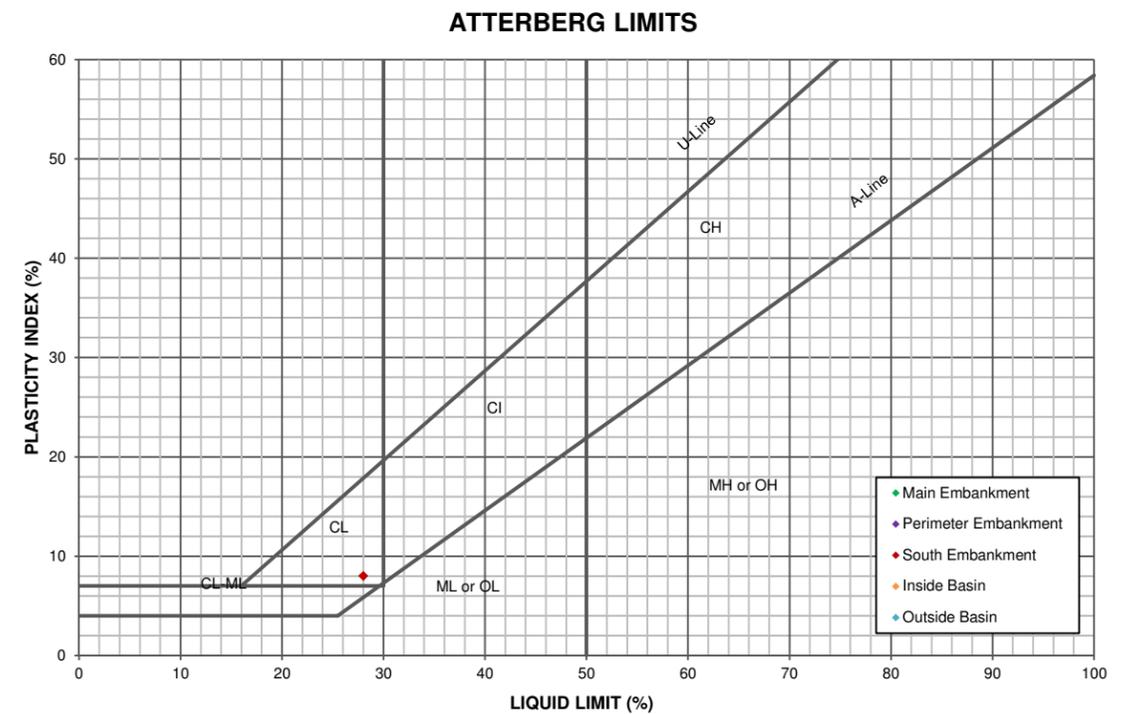
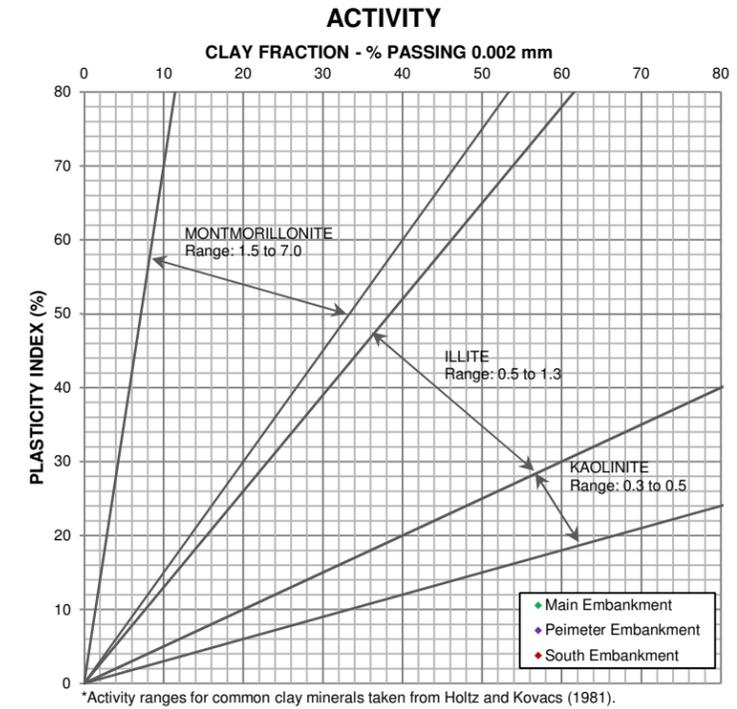
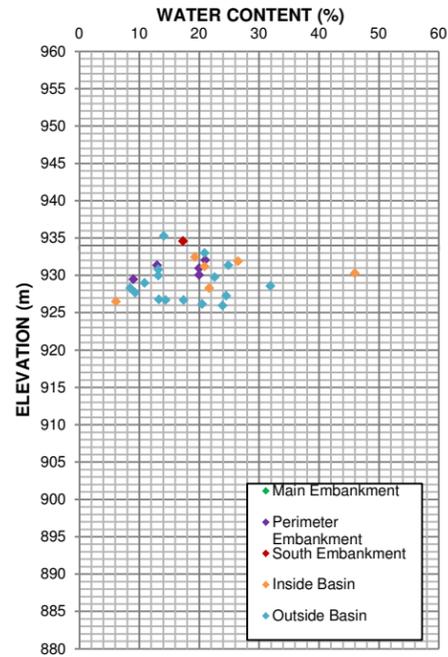
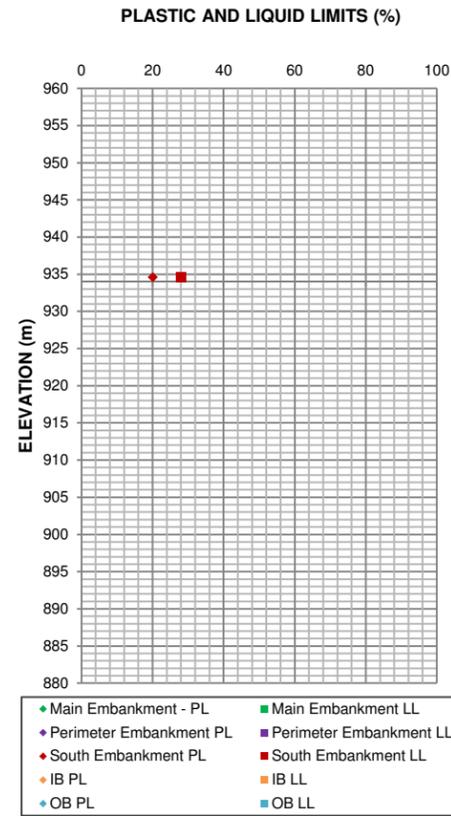
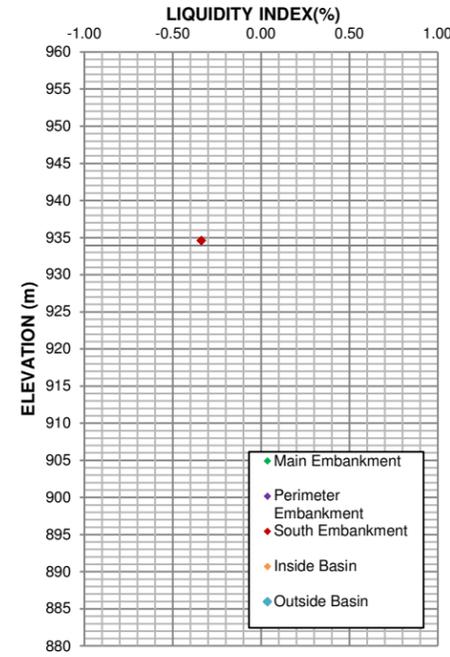
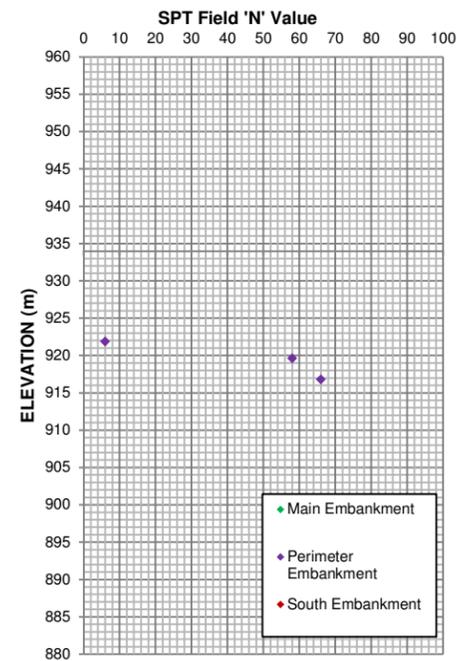
PROJECT	MOUNT POLLEY DAM FAILURE
TITLE	GLACIOLACUSTRINE UNITS WITHIN THE UPPER TILLS
PROJECT No.	M09954 A01
FIG No.	4.12

There is very little index testing data on the UGLU within the upper tills. Data that was gathered is summarized on Figure 4.12. Water content testing was mostly performed on near-surface soil within the borrow areas, inside and outside of the TSF basin. Results ranged from approximately 6% to 46%, with a median value of 20%. Soil log descriptions from drill hole GW96-1A indicate a softer material with a SPT value of 6 (undrained shear strength on the order of 40 kPa).

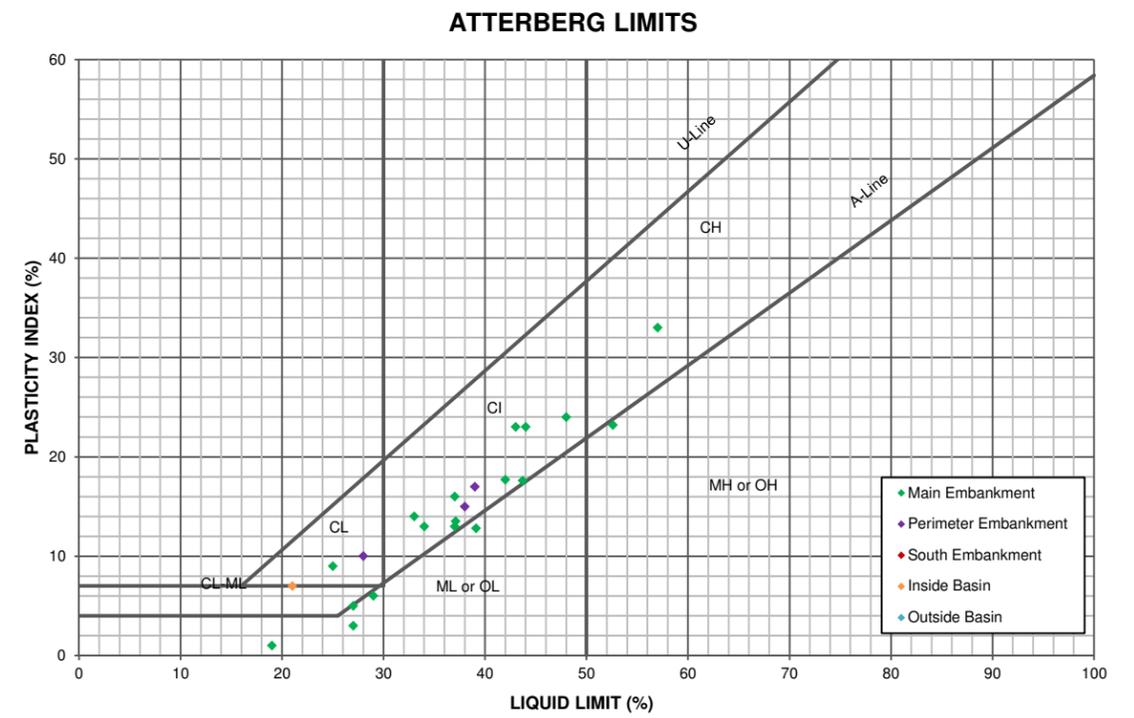
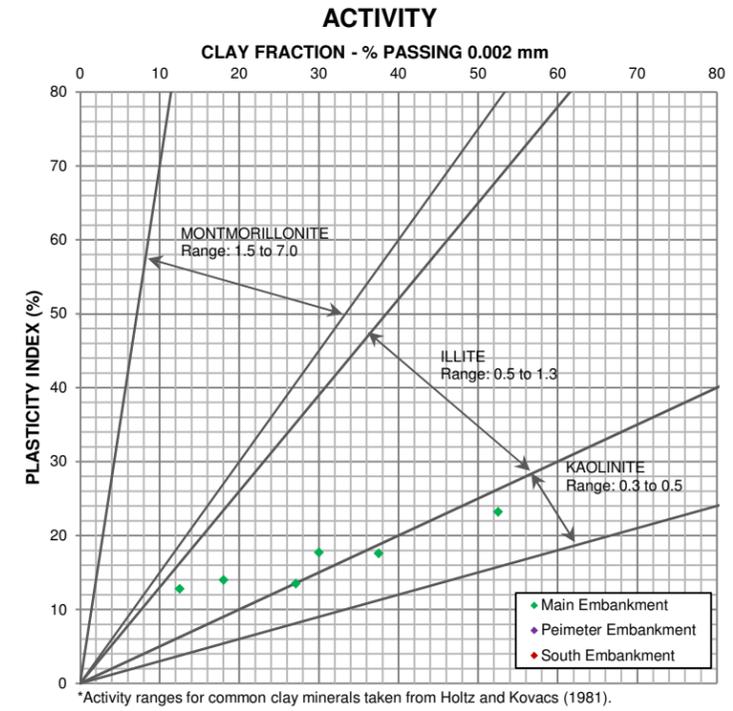
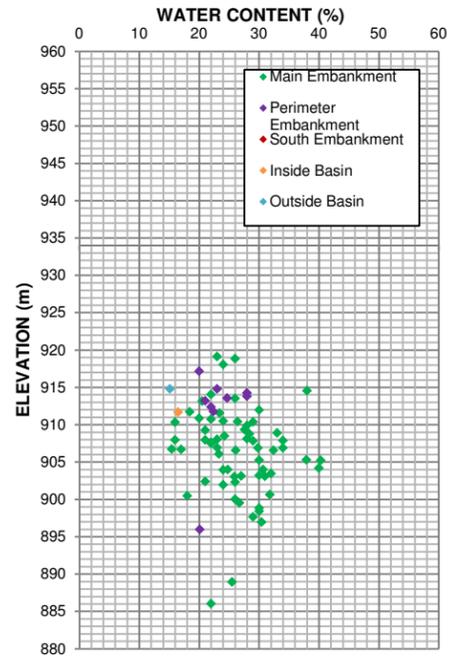
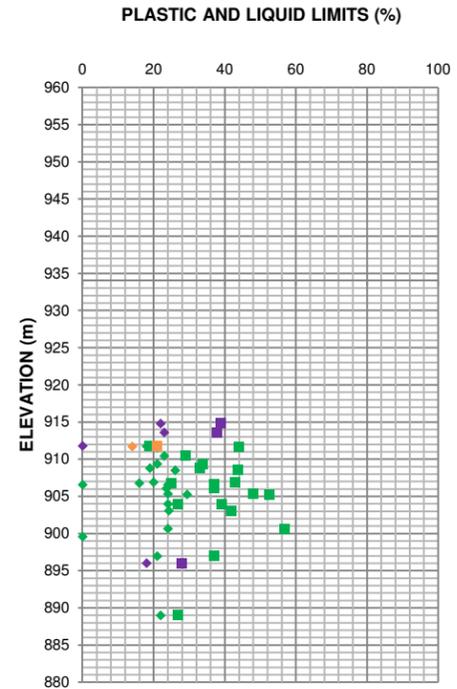
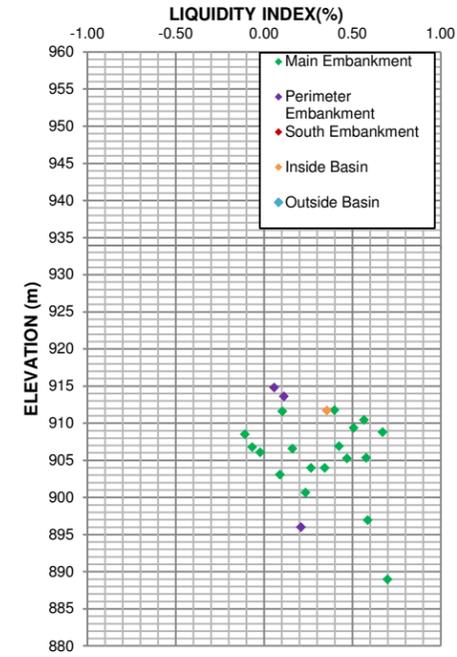
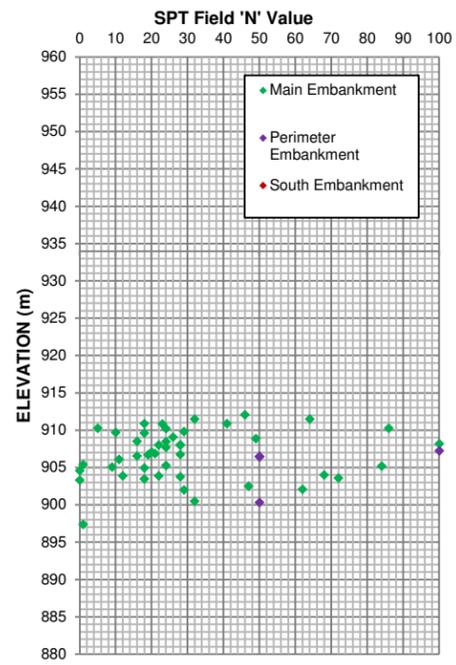
PROJECT	MOUNT POLLEY DAM FAILURE
TITLE	LOWER GLACIOLACUSTRINE UNIT
PROJECT No.	M09954 A01
FIG No.	4.13

A summary of the site investigation index testing data on LGLU is shown on Figure 4.13. Review of the data indicates the following:
