# **Ministry of Energy and Mines**

## **Mount Polley Tailings Dam Failure**

### ***A Summary of Opinions in Support of CIM Investigation***

**Mount Polley Tailings Dam Failure**  
**A Summary of Opinions in Support of CIM Investigation**

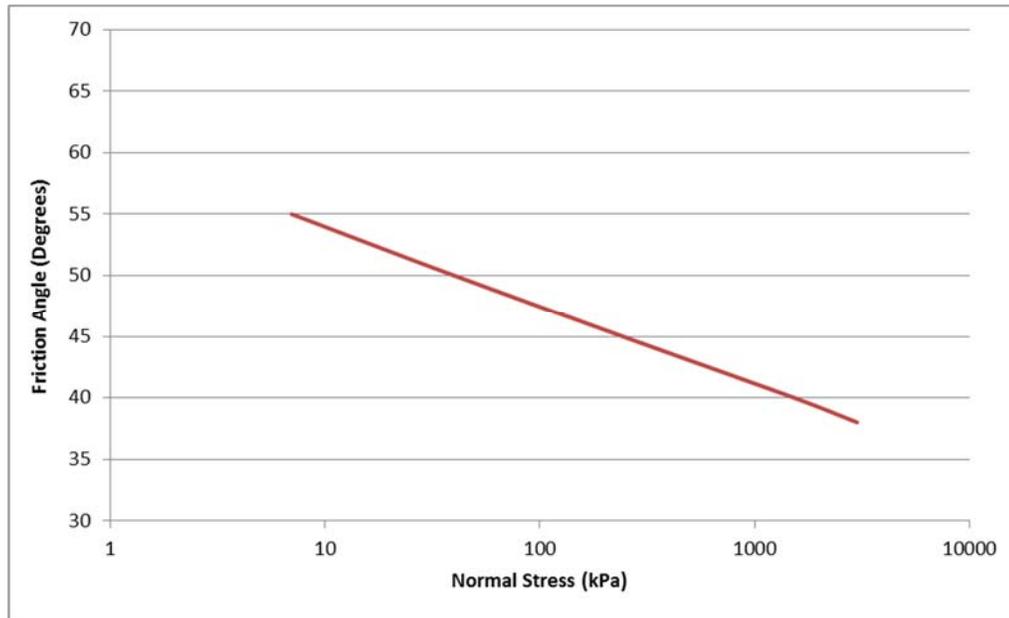
**Figure 4.15 Relationship between Friction Angle and Normal Stress for “Average” Rockfill (adapted from Leps 1970)**

Based on the results of triaxial testing on reconstituted and compacted till samples, a friction angle of 35° for the compacted till core zone is considered appropriate. The strength-stress relationship presented by Leps (1970) for “average rockfill” is appropriate for the angular waste rock placed in Zone C. The relationship is shown graphically in Figure 4.10.

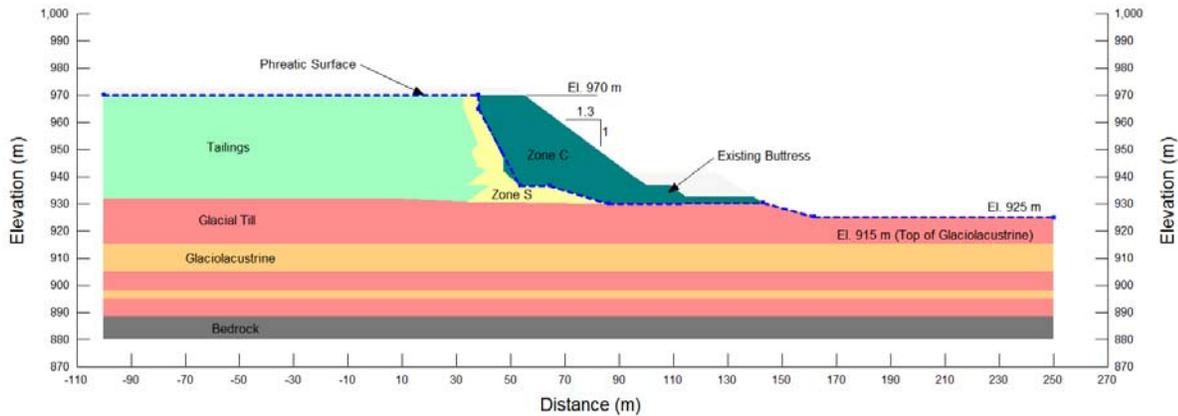
**Figure 4.16** KCB Stability Model Set-Up – Section D – Crest Elevation 970 m

The elevation of the natural ground surface, and the piezometric conditions that BGC assumed at Section D were adopted by KCB as they represent the critical case as discussed in Section 4.5.2. The stability models are shown on Figure 4.16 to Figure 4.18.

Results show that the minimum FoS for Case 1 is not achieved when a buttress is not present for both the 970 m and 972.5 m crest elevations. With a buttress in place, the FoS is slightly below design criteria. A typical critical slip surface is shown on Figure 4.19 and Figure 4.20 for peak and residual GLU shear strength, respectively.

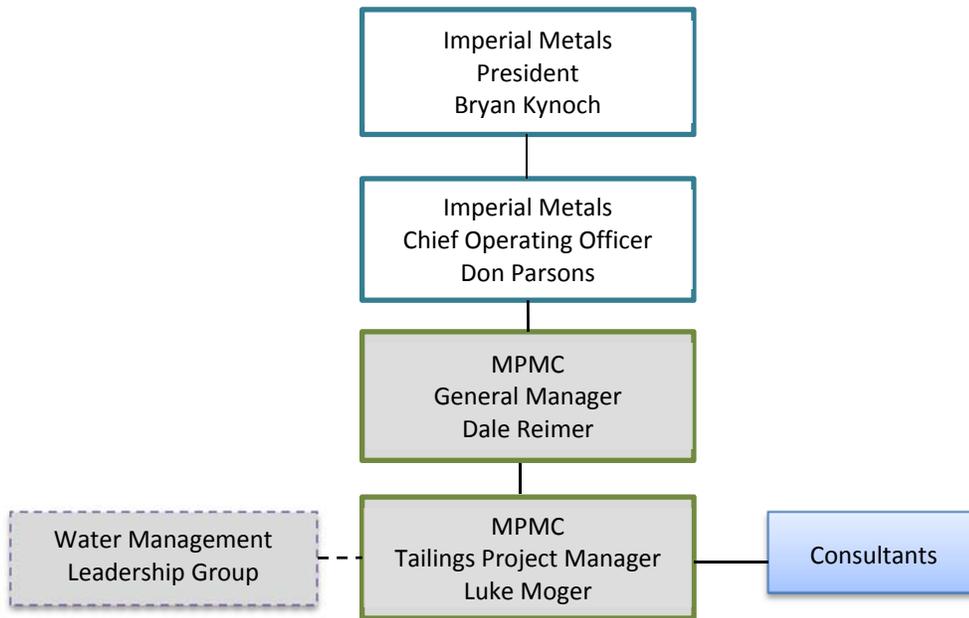
**Figure 6.1 Corporate and MPMC Tailings Management – Organization Chart at Time of Failure**

The management structure consists of both internal (MPMC) and external consultants. The primary reporting structure for MPMC at the time of the failure is illustrated in Figure 6.1. The management structure for operations, which includes both external consultants and other mine departments are presented on Figure 6.1 (extracted from the OMS manual, Figure 2-1, and extended to include Corporate interview observations).

- Imperial Metals, President, Bryan Kynoch– Ultimate responsibility for all activities carried out by MPMC.
- Imperial Metals, Chief Operating Officer, Don Parsons – Overall corporate responsibility for tailings management (MPMC 2013d).
- MPMC, General Manager, Dale Reimer – Responsible for the overall activities of the mine, including the TSF. Approves the annual OMS manual (MPMC 2013d).
- MPMC, Tailings Project Manager, Luke Moger – Responsible for planning, co-ordination and daily management of all construction activities. Responsible for permitting and the annual reports. Water Management Group reports through Luke Moger for the OMS manual.
- MPMC, Water Management Leadership Group – Senior personnel including: Mine Operations Manager (Art Frye), Mill Operations Manager (Doug Ablett), Environmental Coordinator (Colleen Hughes) and the Tailings Manager.

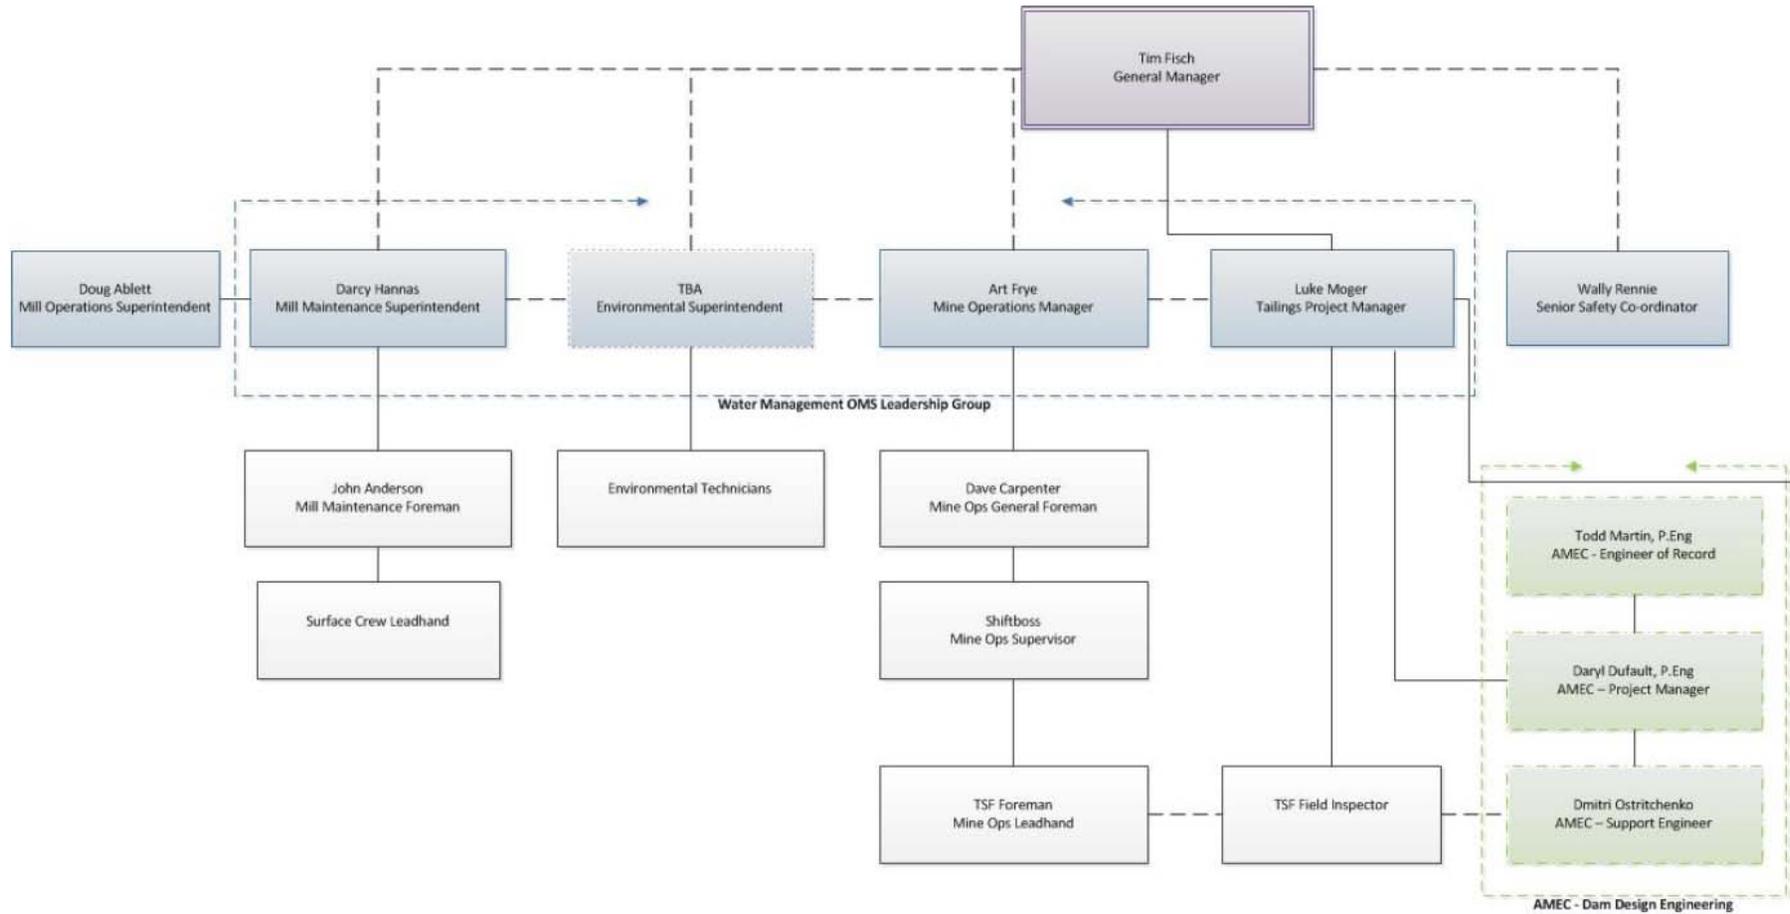
Figure 6.2 Organization Chart – MPMC Responsibility Positions for the TSF According to 2013 OMS Manual (MPMC 2013b)

The organization chart shown on Figure 6.2 presents the reporting structure related specifically to the TSF. The chart is based on the 2013 OMS manual, which has not been updated and, consequently, does not include staff changes such as the new mine manager.

The two organization structures did appear to create some confusion with respect to who was managing the TSF. For example, Art Frye is not included in the TSF Management Chart, although because Luke Moger reports to Art Frye it was sometimes assumed that Art Frye was responsible for tailings management [REDACTED].

The Tailings Manager, Luke Moger, also used the title “Project Engineer” in both the 2013 OMS Manual and the 2013 Tailings Management Framework (Under TSM Protocols), although he is not a Professional Engineer or an Engineer in Training.

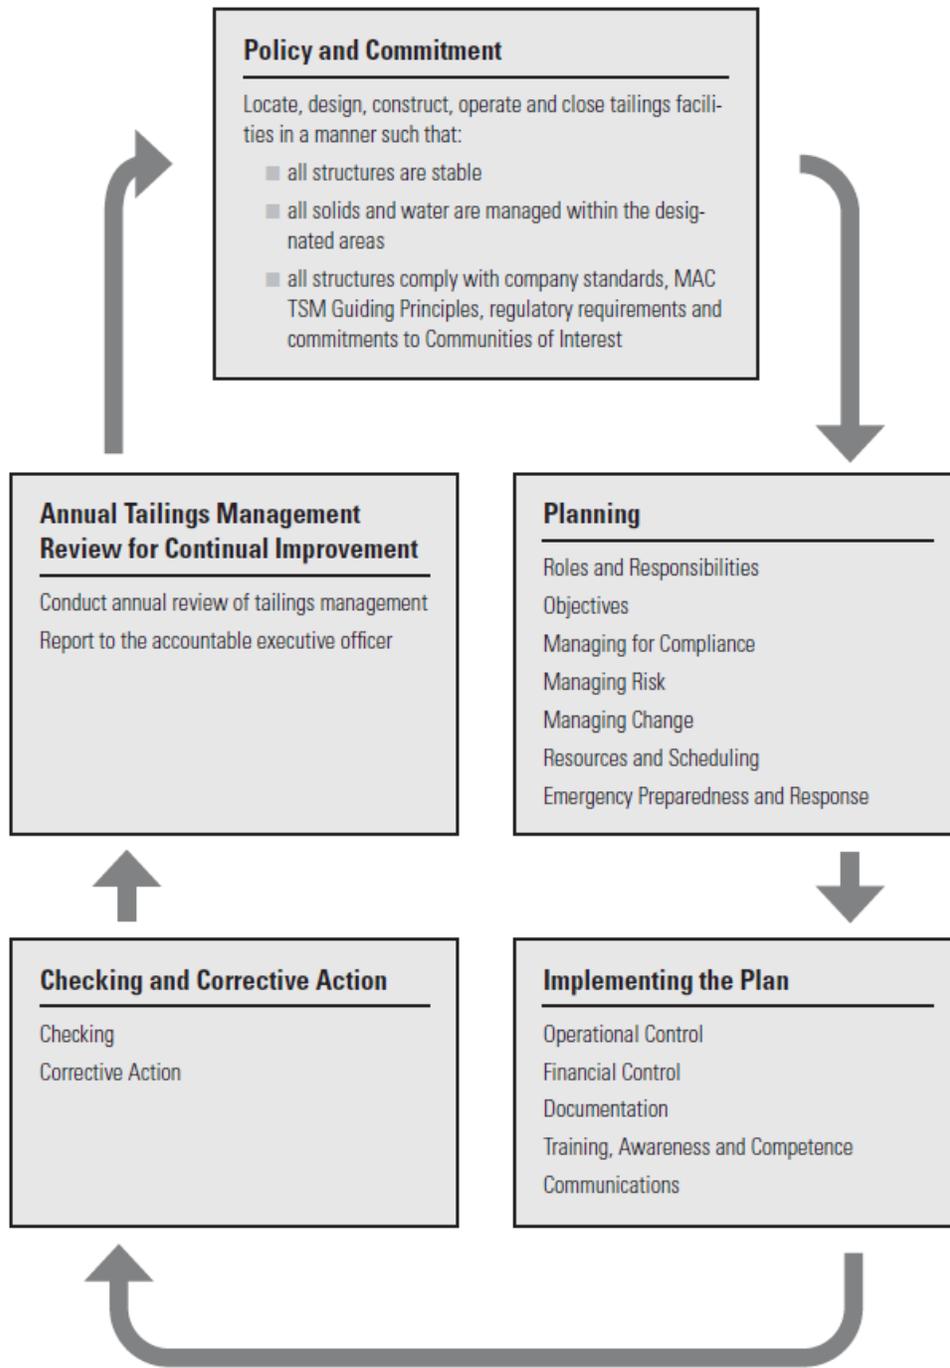
**Figure 6.4 MAC Guideline – Tailings Management Framework (MAC 2011a)**

The MAC Guide to the Management of Tailings Facilities includes the main components that are shown schematically on Figure 6.4. The framework follows the life cycle of the mine and starts with policy and commitment, leading into planning and implementation, followed by checking and corrective actions, leading to continued improvement and confirmation of meeting the policy and commitment.

MPMC was not able to provide to MEM a copy of a documented Tailings Management System and, consequently, MPMC documentation of the tailings management practices appeared to rely on the following:

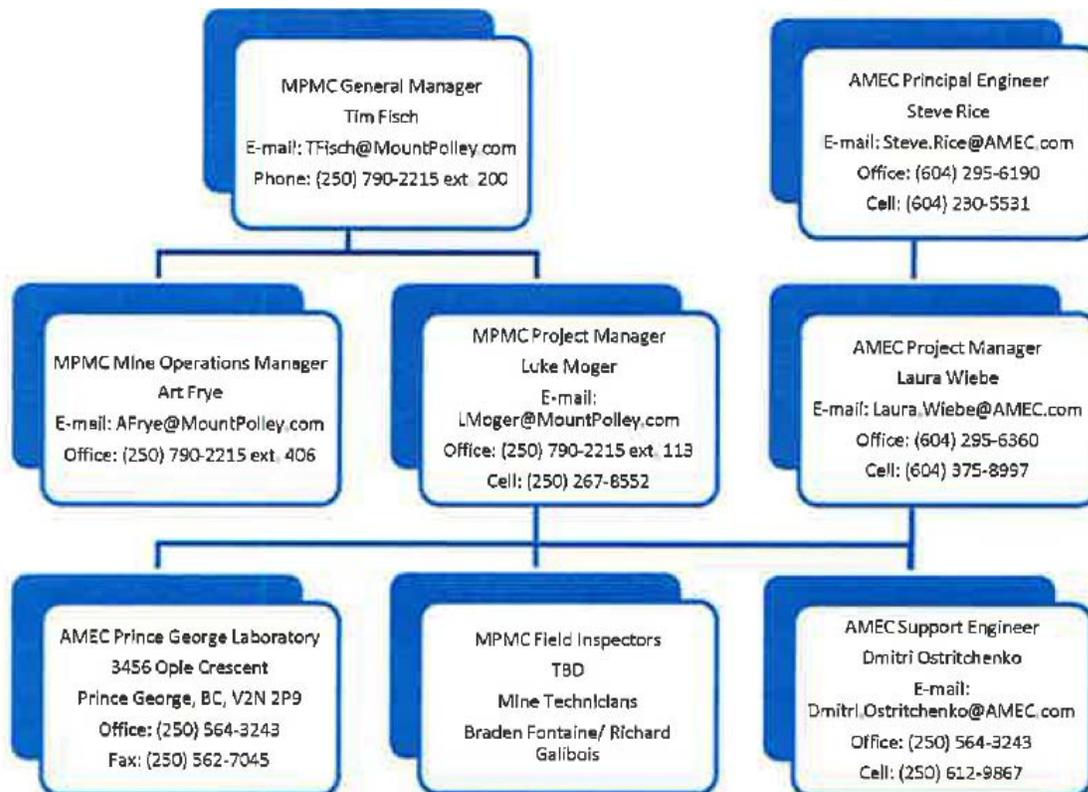
**Figure 7.1 Organization Chart for AMEC – MPMC (AMEC 2013b)**

The AMEC management team, as outlined in the Annual Construction Reports, is shown graphically in Figure 7.1 and responsibilities are summarized in Table 7.2.
