BC Ministry of Transportation & Infrastructure
Old Spences Bridge No. 2411
Inspection Report

2009 December 21

Our Ref: 1884-RPT-SPE-001-0

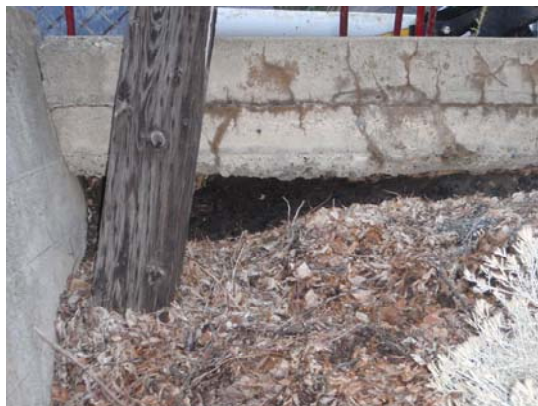
It was observed that the soil on the east and west sides of the North Approach immediately behind the abutment was sloughing away. On the east side, the sloughing soil has undermined the roadway and the guardrail post. A tape measure was used to determine the extent of the undermined area and it was found that a void extended approximately 785 mm (31") under the roadway from the east side, refer to Figure 10. While a void was not identified on the west side, the ground was observed to have sloughed significantly resulting in a vertical face along the west edge, refer to Figure 11. It is recommended that the sides of the North Approach roadway immediately behind the abutment be reinforced and that the void under the roadway be filled (Maintenance Item M-1).

Figure 10: Void and Undermined Post at North Approach-East Side

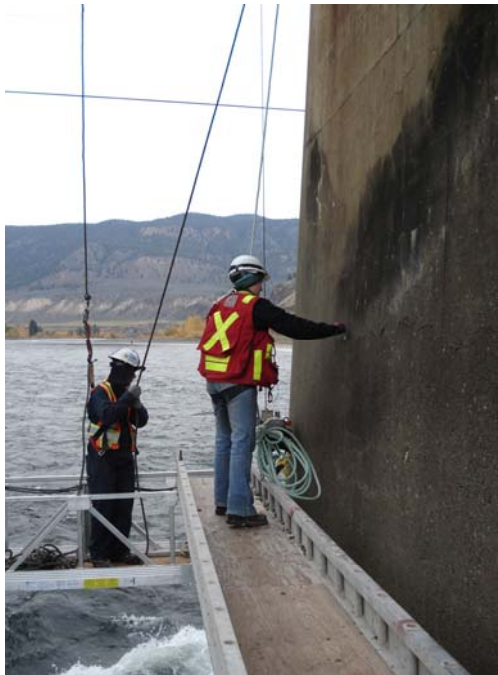
Figure 17: Sounding the North Face of Pier 3

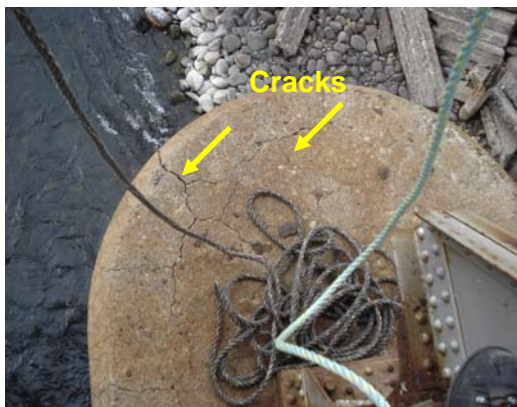
The north side of Pier 4 was visually assessed and the lower 1800 mm (6 feet) was sounded from the ground. No delaminations or hollow areas were detected but numerous cracks were observed in the concrete. Horizontal cracks with widths in the order of 2-3 mm were observed at locations believed to be construction joints during original construction. Additionally, cracks were identified in the top of the pier cap as well as in the vertical face of the pier cap approximately at the centreline of the pier, refer to Figure 21 and Figure 22. No remedial actions are recommended but it is recommended that the condition of the concrete be monitored during future inspections (Inspection Item I-6). However, for long-term durability of the concrete pier BC MoT may wish to consider injecting all cracks with epoxy.

Figure 21: Cracks in Pier Cap of Pier 4

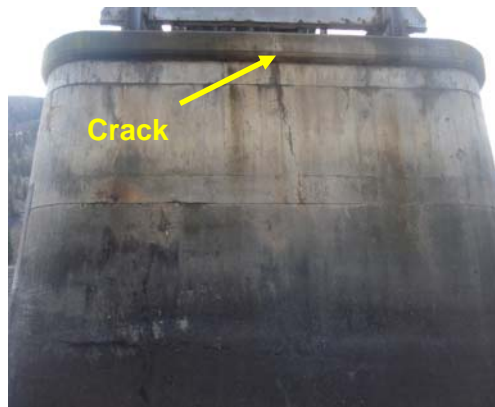
Figure 22: Crack at Centreline of Pier Cap at Pier 4

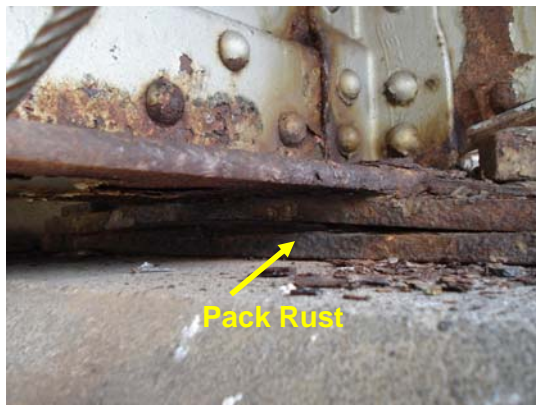
Two types of sliding bearings have been used on the Old Spences Bridge. For the girder spans and the three shorter truss spans the sliding bearings consist of two steel plates sliding across one another. One of the steel plates is outfitted with a steel tab while the other plate has a groove machined into it. This tab prevents transverse displacement of the plates while allowing longitudinal movement. In many locations pack rust was observed in the gap between the two plates, refer to Figure 24. It is believed that this pack rust severely limits the amount of movement that can be accommodated by the bearing and it is likely that the bearings no longer perform as originally intended. It is recommended that rehabilitation options include repairing or replacing the sliding bearings in the girder spans and the shorter truss spans (Rehabilitation Item R-1).

Figure 24: Pack Rust between Bearing Plates

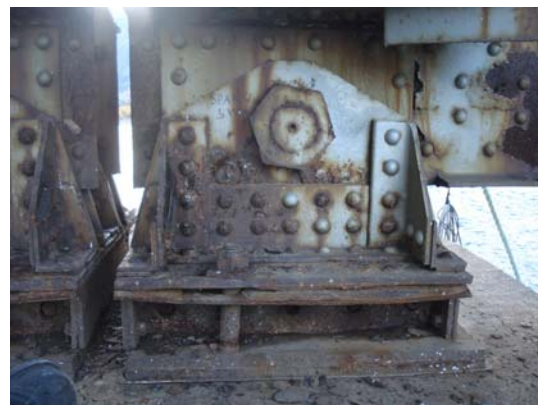
Figure 25: Roller Bearings at Pier 3

The sliding bearings for the longer spans are located at Pier 3 and consist of a pin assembly located on top of a nest of five steel rollers, refer to Figure 25. Three anchor bolts, situated in slotted holes, connect the pin assembly to the bearing base plate and prevent uplift. The ends of the rollers are visible through holes in guide plates on either side of the bearings, although one of the rollers on the east side of the southwest bearing for Span 4 was found to have come out of the hole in the guide plate, refer to Figure 26.

Since it is believed that the bearings are seized, then it is likely that Pier 3 is being subjected to loads for which it was not originally designed. It is recommended that Pier 3 be evaluated for the effects of the seized bearings (Evaluation Item E-1) and that rehabilitation options include repairing or replacing the sliding bearings at Pier 3 (Rehabilitation Item R-2).

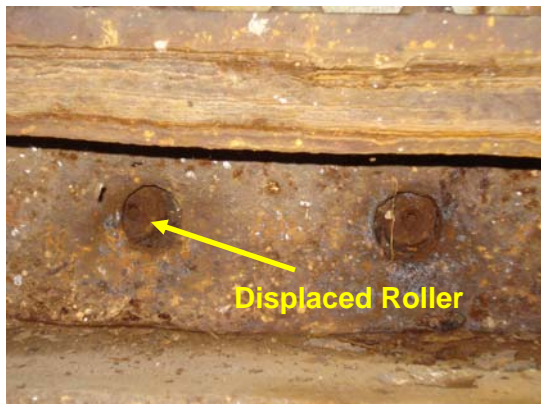
Figure 26: Roller No Longer in Guide Plate in Bearings at Pier 3

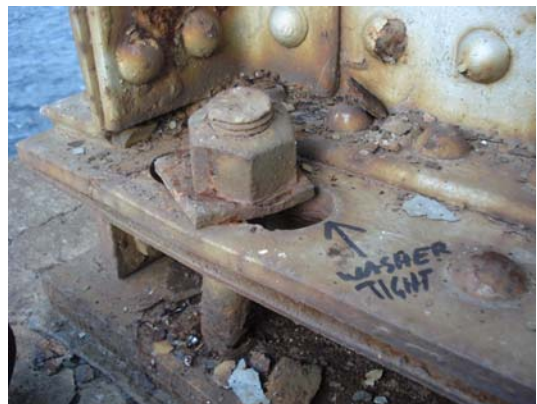
Figure 27: Tight Washer at Anchor Bolt

All four of the sliding bearings at Pier 3, two for Span 3 and two for Span 4, were observed to be widely covered in surface corrosion and pack rust was identified between many of the plates in the bearing assembly. No obvious signs of longitudinal movement were observed and it is believed that the bearings have seized, a theory supported by the undisturbed debris accumulations observed around the bearings. The washer beneath the northwest anchor bolt on the southwest bearing of Span 3 was found to be tight against the surface of the pin assembly bearing plate and this condition may restrict the ability of the bearing to move, refer to Figure 27.

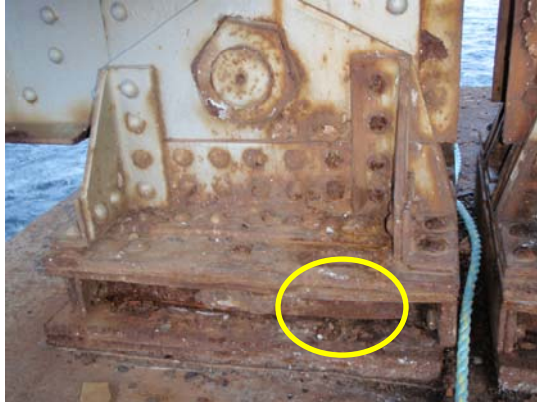
Many of the anchor bolts were found to be out of plumb (i.e. they are no longer vertical), refer to Figure 28. At a given bearing, the anchor bolts did not appear to be bent in the same directions, which implies that misalignment during installation and forces transferred to the anchor bolt through seized bearings are likely what has resulted in the anchor bolts being inclined from the vertical. It is important to note that the top of the anchor bolt on the west side of the southeast bearing of Span 4 has sheared off and was found lying on the top of the pier cap, refer to Figure 29. Additionally, an area of reduced cross section was observed in the southwest anchor bolt at the northwest bearing of Span 3 and in the east anchor bolts at the southeast bearings of Span 4.

Figure 29: Anchor Bolt Sheared off at Span 4 Southeast Bearing

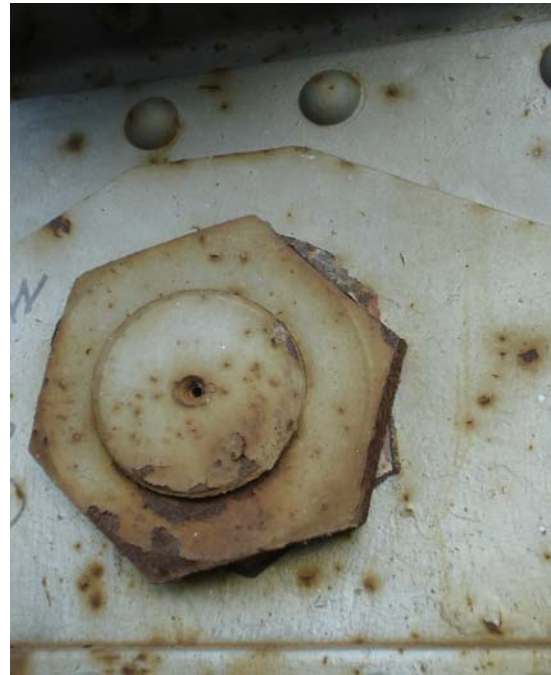
Wear patterns on the pin assembly and rotated keeper nuts on the outside of the bearings suggest that the bearings still allow rotation about the transverse axis, refer to Figure 30.

Figure 30: Evidence of Rotation at Keeper Nut

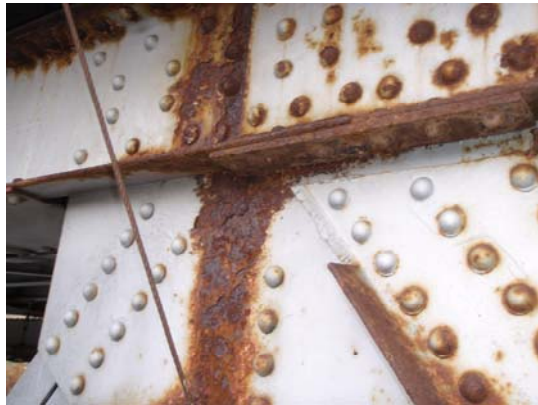
It was also noticed that coating failures typically occur on most members beneath the short deck drains that release deck run-off just below deck level. Degradation was observed to the face of the top chord at the deck drain and to the bottom chords. The smaller trusses have greater coating failure to the bottom chords since they are closer to the drains.

Figure 35: Vertical Area of Coating Failure at Top Chord Connection below Drain

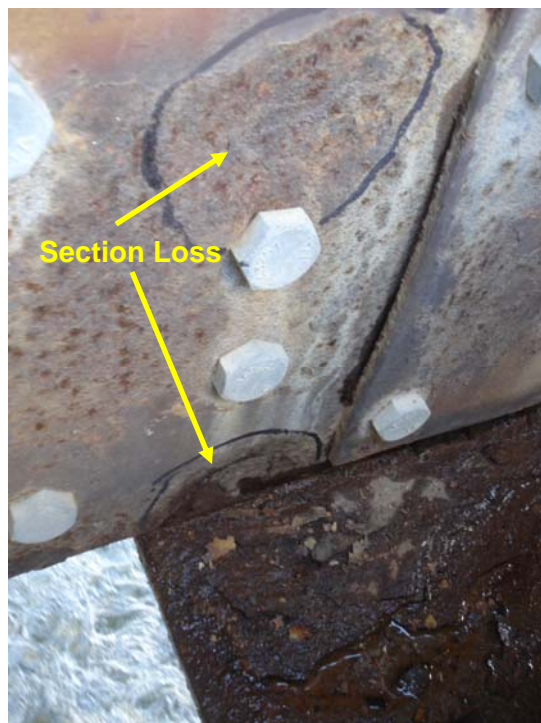
In Spans 3 and 4, localized areas of section loss were frequently observed on the top surface of the top flange and the back side of the channel webs near panel point connections with those in the vicinity of the deck drains generally in worse condition, refer to Figure 40 and Figure 41. Many of the panel points in Spans 3 and 4 where section loss was identified in the chord member were reinforced with cover plates bolted to the webs circa 2004. It is recommended that the capacity of the bottom chord members be evaluated to determine if the existing reinforcing system remains adequate (Evaluation Item E-5). Additionally, a localized area with approximately 8 mm of section loss in the top flange of the bottom chord channel was identified at Panel Point 4 on the east side of Span 4. This corresponds to a small area of the top flange with roughly 50% section loss of the total thickness as the un-corroded thickness of the top flange is 16 mm (5/8"). It is recommended that this area be evaluated to determine the effect of this section loss on the structural capacity of the member and establish whether immediate repairs are required (Evaluation Item E-6).

Figure 41: Section Loss in Back of Web of Channel

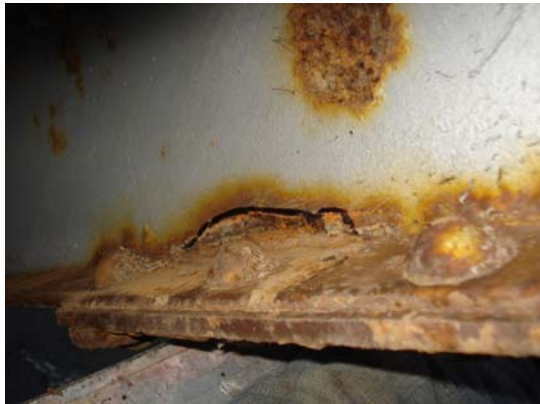
A localized area of minor section loss was identified at the base of the web near the top of member L4-U5 on the west side of Span 3, refer to Figure 46. It is recommended that this area be recoated as part of Rehabilitation Item R-3. Additionally, a portion of member L8-U9 on the west side of Span 4 was observed with coating failure and surface corrosion, refer to Figure 47. The corrosion is not severe and is unlikely to result in section loss in the near future. Therefore, it is also recommended that this member be cleaned and recoated during a recoating program for the entire structure (Rehabilitation Item R-4).

Figure 46: Localized Section Loss at Base of Web in Member L4-U5 Span 3 West

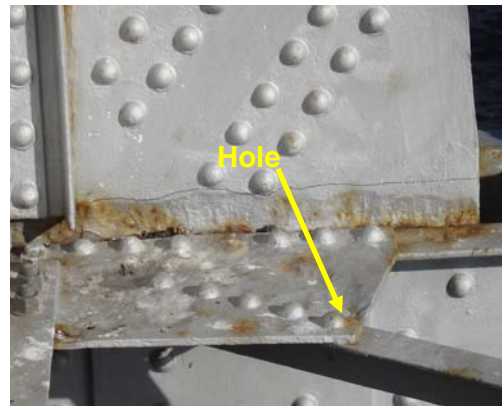
The bottom chord lateral bracing connections were found to be in worse condition than the top chord bracing connections due to their exposure to the elements. Numerous areas of section loss were identified on the bottom chord bracing connections and multiple holes were found, refer to Figure 49 and Figure 50. The bottom chord lateral bracing connections appear to be functioning adequately in their current condition and it is not believed that a widespread repair program is warranted at this time. It is recommended that the connections be cleaned, a Ministry approved coating applied and that they be monitored on an annual basis and replaced or repaired as necessary (Rehabilitation Item R-7 and Inspection Item I-9).

Figure 50: Hole in Gusset Plate

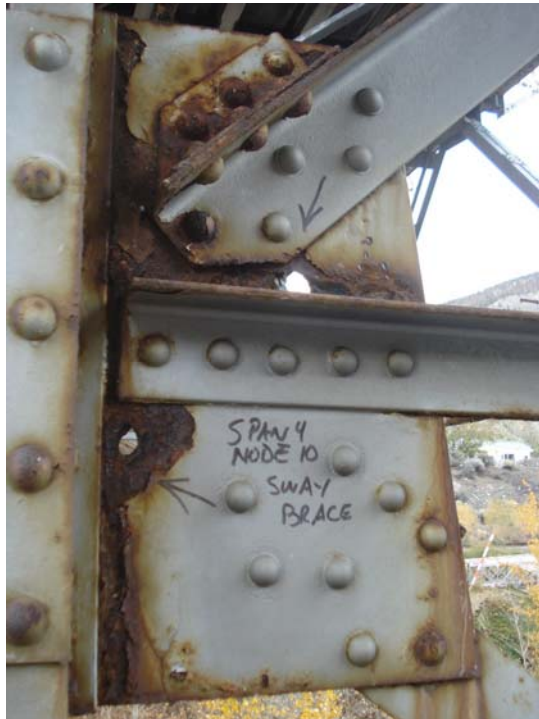
Many of the sway bracing members were observed to be in poor condition which is believed to be due to the fact that they are located directly below the deck joints. Coating failure and surface corrosion were widespread on both the members and gusset plates and numerous holes were identified in members and gusset plates, refer to Figure 52 and Figure 53. Table 5 lists the sway bracing locations where holes were observed in the members. It is recommended that these bracing members be replaced (Rehabilitation Item R-9) and that the remaining bracing members be recoated when the entire structure is recoated (Rehabilitation Item R-4).

Figure 52: Holes in Gusset Plate at Sway Brace at Panel Point 10 – Span 4

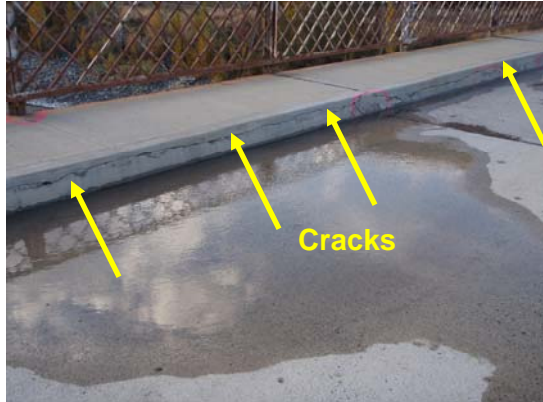
Both concrete curbs along the deck were found to be in poor condition with cracks and spalling concrete observed in multiple areas, refer to Figure 54. Evidence of previous repairs were observed along the west curb but it appears that these repairs are not performing well, refer to Figure 55. It is recommended that an evaluation and rehabilitation of the deck include repairing the concrete curbs (Evaluation Item E-8 and Rehabilitation Item R-10).

Figure 54: Crack in West Curb Face

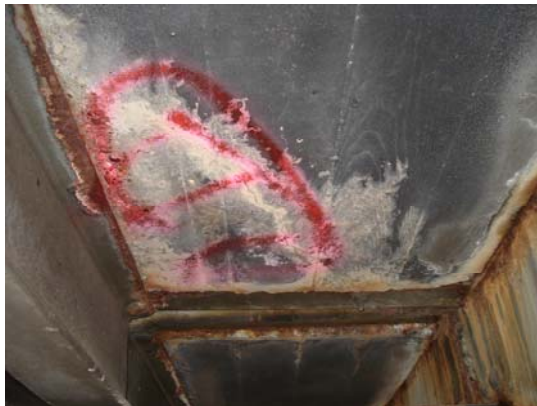
While the top side of the concrete deck appeared to generally be in fair condition, widespread honeycombing was observed on the underside of the deck which is a result of poor consolidation of the concrete during original construction, refer to Figure 59. Additionally, numerous cracks, delaminations and spalls were noted on the underside of the bridge with exposed rebar visible at a number of locations; refer to Figure 60 and Figure 61. A plan view of the bridge showing the observed areas of delaminations and spalls has been provided in Appendix E. It is recommended that the evaluation of the existing deck include repairs to the delaminations and spalls observed on the underside of the concrete deck (Evaluation Item E-8 and Rehabilitation Item R-10).

Figure 60: Deck Delamination above Pier 6

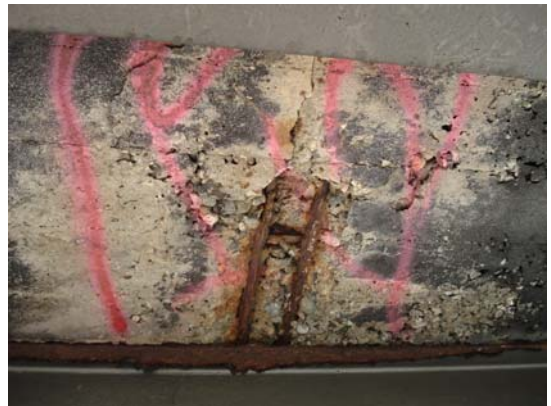
Figure 61: Exposed Rebar in Span 6

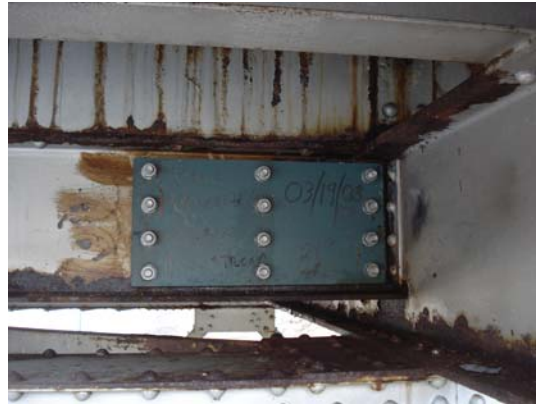
The corrosion and deterioration of the stringers has been identified in previous inspection reports and stringers with areas of section loss have mostly been repaired, although in at least two locations, DS1 in Span 1 between U0 and U2 (west) and DS1 in Span 3 between U5 and U6 (west), the stringers have been marked for repair but the repairs have not been completed, refer to Figure 64 and Figure 65. Based on the corrosion and section loss observed in the stringers, it is recommended that the capacity of the stringers be evaluated (Evaluation Item E-9). Considering the variability in the condition of the stringers, the following evaluation criteria is recommended for the longitudinal deck stringers:

Figure 64: Previous Repair on Exterior Stringer

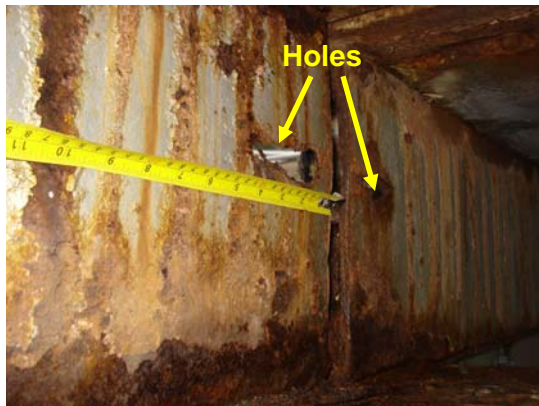
The backside of the web of SS3 was typically observed to be covered in surface corrosion over large areas along its length with minor to moderate section loss identified in isolated areas occasionally identified in the web near mid-span. Major section loss and perforations were observed in multiple stringers at the connection to the floorbeams, refer to Figure 66 and Figure 67. The stringer is supported along its length by DS1 and the localized section loss is not considered to be an immediate structural concern. However, it is recommended that the stringers be included in Rehabilitation Item R- 3.

Figure 66: Holes in Web of SS3 at Floorbeam 0, Span 2

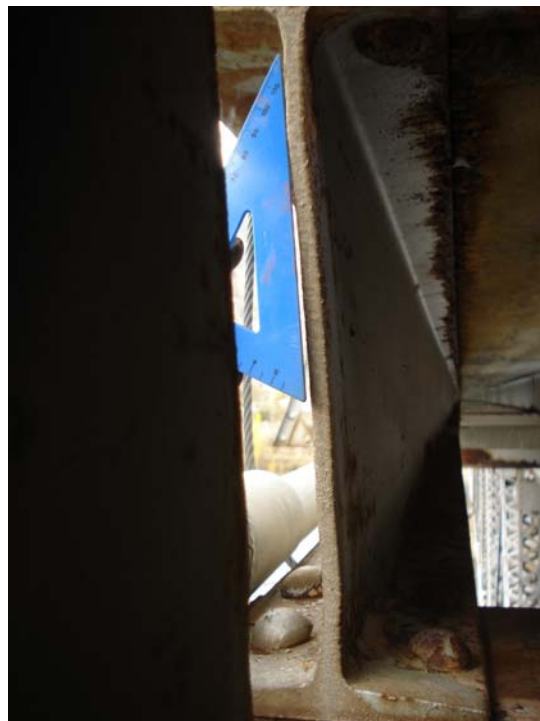
**Figure 70: SS1 Web Not Vertical
between U1 and U2 in
Span 3**

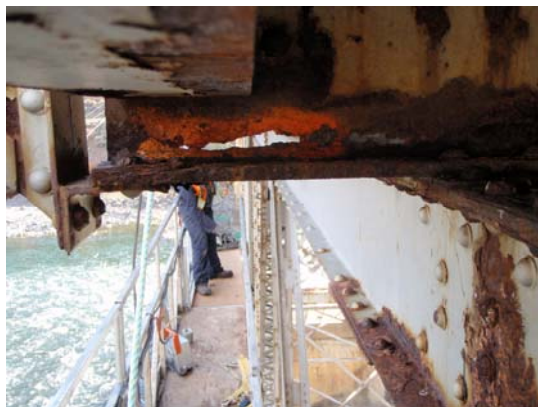
Areas of section loss were also identified in the web at the ends of the floorbeams. On the west end, the areas were typically concentrated along the lower 50-100 mm of the web in the cantilever section. The amount of section loss in these areas was typically 1-3 mm. Similar amounts of section loss were also observed on the faces of the web between stringers DS1 and DS2. At the east end of the floorbeams, the webs of the floorbeams in the vicinity of the top chord were observed to have varying degrees of section loss. Complete section loss was observed in the end of floorbeam 4 in Span 4 and in the web of floorbeam 8 in Span 4, refer to Figure 71 and Figure 72. It is recommended that these areas be repaired (Rehabilitation Item R-11).

**Figure 71: Hole in Web of Floorbeam 4
Span 4**

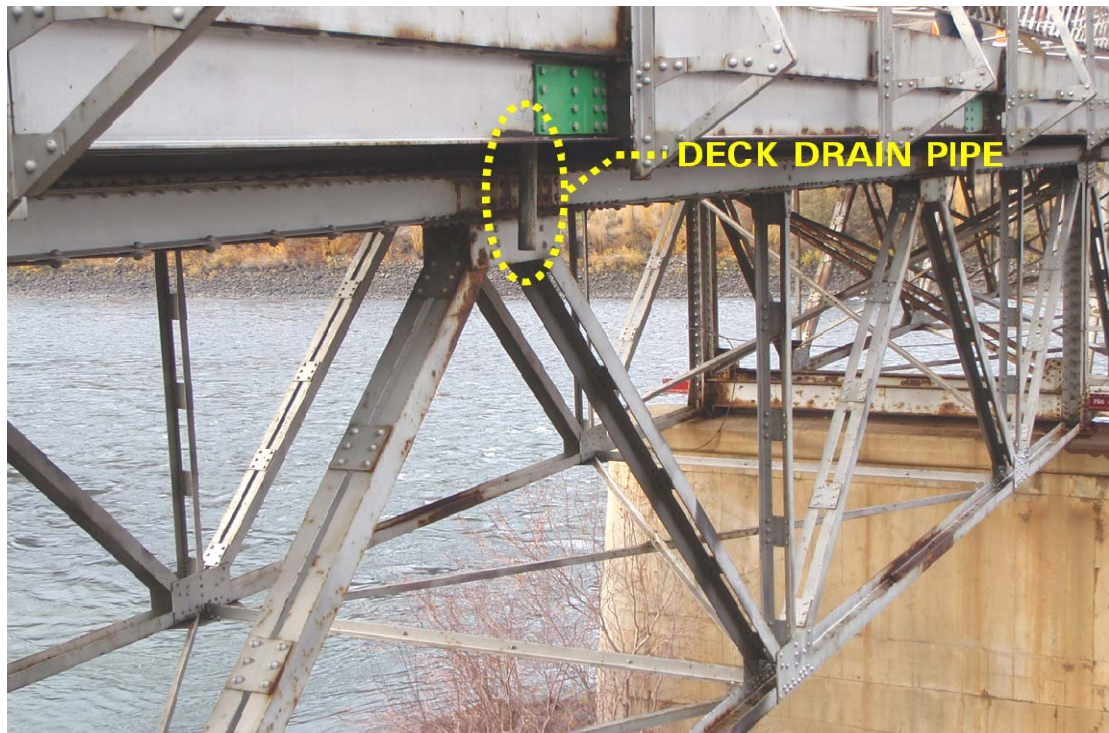
In the truss spans, the deck drains extend only a short distance below deck level as shown in Figure 73. The short deck drains release deck run-off directly onto the bottom chord and the run-off also sprays onto the top chord gussets and verticals. Over the years spray from the run-off and the direct drainage onto the structural steel has caused significant localized corrosion and section loss of the bottom chord, of the truss verticals and their gussets at the bottom chord, and of the top chord (refer to sections 3.5.1, 3.5.2, 3.5.3 and 3.5.4).

Figure 73: Typical Deck Drain Pipe in Truss Span

It is recommended that the deck drains be extended to ensure that the deck run-off drains below the bottom chord to prevent future localized corrosion and section loss (Rehabilitation Item R-13).

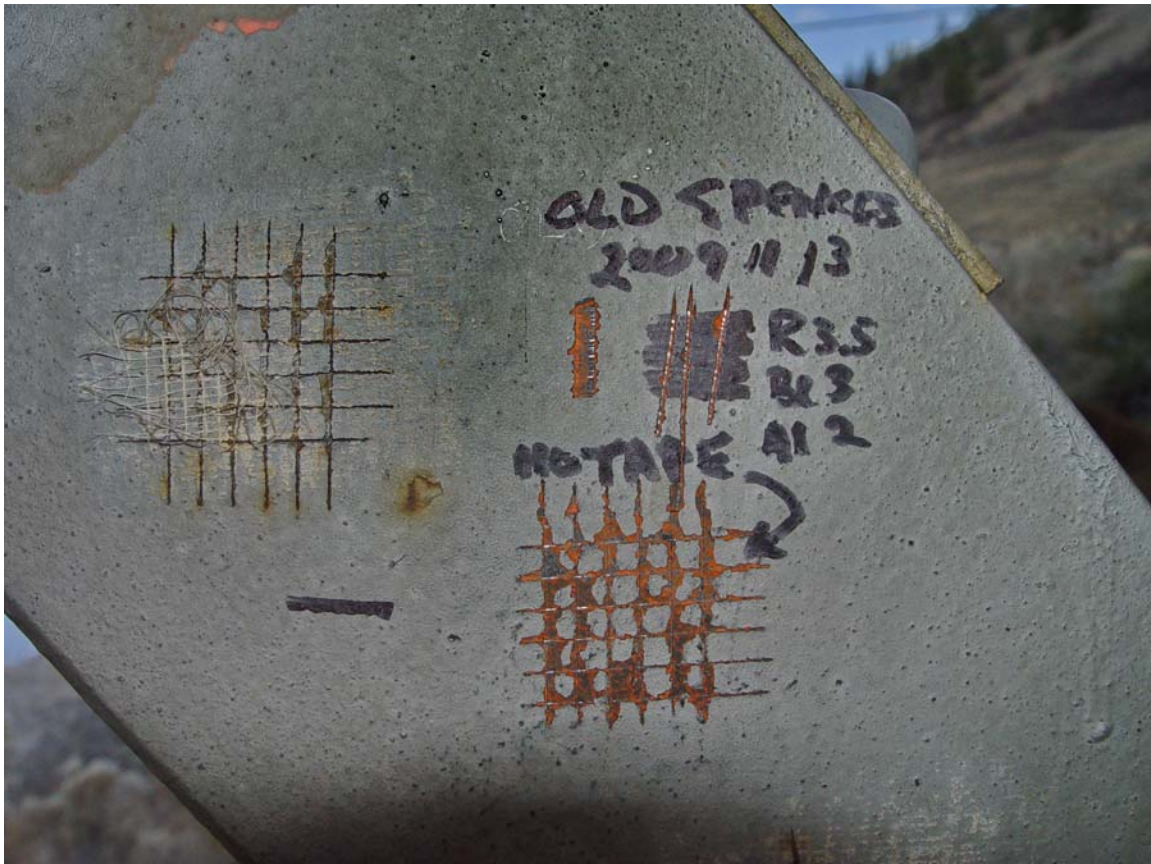
Temperatures were not adequate to do the cross hatch adhesion testing. Non-peeling areas were estimated to be in the sub 2B area. This is poor adhesion. We were not able to access the coating except at the south abutment, span 1.

Figure 1 Attempted Adhesion Comparison. On the left is the original crosshatch done in Sept. 1996 after the tape pull. On the right, is the current crosshatch, but without the tape pull. Paint has spontaneously delaminated from the scribing of the lines. Even without the tape pull it is much worse than the 1996 test.

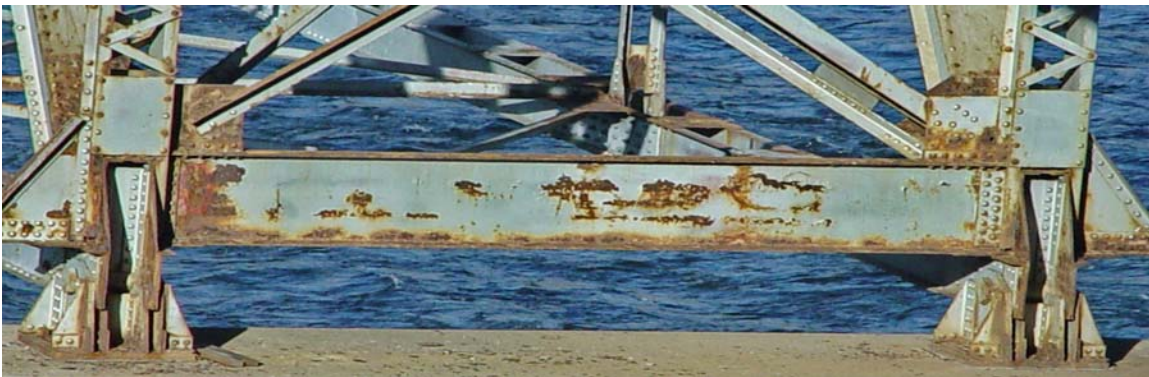
Figure 3 Span 1 North side looking toward the span 1-span 2 bearing area.

Typically, where there is peeling or other coating failure there is considerable corrosion. Other coating defects were noted on Span 1

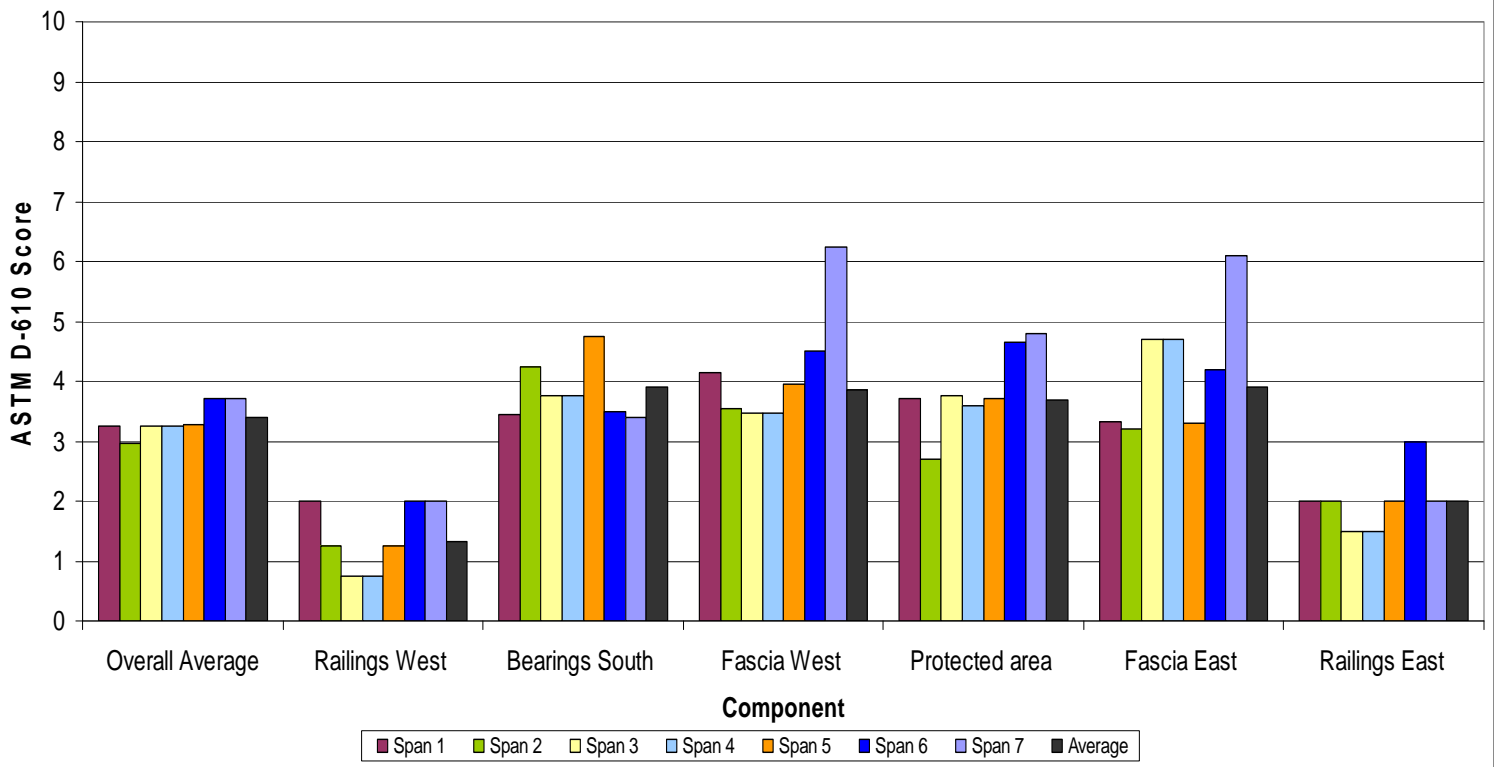
**Component Scores by Span
Old Spences Bridge 2009**

The graph above presents the average ASTM D 610 Corrosion scores by component for each of the spans. The data show that on average there is not much difference span to span implying that the coating is failing relatively uniformly over the structure. The bridge overall scored 3.4 out of 10 (about 10 to 15% coating failure). The average scores, for inspected components except the railings were in the 4 out of 10 range or about 10% failure overall.

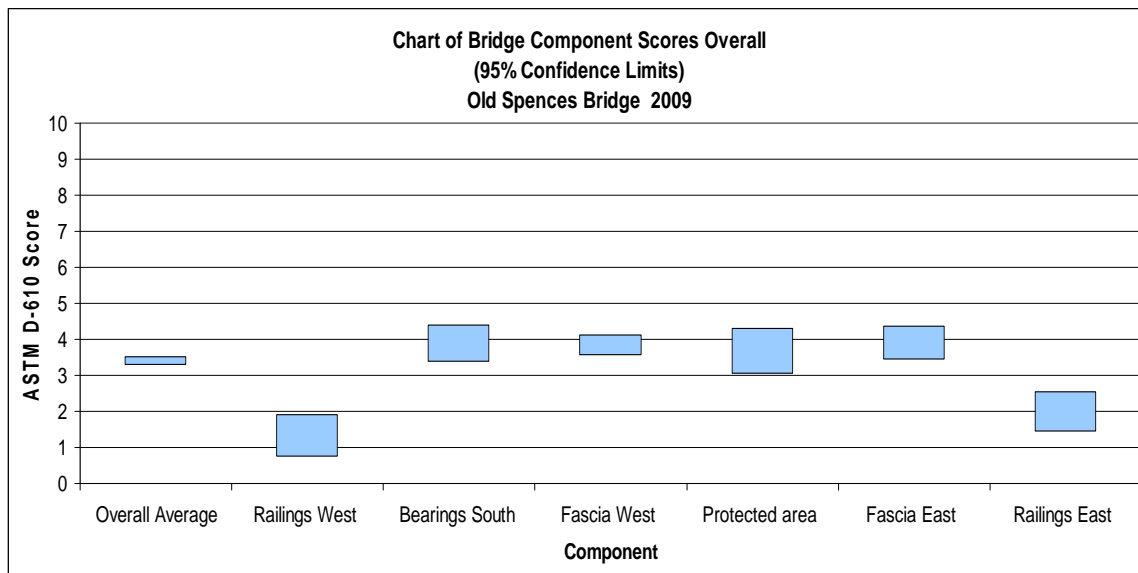
This graph presents the 95% confidence limit of each component averaged over all 7 spans collectively. This presentation gives information on how much spread there is in the data for a given component. Overall the score was about 3.4 for the whole bridge. This indicates very little equity still present in most of the coating.

This bridge was inspected under the Bridge Coating Rating Survey in September 1996. At that time the overall score was 6. This represents a decline from about 1% failure overall then to about 10 to 15% now.

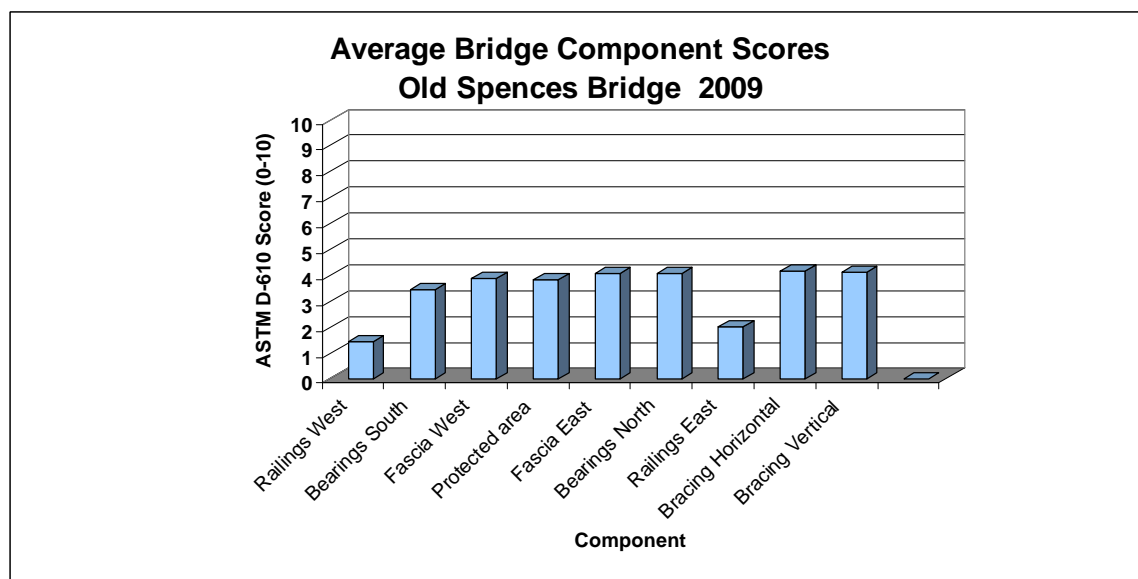
This graph presents the same data as the graph immediately above, but as an average score for each component over all seven spans.
