Project number: 4435-029 Document number: V3729 Version: 3 Date: September 4, 2014

MILE 122.7 DERAILMENT – COAL RECOVERY REPORT FOR SILVER CREEK AND BURNABY LAKE

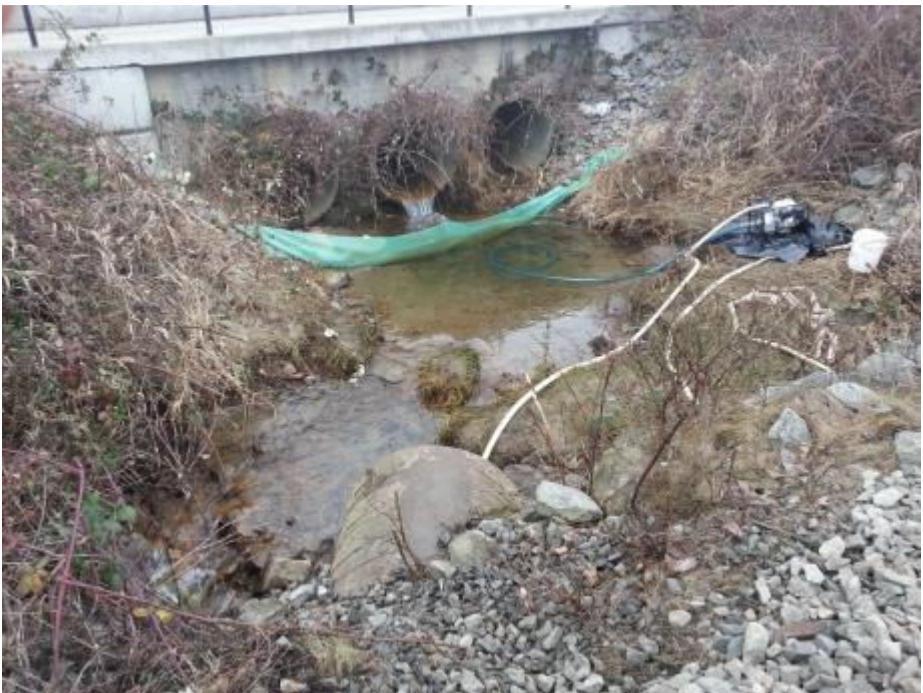
Photo 1. Example of upstream site segregation net and City of Burnaby storm sewer system discharge into Silver Creek at Government Street, upstream of CN crossing.

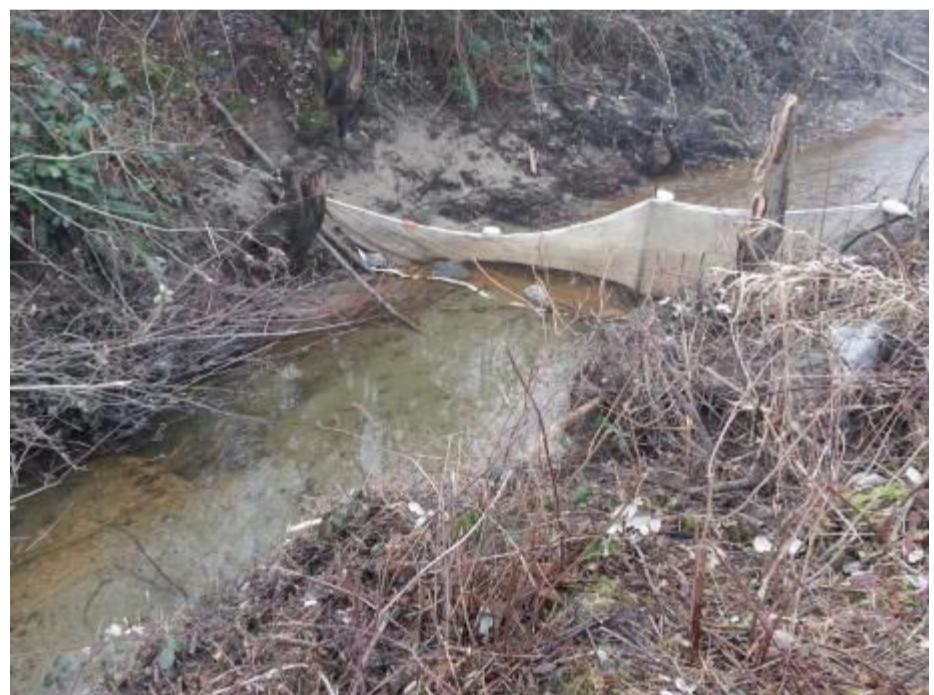
Photo 2. Example of site segregation net in Silver Creek, downstream of working area at CN crossing.

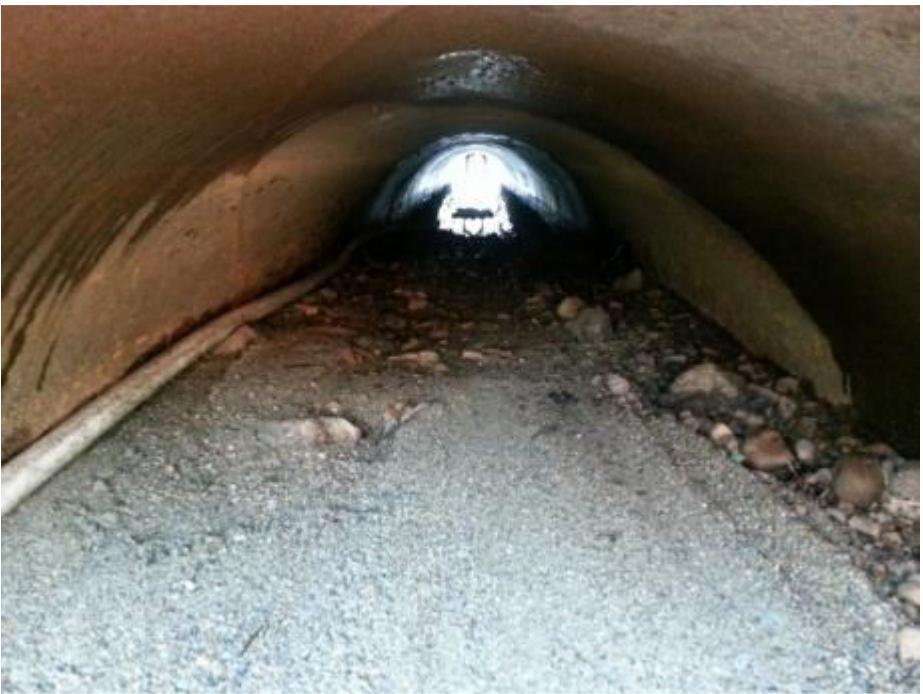
Photo 3. One of the CN crossing culverts (estimated at 50% capacity) before sediment removal.

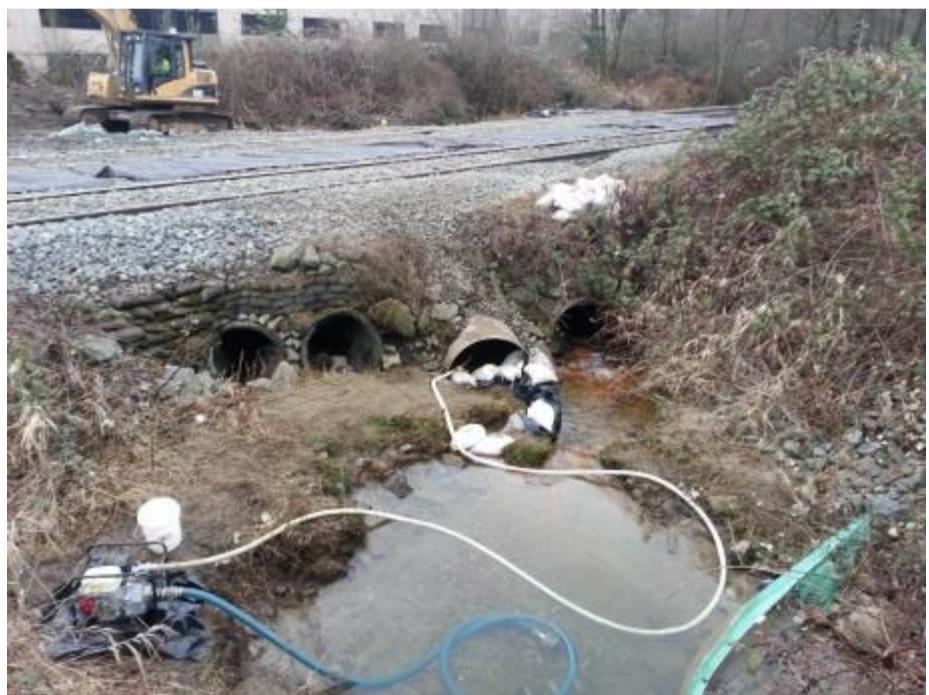
Photo 4. View of upstream site segregation and pump in Silver Creek, looking downstream at the CN crossing from Government Street.

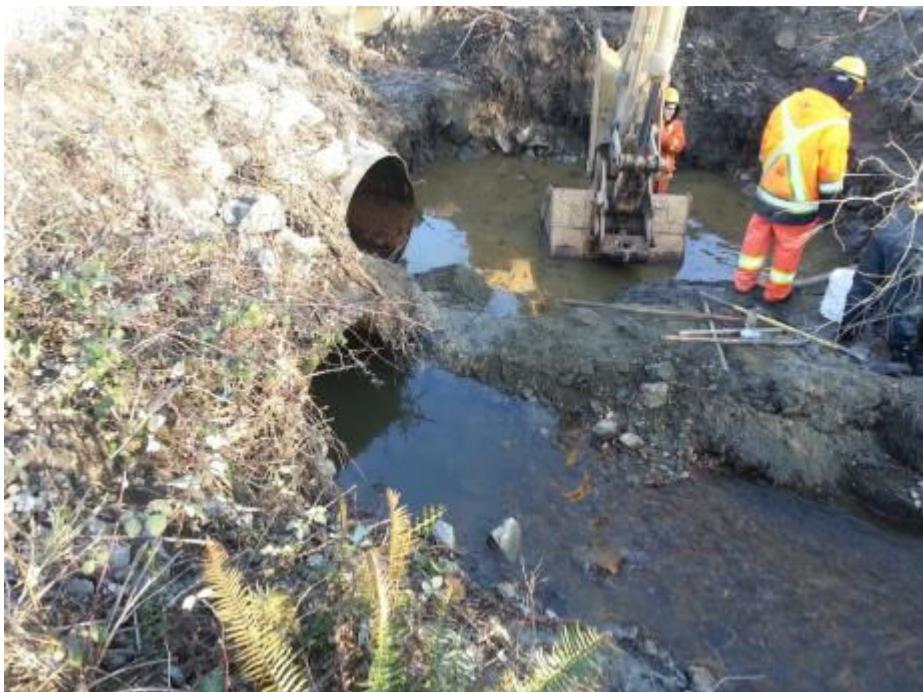
Photo 5. Example of culvert cleaning from isolated work area. Clean water was diverted into a single culvert (shown at the bottom of the photo), while sediment and turbid water was cleaned from other culverts in isolation.

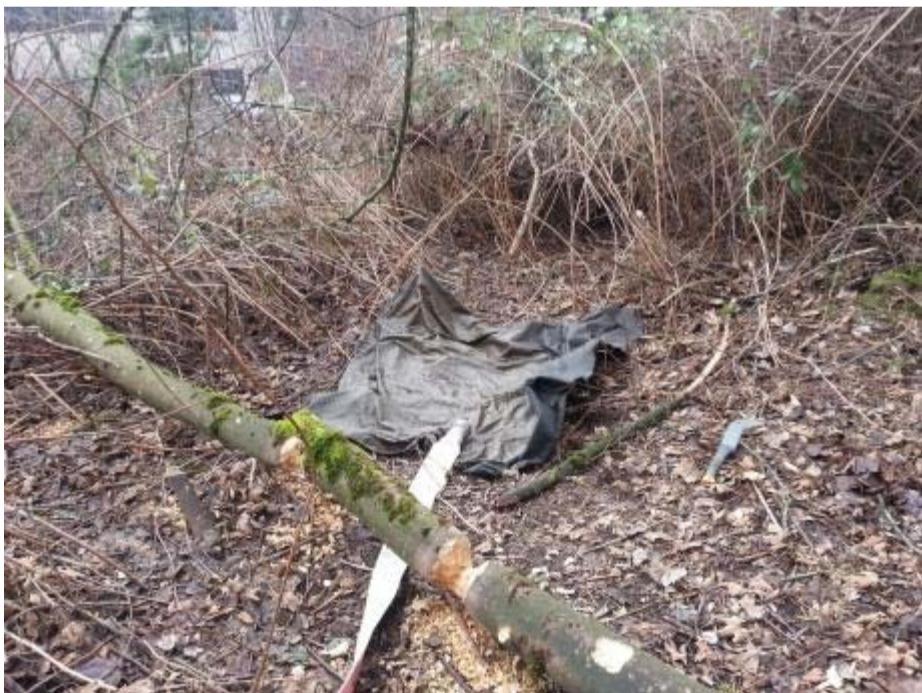
Photo 6. Example of typical set-up for outlet hose discharge from the work area. Turbid water from disturbed work areas was discharged onto filter fabric to eliminate erosion, and into a vegetated area for infiltration and sediment control.

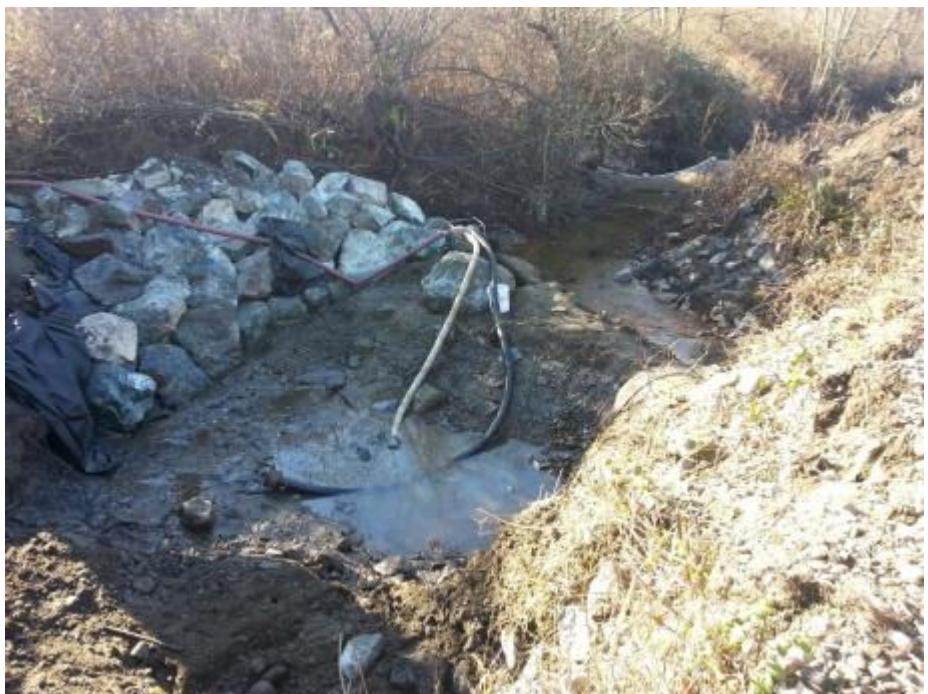
Photo 11. Area downstream of CN crossing after culvert cleaning was complete and bank stabilization works had begun. Disturbed water being removed for infiltration to ground.

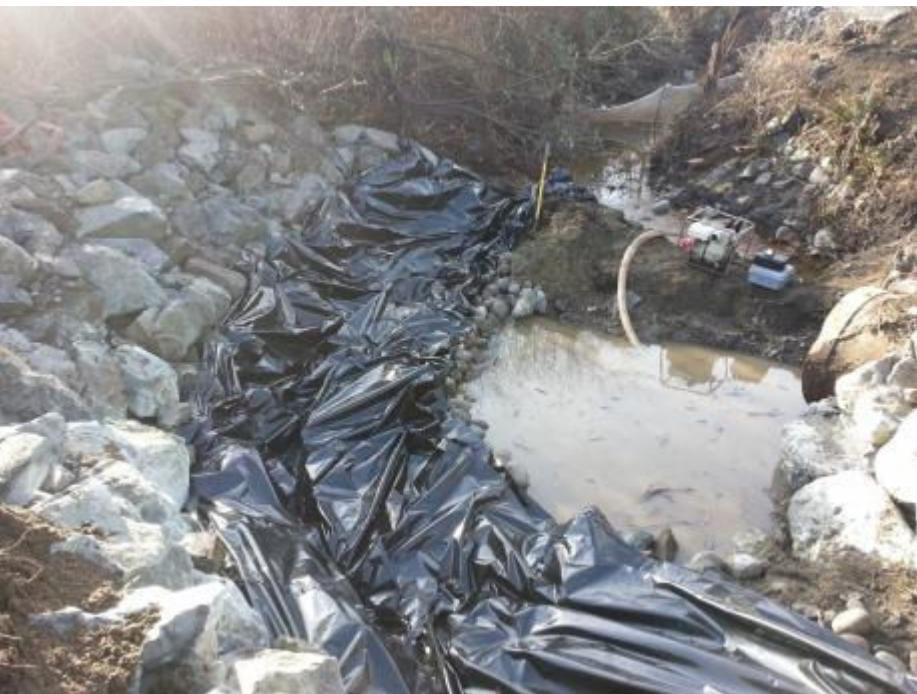
Photo 13. After the riprap was installed on the southeast bank plastic was used to construct a temporary gravity diversion channel and contain the flow along the bank in order to allow work to proceed on the northwest side of the channel.

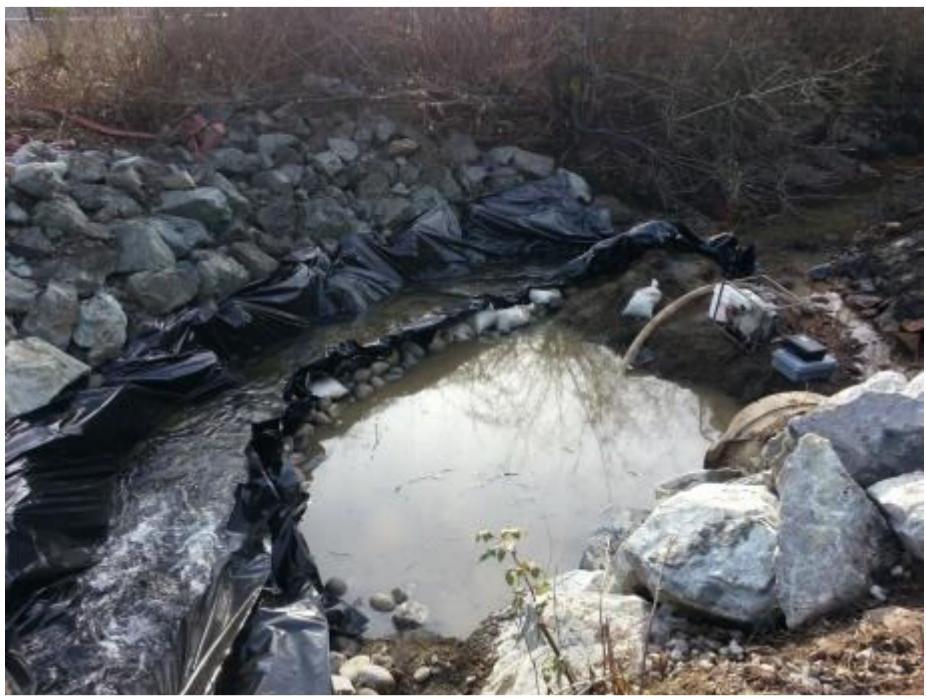
Photo 14. View of functioning gravity diversion on the southeast edge of the pool downstream of the CN crossing.

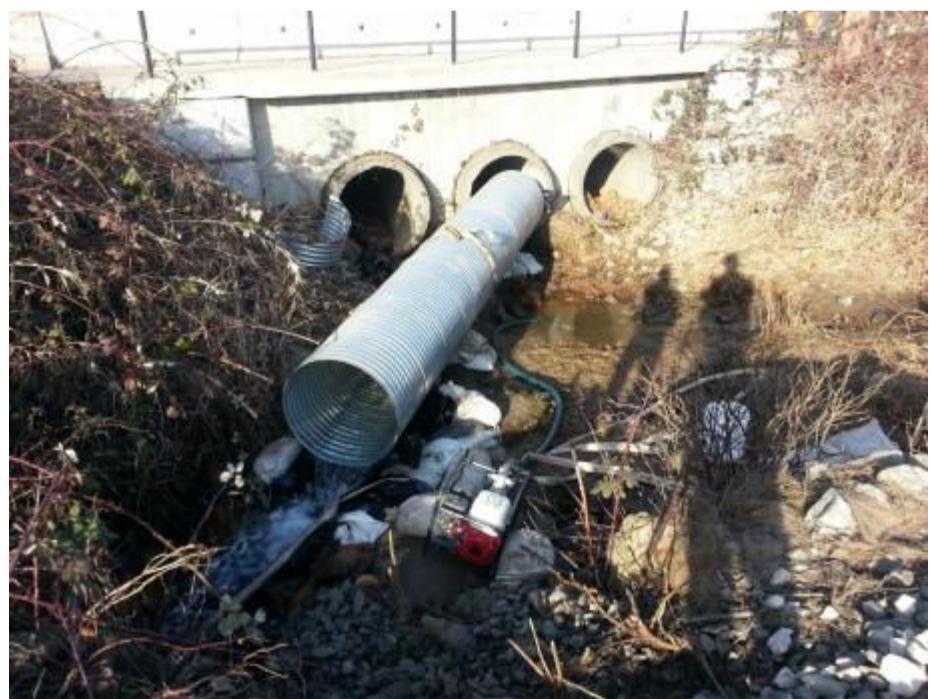
Photo 16. A temporary culvert was used to bypass the outlet pool at the City of Burnaby storm sewer discharge point into Silver Creek. The culvert was installed to allow completion of the upstream stabilization work, but also assisted with diverting water between culverts to facilitate culvert cleaning.

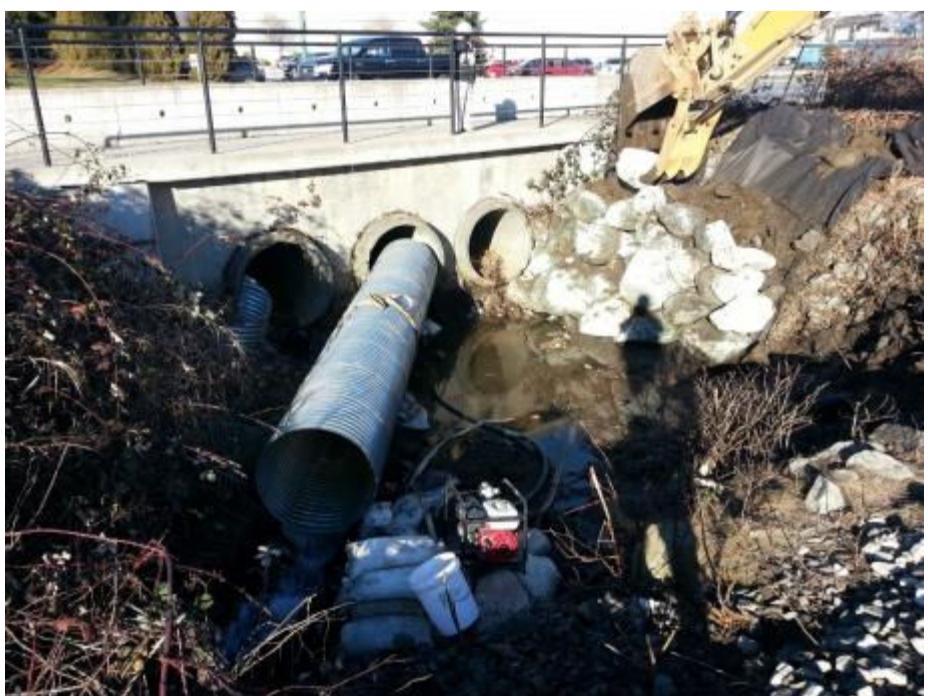
Photo 17. Functioning temporary culvert used to bypass the upstream work area during bank stabilization works upstream of the CN crossing.

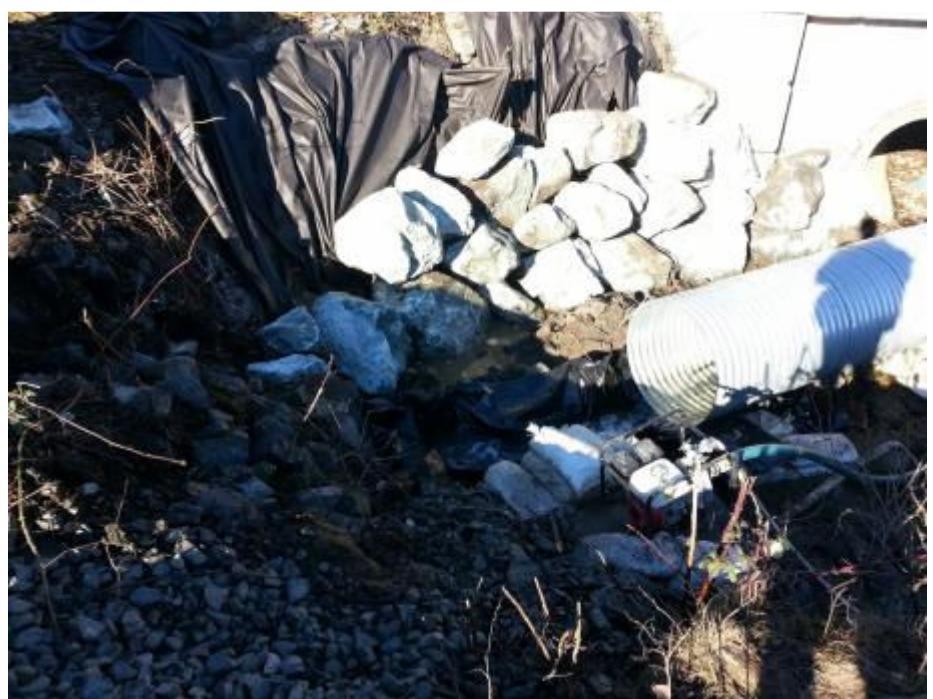
Photo 18. Installing riprap along the western bank of Silver Creek at the storm sewer discharge point upstream of the CN crossing.

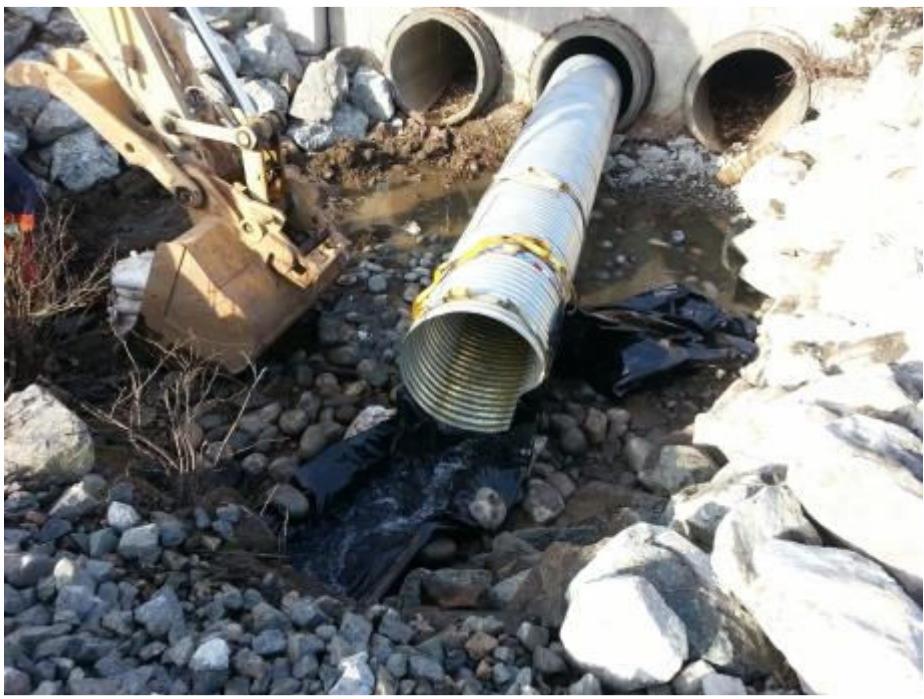
Photo 20. View of the temporary culvert positioned to divert water to the eastern CN culverts and allow bank protection work to proceed on the west side of the channel, and facilitate cleaning of the western culverts.

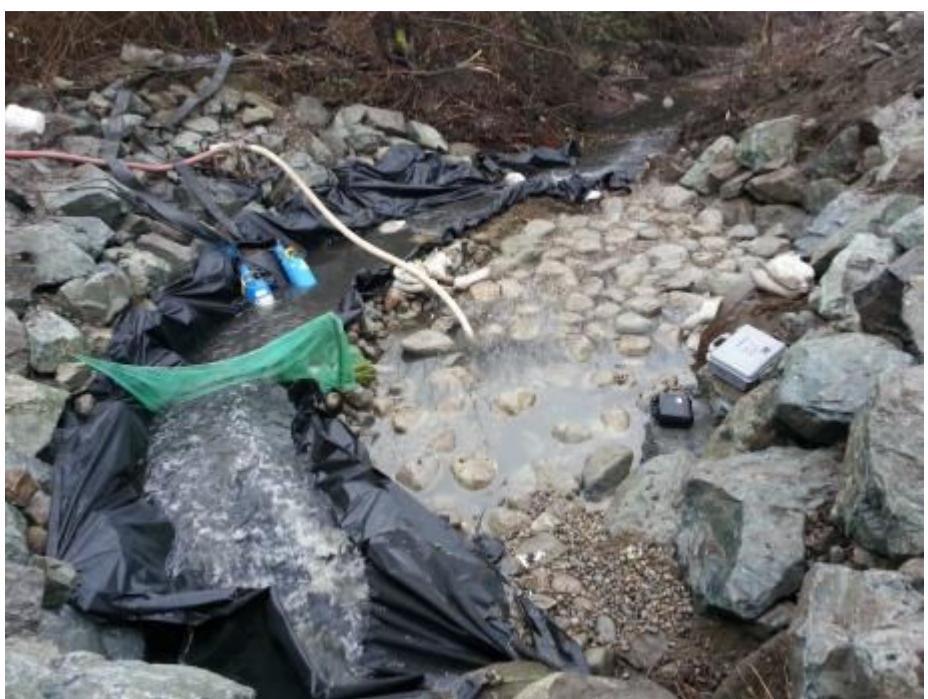
Photo 23. After work on the outlet pools was complete, a net and pumps were installed for site segregation to allow completion of additional bank protection/stabilization work downstream.

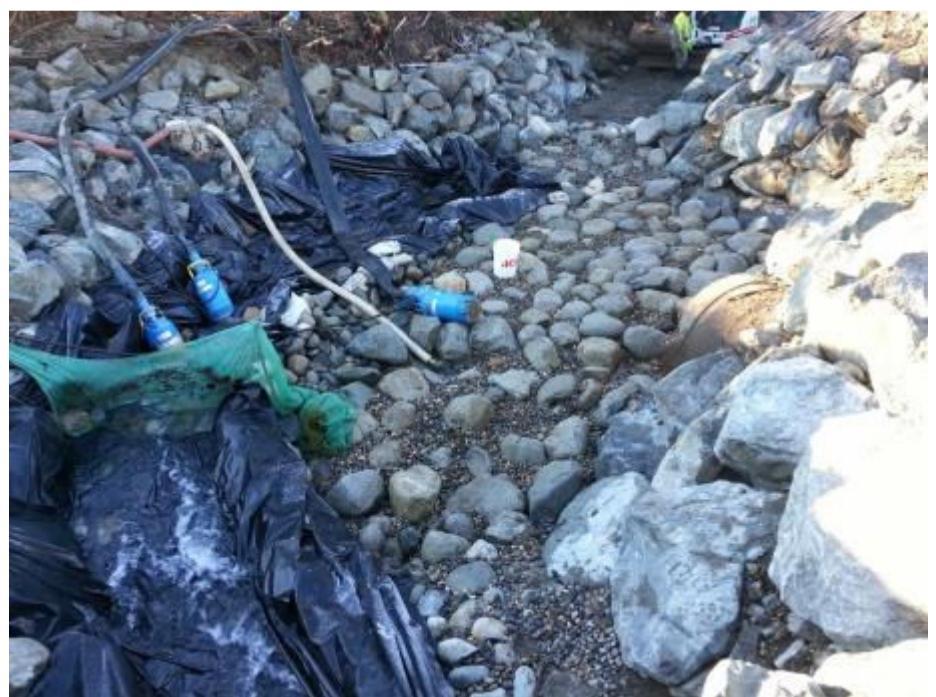
Photo 24. Example of site segregation (isolation net(s)) and diversion pumps used to isolate the work area downstream of the CN crossing.

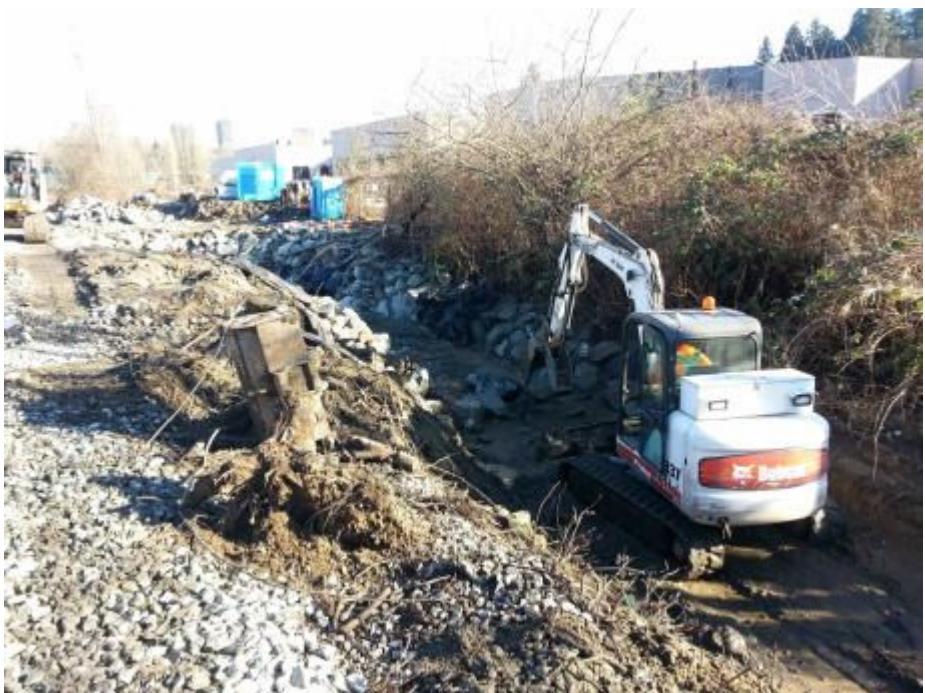
Photo 25. Banks protection/stabilization works underway in Silver Creek within the isolated and dewatered work area downstream of the CN crossing.

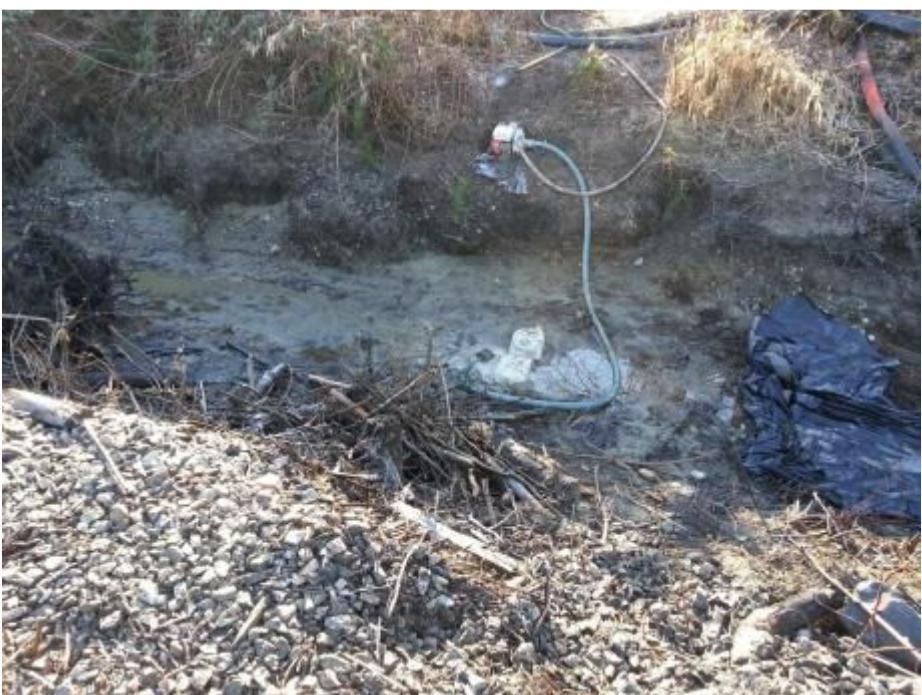
Photo 26. Example of a typical sump used to collect turbid water from disturbed work areas during the downstream channel works. Turbid water was discharged to vegetated areas for infiltration to ground.

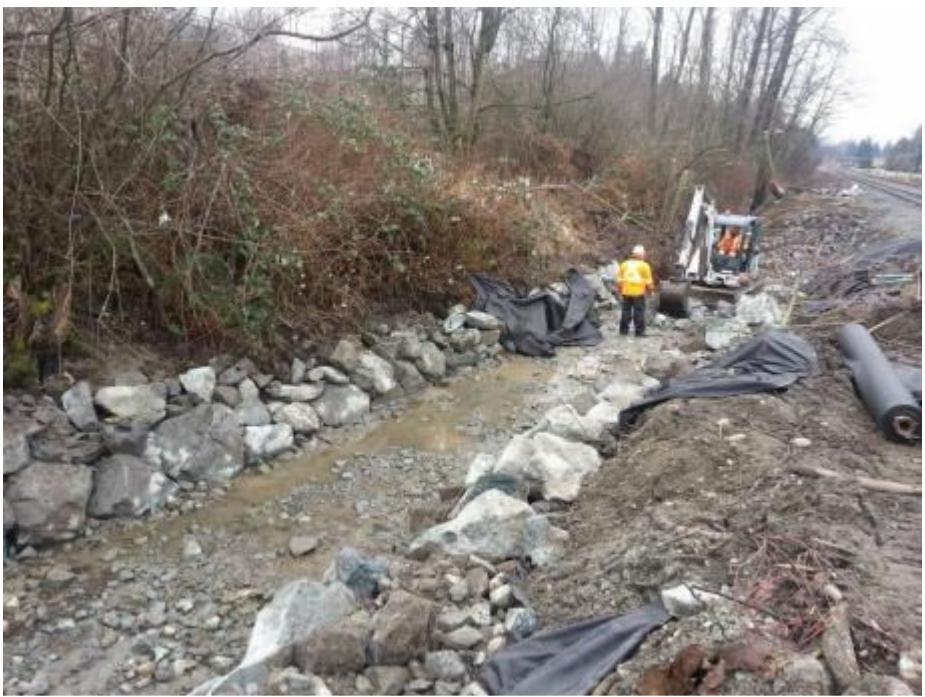
Photo 27. Banks protection/stabilization works underway within an isolated and dewatered work area in Silver Creek downstream of the CN crossing.

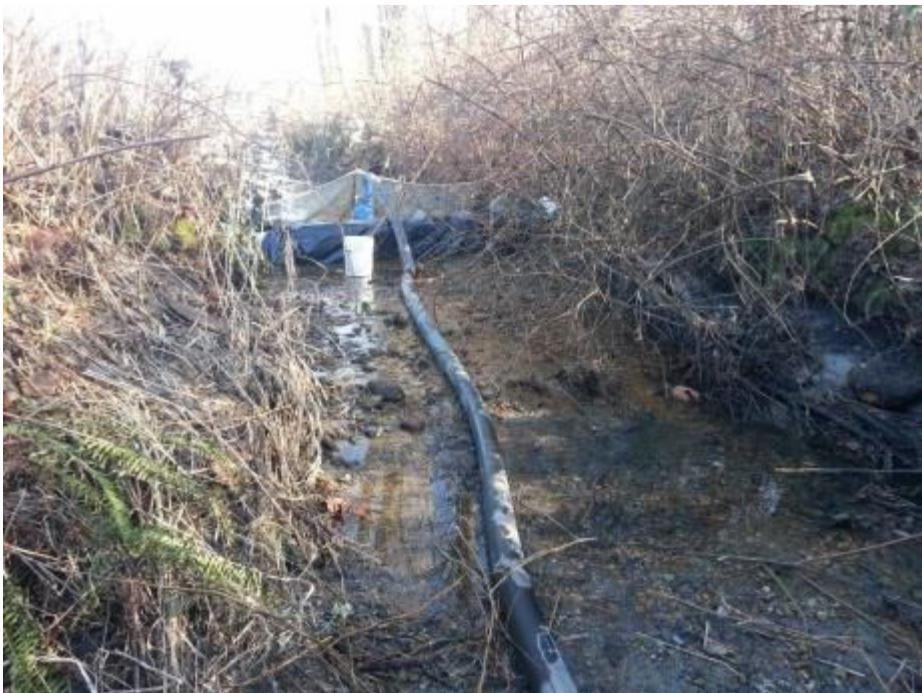
Photo 28. Upstream view of site segregation for the bank protection/stabilization works conducted at the channel bend where Silver Creek turns south away from the CN track.

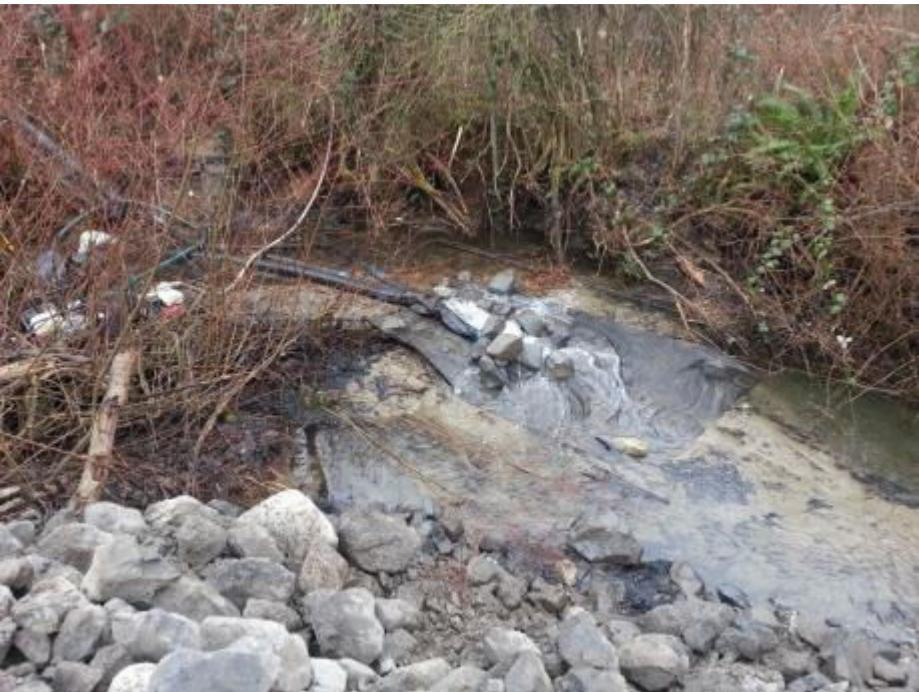
Photo 29. Discharge point for diversion pumps used during the channel works downstream of the CN crossing. Rocks and filter fabric were used to prevent erosion and reduce potential sediment mobilization at the point of discharge.

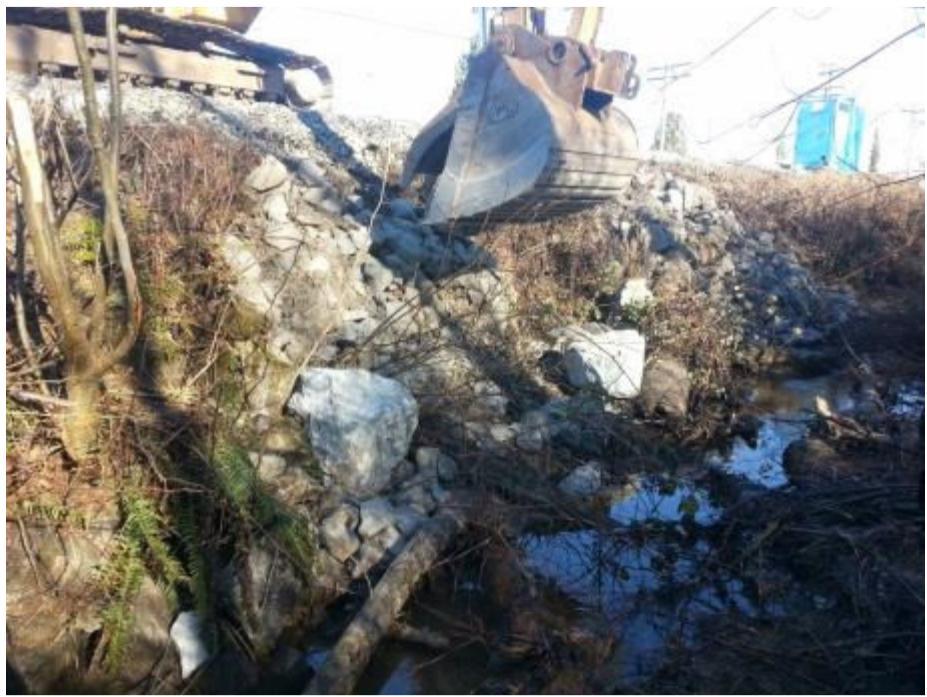
Photo 30. Riprap installation taking place at the channel bend where Silver Creek turns south away from the CN track. Work was conducted to minimize disturbance of pre-existing large woody debris (LWD) present in the channel.

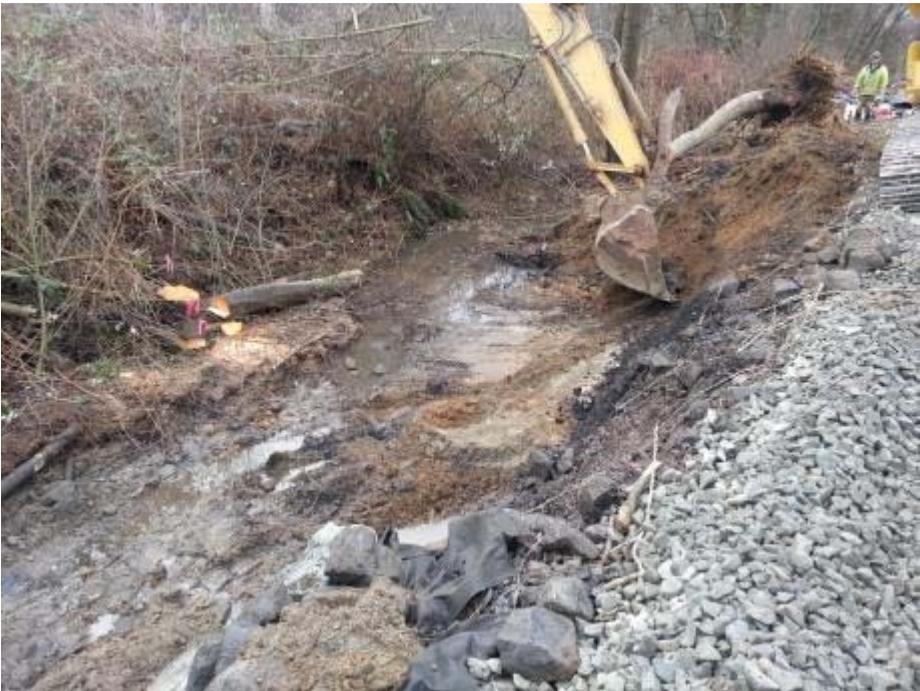
- A knoll located 100 m downstream of the culvert outfall was removed. This knoll was identified as a channel constriction and potential point of failure during the initial post spill investigation and was removed under dry conditions using an excavator⁵ (Appendix 2, Photo 31)

Photo 31. In order to improve channel capacity in Silver Creek downstream of the CN crossing a channel constriction (vegetated knoll) was removed during the downstream bank protection/stabilization works.

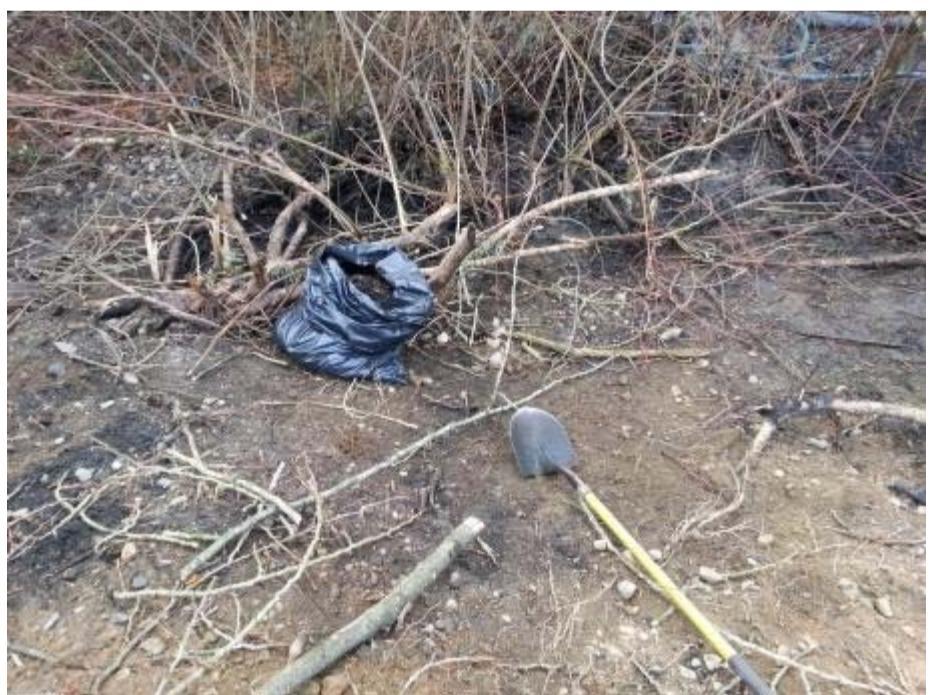
- Coal particles were opportunistically removed in working areas, with a combination of machine and hand removal efforts. This material was removed from the ROW for offsite disposal (Appendix 2, Photo 32).

Photo 32. Hand removal of coal was conducted opportunistically throughout the bank protection/stabilization work in Silver Creek.

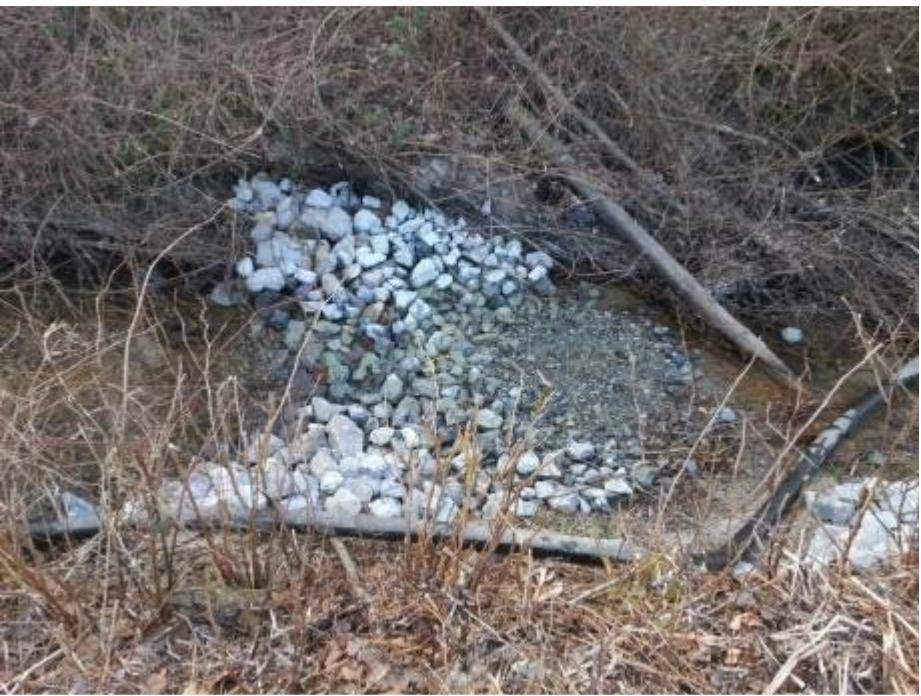
- Two rock weirs (approximately 0.5 m tall, 6 m long and 2 m wide) were constructed in Silver Creek, including one weir upstream of the point where Silver Creek veers south away from the ROW and one below the culvert outlet pool. The weirs were installed to control water levels, reduce the likelihood of bank or channel erosion, and to encourage the creation and enhancement of fish habitat through backwatering and pool formation (Appendix 2, Photo 33).

Photo 33. Rock weir installed to prevent channel down cutting at the bend where Silver Creek turns south away from the CN track.

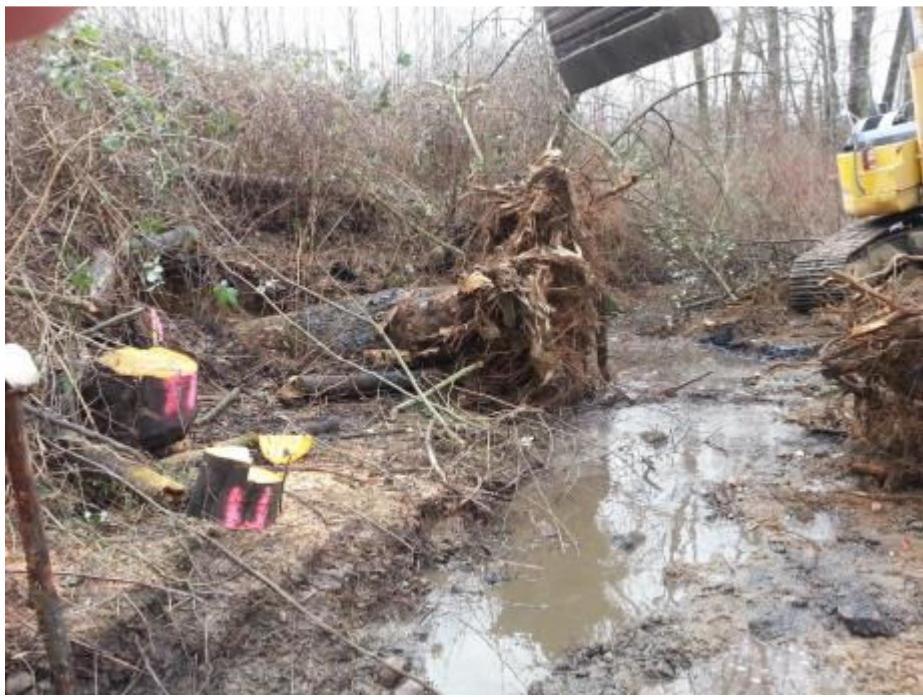
- Rootwads and large woody debris (LWD) from the tree removal were incorporated into the bank protection/stabilization work to enhance fish habitat conditions (Appendix 2, Photo 34 and 35).

Photo 34. Rootwads remaining from tree removal were also used as part of the bank protection/stabilization work and for fish habitat enhancement in Silver Creek.

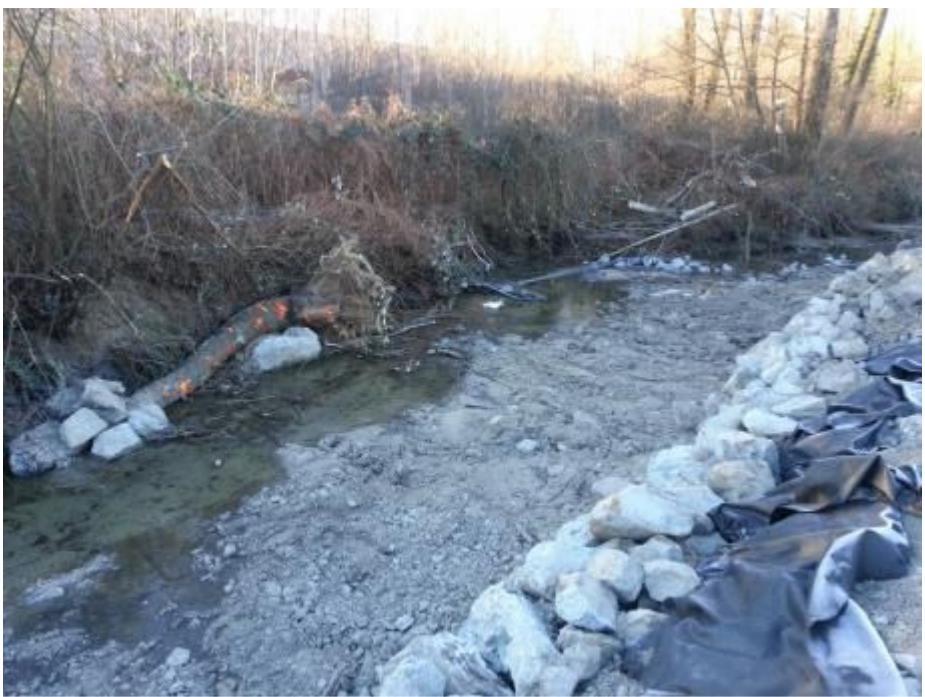
Photo 35. Downstream view of Silver Creek channel and rootwads from tree removal used for bank protection/stabilization work and fish habitat enhancement.

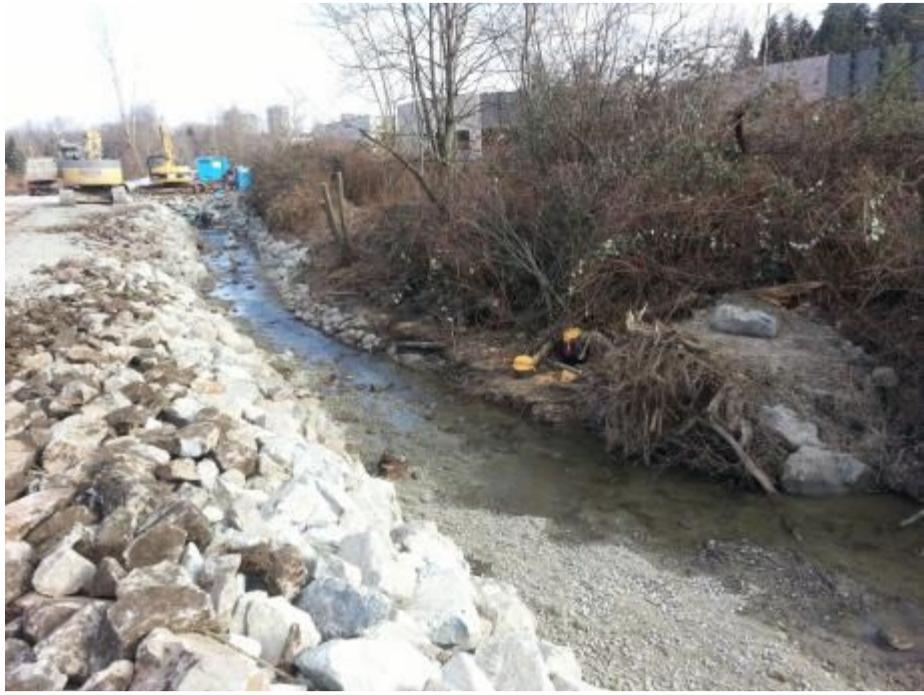
Photo 38. Upstream view from near the channel constriction after the bank protection/stabilization works were completed, the modified channel bed was washed with water and flow was restored.

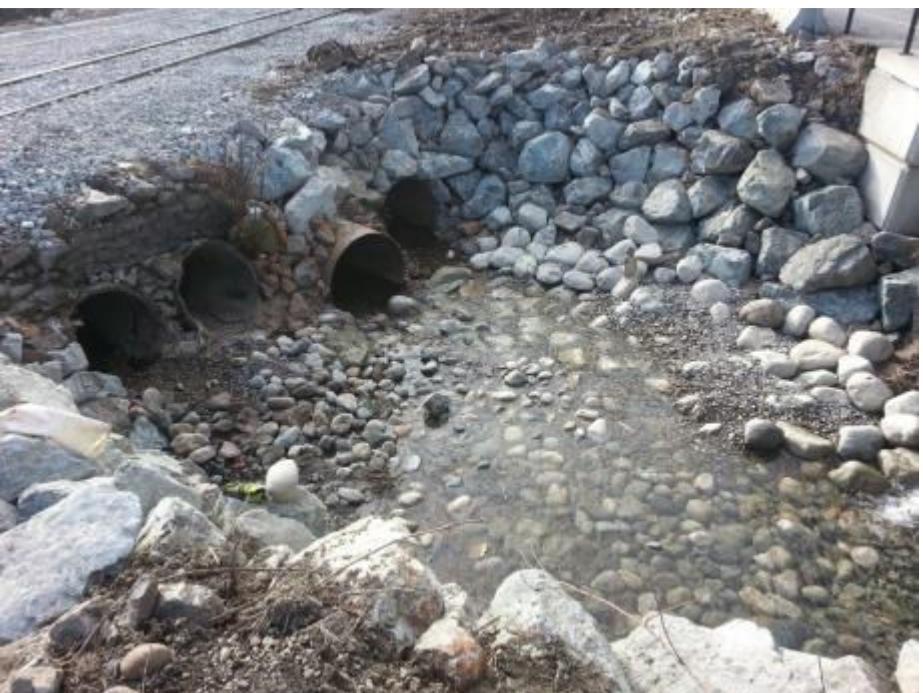
Photo 39. Cross channel view of the City of Burnaby storm sewer outfall into Silver Creek, after the bank protection/stabilization works were completed.

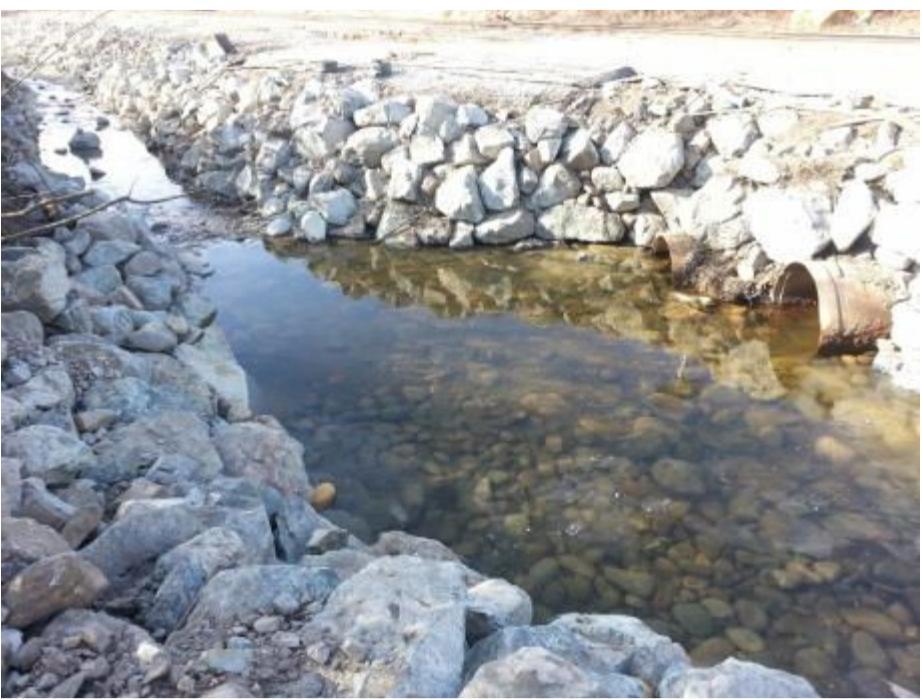
Photo 40. Downstream of the CN crossing outfall in Silver Creek, after the bank protection/stabilization works were completed.

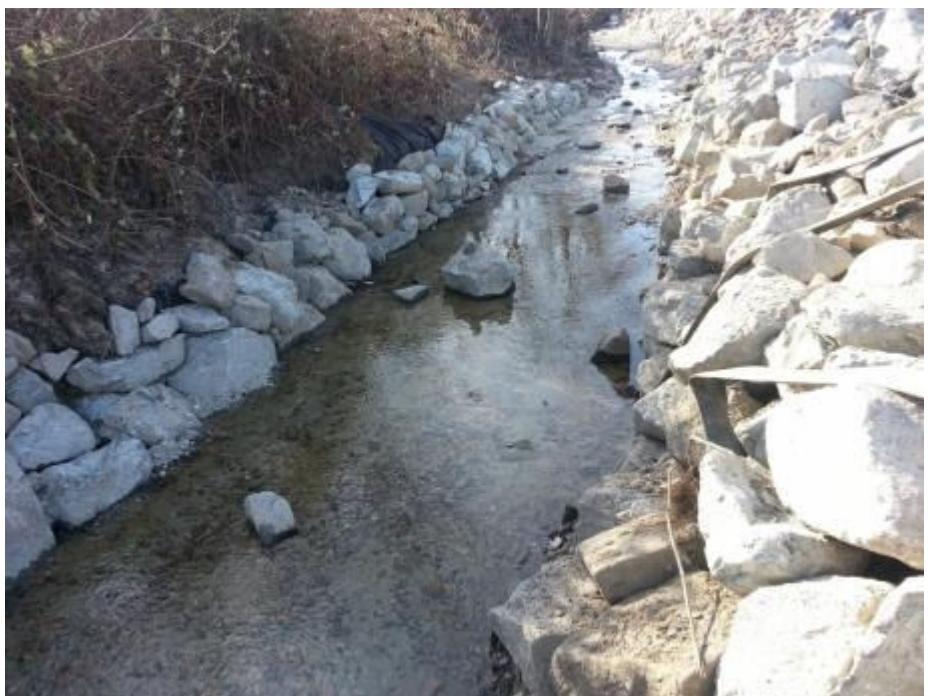
Photo 41. Downstream view of the main channel downstream of the CN crossing in Silver Creek, after the bank protection/stabilization works were completed.

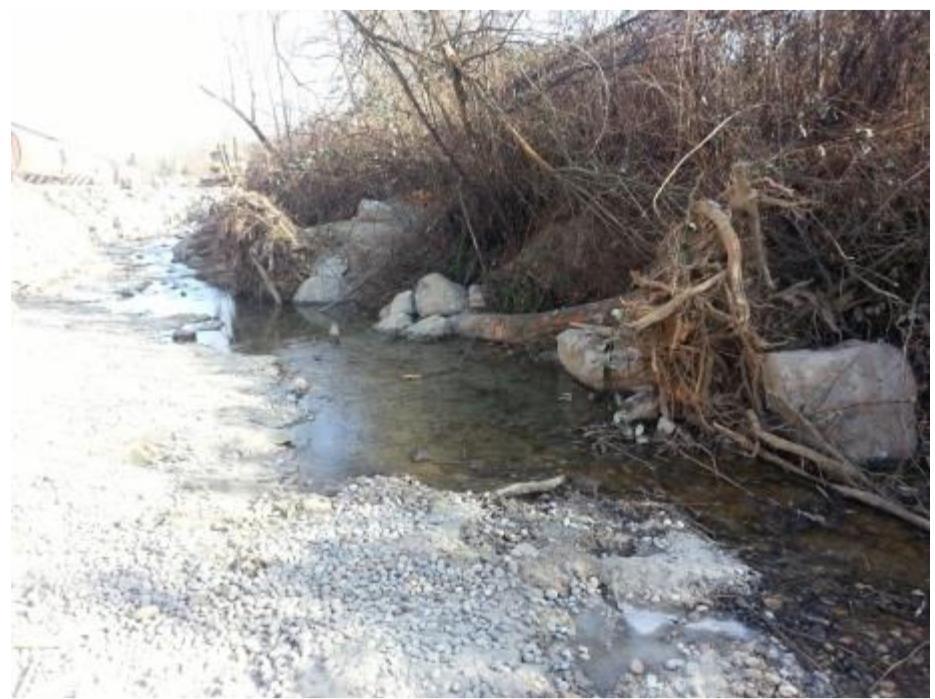
Photo 42. Upstream view of rootwads installed along the south bank downstream of the CN crossing, after the bank protection/stabilization works were completed.

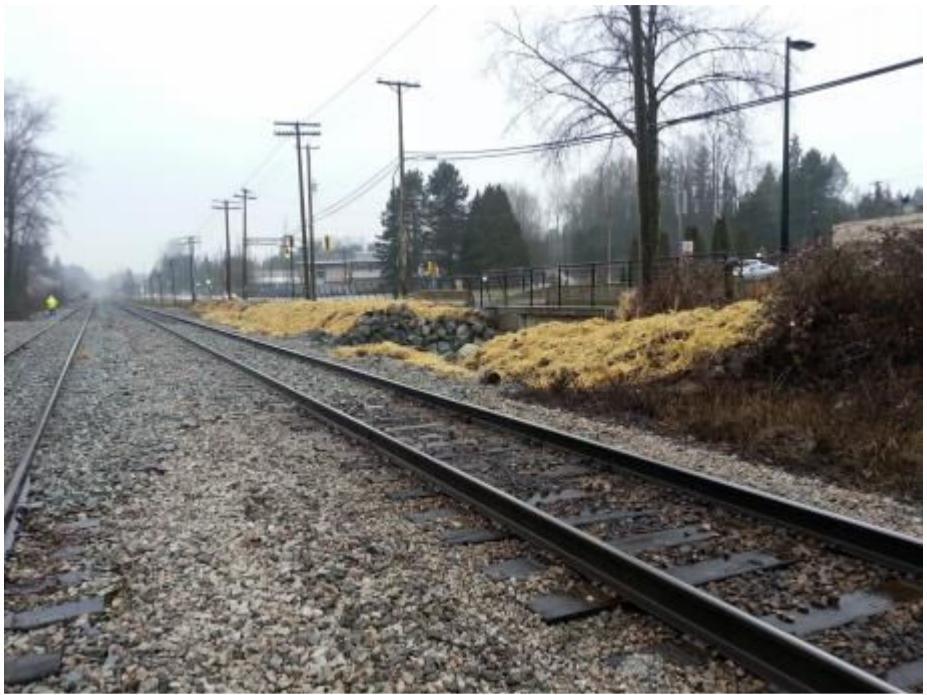
Photo 43. After the works were complete, erosion and sediment control measures were installed to prevent erosion and sediment mobilization from areas disturbed during construction or by heavy equipment access.

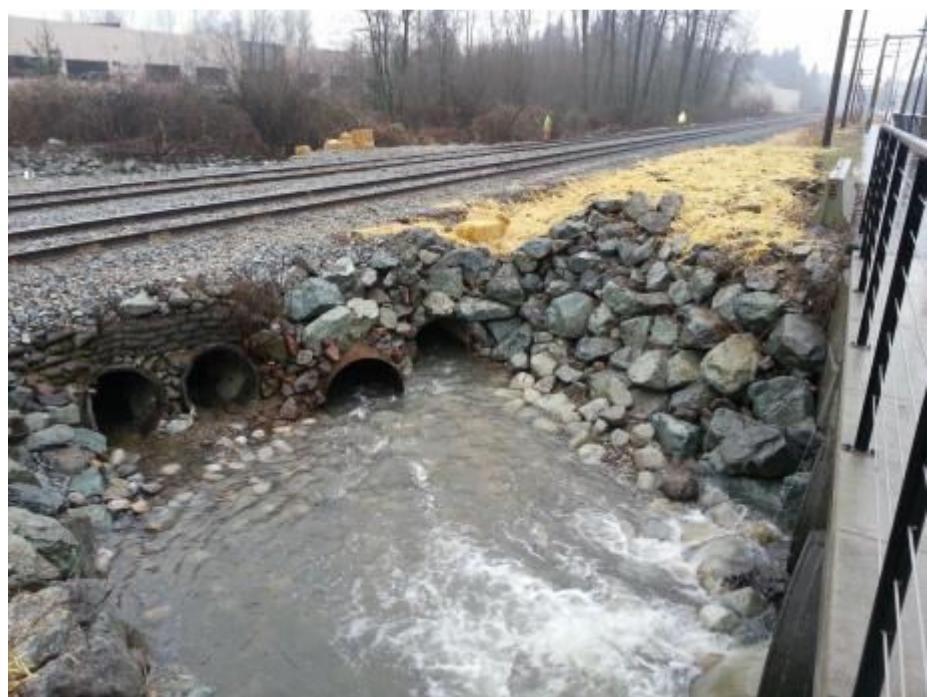
Photo 44. Downstream view from Government Street showing the completed bank protection/stabilization work at of the City of Burnaby storm sewer outfall during a rain event.
