Project number: 4435-029 Document number: V3729 Version: 3 Date: September 4, 2014

MILE 122.7 DERAILMENT – COAL RECOVERY REPORT FOR SILVER CREEK AND BURNABY LAKE

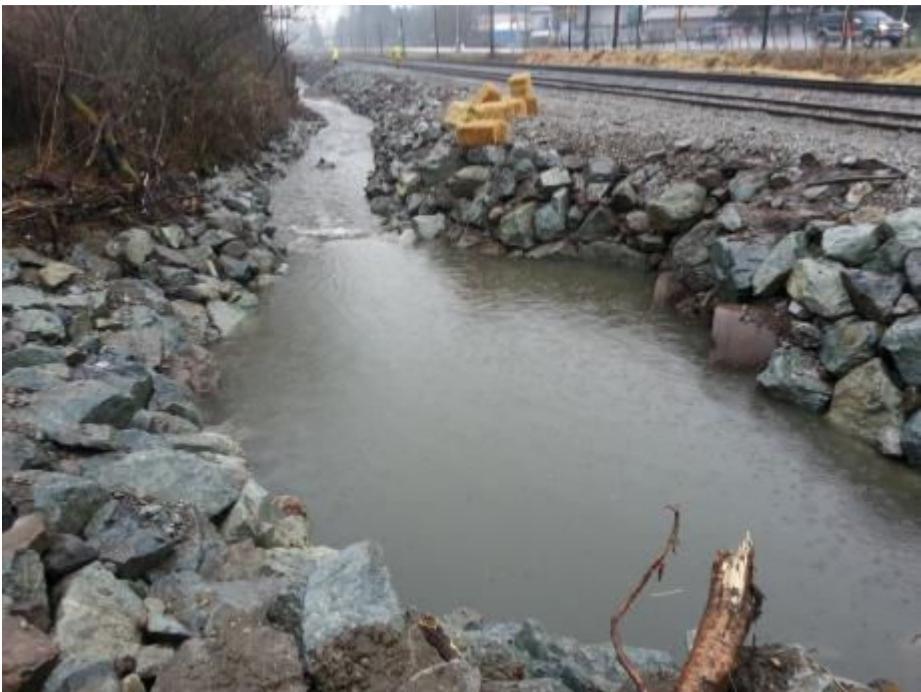
Photo 45. Downstream view showing the completed bank protection/stabilization works on the downstream side of the CN crossing during a rain event.

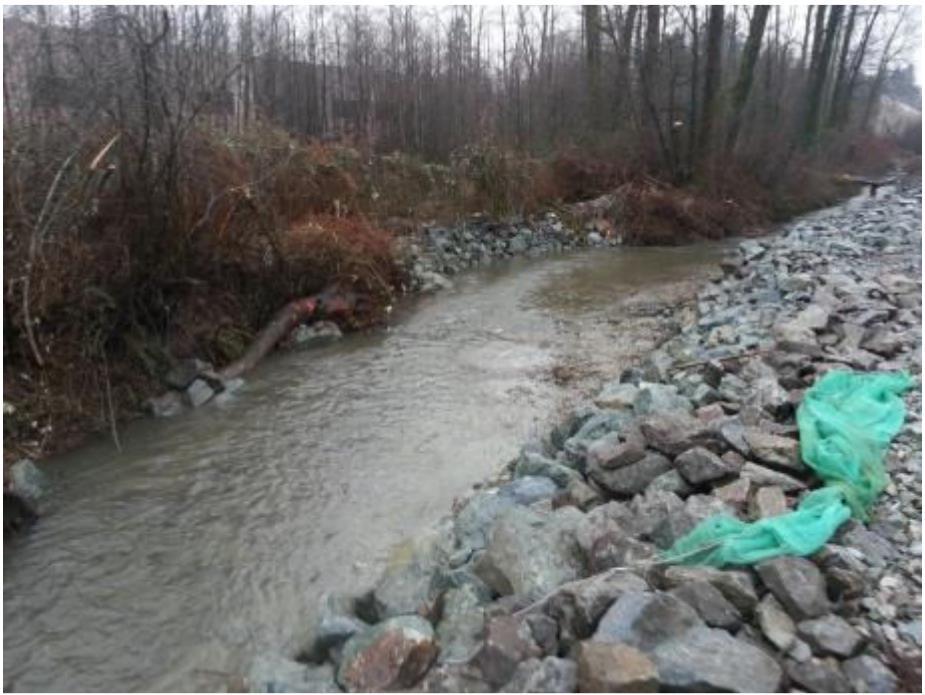
Photo 46. Downstream view of the completed bank protection/stabilization work in the main channel downstream of the CN crossing.

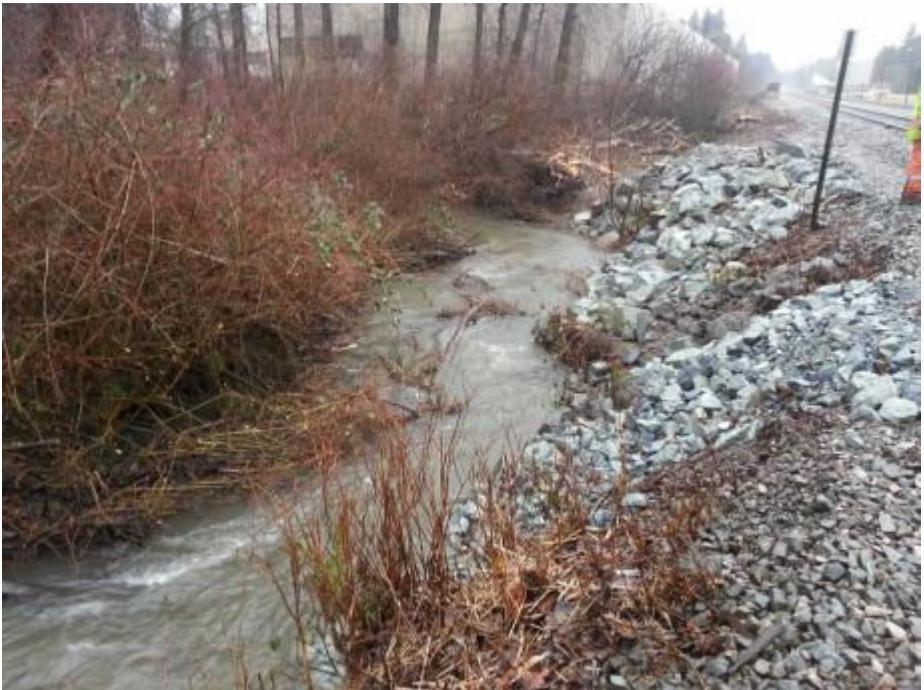
Photo 47. Downstream view of the completed bank protection/stabilization works at the channel bend where Silver Creek turns south away from the CN track (photo taken during a rain event).

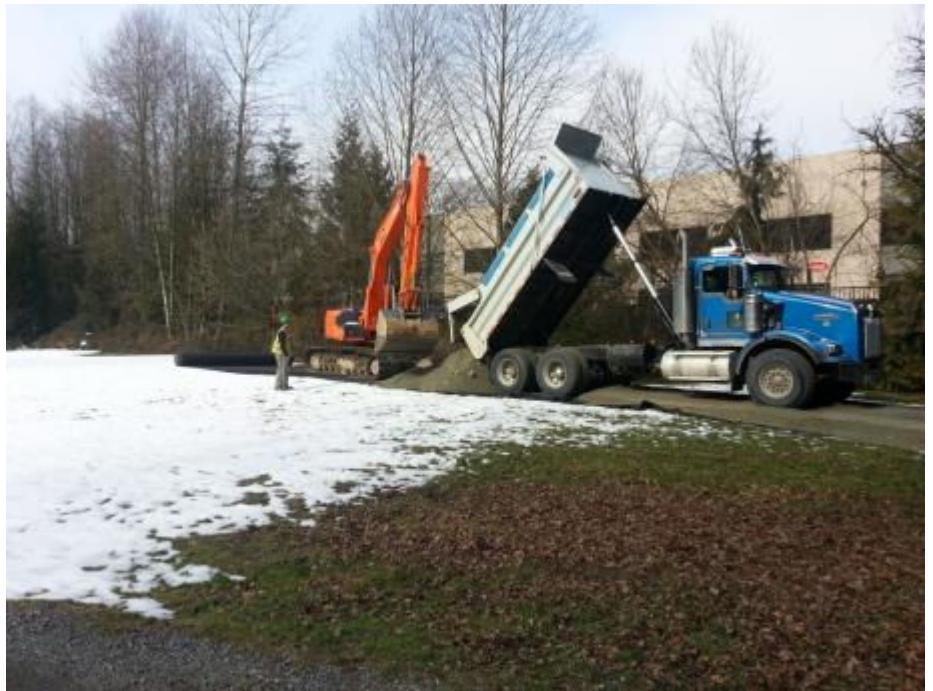
Photo 1. Installation of temporary park user path for the Burnaby Lake coal recovery program.

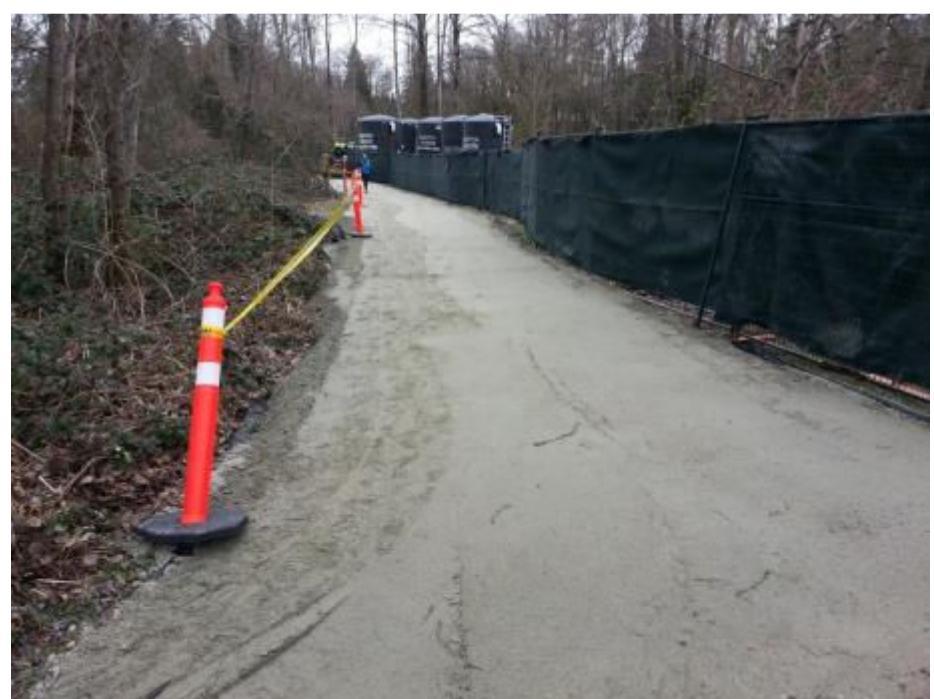
Photo 2. Temporary public path and fencing used to divert recreational users around work area.

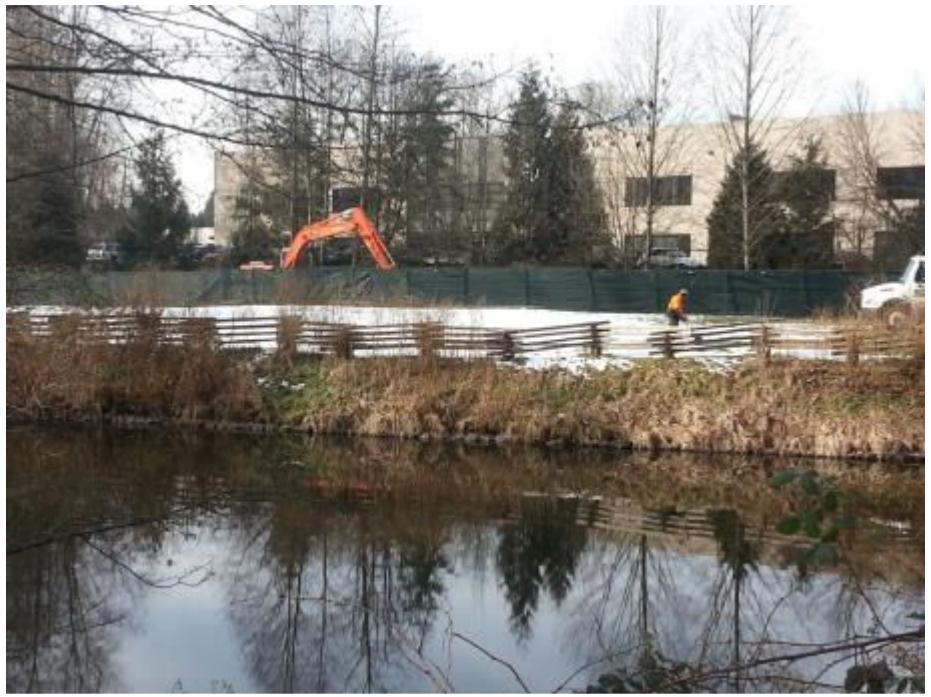
Photo 3. Installation of temporary fencing for the Burnaby Like coal recovery program.

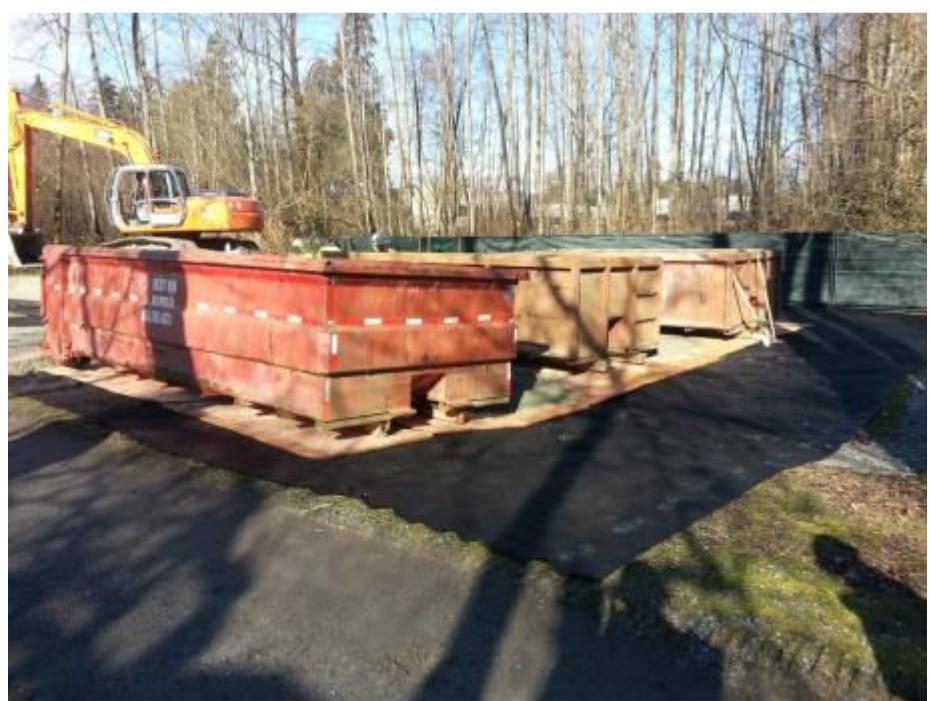
Photo 4. Installation of coal dewatering bins on top of plywood set over geotextile fabric to minimize damage to park areas.

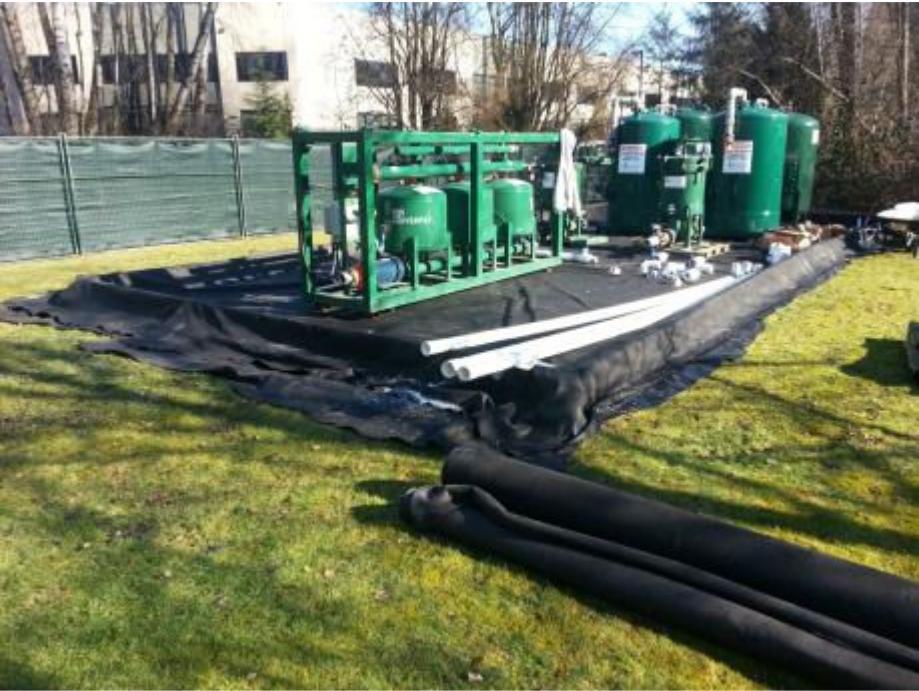
Photo 5. Installation of water treatment system within a geotextile containment.

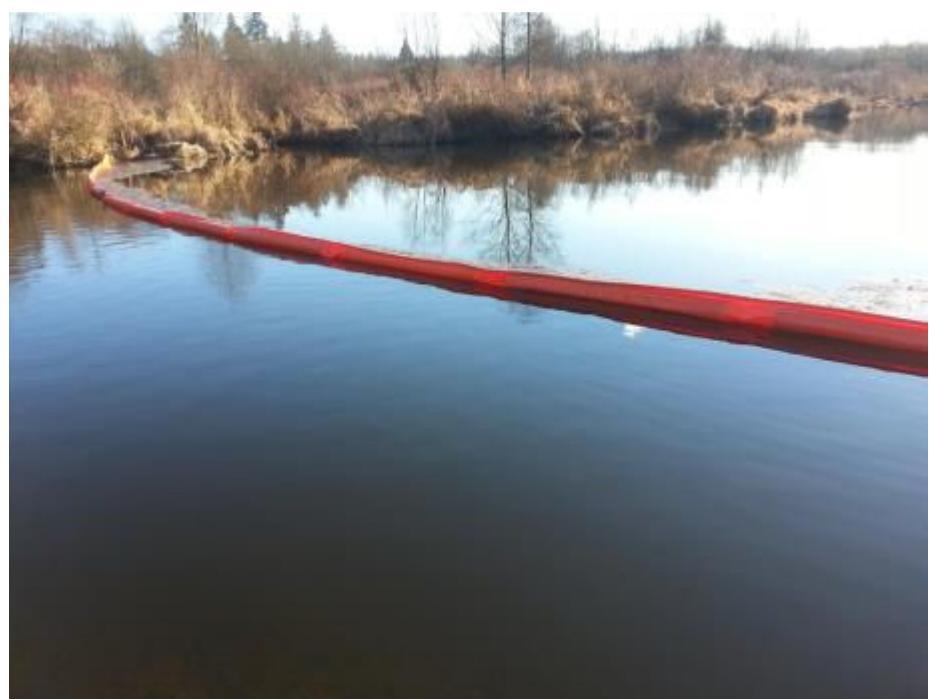
Photo 6. A temporary boom was installed across the channel to keep pleasure boaters away from the work area during coal recovery.

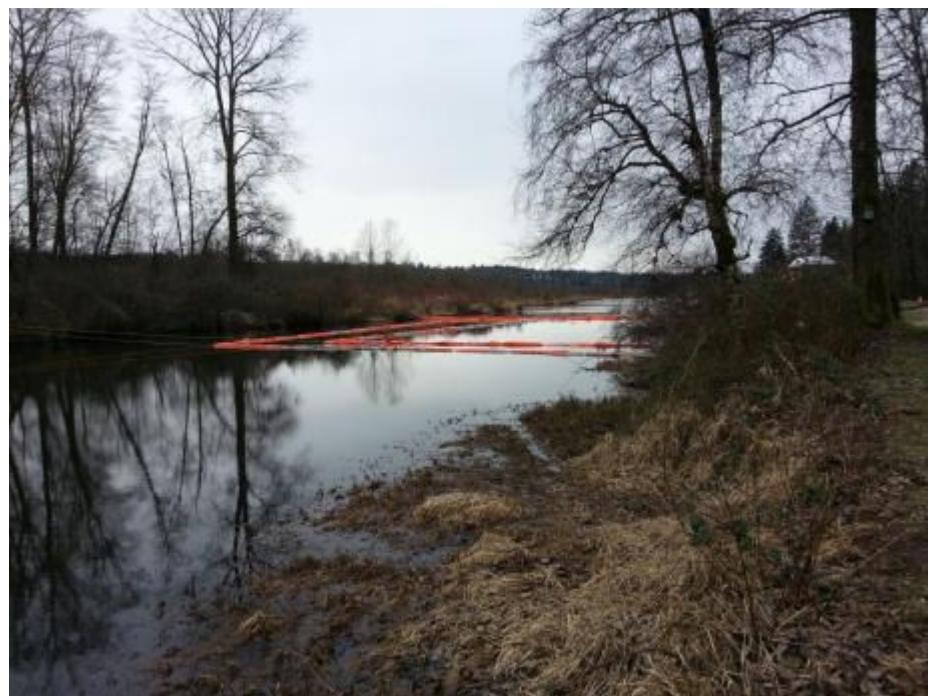
Photo 7. Sediment curtain installed around the work area in Burnaby Lake.

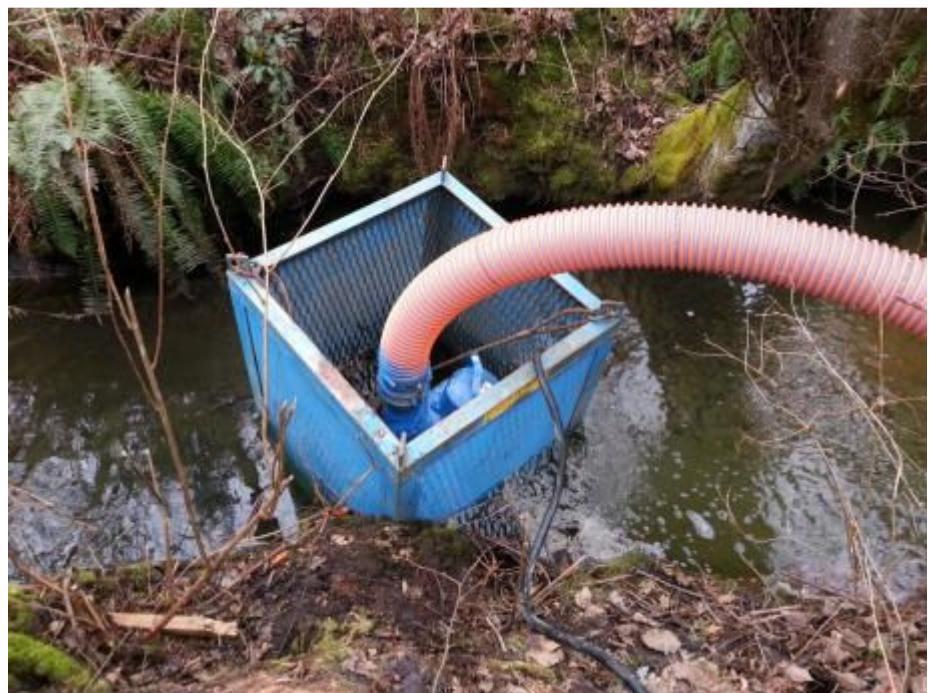
Photo 8. A 6 inch pump with a fish screen was installed in Silver creek upstream of the coal recovery work area to allow diversion of flow around the work area.

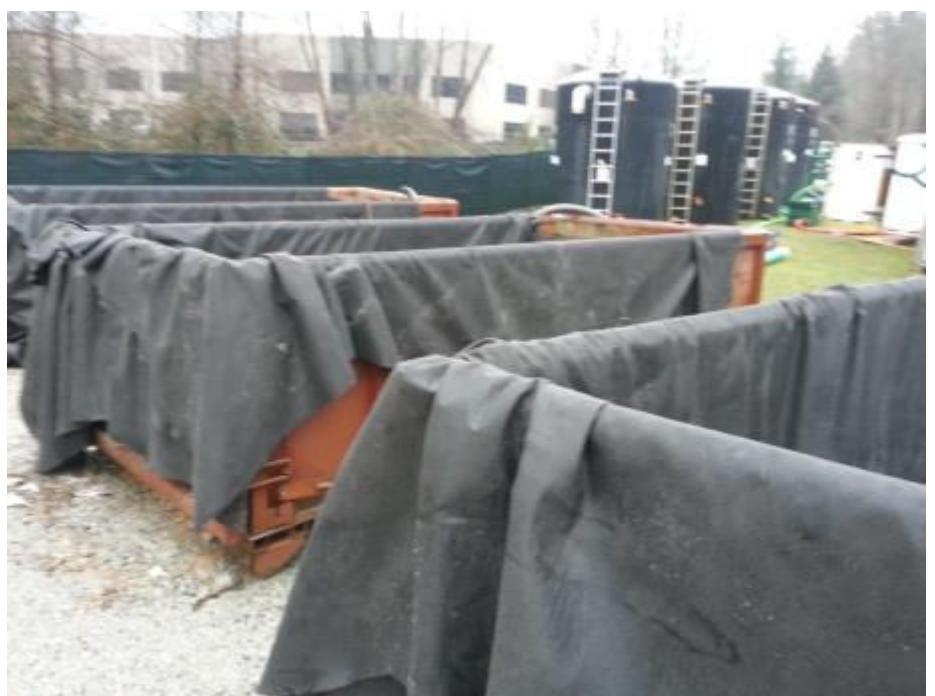
Photo 9. Coal collection bins were lined with geotextile fabric to assist in dewatering and sealed with expanding, quick dry caulking.

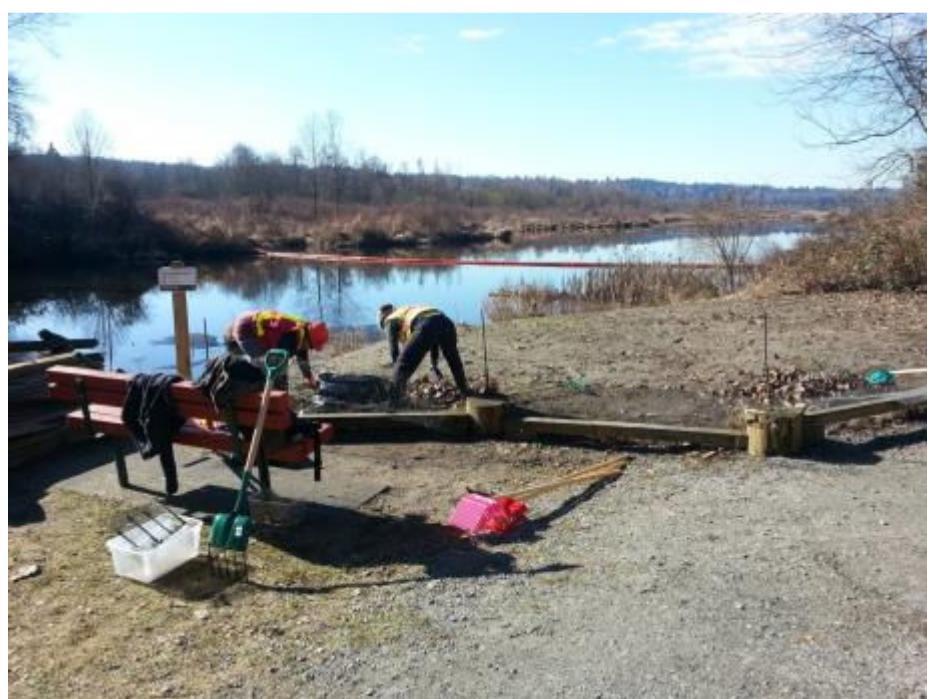
Photo 10. Turtle nesting beach salvage set up.

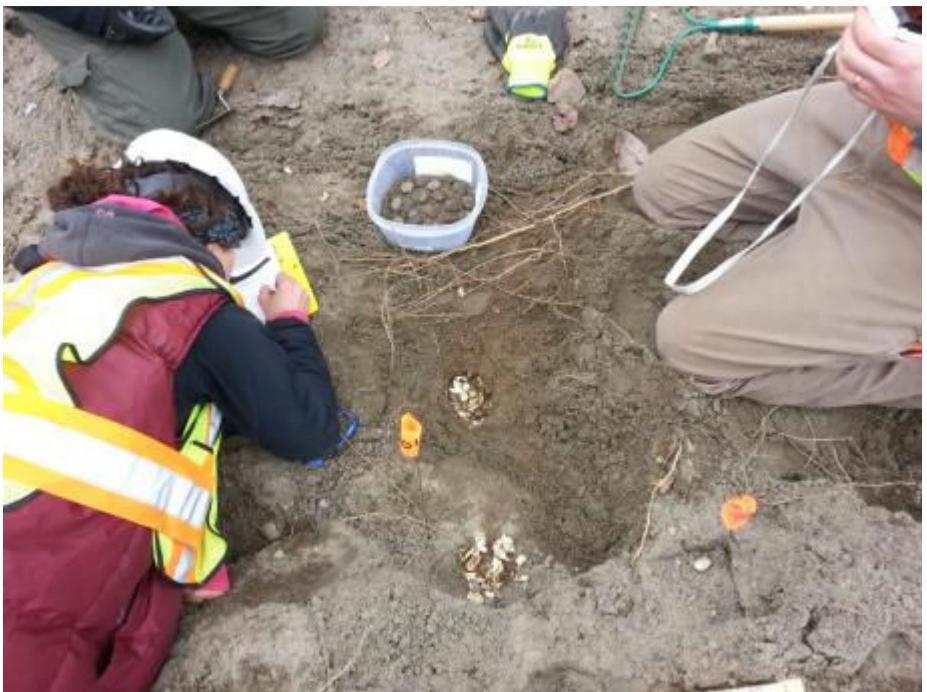
Photo 11. Salvaging and documenting and a turtle nesting site during the turtle beach salvage.

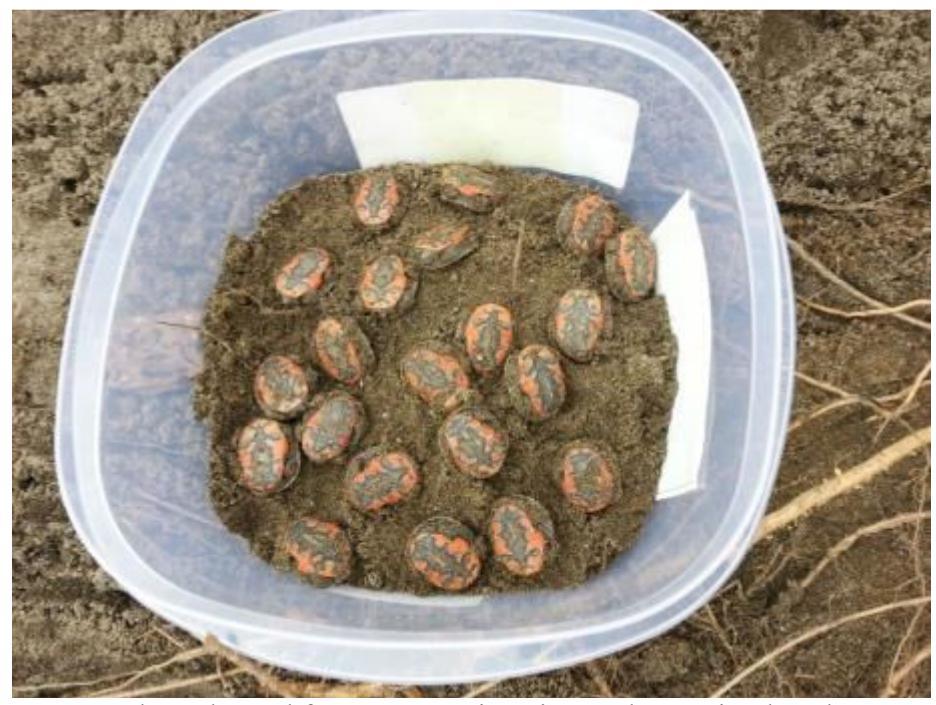
Photo 12. Neonate turtles salvaged from one nesting site on the nesting beach.

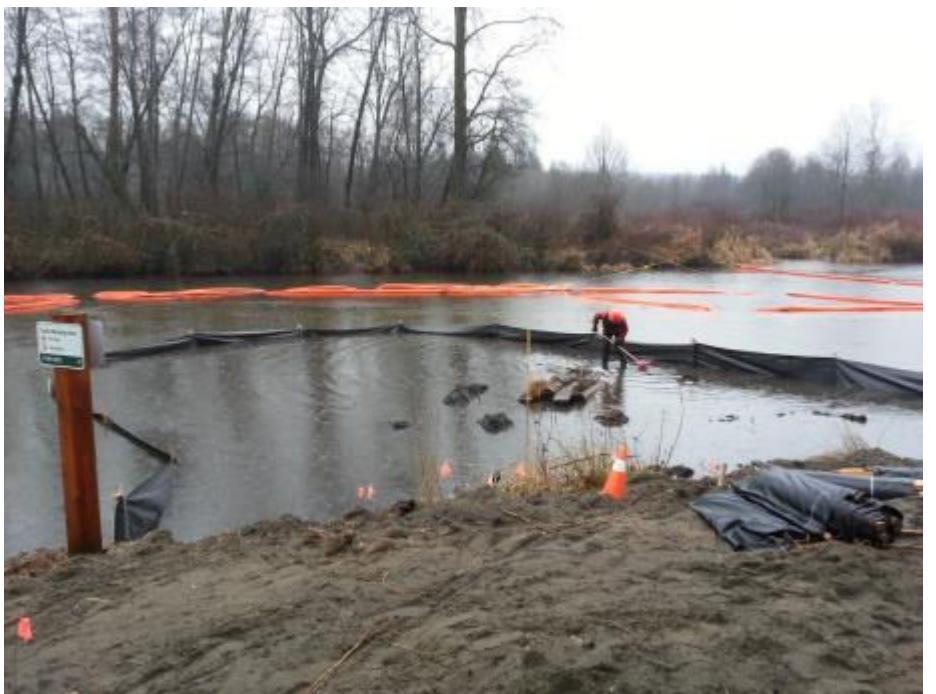
Photo 13. Shallow area of the alluvial were segregated with sediment fencing and salvaged for wildlife prior to any coal recovery.

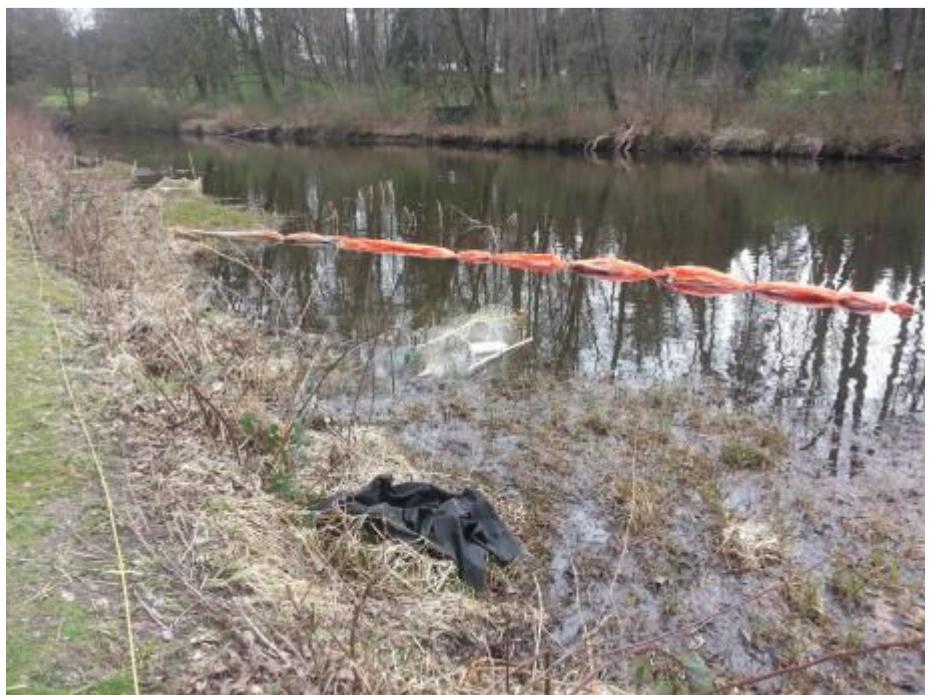
Photo 14. Turtle traps were maintained and monitored throughout the Burnaby lake coal recovery program.

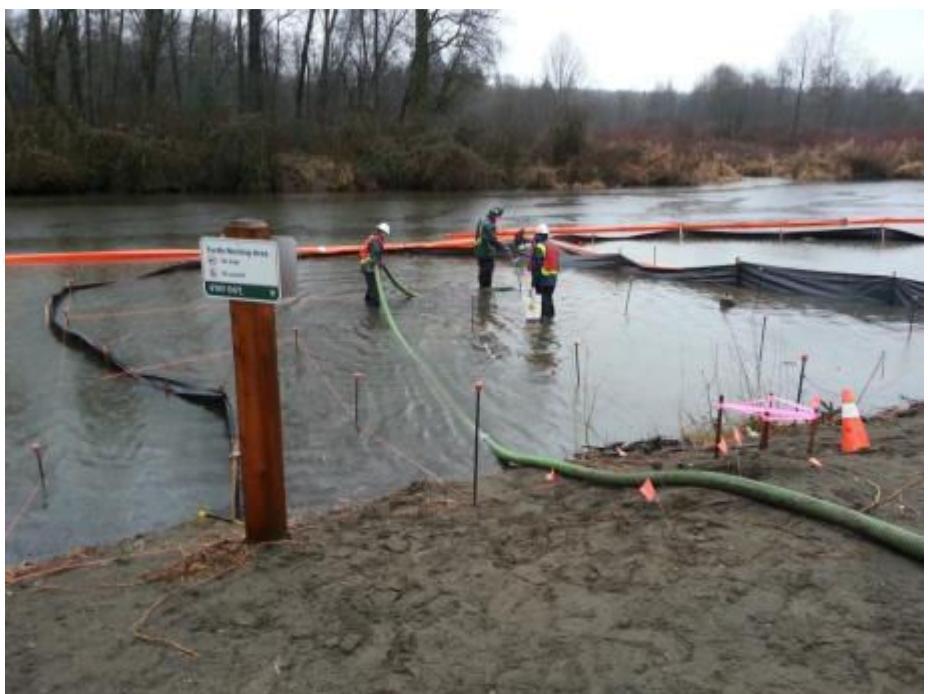
Photo 17. Shallow area segregated with sediment fencing with outer sediment curtain from the rest of the lake; grid for mapping coal removal progress.

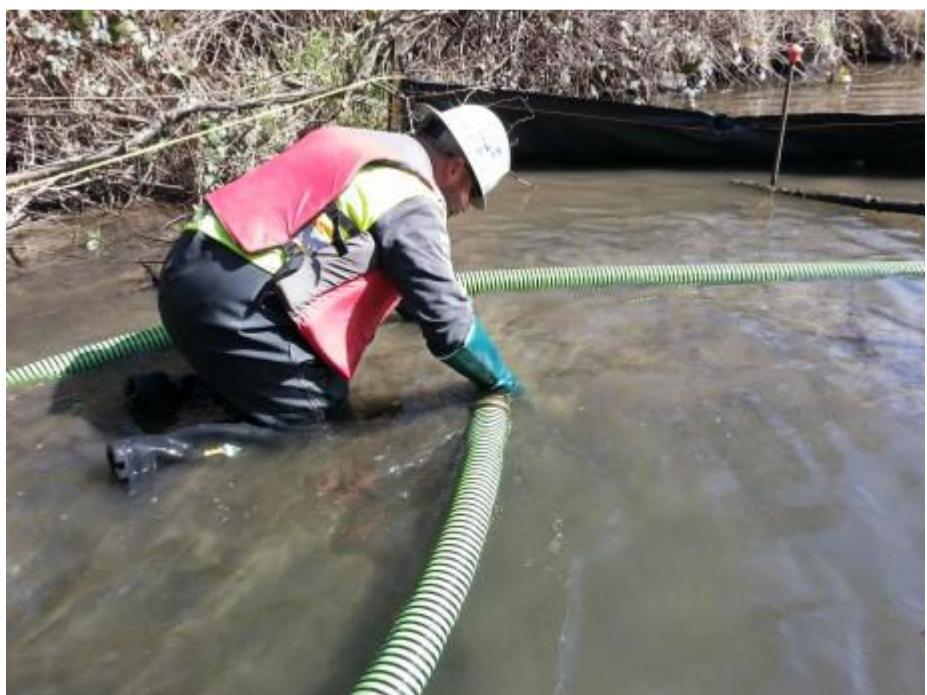
Photo 18. Solid materials were often hand fed into the vac hose to minimize the potential for sucking up turtles or other aquatic wildlife.

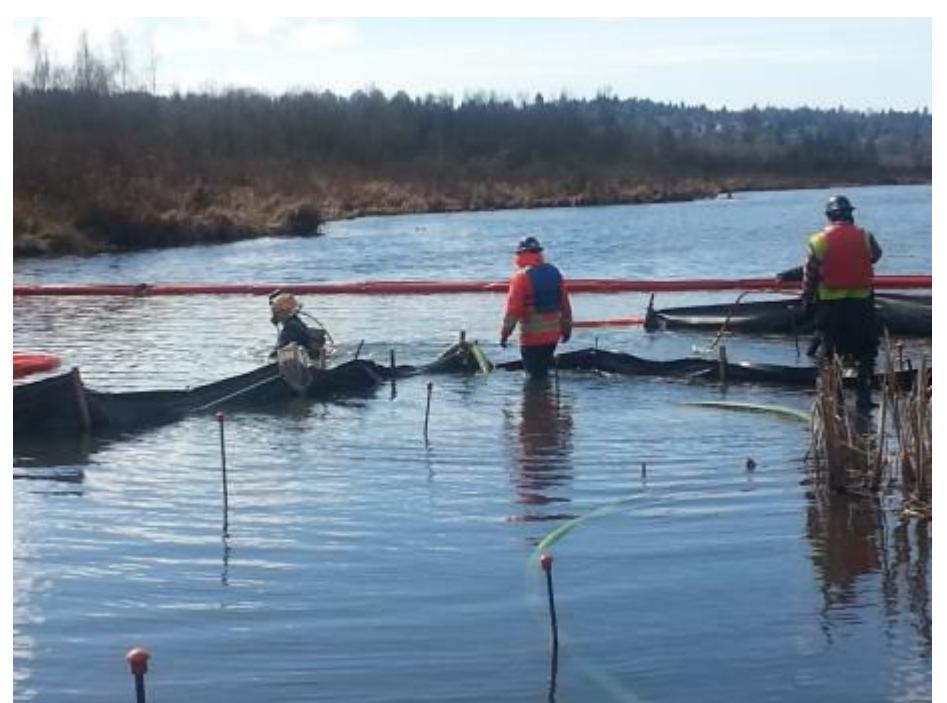
Photo19. Divers operated the vac truck hoses during coal recovery of the deeper sections of the lake.

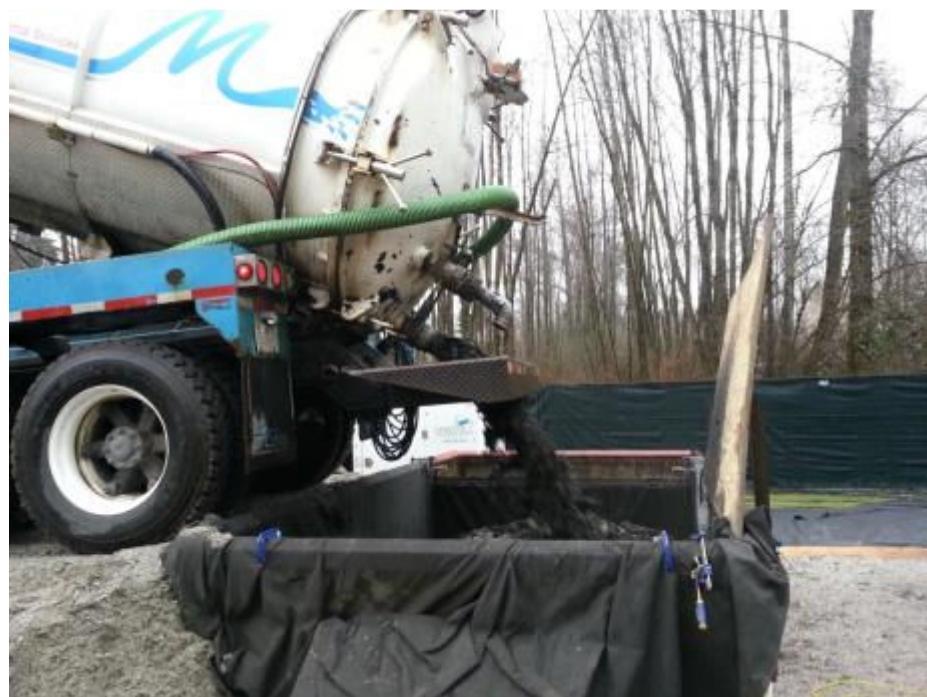
Photo 20. Vac trucks were emptied into the coal collection bin for the beginning of coal separation and water treatment.

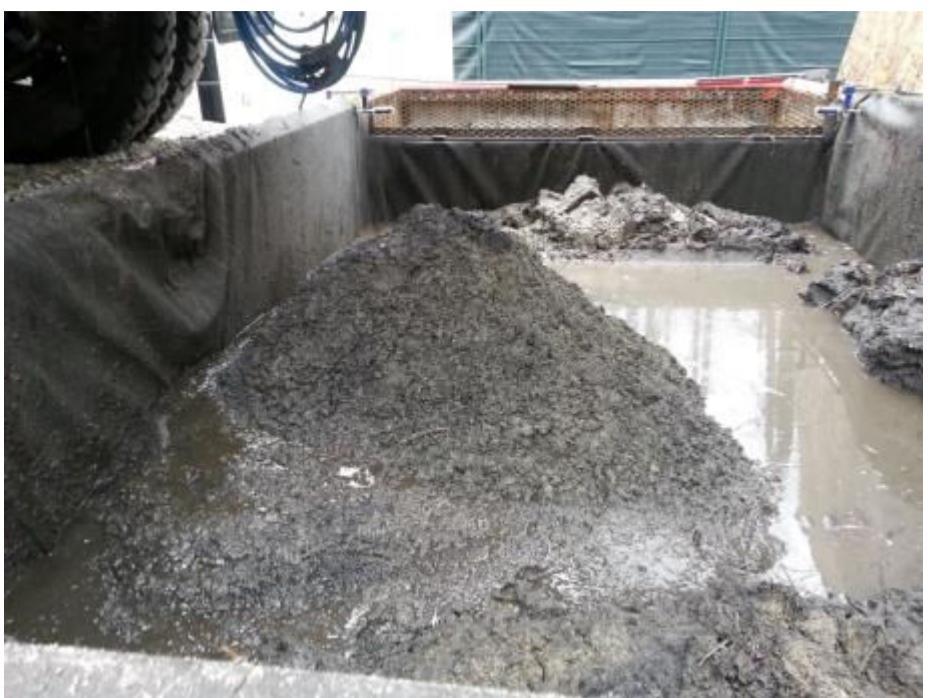
Photo 21. Vac trucks were emptied into the coal collection bin where water was filtered out to the water treatment system and coal was removed by excavator.

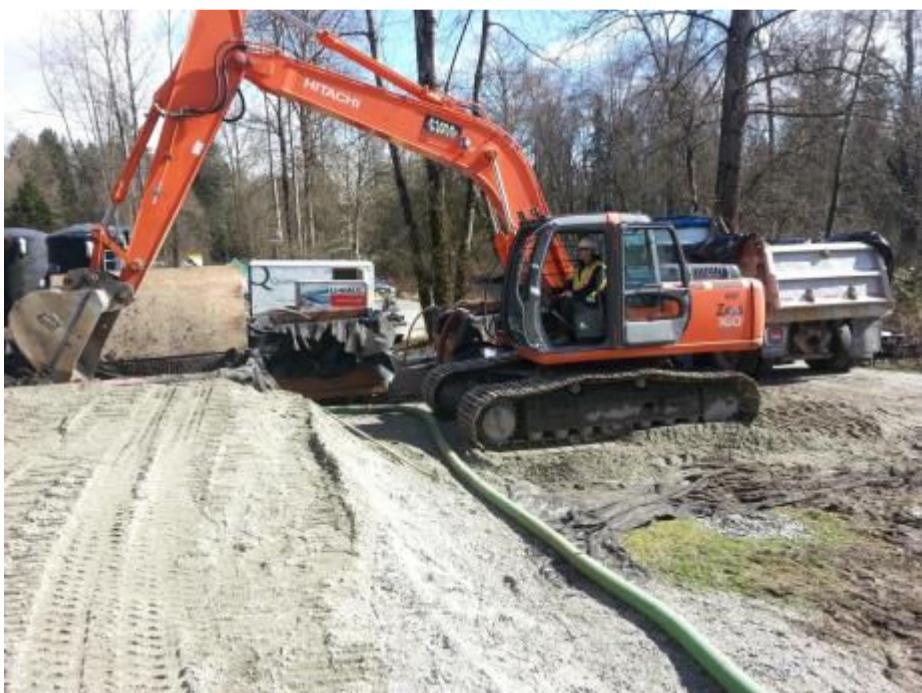
Photo 22. Solids were removed from the coal collection bins by excavator and the material was trucked off site.

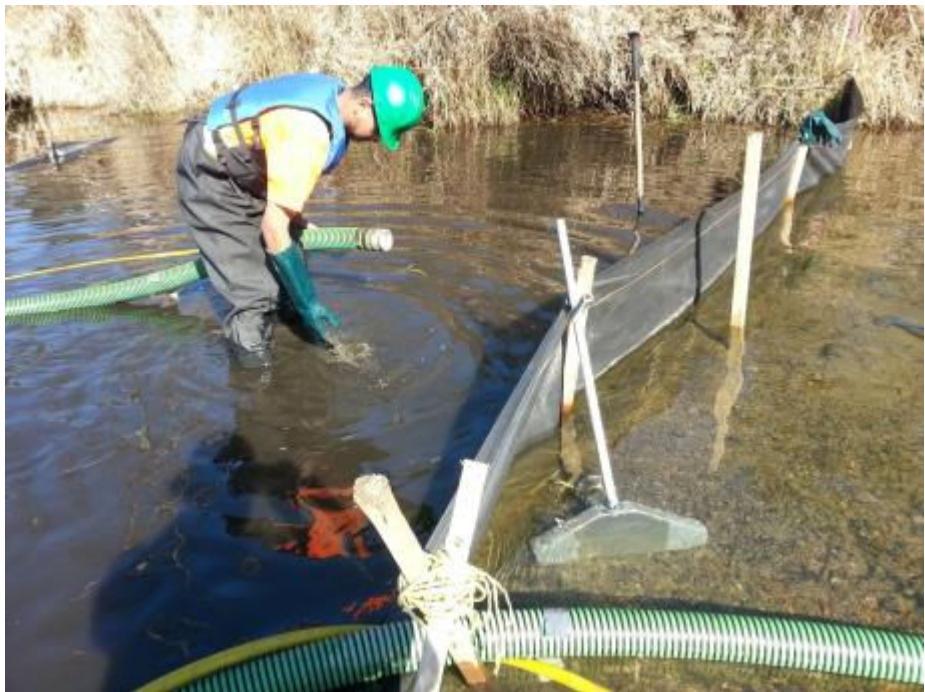
Photo 23. Sediment fencing was used to isolate shallow work areas during the coal recovery program, and proved to be effective at contain turbid water, as demonstrated by this photo.

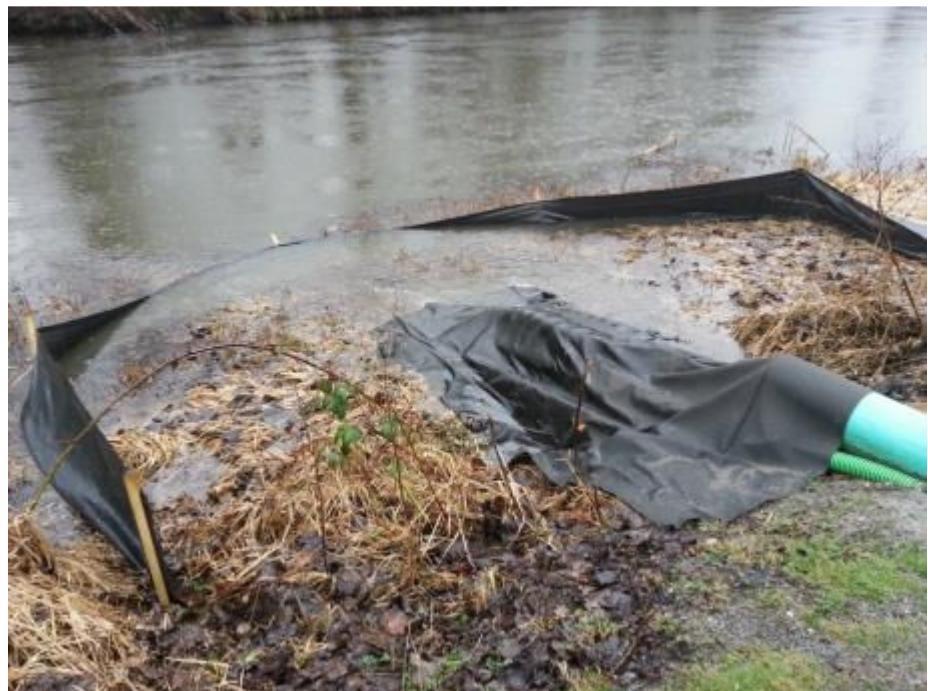
Photo 24. After water was treated it was returned to the lake through filter fabric and silt fence to minimize sediment mobilization at the point of discharge.

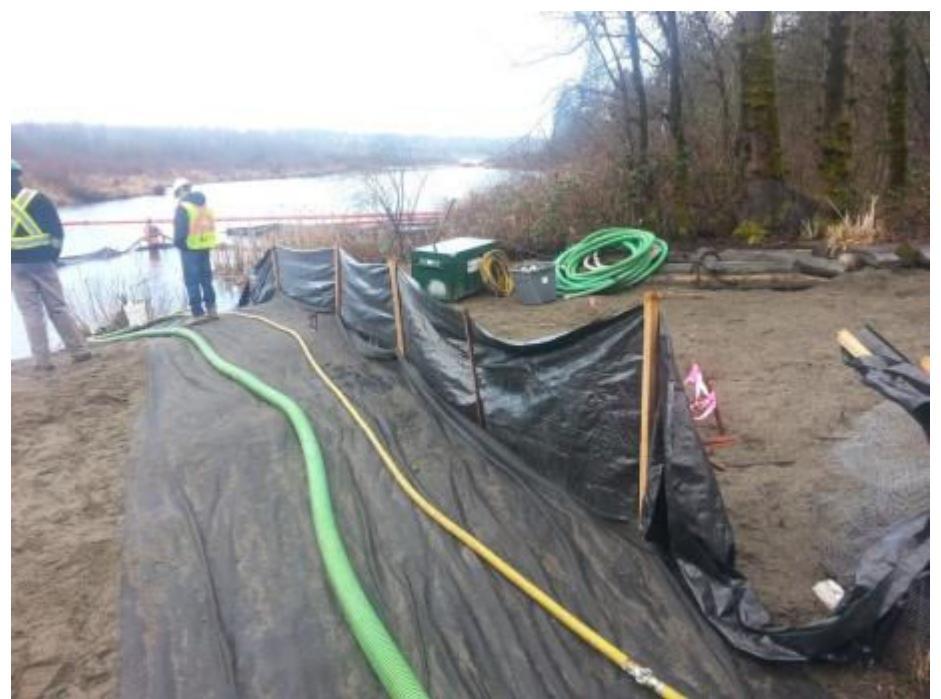
Photo 25. Turtle beach was protected by filter fabric and sediment fence during coal recovery.

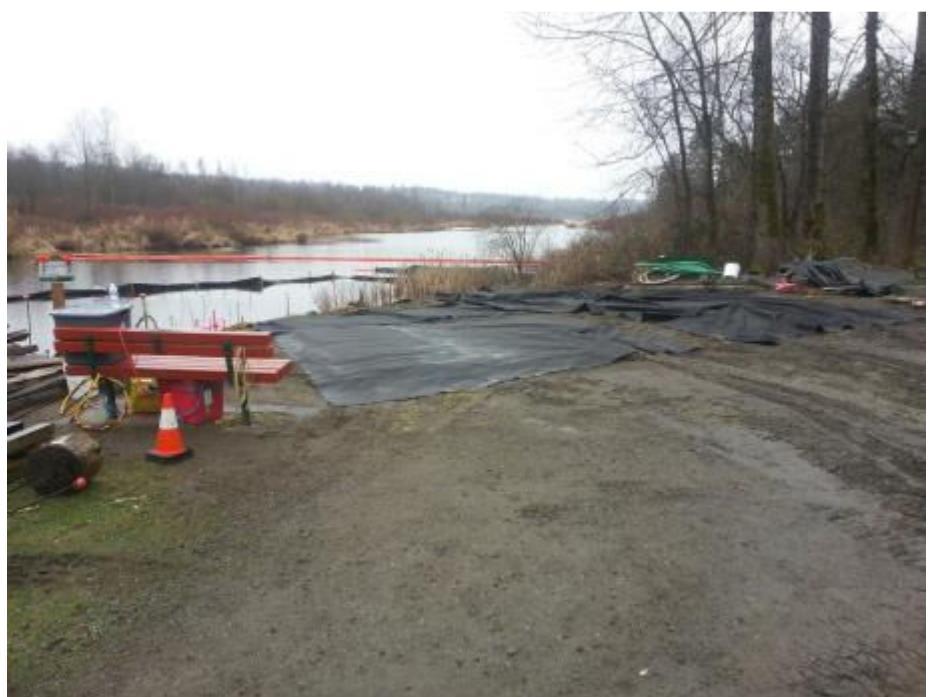
Photo 26. Containment constructed with geotextile, poly and plywood on the nesting beach to distribute the weight of the vac trucks and minimize compaction.

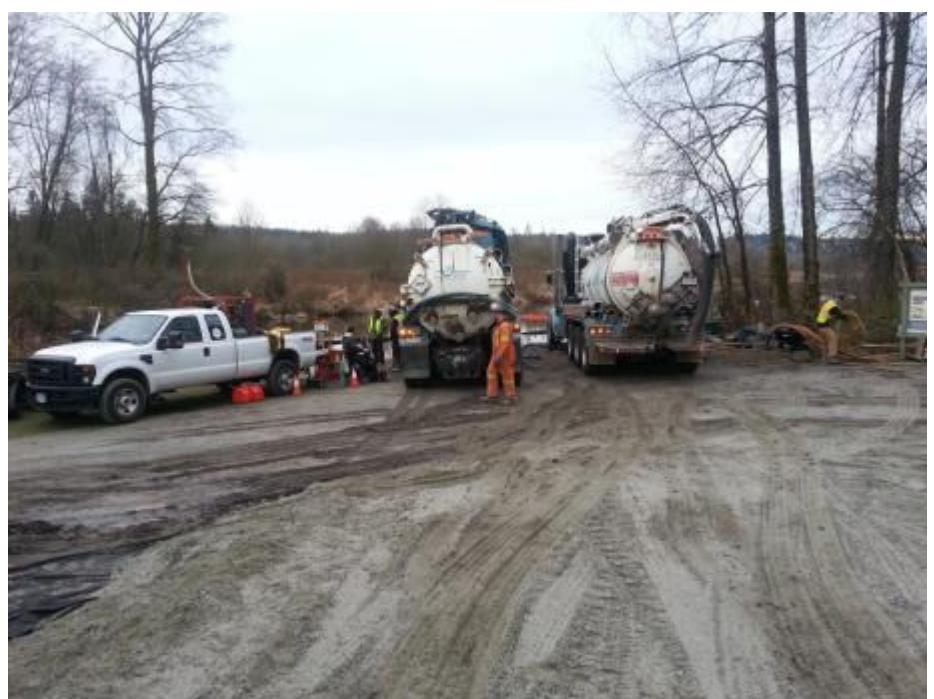
Photo 27. The vac trucks were parked on containment constructed with geotextile, poly and plywood on the nesting beach to distribute the weight and minimize compaction.

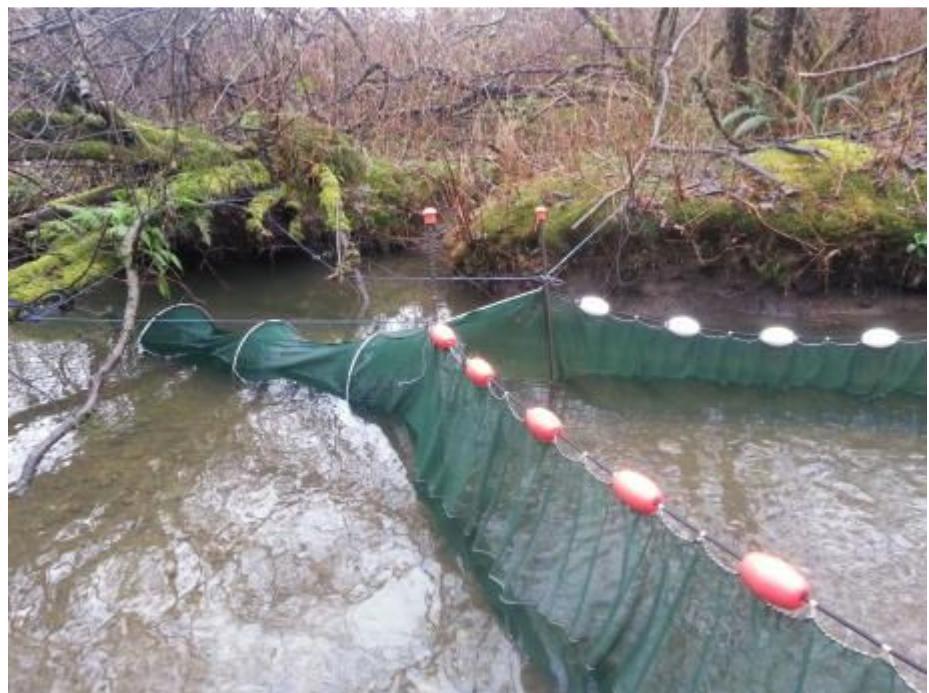
Photo 28. A fyke net was installed upstream of the site in Silver Creek to help segregate the site from fish in Silver Creek and monitor fry emergence.

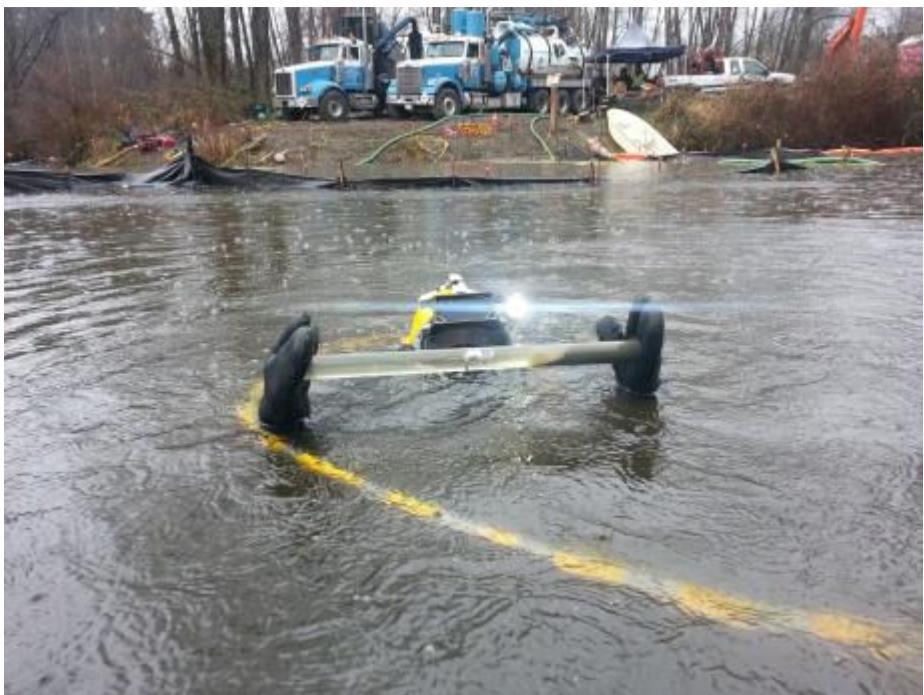
Photo 29. Core samples were collected from various shallow and deep water areas throughout the duration of the coal recovery program in order to evaluate coal recovery and make decisions about subsequent clean-up efforts.

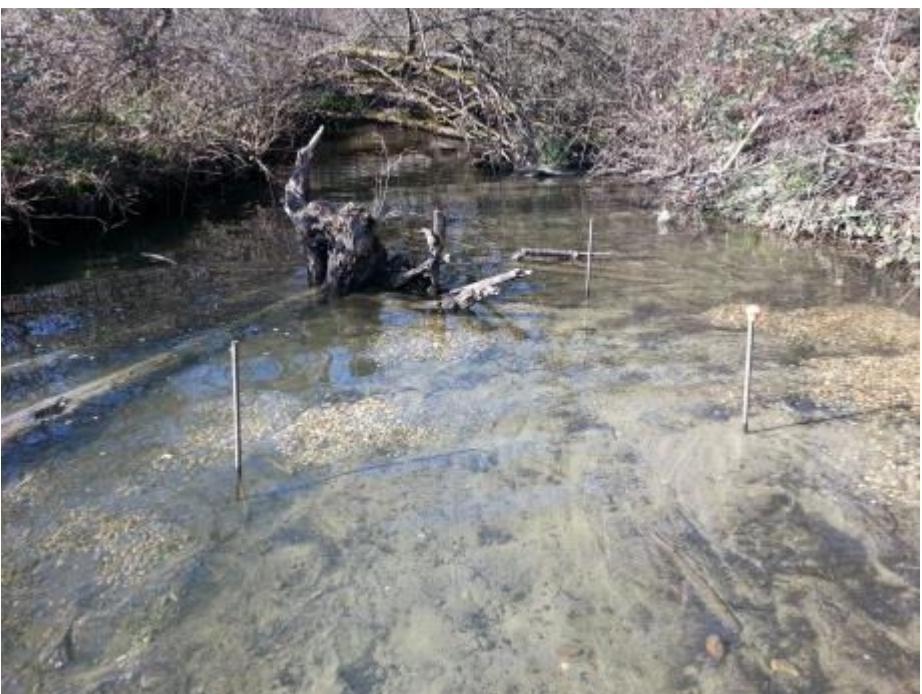
Photo 31. Upstream view near the confluence of Silver Creek and Burnaby Lake after coal recovery was completed.

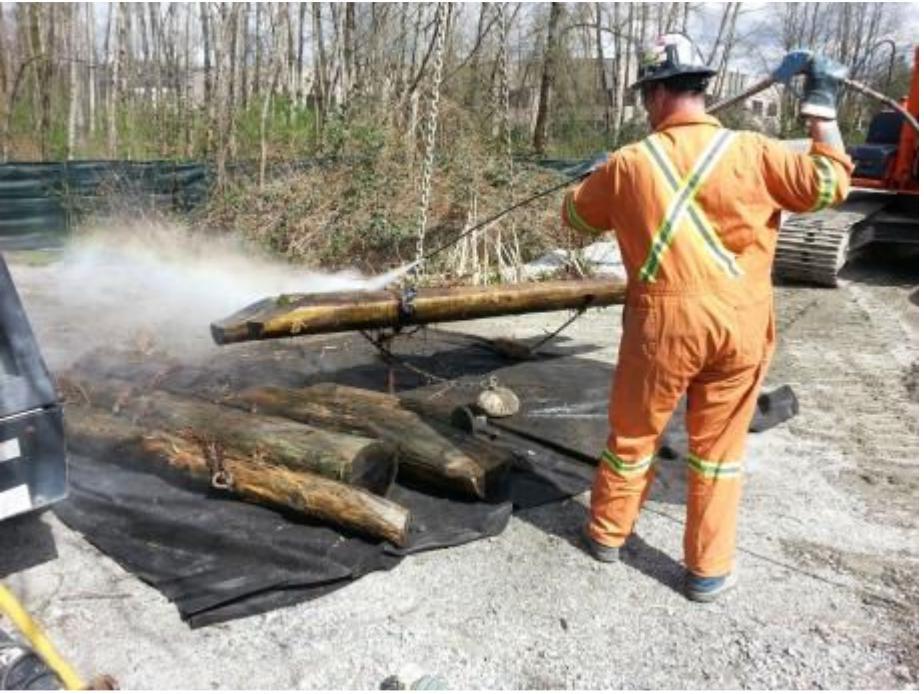
Photo 33. Basking logs were washed off, with clean high pressure water.

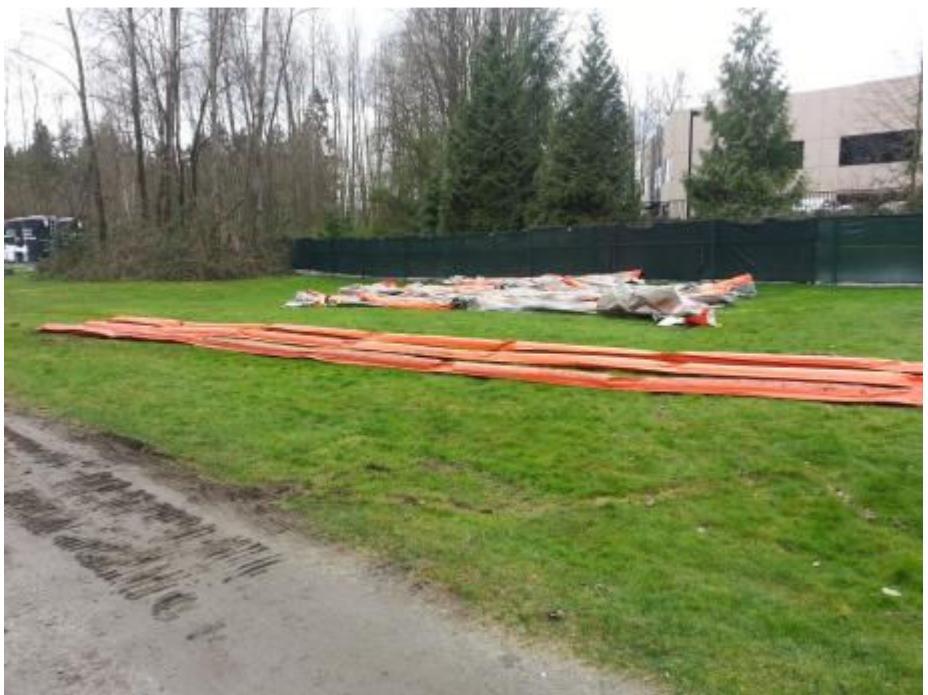
Photo 34. Removal of the sediment curtain and barrier fence began after coal recovery was complete.

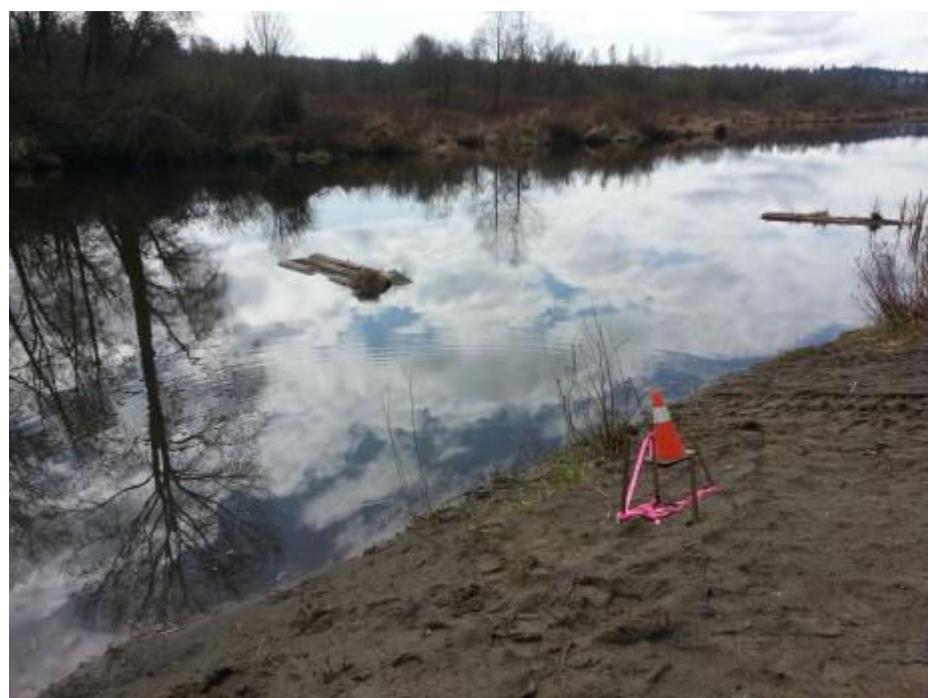
Photo 35. Basking logs were returned to their former position after they had been cleaned and coal recovery was complete.
