Project number: 4435-029 Document number: V3729 Version: 3 Date: September 4, 2014

MILE 122.7 DERAILMENT – COAL RECOVERY REPORT FOR SILVER CREEK AND BURNABY LAKE

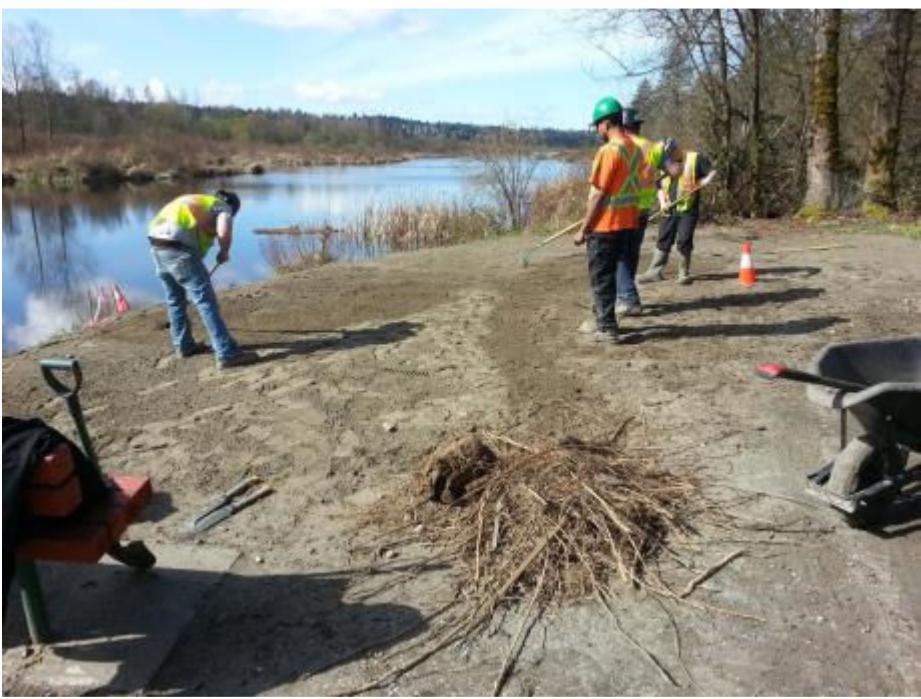
Photo 36. Crews raked the turtle nesting beach to reverse compaction and remove roots and other debris.

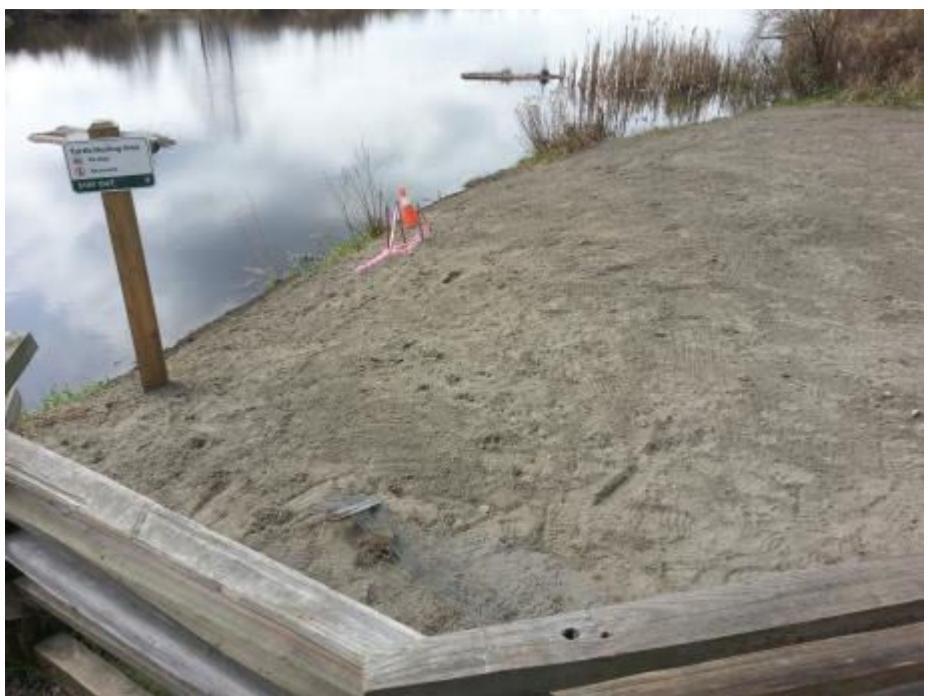
Photo 37. Southwest facing view of the turtle nesting beach after restoration was complete and the pedestrian exclusion fence was replaced.

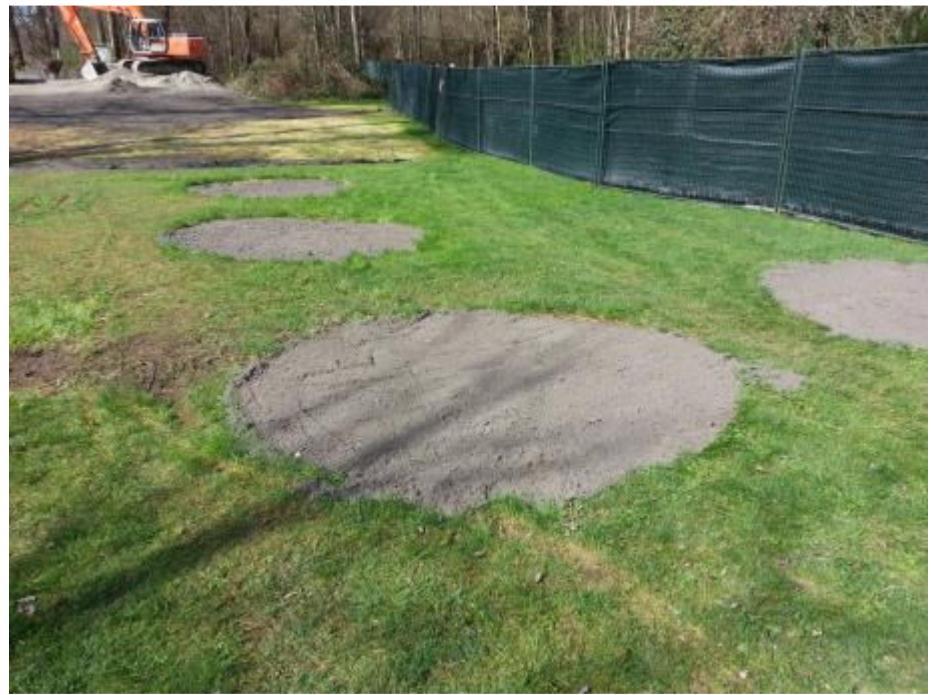
Photo 38. Areas where equipment had been staged were covered with turf soil and seeded for restoration.

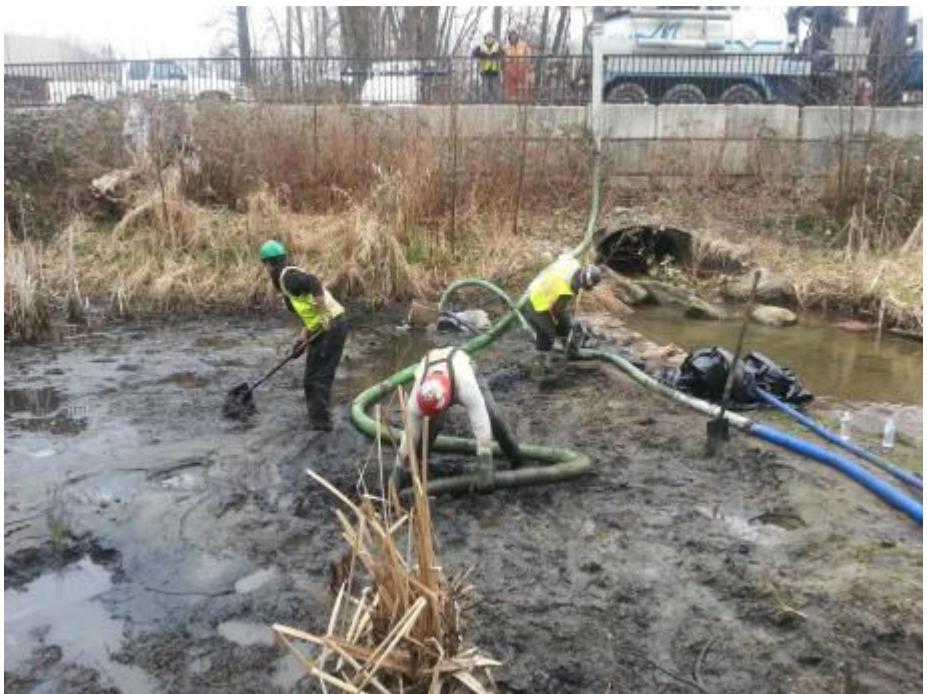
Photo 39. Removal of coal from the off channel habitat area just downstream of the Cariboo Business Park driveway.

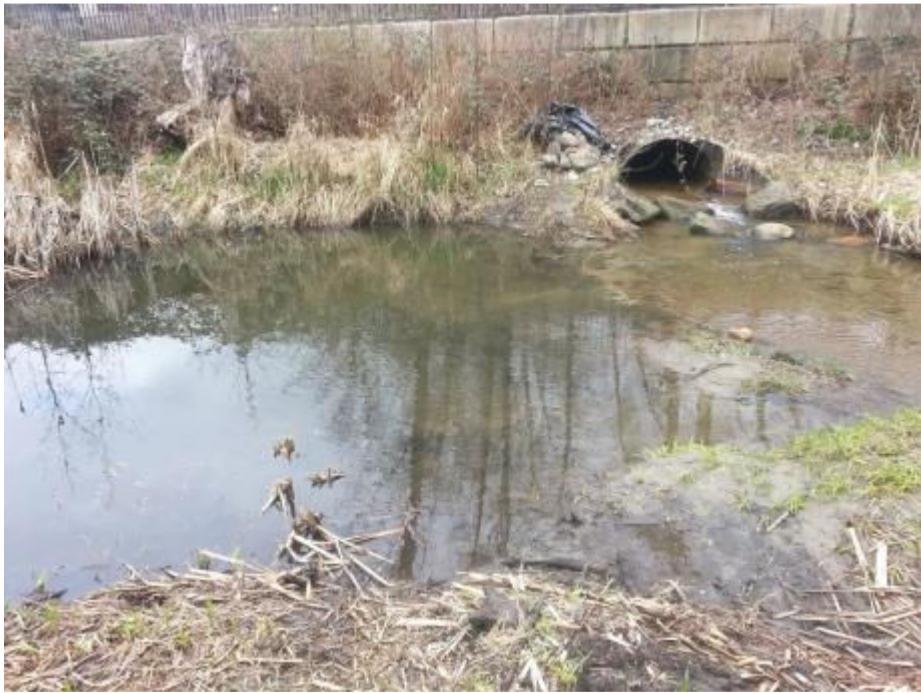
Photo 40. The off channel habitat area near the Cariboo Business Park driveway after coal removal was completed.
