2016

Ministry of Forests, Lands
and Natural Resource
Operations

DETERMINATION OF UNIDENTIFIABLE BRIDGE COMPONENTS – K1629

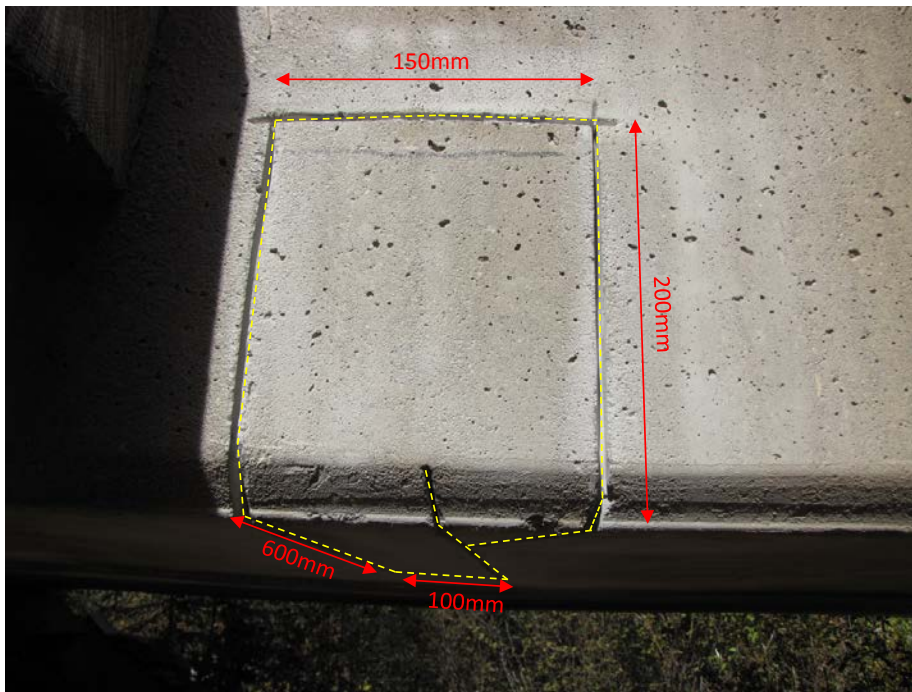
1. Guide lines were marked within 3 metres of the town side end of the bridge on the underside of the outermost upstream slab girder. These were approximately 100m wide and extended past the slab's longitudinal centreline (roughly 500-600mm) – as the reinforcing steel would be expected to be symmetrical about centre line, there was no need to fully expose the full width. Guide lines continued up the side face of the slab past mid-height (roughly 200mm). The width on the side of the slab was increased to approximately 150mm to provide for increased tamping rod maneuverability and grout work in the repair phase. The guide lines can be seen below in Figure 7.

Figure 7: Sawcutting Guidelines Marked Onto Exterior Girder

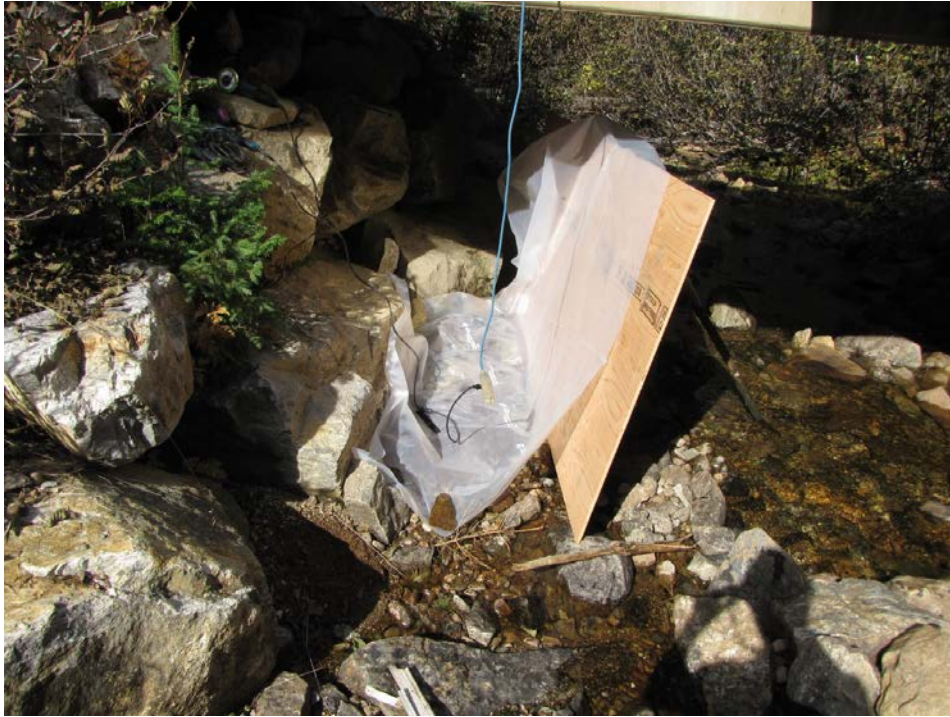
Figure 8: Containment Field for Debris Collection

2. A plywood board overlain with plastic sheeting was placed beneath the work area to capture debris during the sawcutting, chipping and repair works. See Figure 8.

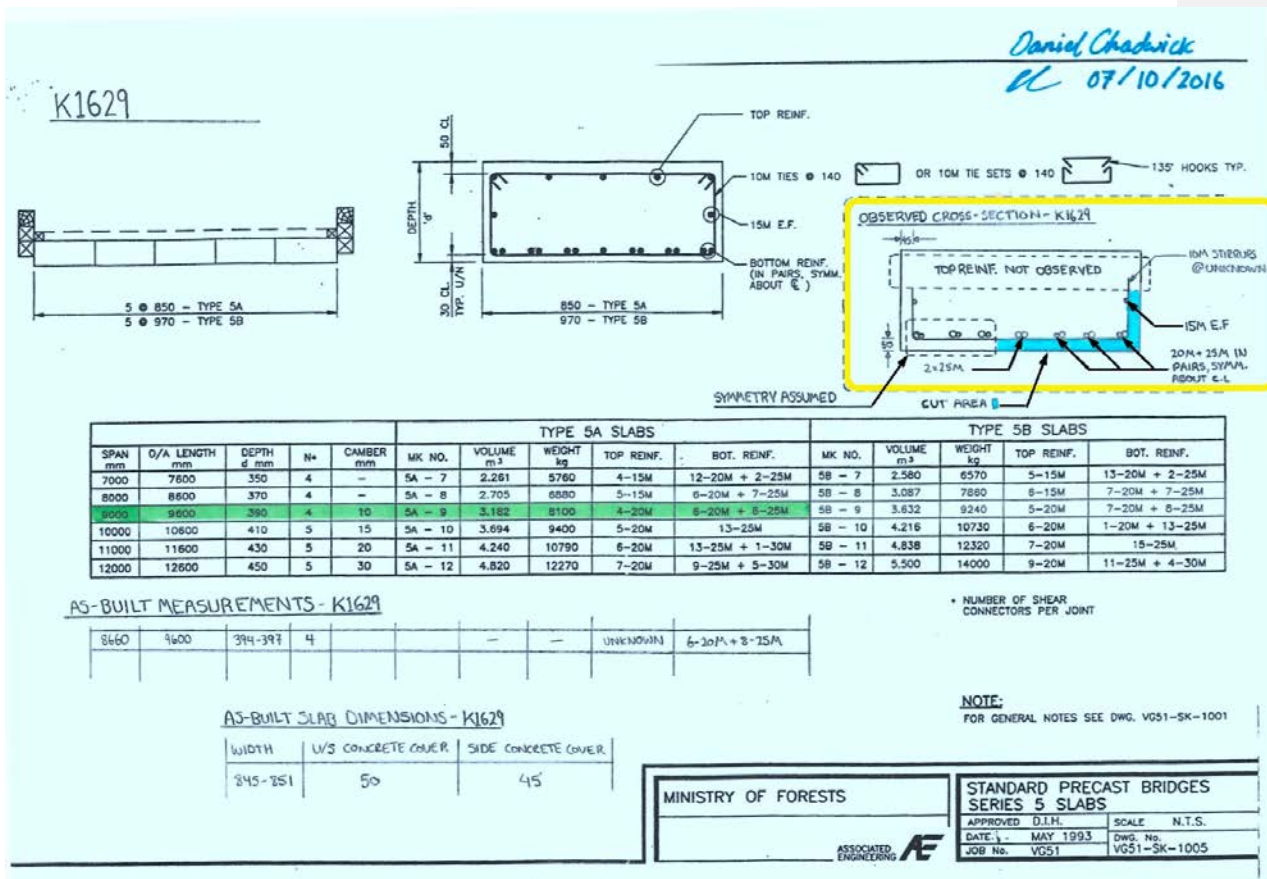
After chipping, it was observed that the underside reinforcement matrix is arranged as three pairs of 20M + 25M and one pair of 25M in the centre. Presuming that the slab is symmetrical about the longitudinal centreline, there would be three pairs of 20M + 25M on either side of the 25M pair. The shear reinforcement (side face) was found to be one 15M bar longitudinally accompanied by 10M stirrups. The top reinforcement and spacing between the stirrups was not observed.

No rust or corrosion was noted on the reinforcement.

This configuration can be seen in the attached Figures 25-28 of Appendix B, and directly below in Figure 14. These results and the measurements taken initially provide a comfortable match with the deck configurations shown in Figure 10 (specifically, the configuration highlighted in green). This figure also provides a hand-drawn sketch of what was observed in the field.

Figure 14: Ministry Standard Bridge Deck Configurations, Type 5 Slabs

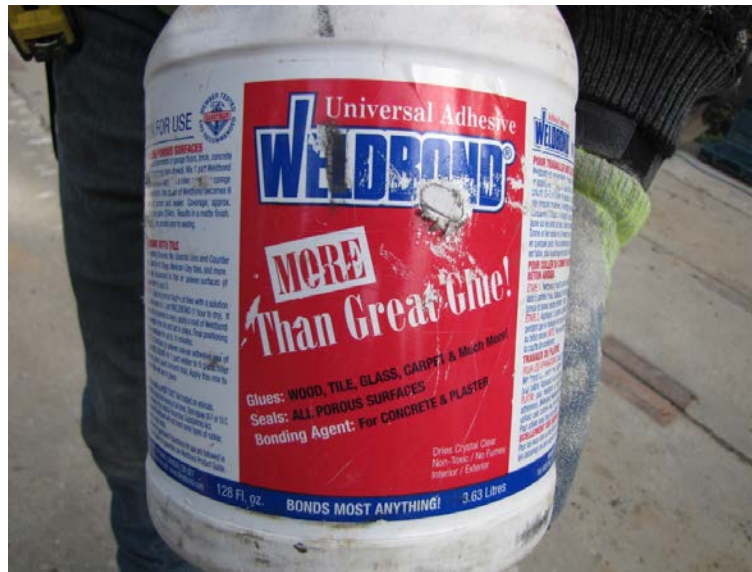
Figure 15: Weldbond Concrete Bonding Agent Used for Patching

1. The exposed area was rinsed with water in order to remove any dust and debris. This was then allowed to dry, achieving a saturated surface-dry condition. This would permit greater bond quality with the grout.
2. Weldbond, as seen in Figure 15, was selected as a bonding agent for the concrete-grout interface. This was prepared using a one-to-five ratio of product-to-water. The solution was applied to the exposed area surface, as seen in Figure 16, and allowed to set for a short time (up to an hour according to manufacturer instructions). At some stage, the solution appeared to have a blue sheen, at which point it was ideal to apply the grout.

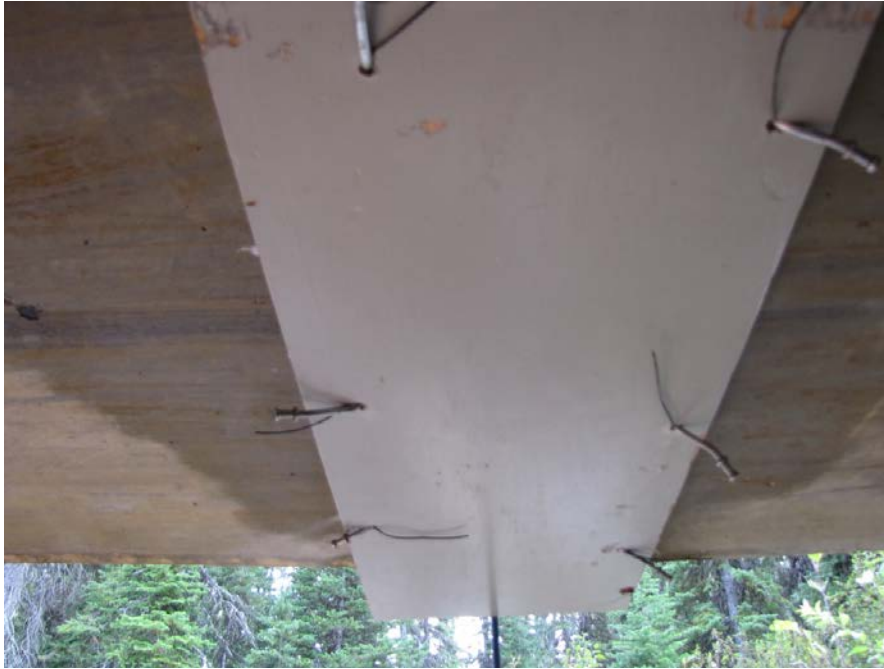
Figure 17: Underside Form for Concrete Repair (Relief Holes Are at the Top of This Image)

3. Formwork was constructed around the exposed area with painted plywood. The form consisted of an underside plywood board approximately 650mm long x 200mm wide. This was fastened by drilling pilot holes into the concrete and fixing with nails and pieces of wire for friction development. Two small holes were drilled in the board near the end of the exposed area. This

would allow for the contractor to estimate when the grout had filled its form. The form can be seen in Figure 17.

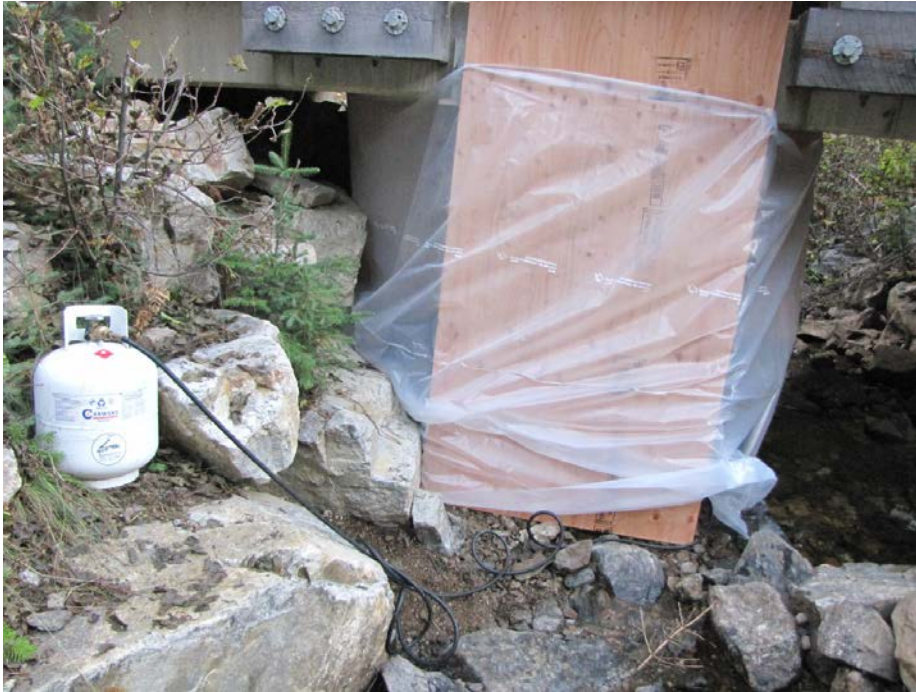
Figure 18: Heating and Hoarding Performed on Repair Works

6. Due to cold temperatures at higher elevations, hoarding and heating was deemed necessary to maintain acceptable curing conditions for the initial setting of the grout repair. Two large plywood sheets were erected against the underside of the bridge, which were enclosed by a polyurethane sheet. A Tiger Torch was placed on the ground within the enclosure. The heat would be trapped by the hoarding apparatus and rise to the grout repair. This setup was left overnight to allow the grout to set (approximately 18 hours). The hoarding apparatus and propane tank supplying the Tiger Torch fuel source can be seen below in Figure 18.

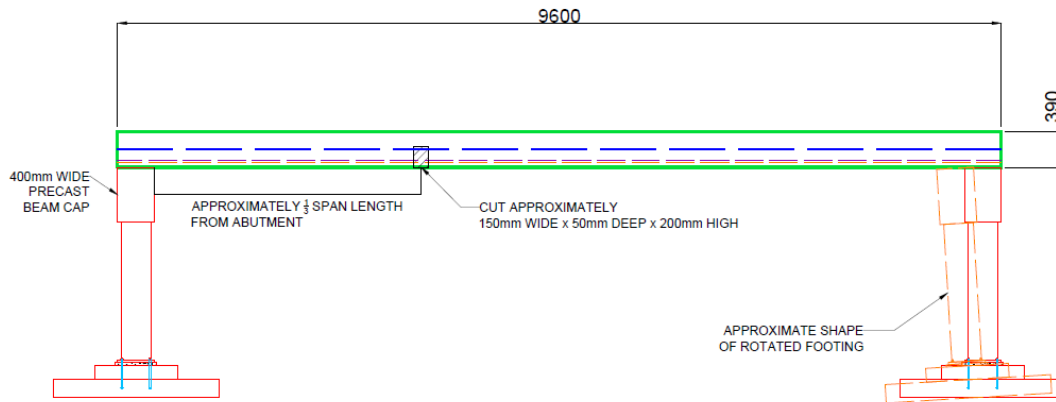
PROFILE

*FOUNDATION TYPE ASSUMED

Figure 25: Profile View of K1629; Note that Foundation Type is Assumed and Unobservable (Ignore Scale)

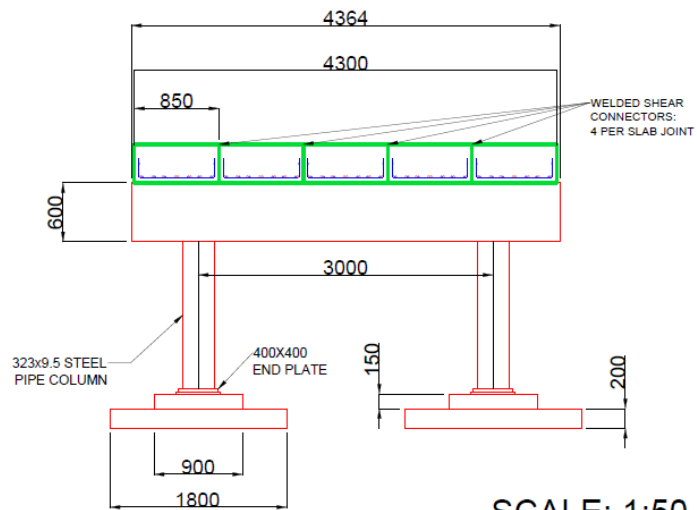
BRIDGE DECK CROSS-SECTION

Figure 26: Bridge Deck Cross-Section; Note that Foundation Type is Assumed and Unobservable (Ignore Scale)

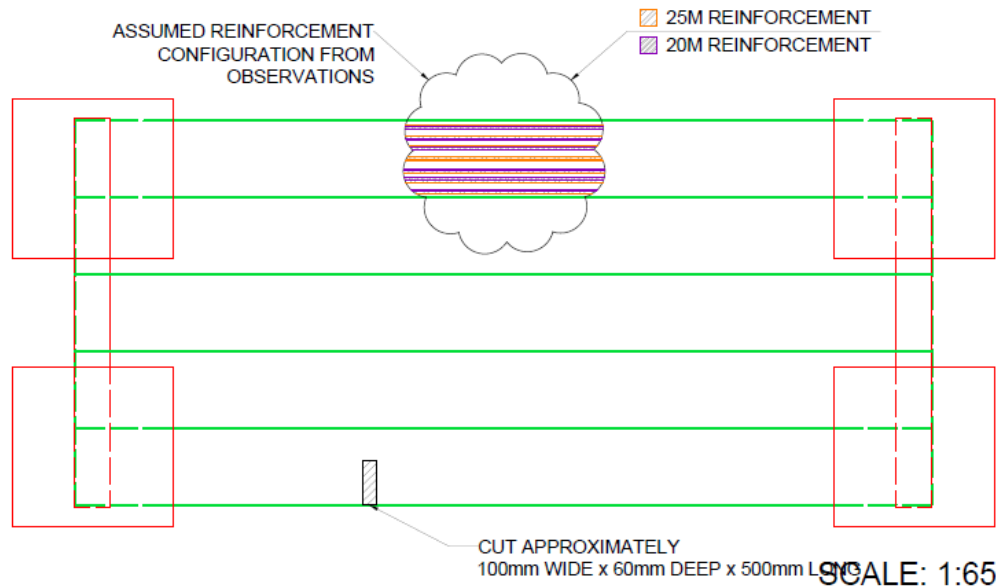
UNDERSIDE

Figure 27: Underside of Bridge Deck; Note Reinforcement Configuration Imposed on Top Slab (Ignore Scale)

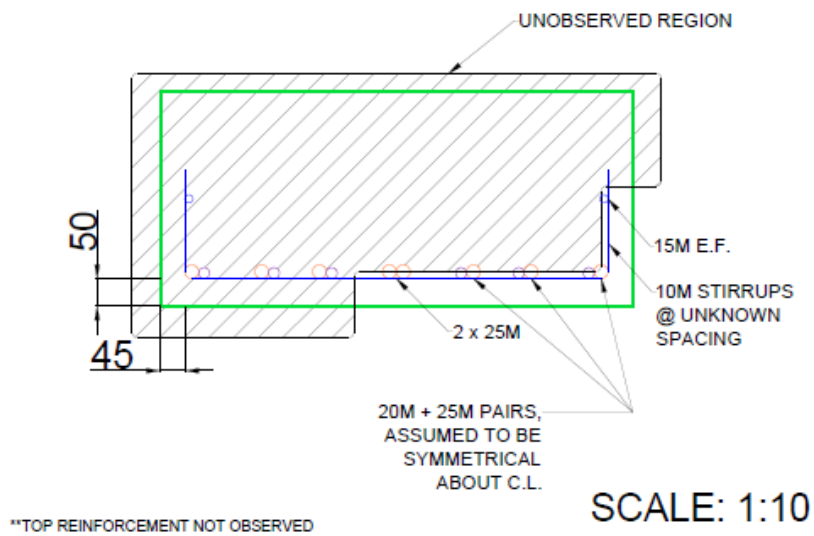
SLAB CROSS-SECTION

**TOP REINFORCEMENT NOT OBSERVED

Figure 28: Slab Cross-Section; Cut-out Section - Bottom-Right (Ignore Scale)
