## MEMORANDUM

**File:** 38000-25/CI Hullcar

**RE:** Memorandum regarding the April 11, 2017 site inspection in Hullcar, BC

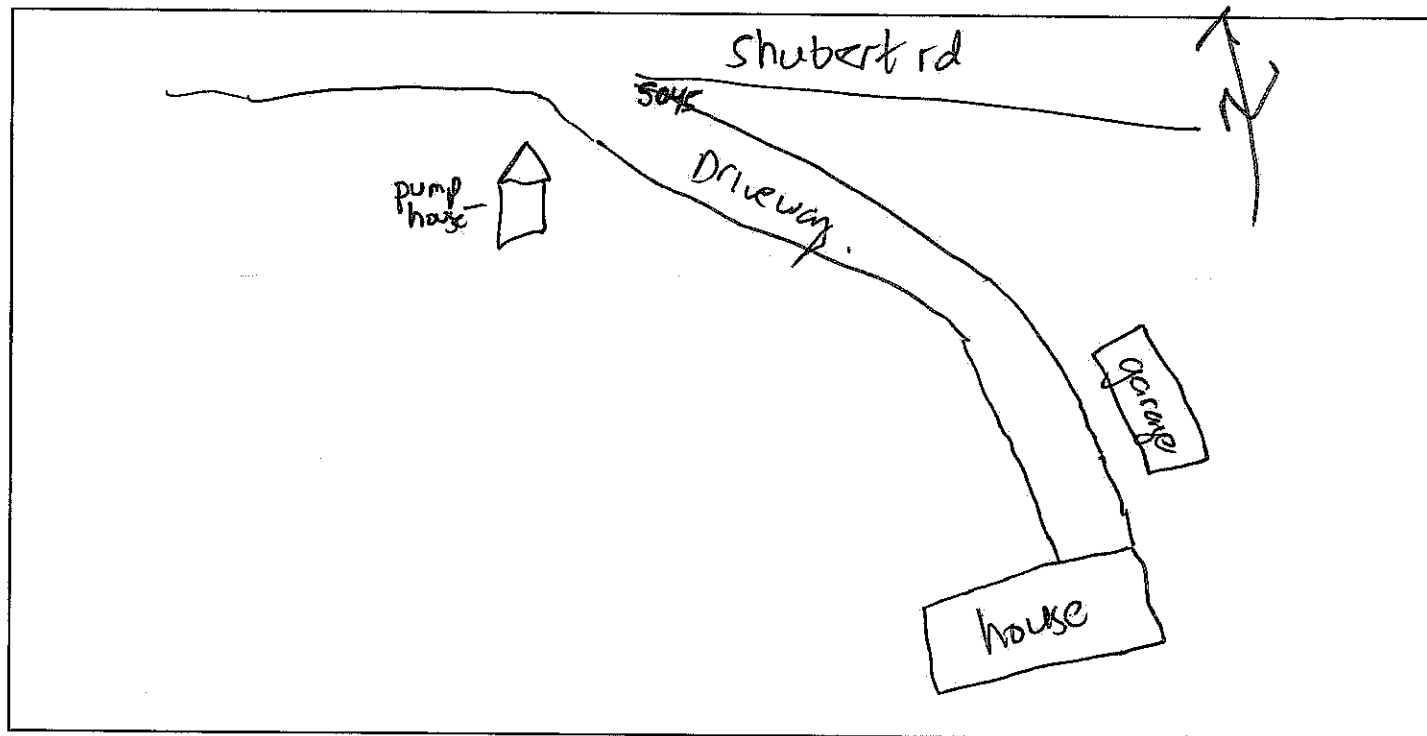
Diagram/Site pictures:

COMMENTS & RECOMMENDED ACTIONS: - owner moved here 6 years ago. - well here  
- well house is typically locked - call first before inspection.  
- well pit ~~pit~~ drained - dry inside.  
- bare ground pump house flat; appears good drainage on outside around pump house.
