June 28, 2023 Project No.: 0272102

Re: Crazy Creek Bridge –Geotechnical Assessment of Scour and Erosion Mitigation Design

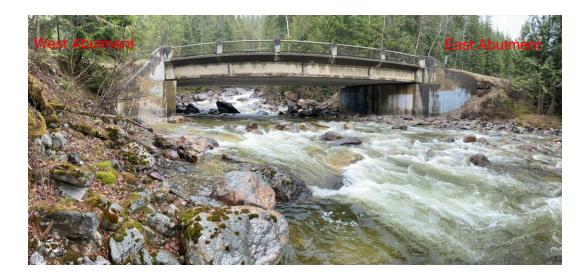
- East abutment area is shown in Photographs 1 to 4 and 10.
- BGC observed that there is no riprap amour against the foundation wall and at the downstream wingwall. Some cobbles and boulders were present at the upstream wingwall.

Photograph 1. View looking northeast (upstream) at the Crazy Creek Bridge (Photograph by BGC taken on April 26, 2023).
