Testing of FLNR Standard Curb Systems

B. Robazza & S.F. Stiemer, Dept. of Civil Engineering, UBC August 2013

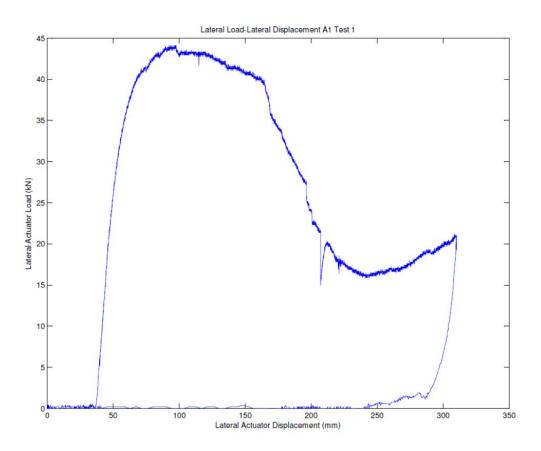
Figure 5: Load/Deflection Curve of Top of Bracket, A-1-1 (Note that initial drop in load corresponded to when the compression concrete on the slab face crushed to the drip groove)

Panels A, B and C all failed primarily due to crushing of the compression concrete beneath the anchors and up until the inset drip groove. There was very little surface cracking on the top of the panels as the relatively small compression zone of the bottom portion of the panel failed at load levels low enough that there was little strain on the anchors. The cracking was located only on the bottom side of the panel in the form of diagonal shear cracks extending to the drip groove from which they terminated. After the compression zone crushed and spalled away, the loads were transferred almost entirely through bending to the botts connecting the brackets to the panels. In one instance, bolt failure eventually occurred after significant bending stress and strains had been induced within the bolts.

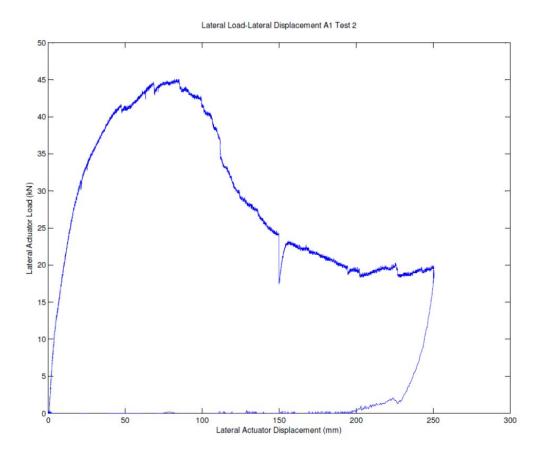
Figure 7: Load/Deflection Curve of Top of Bracket, A-1-2 (Note that initial drop in load corresponded to when the compression concrete on the slab face crushed to the drip groove)

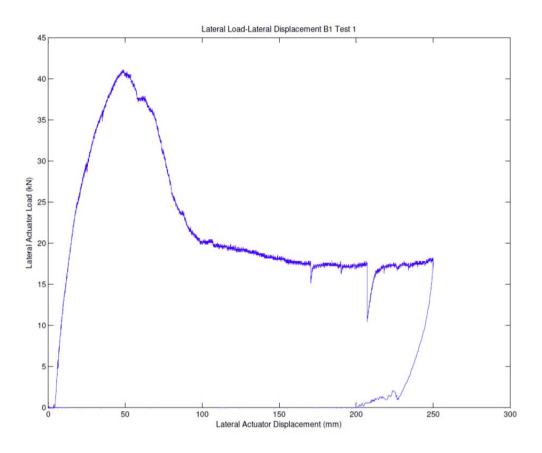
Figure 9: Load/Deflection Curve of Top of Bracket, B-1-2 (Note that initial drop in load corresponded to when the compression concrete on the slab face crushed to the drip groove)

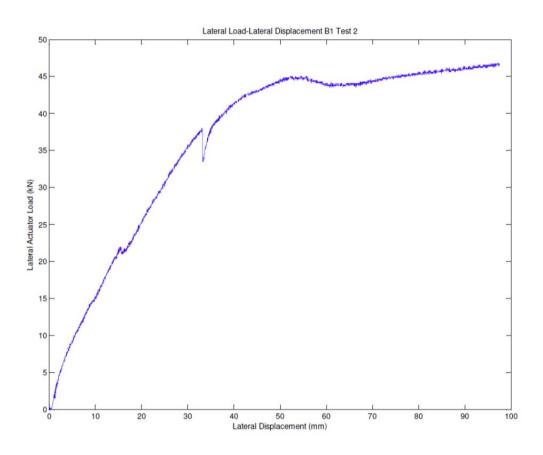
Figure 11: Load/Deflection Curve of Top of Bracket, B-1-2 (Note that drop in stiffness corresponded to when the compression concrete on the slab face crushed to the drip groove, after this point the load was entirely carried by the bending of the bolts. The test was halted as safety became a concern after this point)

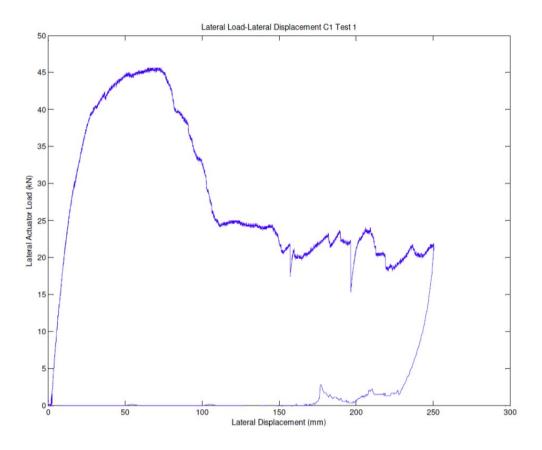
Figure 13: Load/Deflection Curve of Top of Bracket, C-1-1 (Note that initial drop in load corresponded to when the compression concrete on the slab face crushed to the drip groove)

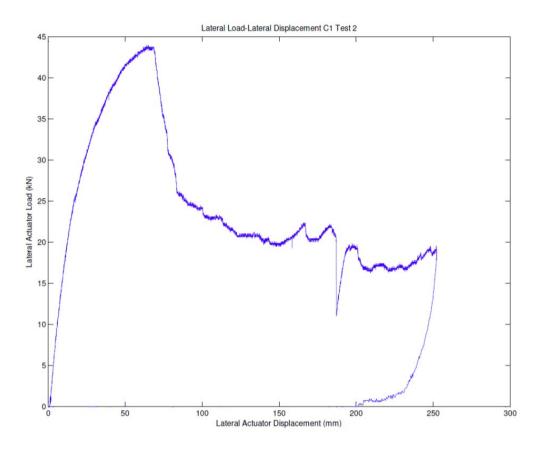
Figure 15: Load/Deflection Curve of Top of Bracket, C-2-1 (Note that initial drop in load corresponded to when the compression concrete on the slab face crushed to the drip groove)

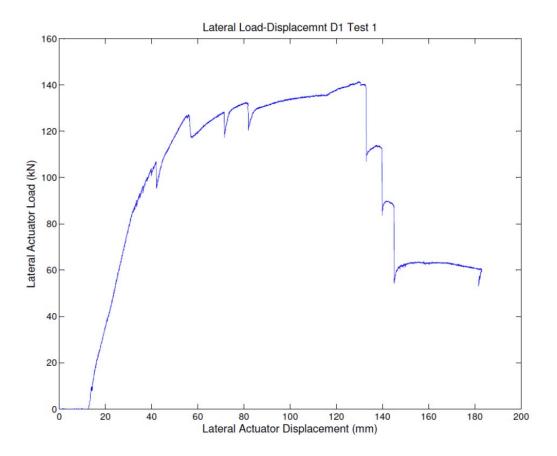
Figure 21: Load/Deflection Curve of Top of Bracket, D-1-1 (Note drops in load correspond to roughly the capacity of one of the four main anchor rods as they fractured in sequence)

Panels D and E failed primarily due fractures of the exterior anchors with the most development length. After the majority of these four anchors had fractured, the interior four short anchors with insufficient development length would begin to pull out along their length. Interestingly, the most exterior, well developed anchor bars would fracture prior to the adjacent bars. This behaviour is not fully understood and may be due to varying workmanship during the welding. The cracking for these panels was extensive. On the top surface, the cracking consisted of flexural cracks extending over the breadth of the panels perpendicular to the loading. These cracks developed from roughly 300 mm from the bracket to the support holes on the opposite side of the panel. On the top surface near the bracket there were diagonal shear cracks forming a semicircular shape extending 250 mm along the length of the panel and 200 mm on either side of the bracket along the breadth of the panel. On the side face of the panel there were diagonal cracks formed at approximately 30° angles on either side of the bracket. On the bottom face of the panel, diagonal shear cracks extended from the bracket to the drip groove.

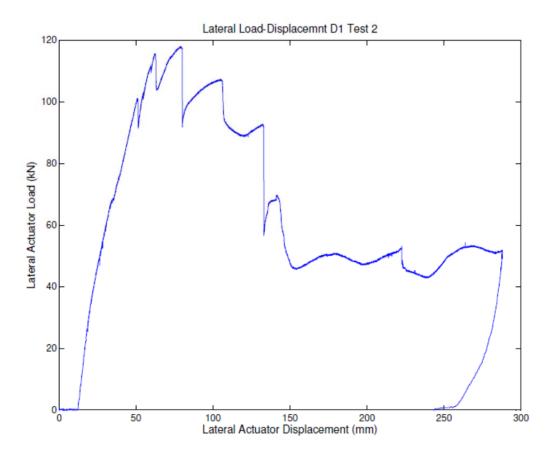
Figure 24: Load/Deflection Curve of Top of Bracket, D-1-2 (Note that the major drops in load correspond to anchor fracture and/or slippage)

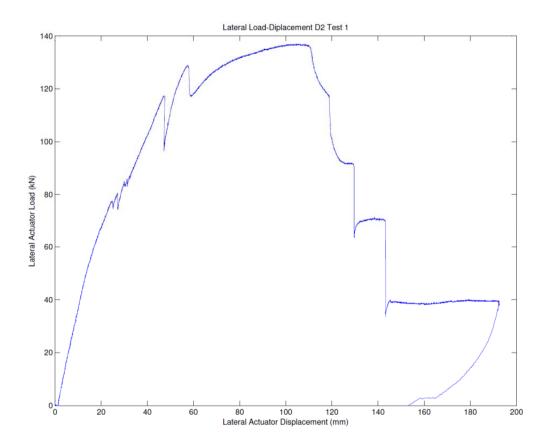
Figure 26: Load/Deflection Curve of Top of Bracket, D-2-1 (Note drops in load correspond to roughly the capacity of one of the four main anchor rods as they fractured in sequence)

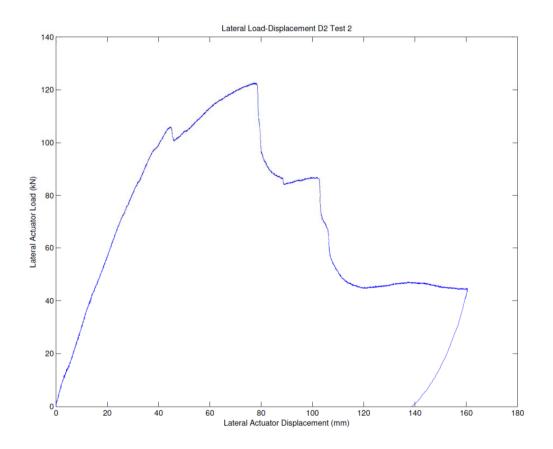
Figure 28: Load/Deflection Curve of Top of Bracket, D-2-2 (Note drops in load correspond to roughly the capacity of one of the four main anchor rods as they fractured in sequence)

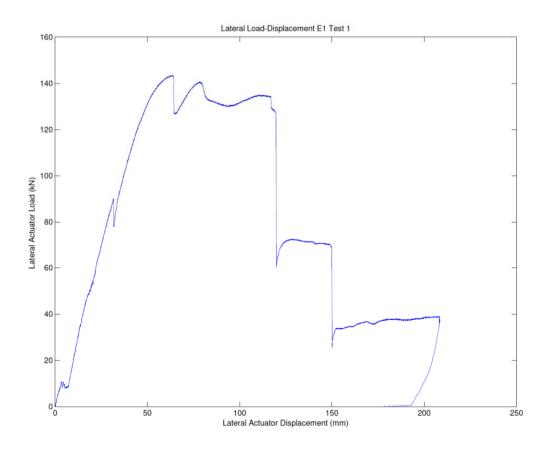
Figure 30: Load/Deflection Curve of Top of Bracket, E-1-1 (Note drops in load correspond to roughly the capacity of one of the four main anchor rods as they fractured in sequence)

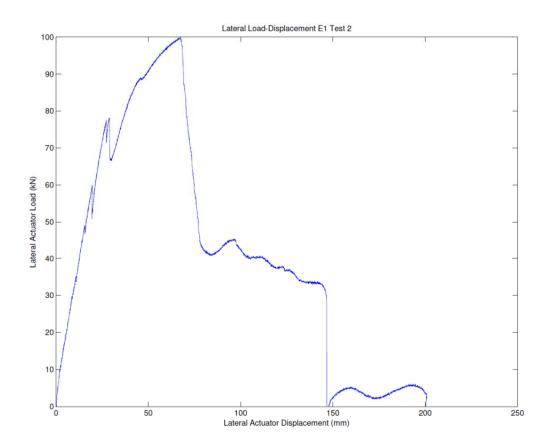
Figure 32: Load/Deflection Curve of Top of Bracket, E-1-2 (Note initial slipping of support apparatus caused initial drops in load during the initial portion of the loading curve. There may have been an initial preload of roughly 50 kN which resulted in the low lateral load capacity of this specimen)

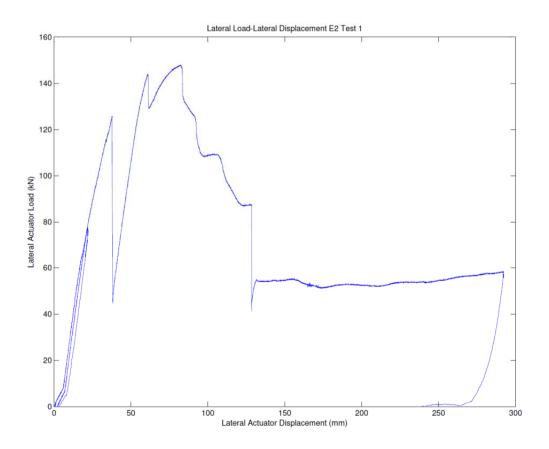
Figure 34: Load/Deflection Curve of Top of Bracket, E-2-1 (Note drop in load of 83 kN at lateral displacement of 39 mm due to panel support apparatus shifting under load)

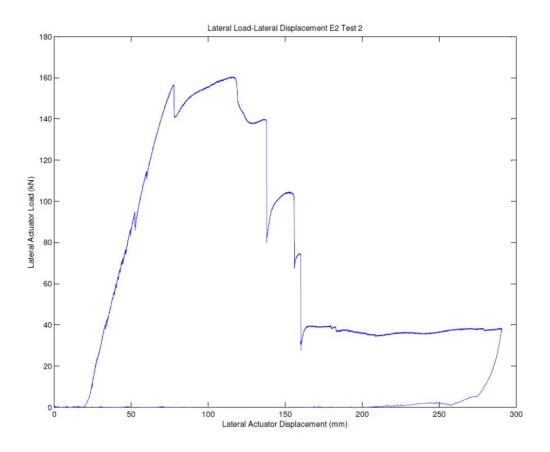
Figure 36: Load/Deflection Curve of Top of Bracket, E-2-2 (Note that the major drops in load correspond to the capacity of an anchor bar as it fractured)

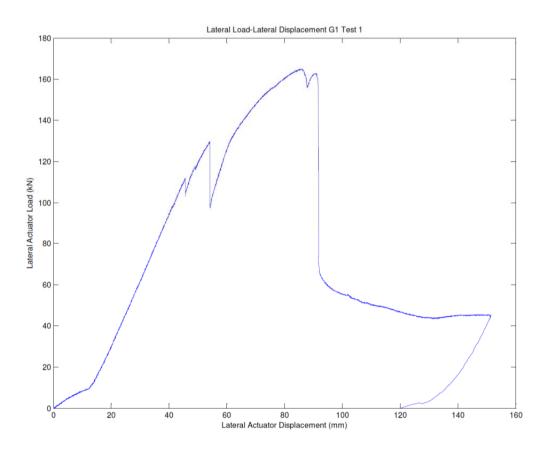
Figure 38: Load/Deflection Curve of Top of Bracket, G-1-1 (Note that the primary failure mechanism was characterized by the concrete cover above the Nelson studs breaking away as the rigid studs reached a critical curvature demand)

Panels G and H failed due to cover spalling on the top surface as the highly rigid Nelson studs experienced high levels of curvature. There were first flexural cracks extending over the length of the panel similar to what was observed for Panels D and E above. This was followed by shear cracks forming on the top surface at a distance corresponding to the length of the Nelson studs. At the peak load, the Nelson studs would spall off the cover concrete. At this point the load would remain nearly constant as the remaining anchors pulled out of the concrete. Similar to the D and E Panels, the cracking on the sides and bottom consisted of diagonal shear cracking to the bottom of the panels and the drip groove respectively.

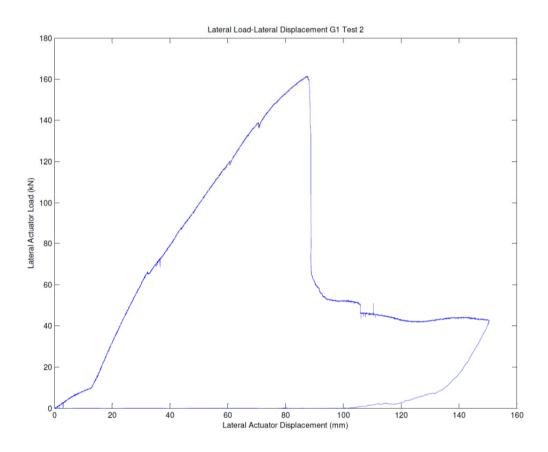
Figure 42: Load/Deflection Curve of Top of Bracket, G-1-2 (Note that the primary failure mechanism was characterized by the concrete cover above the Nelson studs breaking away as the rigid studs reached a critical curvature demand)

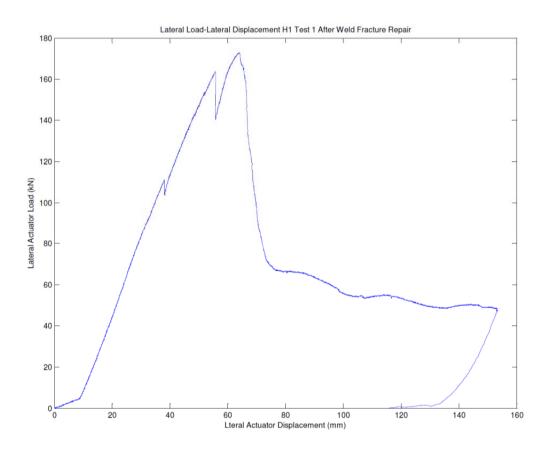
Figure 44: Load/Deflection Curve of Top of Bracket, H-1-1 (Note that the primary failure mechanism was characterized by the concrete cover above the Nelson studs breaking away as the rigid studs reached a critical curvature demand)

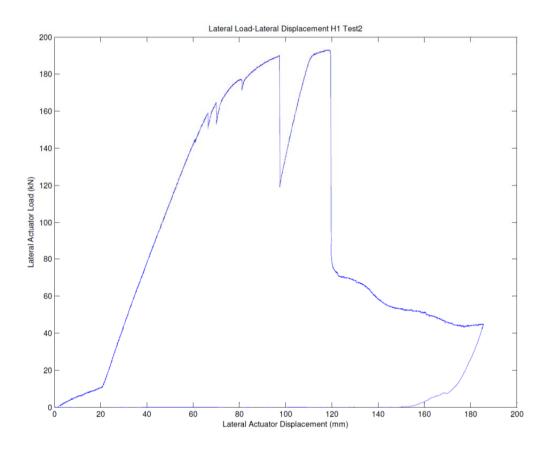
Figure 47: Load/Deflection Curve of Top of Bracket, H-1-2 (Note the major drop in load at 97 mm lateral displacement was caused by the slippage of the support apparatus. Also note that the primary failure mechanism was characterized by the concrete cover above the Nelson studs breaking away as the rigid studs reached a critical curvature demand)

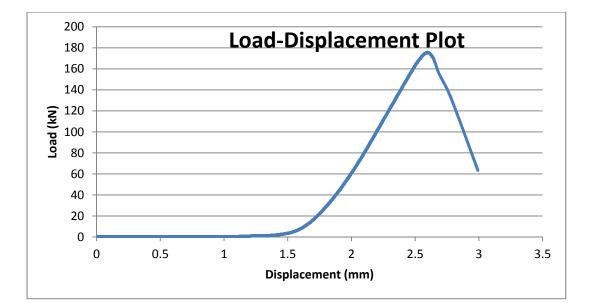
Figure 53: Core Compression Test E-1

Note: Samples 675D, 676D, D1, D2, and E1 had raw ends, which was causing earlier failure due to uneven loading.

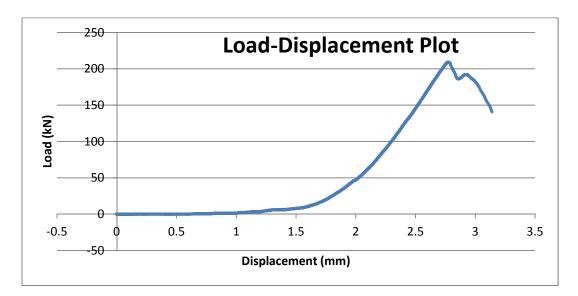
Figure 54: Core Compression Test 675D

675D	Originally cast cylinder faces exhibiting columnar type fracture		
676D	676D Originally cast cylinder faces exhibiting columnar type fracture
