ALASKA HIGHWAY #97N CORRIDOR IMPROVEMENT STUDY

DAWSON CREEK TO FORT ST. JOHN, BC

FINAL REPORT

March 2008
H-08321.00

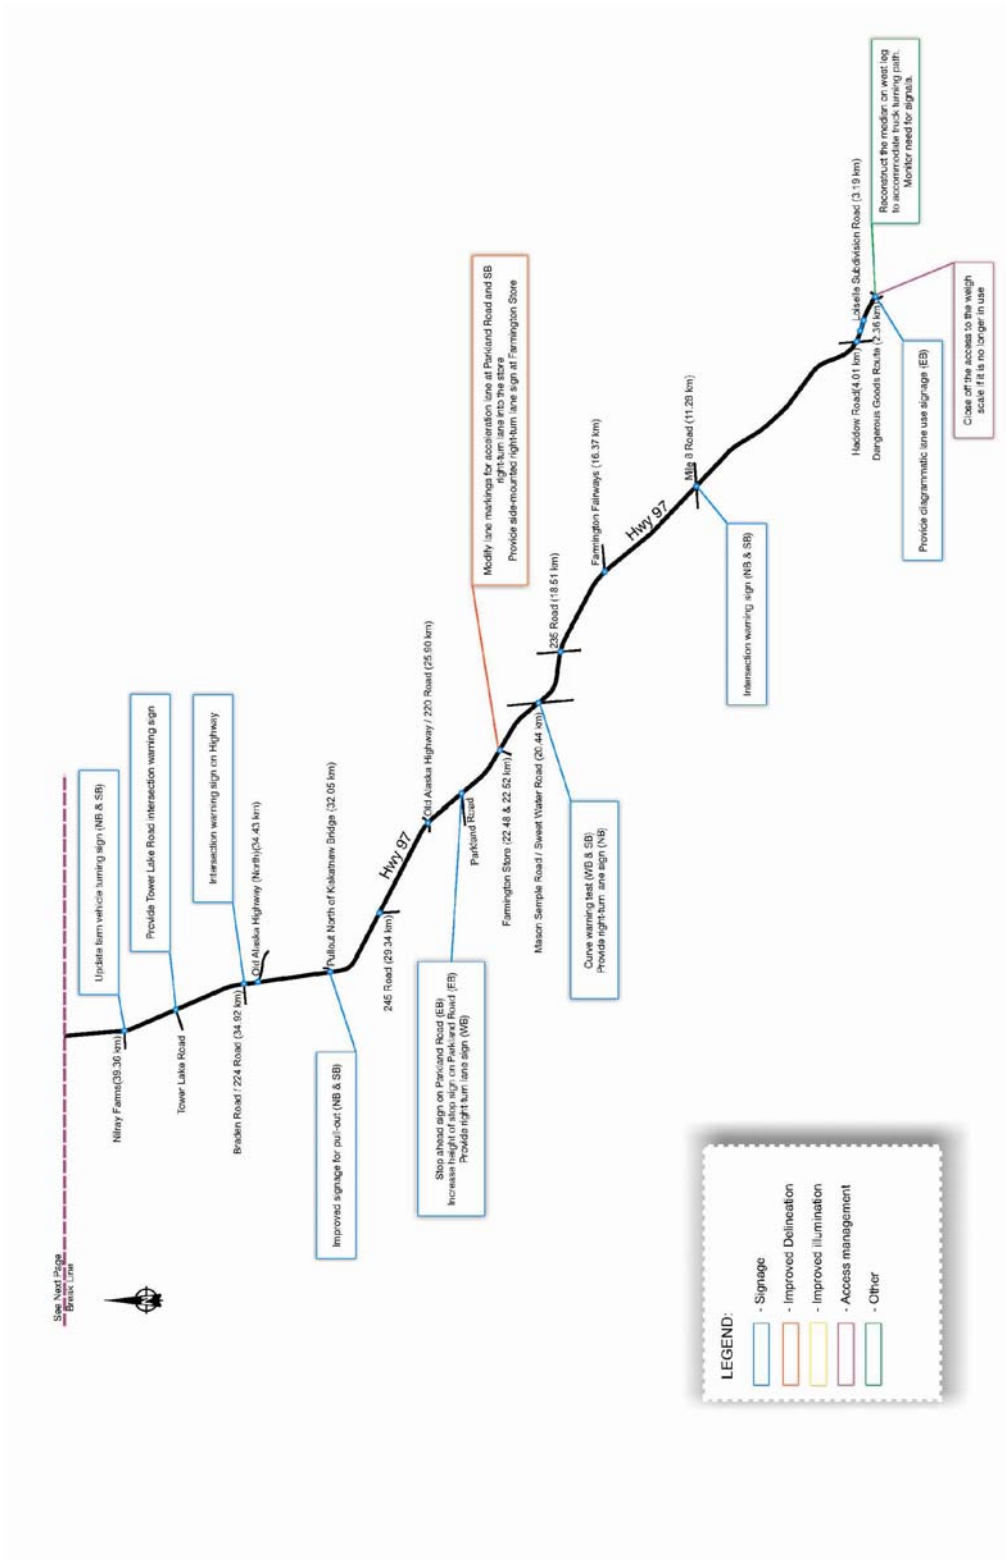
FIGURE 4.1A SHORT TERM IMPROVEMENTS – SOUTH SECTION

Short-term improvements recommended for specific intersections mainly consist of improving signage, delineation, illumination, and access management as shown in FIGURES 4.1A and 4.1B. Sign improvements are summarized in TABLE 4.1, other improvements are summarized in TABLE 4.2.

Upon conducting field observations, signage improvements are recommended at many of the intersections, summarized in TABLE 4.1. Where major intersections are not as conspicuous as they could be, advance intersection signing is recommended.

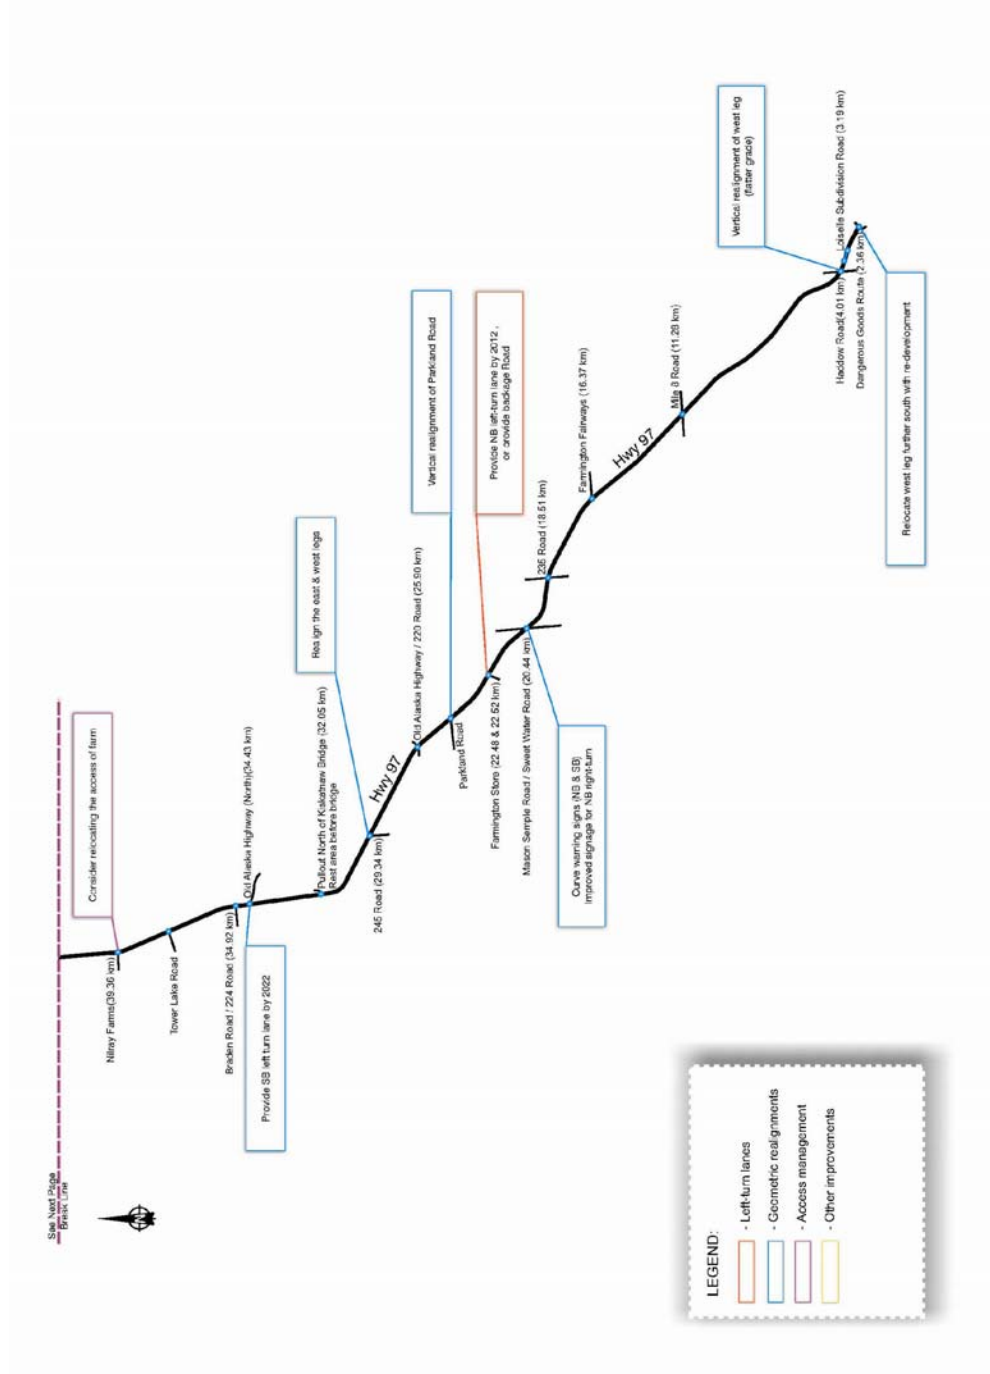
FIGURE 4.3A LONG TERM IMPROVEMENTS – SOUTH SECTION

Based on the results of the site visits, capacity analysis, collision analysis and site visits, numerous issues were identified at intersections. The issues and potential solutions are summarized in FIGURES 4.3A and 4.3B, as well as TABLE 4.2.

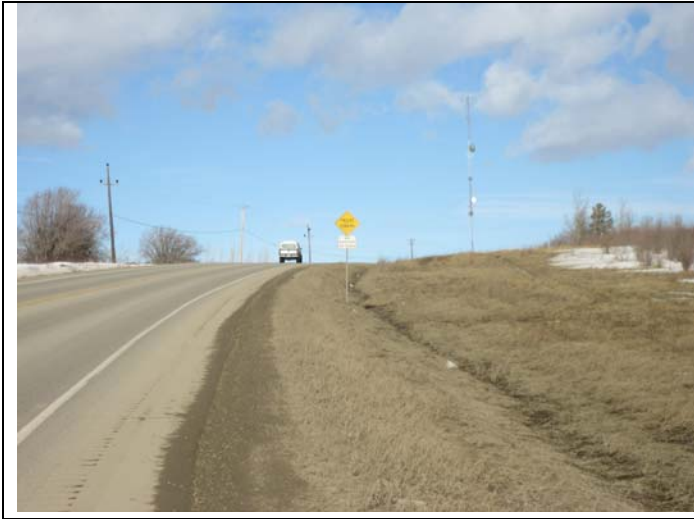
Intersection of Gagne and Collins (Road 230) and Alaska Highway #97N

PHOTO	ISSUE
	<p>Southbound Approach</p> <p>Lighting is not provided at the intersection.</p> <p>Sight distance to the south from both the westbound and eastbound approaches is limited by the horizontal and vertical curves.</p>

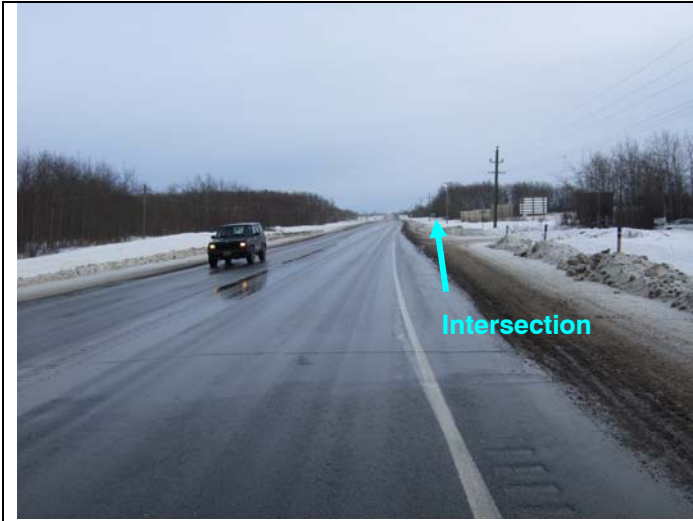
Southbound Approach

The intersection is inconspicuous from the southbound approach.
